# MUAZUDDIN TEXTILE LTD (Extension 3)

B31 PLOT # 235/236, EAST CHANDURA, SHOFIPUR, KALIAKOR, GAZIPUR.

21 April 2024

B+G+2: Chemical & Fabric Store Building.

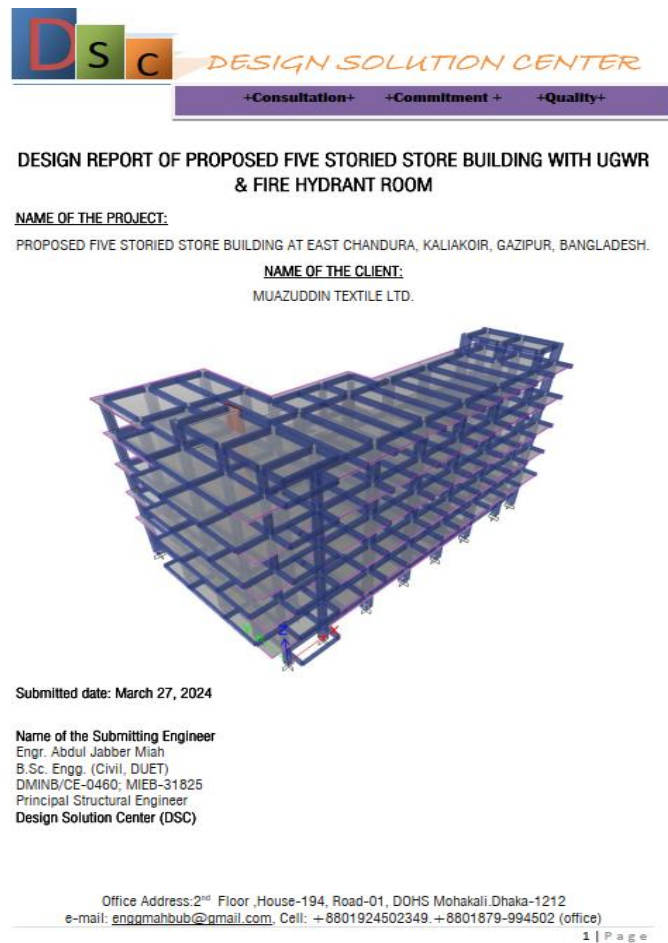
### Observation-1: Inconsistencies in the design report. (Chemical & Fabric Store Building)

**Description:** Special Moment Resisting Frame (SMRF) is considered as a structural system. No detailed calculation was provided to justify the SMRF detailing. The building engineer is required to review the seismic load design parameters used in the design report. The building engineer is required to confirm the seismic detailing and amount of rebar by ferro scanning or pictorial evidence during the construction period if required.

| CAP Item No | Observation | Action Plan | Timeline |
|---|---|---|---|
| 1 | Inconsistencies in the design report. (Chemical & Fabric Store Building) | The building engineer is required to review the seismic load design parameters used in the design report. | within 6 weeks |
| 2 | | The building engineer is required to confirm the seismic detailing and amount of rebar by ferro scanning or pictorial evidence during the construction period if required. | within 6 weeks |
| 3 | | Implement remediation work if required. | within 6 months |

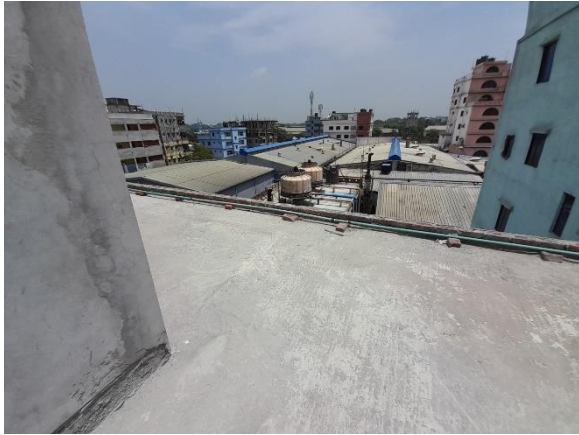
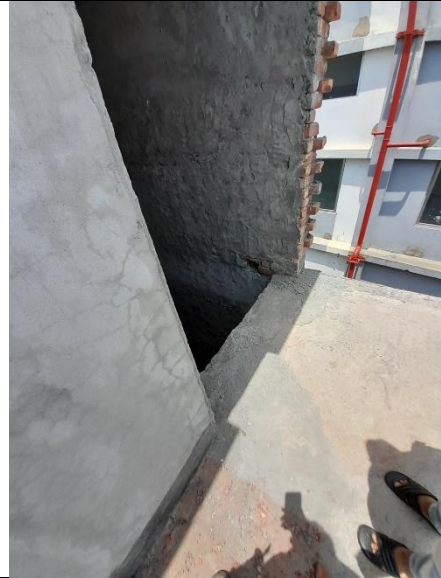
**Observation-3:** Falling hazard at the roof and lift core (Chemical & Fabric Store Building).

**Description:** Parapet and safety barrier not provided on the roof and around the lift core. Building engineer is required to provide a safety barrier to prevent the falling hazard.

| CAP Item No | Observation | Action Plan | Timeline |
|---|---|---|---|
| 5 | Falling hazard at the roof and lift core (Chemical & Fabric Store Building). | The building engineer is required to provide a safety barrier to prevent the falling hazard. | within 6 weeks |

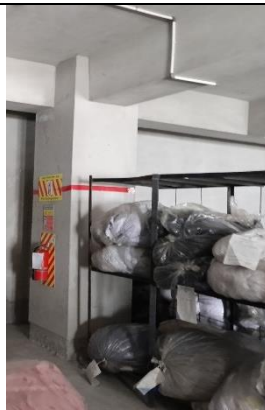
**Observation-4:** Nonstructural elements found not anchored (Chemical & Fabric Store Building)

**Description:** Nonstructural elements found not anchored. The building engineer is required to anchor/brace all nonstructural elements including storage racks to resist the earthquake force.

| CAP Item No | Observation | Action Plan | Timeline |
|---|---|---|---|
| 6 | Nonstructural elements found not anchored (Building 5-ETP Building) | The building engineer is required to anchor/brace all non-structural elements including storage racks to resist the earthquake force. | within 6 months |

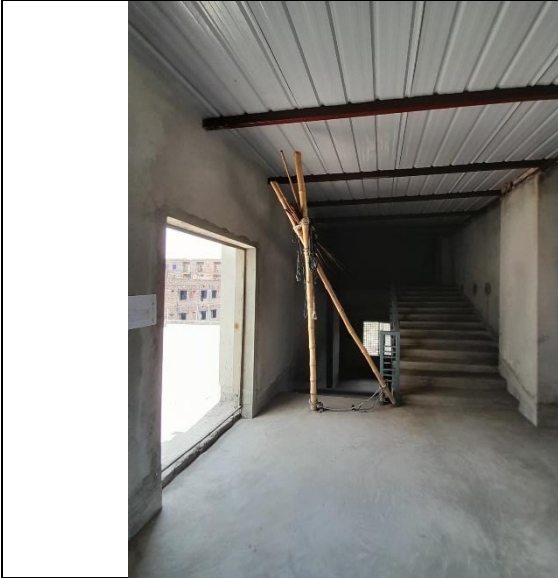
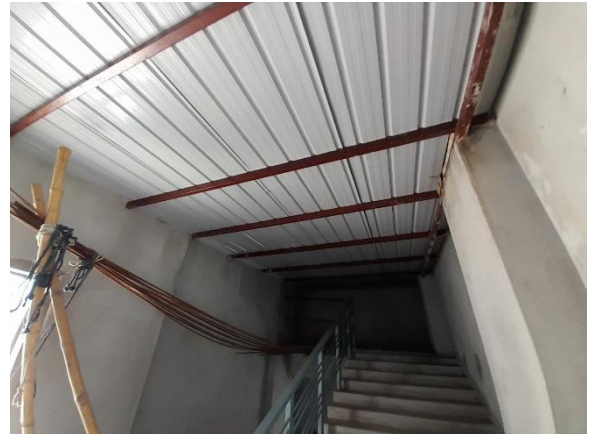
**Observation-5:** Bamboo support of the hanged rebar. (Chemical & Fabric Store Building)

**Description:** The hung bundled rebars of the stairs are supported by bamboo which has the potential risk of falling on humans using the stairs. The building engineer is required to take the necessary steps to support the rebar appropriately.

| CAP Item No | Observation | Action Plan | Timeline |
|---|---|---|---|
| 7 | Bamboo support of the hanged rebar. (Chemical & Fabric Store Building) | The building engineer is required to take the necessary steps to support the rebar appropriately. | within 6 months |

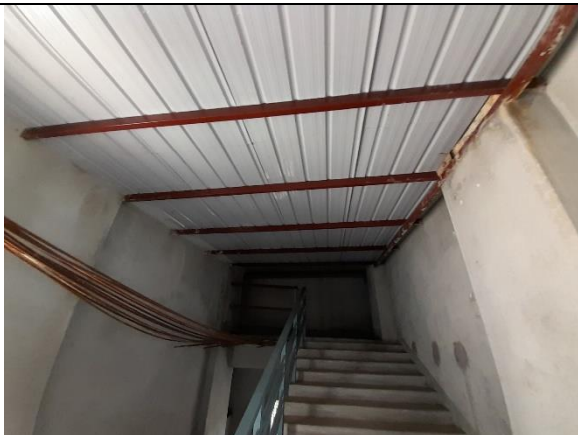
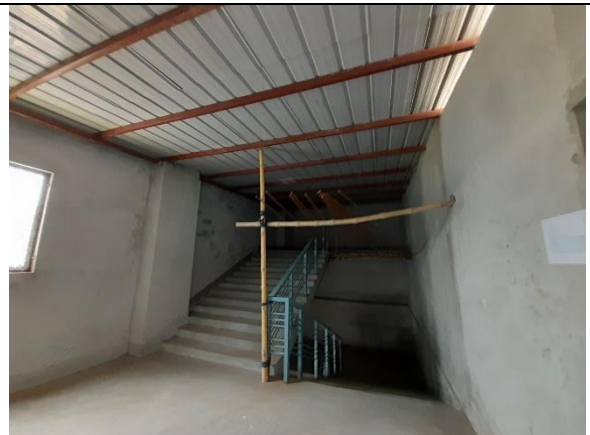
**Observation 6:** Non-engineered staircase roof (Chemical & Fabric Store Building).

**Description:** Non-engineered connection was observed in the staircase roof structure. The building engineer is required to improve the connection of the stair roof for the uplift forces.

| CAP Item No | Observation | Action Plan | Timeline |
|---|---|---|---|
| 8 | Non-engineered staircase roof (Chemical & Fabric Store Building). | Building engineer is required to check the connection adequacy and propose the improved connection details of the stair roof for the uplift forces. | within 6 weeks |
| 9 | | Implement remediation work if required. | within 6 months |
