Rich Cotton Apparels Limited

Sardaganj, Kashimpur, Gazipur Sadar, Gazipur, Bangladesh

29 April 2024

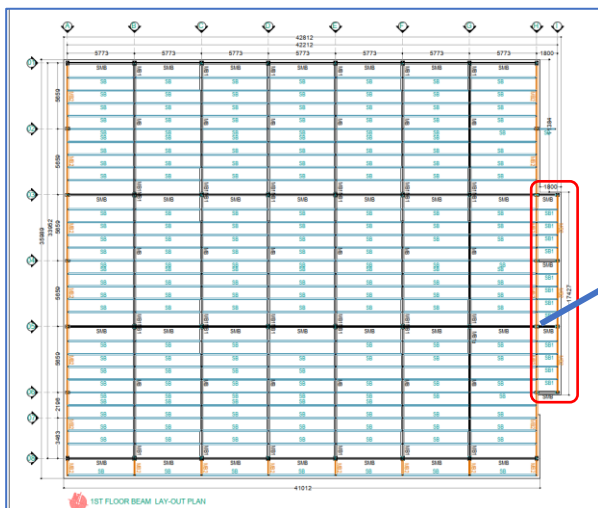
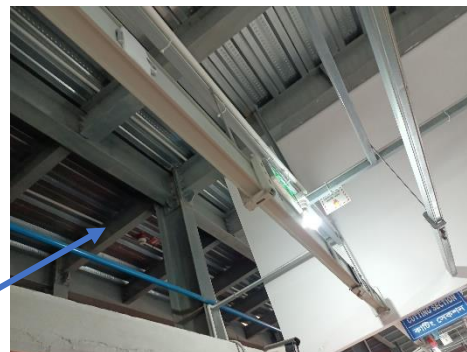
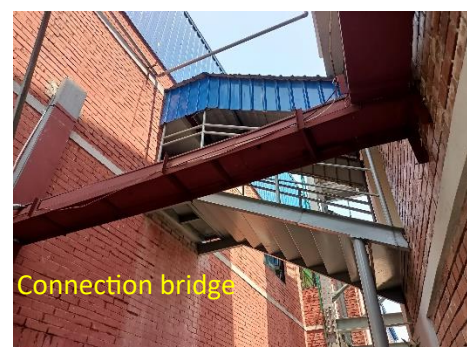
Observation-2: Inconsistencies in as-built drawings. (Factory Shed Building)

Description: Sub-beam at the toilet portion didn't fully match with drawings. All sub-beams were found as SB1 [W(250x5), F(100x6)] instead of SMB [W(450x6), F(175x8)]. Also, the connection bridge (at the West) was not shown in the drawings. The building engineer is required to update the as-built drawing reflecting the actual site condition.

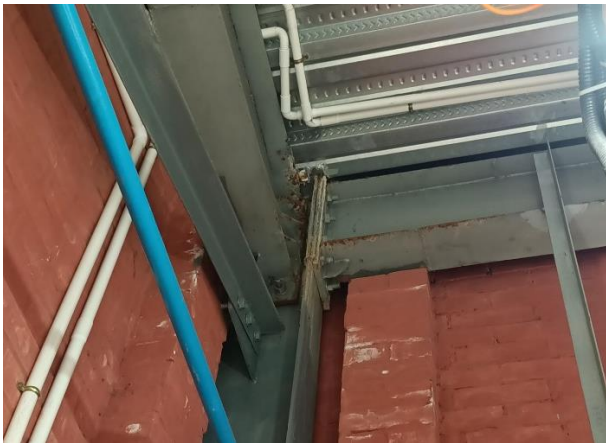
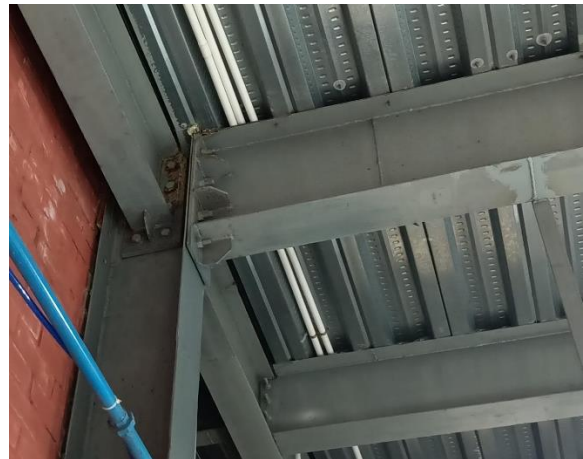
Observation-3: Corrosion in steel member. (Factory Shed Building)

Description: Corrosion was in the steel member. The building engineer is required to provide rust-proof paint on corroded steel member to protect from corrosion.

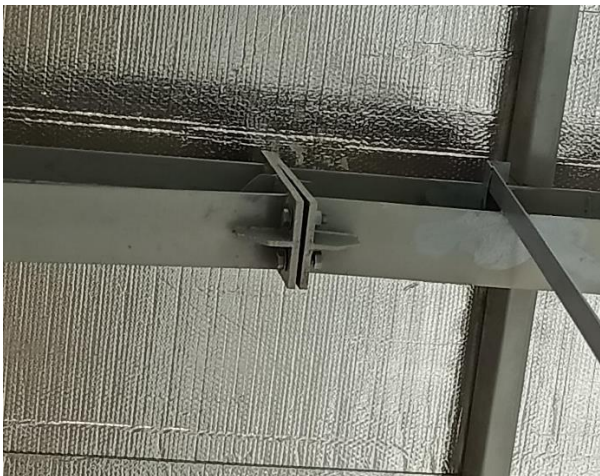
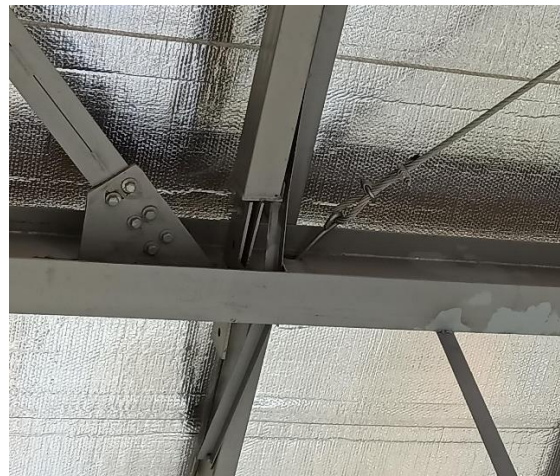
Observation-4: Connection gap and bolt missing. (Factory Shed Building)

Description: Connection gaps and bolt missing were observed in the steel joint. The building engineer is required to carry out suitable remedial works.

6	Connection gap and bolt missing. (Factory Shed Building)	The building engineer is required to carry out suitable remedial works. Also, install missing bolts where necessary.	within 6 months
7	Non-structural elements not anchored or braced. (Factory Shed Building)	The factory is required to anchor/brace all non-structural elements adequately to resist earthquake forces.	within 6 months
8	The design report required to be revised. (Utility Building)	The building engineer is required to check & confirm the material strength in the design report and revise the design accordingly. Submit the revised documents to the RSC for review.	within 6 weeks
9	The design report required to be revised. (Utility Building)	Implement the remedial works if required.	within 6 months
10	The design report required to be revised. (Utility Building)	Implement floor load plan	within 6 months
11	Lack of information in as-built drawings. (Facility Shed)	The building engineer is required to update the as-built drawing including all connection details.	within 6 weeks

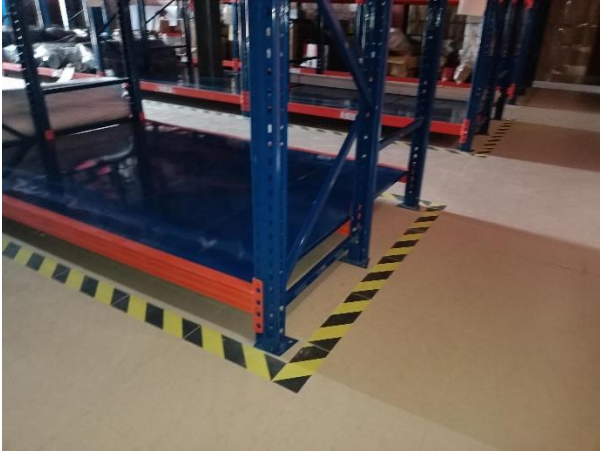
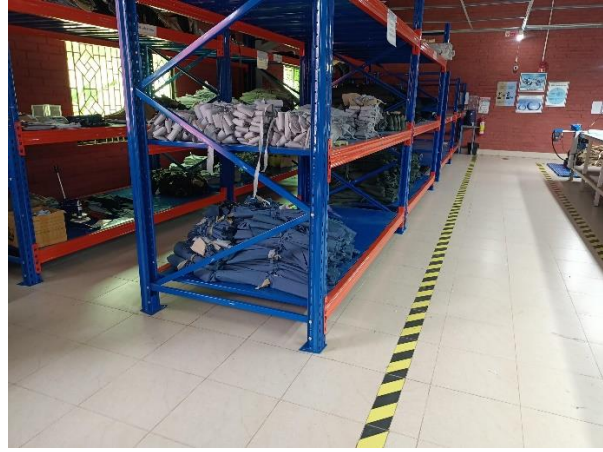
Observation-5: Non-structural elements not anchored or braced. (Factory Shed Building)

Description: Some racks on floors are not anchored or braced to resist lateral (earthquake) forces. The factory is required to anchor/brace all non-structural elements adequately to resist earthquake forces.

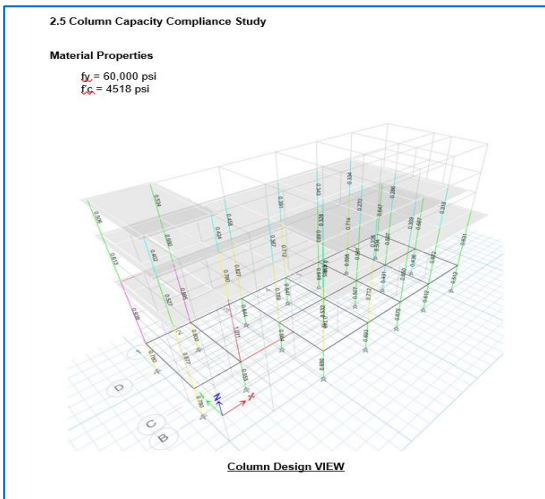
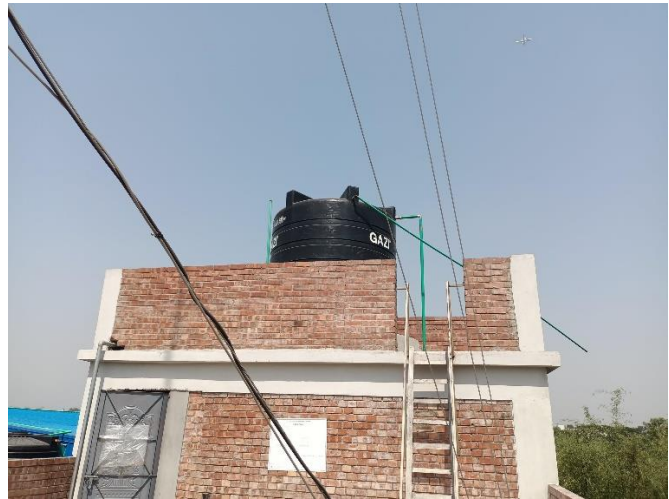
Observation-6: The design report required to be revised. (Utility Building)

Description: In the design report, the compressive strength of concrete was considered more than 4500 psi. The factory didn't provide any cylinder test report for the building. Also, a 10,000 L PVC water tank was found at the stair top. Slab adequacy check needs to be incorporated in the revised EA and submitted to RSC.

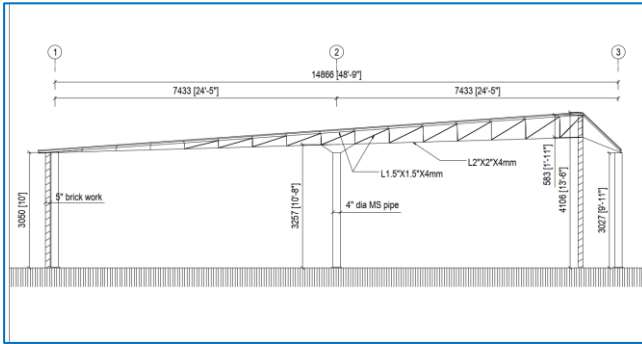
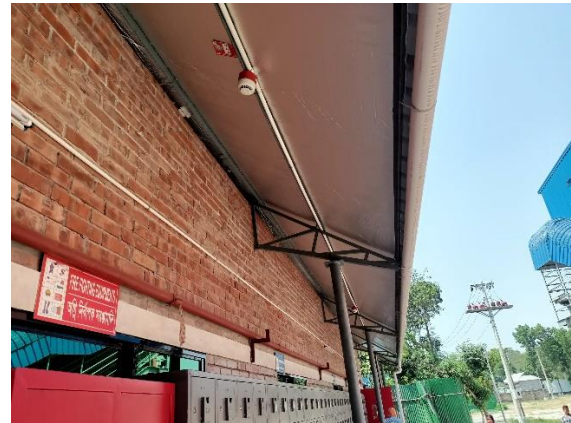
Observation-7: Lack of information in as-built drawings. (Facility Shed)

Description: Sectional details were not fully matched with the drawings. Also, connection details were not found. The building engineer is required to update the as-built drawing providing all connection details.

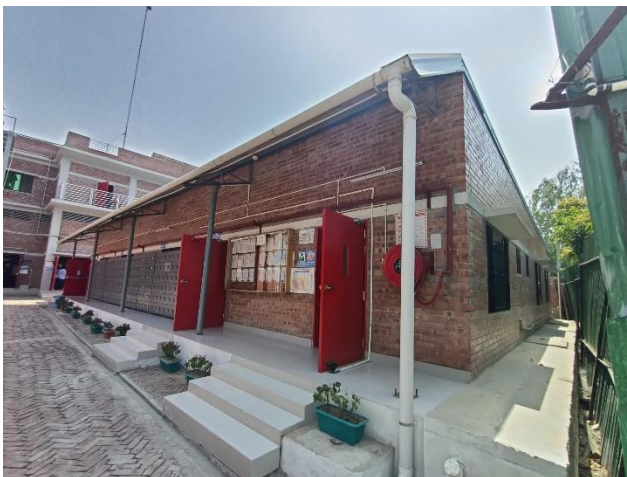
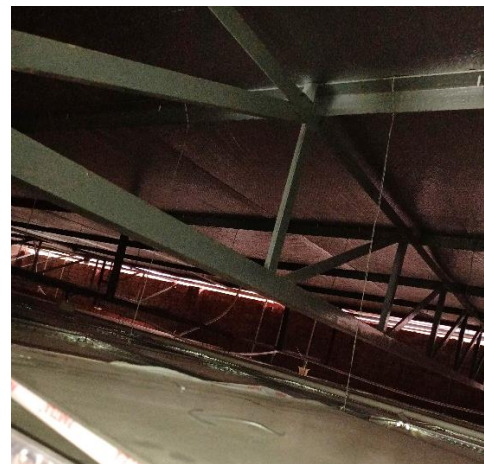
Observation-8: Lack of lateral stability. (Facility Shed)

Description: Lateral load transfer media was found missing in North-south direction. Also, truss frames were welded with the steel pipe column. Building engineer is required to check the connection adequacy and lateral stability of the structure.

12	Lack of lateral stability. (Facility Shed)	Building engineer is required to check the connection adequacy and lateral stability of the structure.	within 6 weeks
13	Lack of lateral stability. (Facility Shed)	Carry out remedial works if required.	within 6 months
14	Lack of structural drawings. (Office Shed-Part-1)	Building engineer is required to prepare a full set of structural drawing for the shed.	within 6 weeks

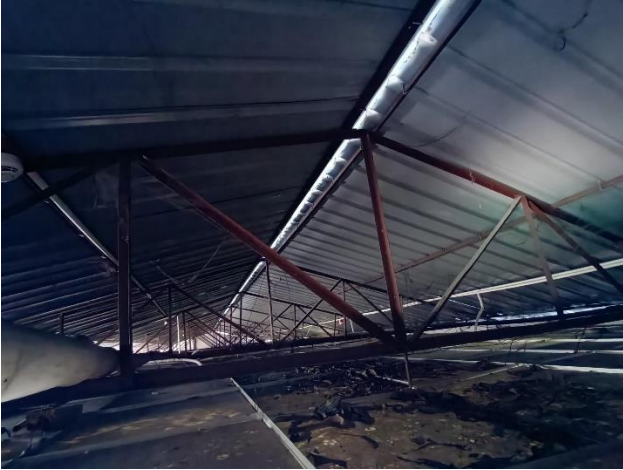
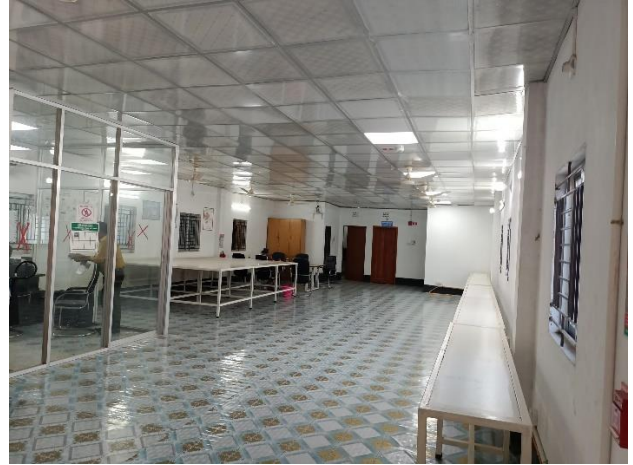
Observation-09: Lack of structural drawings. (Office Shed Part-1)

Description: Structural drawings were not available for the Office Shed (South Part). Building engineer is required to prepare a full set of structural drawing for the shed.

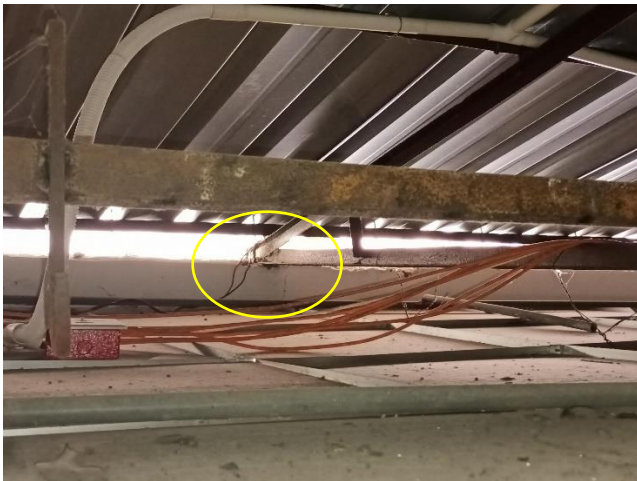
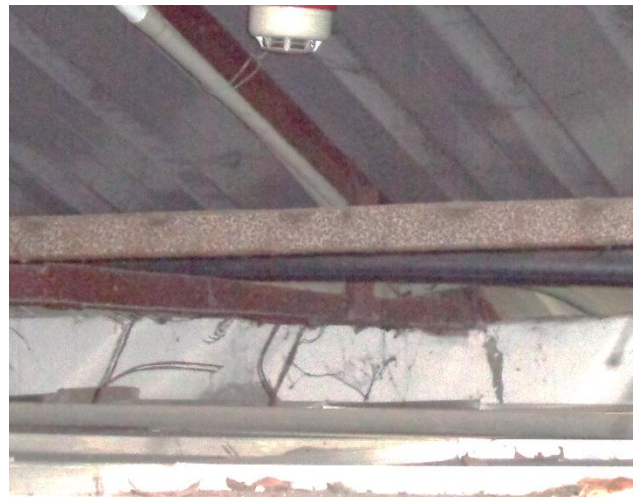
Observation-10: Apparently inadequate connection. (Office Shed Part-2)

Description: Inadequate connections were observed at the lightweight roof of the single-storied wooden sheds. The building engineer is required to check the connection adequacy of the lightweight roof against the uplift forces.

15	Apparently inadequate connection. (Office Shed Part-2)	The building engineer is required to check the connection adequacy of the lightweight roof against the uplift forces.	within 6 weeks
16	Apparently inadequate connection. (Office Shed Part-2)	Carry out remedial works if required.	within 6 months
17	Lack of as-built drawings (Guard Room, Waste Shed, Car parking and Water tank platform).	The building engineer is required to survey the whole structure and prepare a full set of as-built drawings.	within 6 weeks
18	Deflected beam underwater tank platform. (Water tank platform)	The building engineer is required to check the adequacy of the steel beam and suggest proper remedial methods.	within 6 weeks
19	Deflected beam underwater tank platform. (Water tank platform)	Carry out remedial works if required.	within 6 months

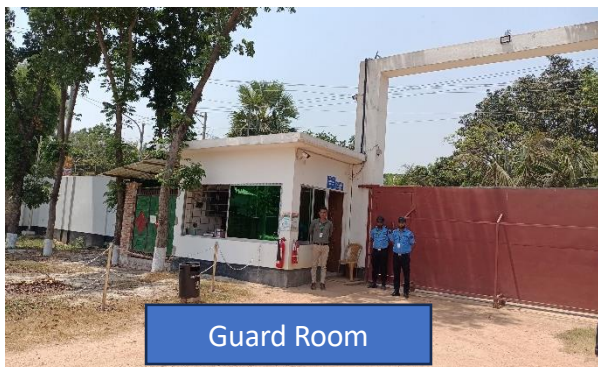
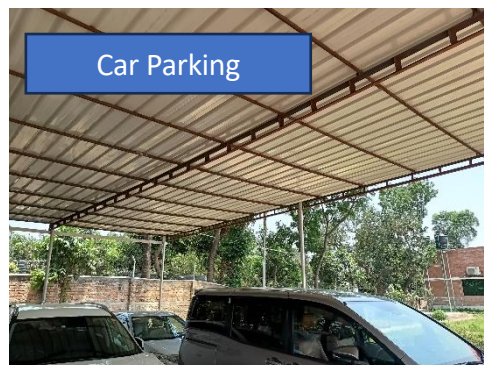
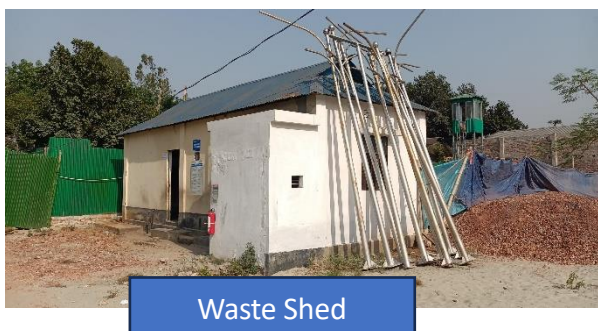
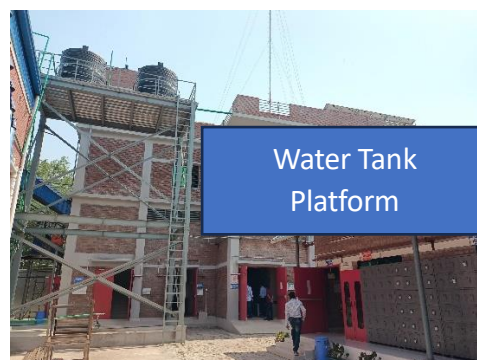
Observation-11: Lack of as-built drawings (Guard Room, Waste Shed, Car parking and Water tank platform).

Description: As-built drawings were not available for the single-storied Guard Room, Waste Shed, Car parking and Water tank platform. The building engineer is required to survey the whole structure and prepare a full set of as-built drawings.

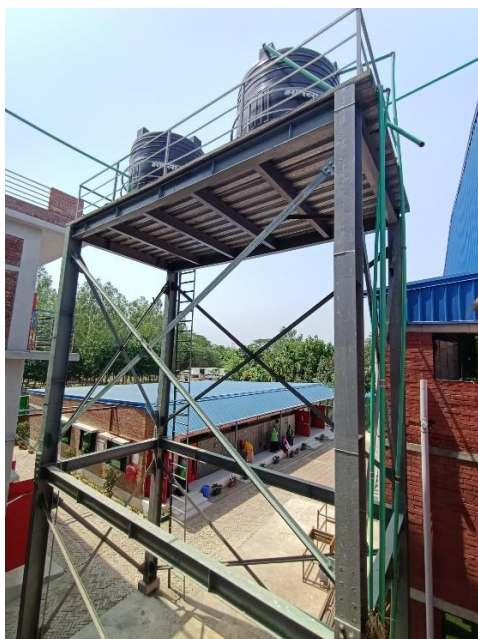
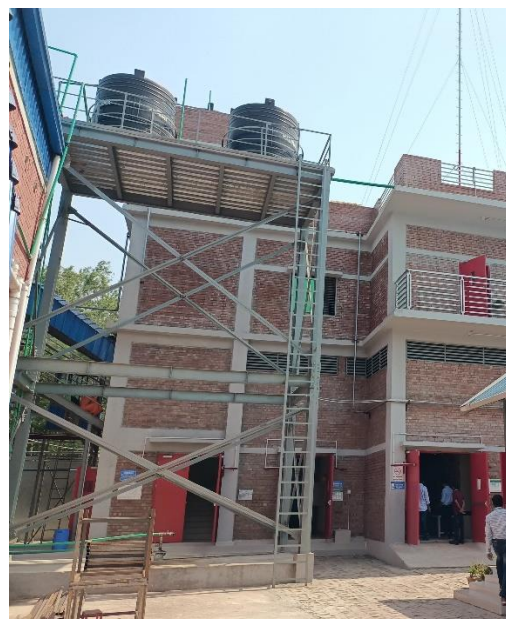
Observation-12: Deflected beam under water tank platform. (Water tank platform)

Description: Deflected beam was observed under water tank platform by visual inspection. The building engineer is required to check the adequacy of the steel beam and suggest proper remedial methods.
