# Soultex Fashion Ltd

Toyebpur, Zirabo, Ashulia, Savar, Dhaka-1341.

5 May 2024

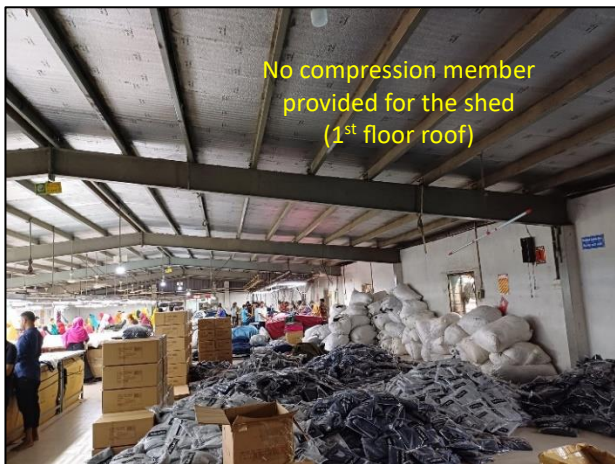
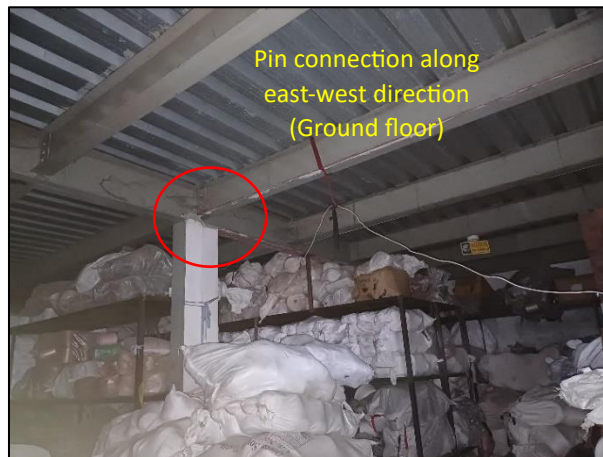
**Observation-01:** Lack of lateral stability system (Main Building).

**Description:** The compression member was absent in the bracing system which may cause inactive lateral stability of the roof. Also, for the ground floor, pin connection is provided along east-west direction, but no vertical bracing or resisting system is provided along that direction.

During inspection, geotechnical investigation report was not available. Also load plan was not found for the Main building.

The building engineer is required to check the lateral stability system of the structure, perform geotechnical investigation & check foundation adequacy for the structure, Produce & actively manage a loading plan for all floor plates within the factory based on floor, column & foundation capacity and suggest necessary remedial action accordingly.

| Item No. | Observation | Action Plan | Timeline |
|---|---|---|---|
| 1 | Lack of lateral stability (Main Building). | The building engineer is required to check the lateral stability system of the structure. | within 6 weeks |
| 2 | Lack of lateral stability (Main Building). | Perform geotechnical investigation & check foundation adequacy for the structure. | within 6 weeks |
| 3 | Lack of lateral stability (Main Building). | Produce & actively manage a loading plan for all floor plates within the factory giving consideration to floor capacity and column capacity. | within 6 weeks |
| 4 | Lack of lateral stability (Main Building). | Implement remediation work if required. | within 6 months |

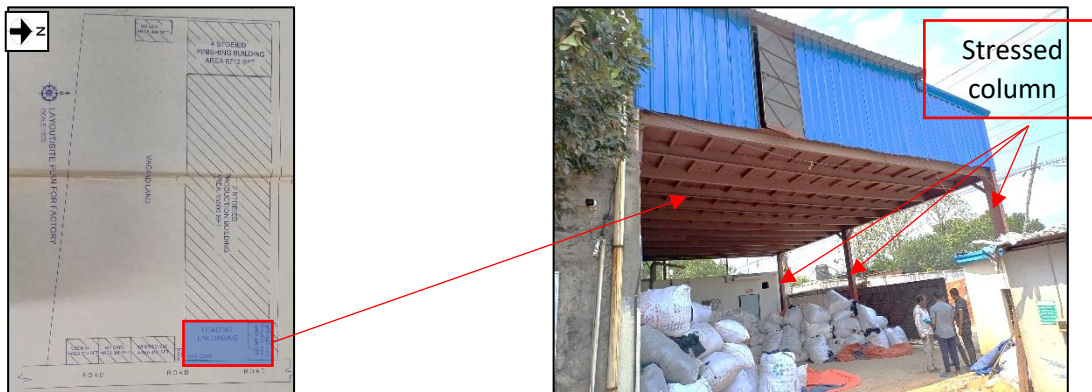
**Observation-02:** Marginally Stress in column exceeds normal design limit for the extension part of Main building (loading-unloading shed).

**Description:** During inspection an undocumented and non-engineered horizontal extension (loading-unloading shed) was observed at the front of Main building. The cursory calculation indicates that stress in the marked column exceeds the normal design limit considering provided floor live load of 6 kPa for 1<sup>st</sup> floor floor, roof live load of 1 kPa considering minimum steel strength (248 Mpa). The building engineer is required to review the design, loads, and column stresses for the marked columns based on in-situ material strength. The factory engineer is also required to Produce and actively manage a loading plan for all floor plates within the factory based on floor, column & foundation capacity.

| Item No. | Observation | Action Plan | Timeline |
|---|---|---|---|
| 6 | Marginally Stress in column exceeds normal design limit for the extension part of Main building (loading-unloading shed). | The building engineer is required to review the design, loads, and column stresses for the marked columns based on in-situ material strength. | within 6 weeks |
| 7 | Marginally Stress in column exceeds normal design limit for the extension part of Main building (loading-unloading shed). | Produce and actively manage a loading plan for all floor plates within the factory giving consideration to floor capacity and column capacity. | within 6 weeks |
| 8 | Marginally Stress in column exceeds normal design limit for the extension part of Main building (loading-unloading shed). | Implement remediation work if required. | within 6 months |

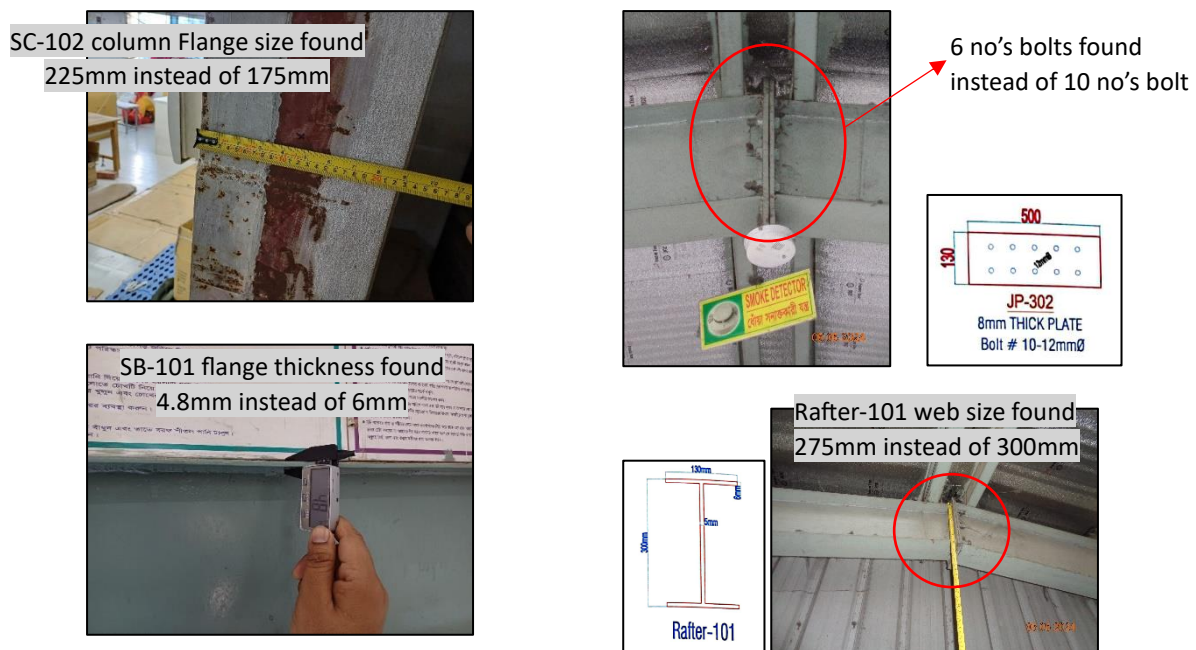
**Observation-03:** Mismatch found in structural drawings (Main Building).

**Description:** Mismatch was observed in beam, rafter and column of Main building's drawings. Also, the drawings for the sub-structure were not available.

The building Engineer is required to survey the whole structure and prepare the as built drawings as per site condition.

| Item No. | Observation | Action Plan | Timeline |
|---|---|---|---|
| 9 | Mismatch found in structural drawings (Main Building). | The building Engineer is required to survey the whole structure and prepare the as built drawings as per site condition. | within 6 weeks |

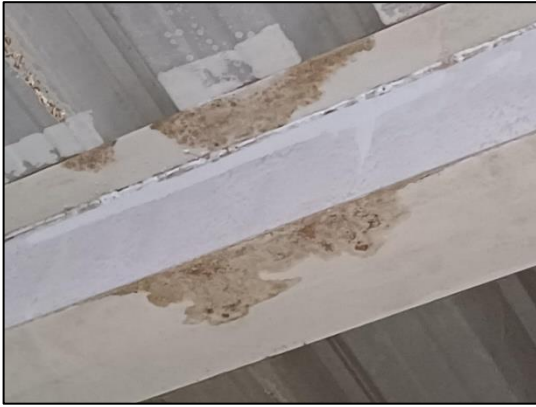
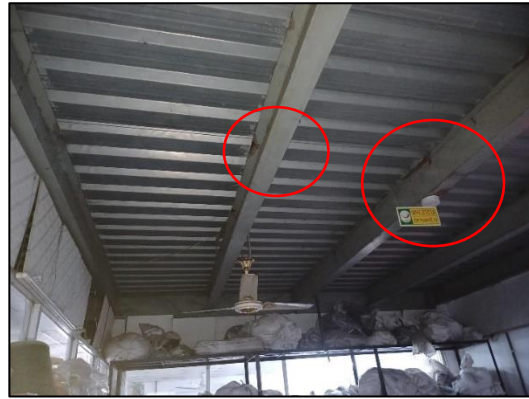
**Observation-04:** Corrosion found on steel members at different locations (Main Building).

**Description:** Corrosion was found on steel members at different locations of Main building. The factory is required to identify the locations, remove corrosion and provide rust-proof coating on all steel members to protect them from rusting.

| Item No. | Observation | Action Plan | Timeline |
|---|---|---|---|
| 11 | Corrosion found on steel members at different locations (Main Building). | The factory is required to identify the locations, remove corrosion and provide rust-proof paint on all steel members to protect them from rusting. | within 6 weeks |

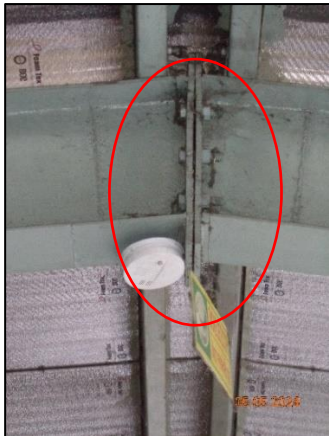
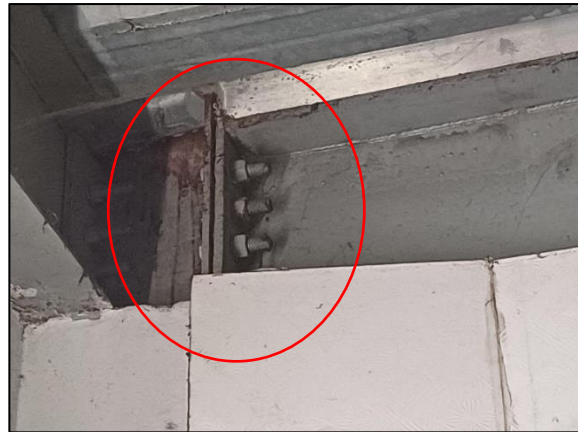
**Observation-05:** Connection gap at different locations (Main Building).

**Description:** During inspection, connection gap was observed at different location of Main building. The factory is required to fill the connection gap as per adequate techniques.

| Item No. | Observation | Action Plan | Timeline |
|---|---|---|---|
| 12 | Connection gap at different locations (Main Building). | The factory is required to fill the connection gap as per adequate techniques. | within 6 months |

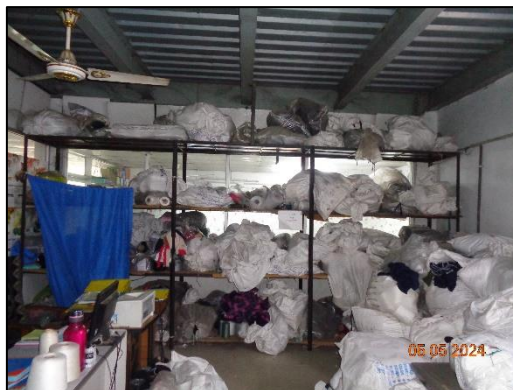
**Observation-06:** Non-structural elements are not anchored or braced (Main Building).

**Description:** Racks on ground are not adequately anchored or braced to resist lateral (earthquake) forces. Factory is required to adequately anchor and brace all non-structural elements to resist earthquake forces to comply with the BNBC.

| Item No. | Observation | Action Plan | Timeline |
|---|---|---|---|
| 13 | Non-structural elements are not anchored or braced (Main Building). | Building engineer is required to adequately anchor and brace all non-structural elements to resist earthquake forces to comply with the BNBC. | within 6 months |

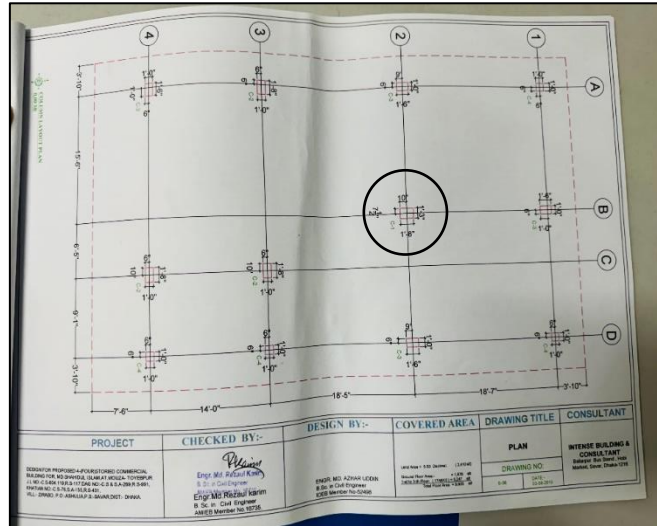
**Observation-07:** Stress in column exceeds normal design limit (RC Building).

**Description:** The cursory calculation indicates that stress in the marked column exceeds the normal design limit considering provided floor live load of 6 kPa for typical floor, roof live load of 1 kPa and minimum concrete strength of 14.1 MPa.

During inspection, the geotechnical report was not available to check the foundation capacity of the structure. Also, no material test report was available.

The building engineer is required to review the design, loads, and column stresses for the marked columns based on in-situ material strength, perform geotechnical investigation to check foundation capacity. The building engineer is also required to produce and actively manage a loading plan for all floor plates based on floor, column and foundation capacity.

| <b>RC Building</b> | | | |
|---|---|---|---|
| 14 | Stress in column exceeds normal design limit (RC Building). | The building engineer is required to review the design, loads, and column stresses for the marked columns based on in-situ material strength. | within 6 weeks |
| 15 | Stress in column exceeds normal design limit (RC Building). | Verify in-situ concrete stresses by 100mm dia. cores from minimum of 4 columns and beam & slab. | within 6 weeks |
| 16 | Stress in column exceeds normal design limit (RC Building). | Perform geotechnical investigation to check the adequacy of the foundation of the structure. | within 6 weeks |
| 17 | Stress in column exceeds normal design limit (RC Building). | Produce and actively manage a loading plan for all floor plates within the factory giving consideration to floor capacity and column capacity. | within 6 weeks |
| 18 | Stress in column exceeds normal design limit (RC Building). | Implement remediation work if required. | within 6 months |

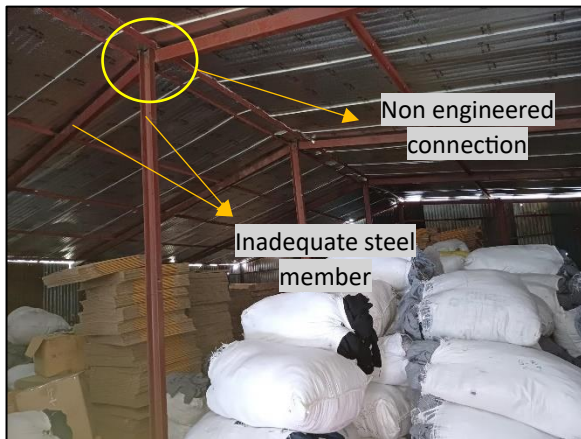
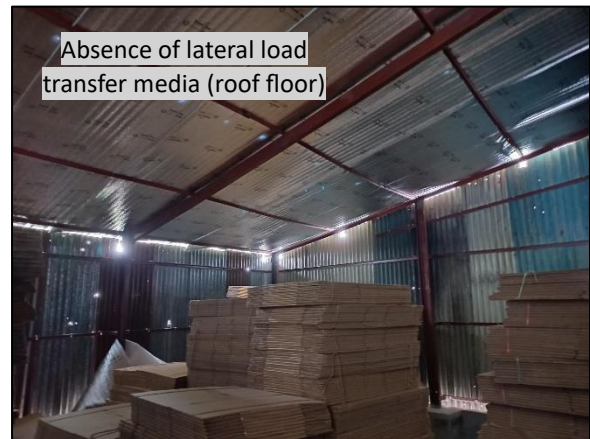
**Observation-08:** Lack of lateral stability of undocumented non-engineered steel shed on roof (RC Building).

**Description:** Lack of stability against the lateral load and apparent inadequate members and non-engineered connection were observed at the roof of RC Building. The building engineer is required to check the member, connection & stability system of the structure and suggest proper alternatives accordingly.

| <b>RC Building</b> | | | |
|---|---|---|---|
| 20 | Lack of lateral stability of undocumented non-engineered steel shed on roof (RC Building). | The building engineer is required to check the member, connection & stability system of the structure | within 6 weeks |
| 21 | Lack of lateral stability of undocumented non-engineered steel shed on roof (RC Building). | Implement remediation work if required. | within 6 months |

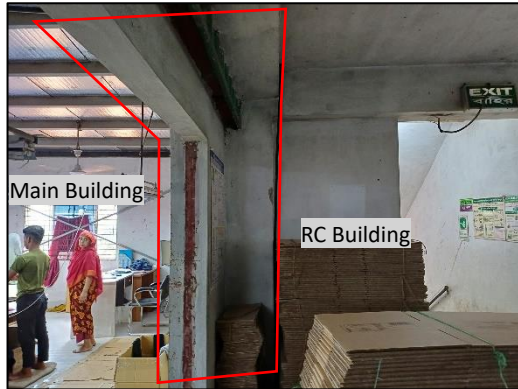
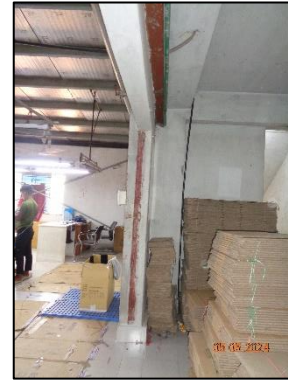
**Observation-09:** Inadequate expansion gap between RC building and Main building (RC Building).

**Description:** The expansion gap between Main Building and RC Building seems to be inadequate. The Building Engineer is required to check the expansion gap requirements for the two-building structural separation and suggest proper alternatives accordingly.

| <b>RC Building</b> | | | |
|---|---|---|---|
| 22 | Inadequate expansion gap between RC building and Main building (RC Building). | The Building Engineer is required to check the expansion gap requirements for the two-building structural separation | within 6 weeks |
| 23 | Inadequate expansion gap between RC building and Main building (RC Building). | Implement remediation work if required. | within 6 months |

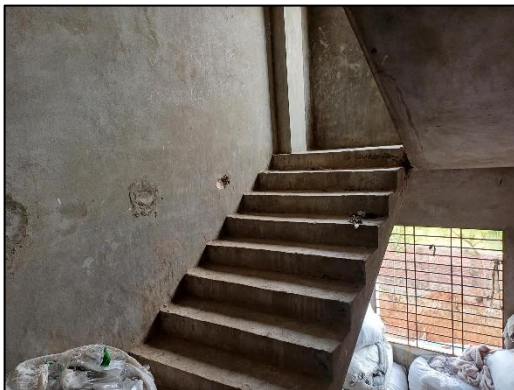
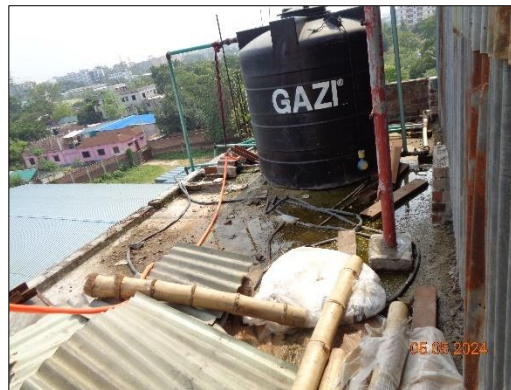
**Observation-10:** Falling hazard in stairs and at roof (RC Building).

**Description:** Railing was not found on the 4<sup>th</sup> floor of the RC building. Also, the parapet wall was missing at partial roof.

The factory is required to provide railing at stairs and parapet wall at roof to avoid falling hazard.

| <b>RC Building</b> | | | |
|---|---|---|---|
| 24 | Falling hazard in stairs and at roof. (RC Building). | The factory is required to provide railing/barrier at stairs/roof to avoid falling hazard. | within 6 weeks |

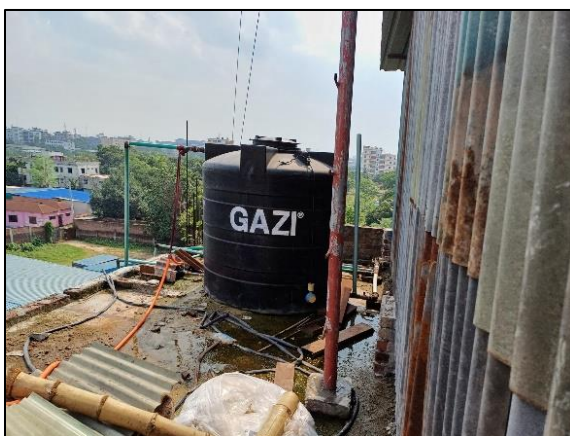
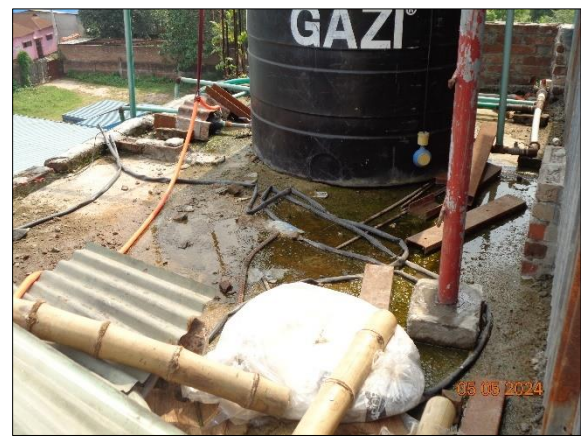
**Observation-11:** Dampness and water ponding found on roof slab (RC Building).

**Description:** Dampness and water ponding were found on roof slab. The factory is required to repair the damp areas. Also, improve the drainage system on roof slab.

| <b>RC Building</b> | | | |
|---|---|---|---|
| 25 | Dampness and water ponding found on roof slab (RC Building). | The factory is required to seal the source of water leakage and repair the damp areas. Also, improve the drainage system on roof slab. | within 6 months |

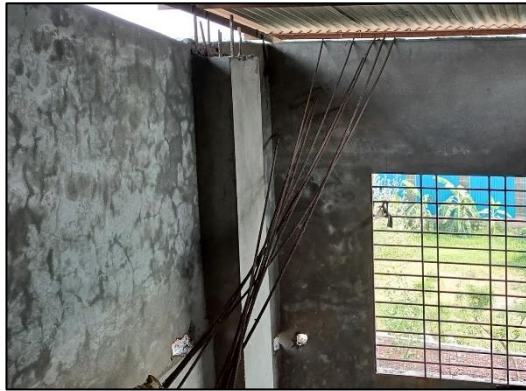
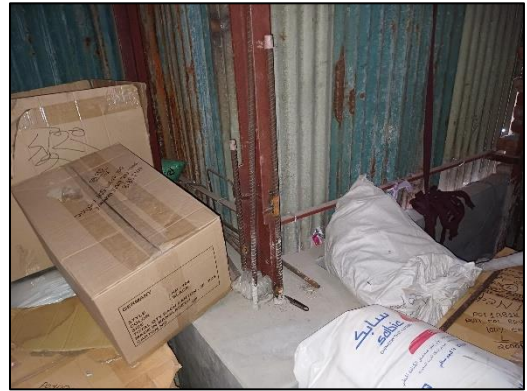
**Observation-12:** Exposed rebar found on roof and staircase (RC Building).

**Description:** During inspection, exposed & corroded re-bar was found on the roof of RC Building and staircase area. Factory is required to take necessary action (remove corrosion and apply ant-rusting coating) to protect exposed re-bar from corrosion.

| <b>RC Building</b> | | | |
|---|---|---|---|
| 26 | Exposed rebar found on roof and staircase (RC Building). | Remove the corrosion & apply anti-rusting coating to protect exposed re-bar from corrosion. | within 6 months |

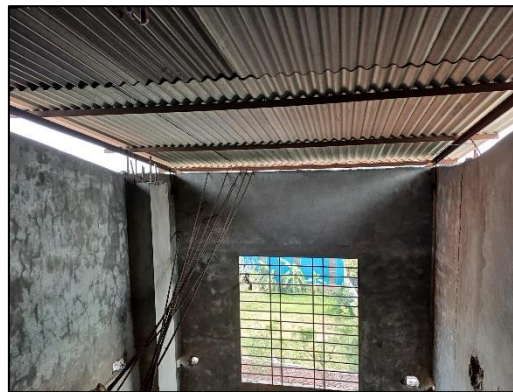
**Observation-13:** Non-engineered light weight roof on staircase (RC Building).

**Description:** During inspection, a lightweight roof was observed at staircase roof of main building. The building engineer is required to check the connection adequacy of light weight roof of the staircase against the uplift forces and suggest proper alternatives accordingly.

| <b>RC Building</b> | | | |
|---|---|---|---|
| 27 | Non-engineered light weight roof on staircase (RC Building). | The building engineer is required to check the connection adequacy of light weight roof of the staircase against the uplift forces. | within 6 weeks |
| 28 | Non-engineered light weight roof on staircase (RC Building). | Implement remediation work if required. | within 6 months |

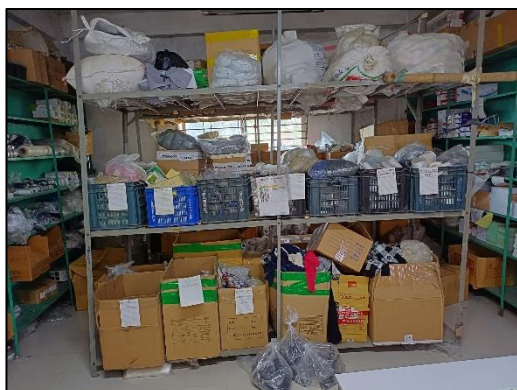
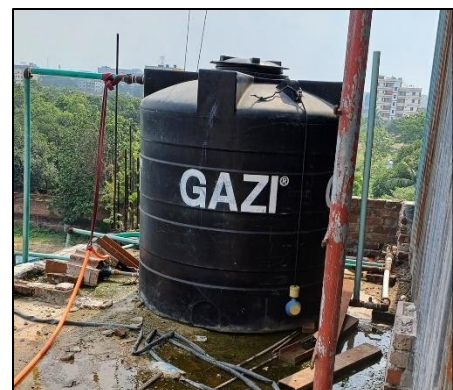
**Observation-14:** Non-structural elements not anchored or braced (RC Building).

**Description:** Racks on different floors and plastic water tank on roof are not adequately anchored or braced to resist lateral (earthquake) forces. Factory is required to adequately anchor and brace all non-structural elements to resist earthquake forces to comply with the BNBC.

| 29 | Non-structural elements not anchored or braced (RC Building). | Factory is required to adequately anchor and brace all non-structural elements to resist earthquake forces to comply with the BNBC | within 6 months |

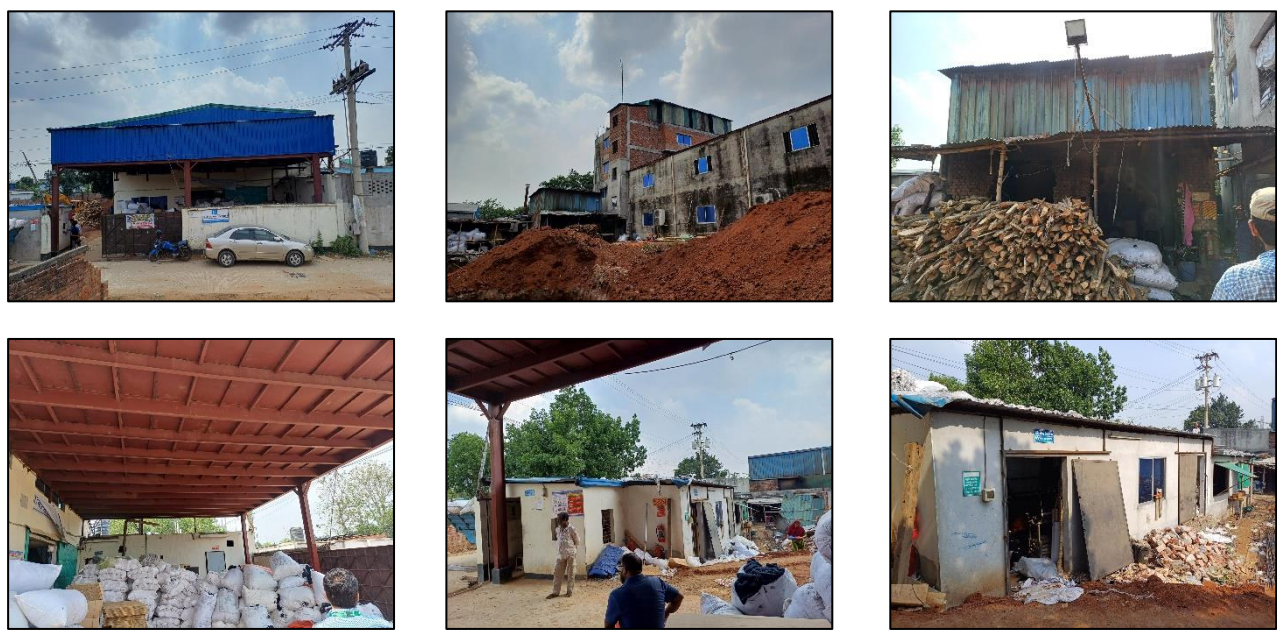
**Observation-15:** Lack of permit drawings from local authority (Main Building, RC Building, Sub-station Building, Boiler Shed, Winding Shed).

**Description:** During inspection, no permit drawings were available for Main Building, RC Building, Sub-station Building, Boiler Shed & Winding Shed. The factory is required to collect the permit drawings from the government approved local authority.

| 30 | Lack of permit drawings from local authority (Main Building, RC Building, Sub-station Building, Boiler Shed, Winding Shed). | The factory is required to collect the permit drawings from government approved local authority. | within 6 months |

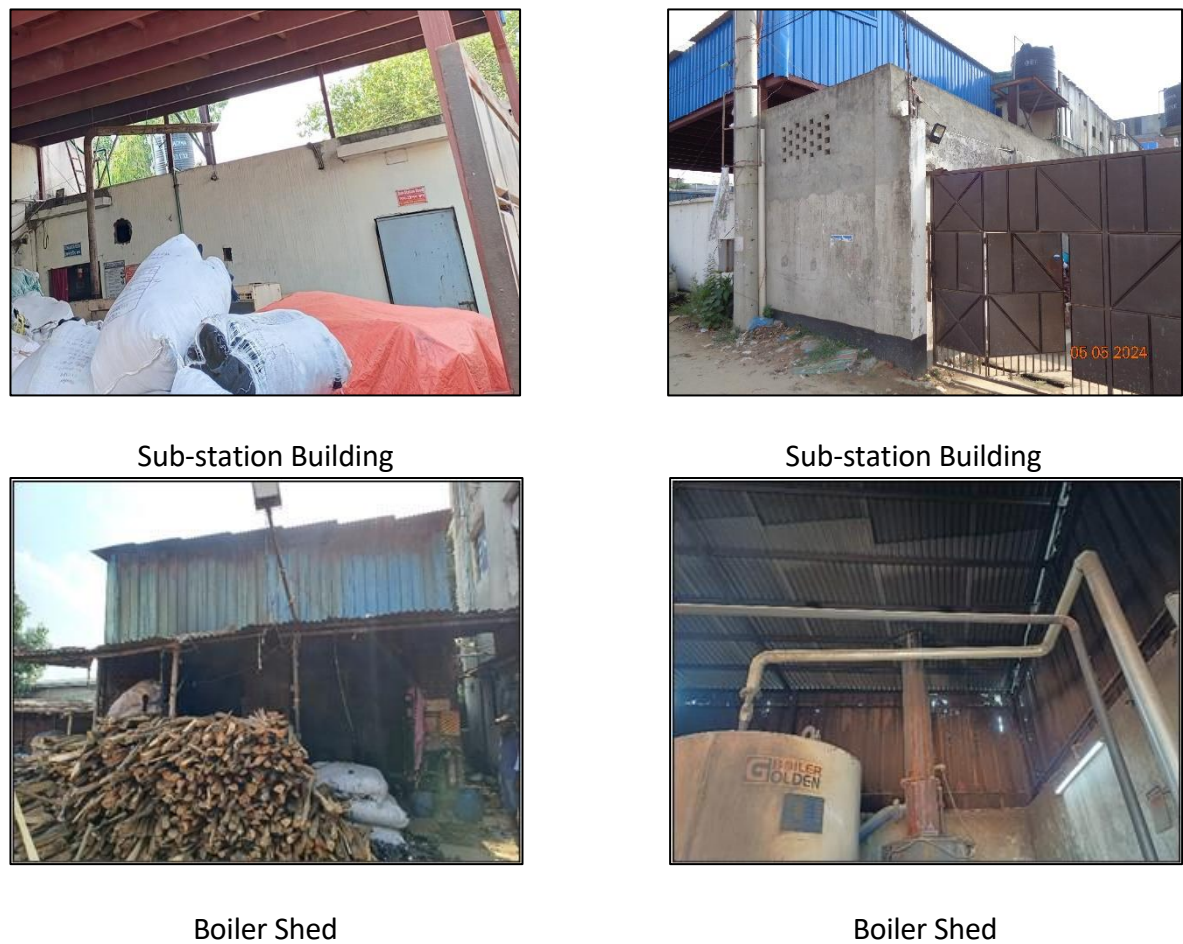
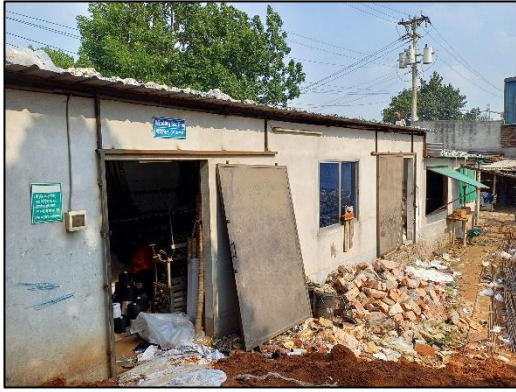
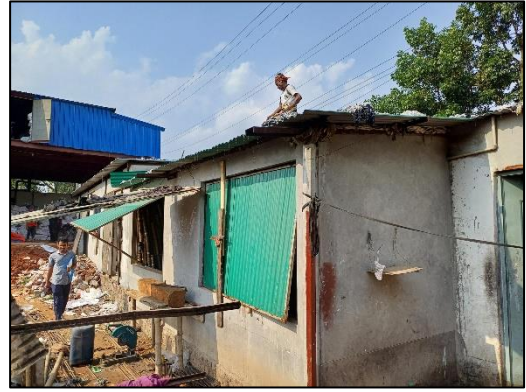
**Observation-16:** Lack of as-built drawings (Sub-station Building, Boiler Shed, Winding Shed).

**Description:** During inspection, there is no drawings were available for the above-mentioned structures. The building engineer is required to survey those structures and prepare accurate as built drawings for each structure separately.

| 31 | Lack of as-built drawings (Sub-station Building) | The building engineer is required to survey the structures and prepare accurate as-built drawings. | within 6 weeks |
| 34 | Lack of as-built drawings (Boiler Shed) | The building engineer is required to survey the whole structures and prepare accurate as built drawings as per site condition | within 6 weeks |
| 37 | Lack of as-built drawings (Winding Shed) | The building engineer is required to survey the whole structures and prepare accurate as built drawings as per site condition | within 6 weeks |

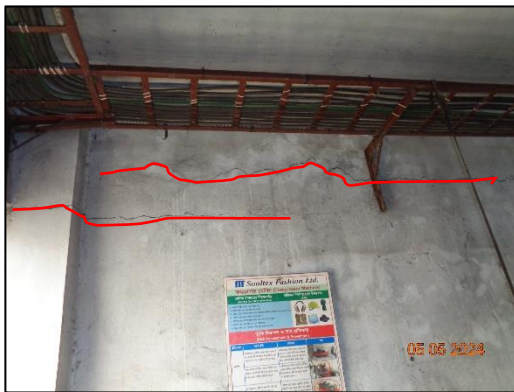
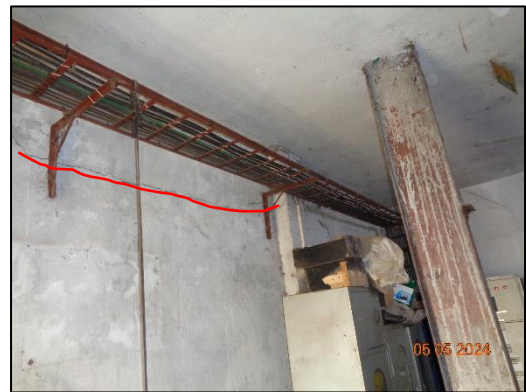
**Observation-17:** Crack on brick wall (Sub-station Building).

**Description:** Crack was observed on the brick wall of Sub-station Building. The building engineer is required to investigate the reason for the crack and carry out remedial works accordingly.

| 32 | Crack on brick wall (Sub-station Building). | The building engineer is required to investigate the reason for the crack and carry out remedial works accordingly. | within 6 weeks |

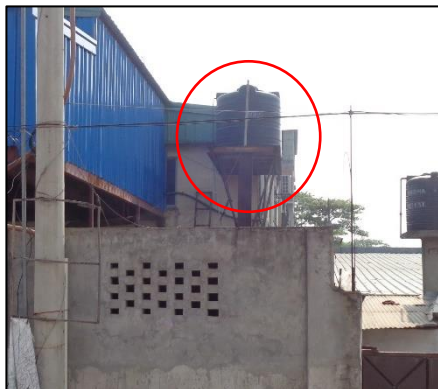
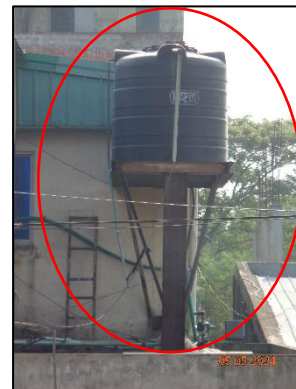
**Observation-18:** Lack of anchorage and lateral bracing for the plastic water tank/platform (Sub-station Building).

**Description:** A plastic water tank supported by single steel member was found above sub-station building. Factory is required to adequately anchor and brace the plastic water tank/ platform to resist earthquake forces to comply with the BNBC.

| 33 | Lack of anchorage of plastic water tank (Sub-station Building). | Factory is required to adequately anchor and brace the plastic water tank to resist earthquake forces to comply with the BNBC | within 6 months |

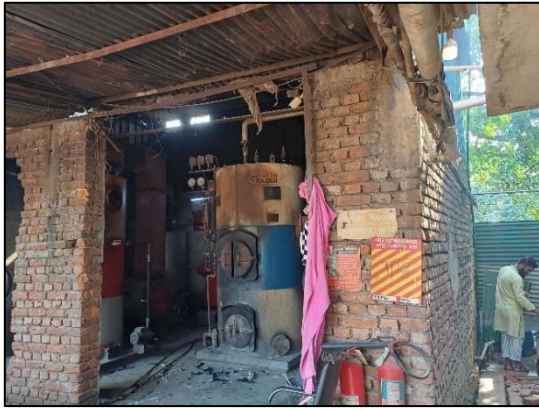
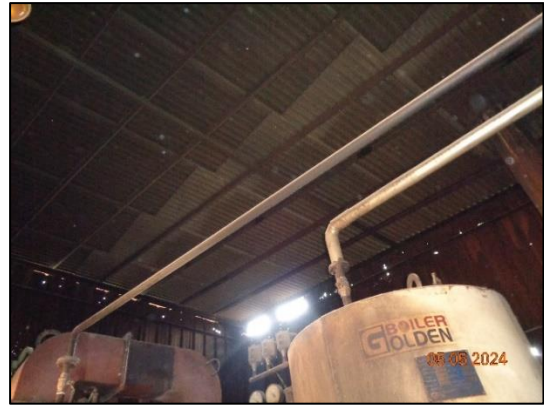
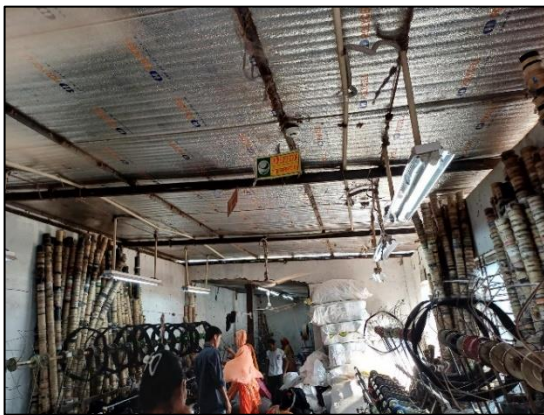
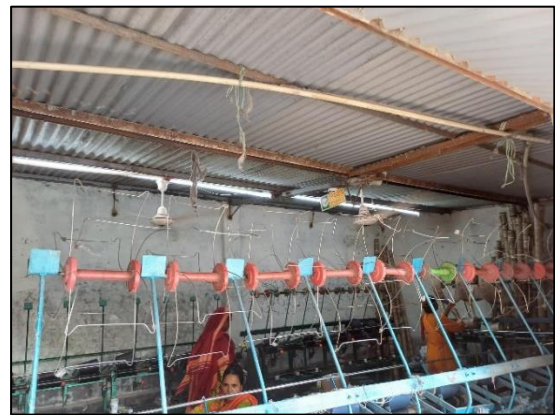
**Observation-19:** Apparently non-engineered lightweight roof shed (Boiler Shed, Winding Shed).

**Description:** Lack of lateral stability system, apparent inadequate members and non-engineered connection were observed at the roof. The building engineer is required to check the member, connection & stability system of the structure and suggest proper alternatives accordingly.

| 35 | Apparently non-engineered lightweight roof shed (Boiler Shed) | The building engineer is required to check the member, connection & stability system of the structure and suggest necessary alternation. | within 6 weeks |
| 36 | Apparently non-engineered lightweight roof shed (Boiler Shed) | Implement remediation work if required. | within 6 months |
| 38 | Apparently non-engineered lightweight roof shed (Winding Shed) | The building engineer is required to check the member, connection & stability system of the structure and suggest necessary alternation. | within 6 weeks |
| 39 | Apparently non-engineered lightweight roof shed (Winding Shed) | Implement remediation work if required. | within 6 months |

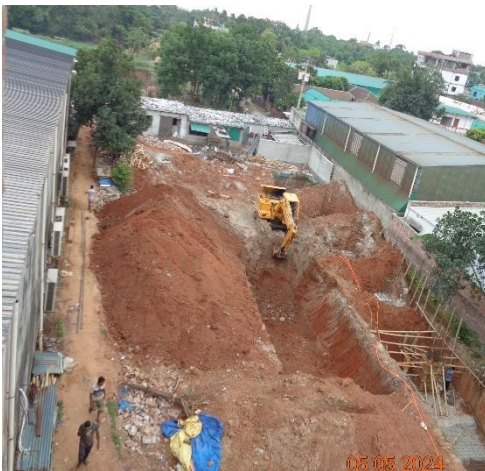
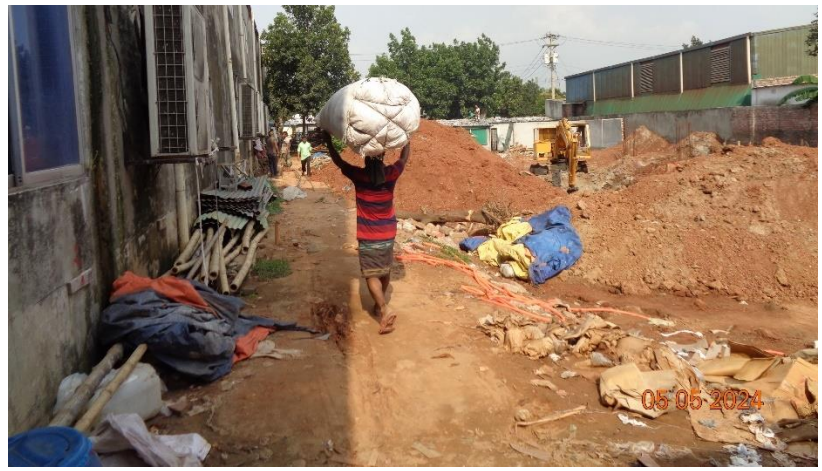
**Observation-20:** Lack of construction safety at factory premises.

**Description:** During inspection, construction of a multi-storied factory building was found ongoing in the factory premises. But no construction safety measures have been taken. Garment workers are passing through the construction site as no safety signage has been provided. Also, construction workers did not wear any PPE.

The factory management and building engineer is required to take necessary measures immediately to ensure the construction safety as per BNBC guideline.

| 40 | Lack of construction safety at factory premises. | The factory management and building engineer is required to take necessary measures immediately to ensure the construction safety as per BNBC guidelines. | Immediate |
