# Moms Touch Sweater

14/2 Nayabari Road, Sataish, Tongi

15 May 2024

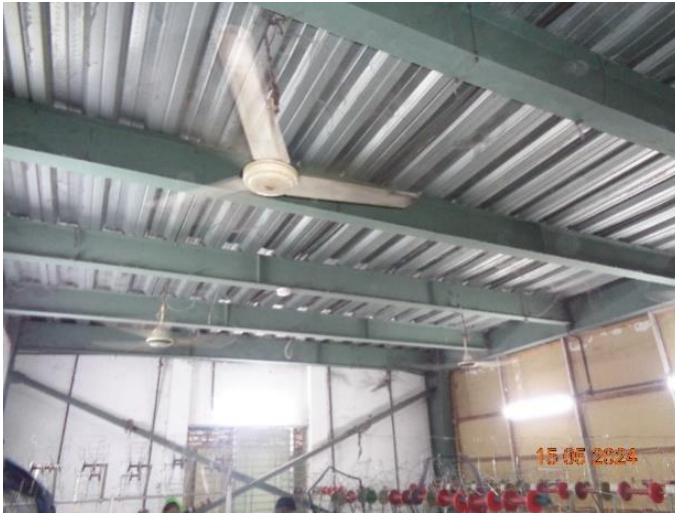
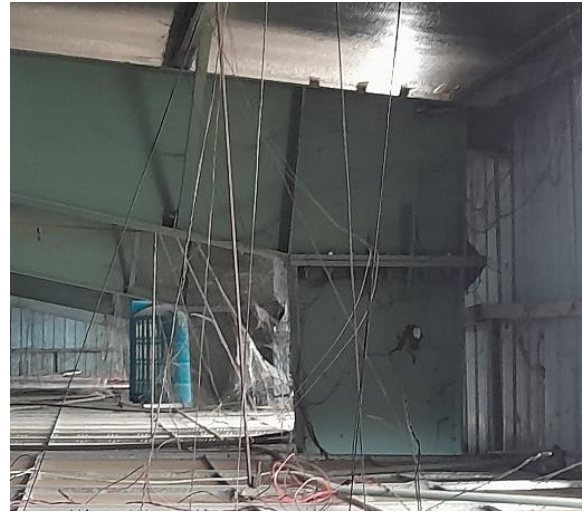
**Observation-01:** Lack of stability and unavailability of as-built documents. (Production Building).

During the inspection, the as-built drawing, and foundation details are unavailable. Also, design documents as well as material test reports (Steel & Geotechnical Investigation) were not available. Additionally, lateral load transfer media such as compression strut is missing for the roof shed.

**Description:** The Factory engineer is required to survey the whole structure and prepare accurate as-built drawings. Also building engineer is required to perform a Detailed Engineering Assessment (DEA) for the structure based on in-situ material strength, floor live load and geotechnical investigation report and prepare a DEA report based on the FEA model.

| Serial No | Observation | Action Plan | Timeline |
|---|---|---|---|
| 1 | Lack of stability and unavailability of as-built documents. (Production Building). | Building engineer to Survey the whole structure and prepare accurate as-built drawings including the detailed foundation information. | within 6 weeks |
| 2 | Lack of stability and unavailability of as-built documents. (Production Building). | Building engineer is required to perform a Detailed Engineering Assessment (DEA) of the structure according to BNBC and submit it to RSC for review. | within 6 weeks |
| 4 | Lack of stability and unavailability of as-built documents. (Production Building). | Carry out remedial work if required. | within 6 months |

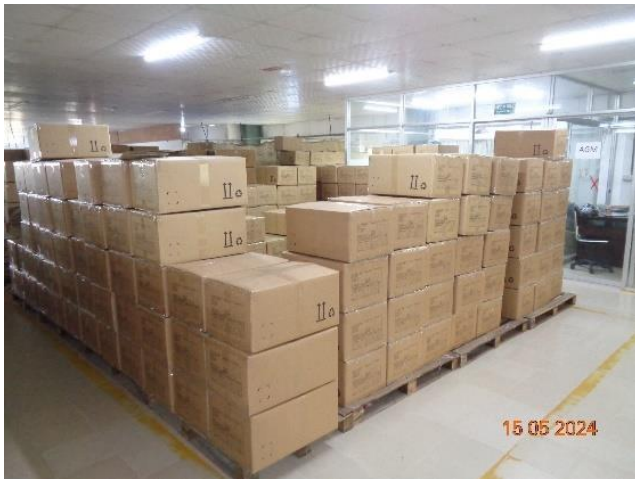
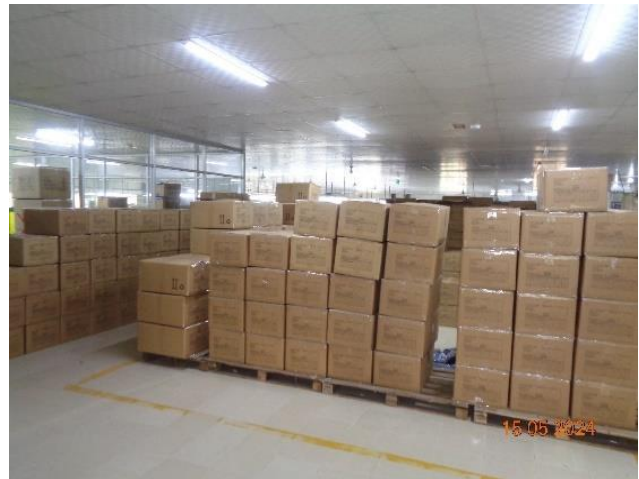
The load plan was not available for the building. The building is being used as storage on the 1st floor. The building engineer is required to prepare the loading plan for the building based on the capacity of the structural members and design review. Also, post the load plan at the entry and storage area. The Factory engineer is required to ensure the implementation of the load management program.

| Serial No | Observation | Action Plan | Timeline |
|---|---|---|---|
| 3 | Lack of stability and unavailability of as-built documents. (Production Building). | Produce and actively manage a loading plan for all floor plates considering floor and column capacity. | within 6 weeks |
| 5 | Lack of stability and unavailability of as-built documents. (Production Building). | Continue to implement the floor loading plan. | within 6 months |

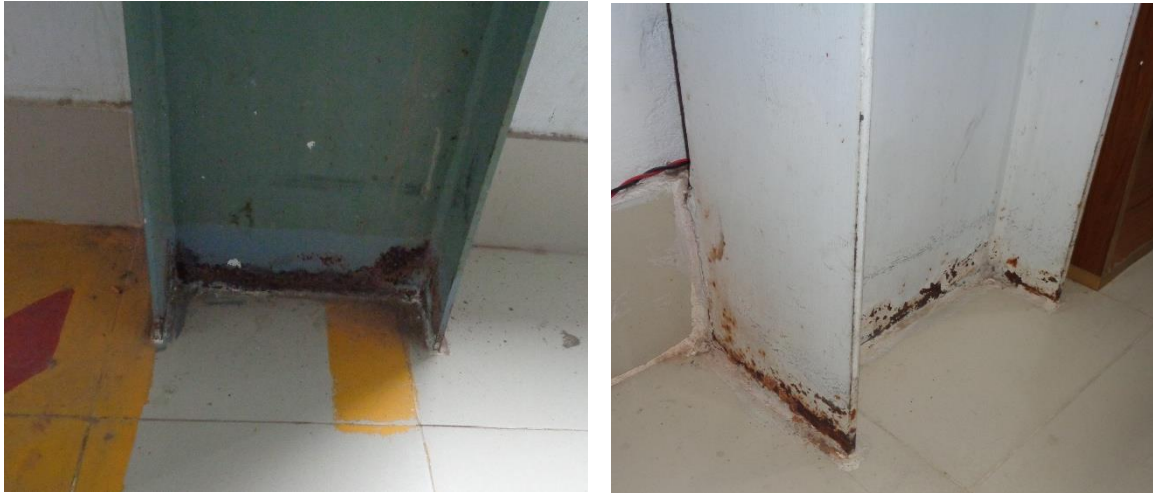
**Observation-02: Corrosion in steel member. (Production Building)**

**Description:** Corrosion was in the steel member. The building engineer is required to provide rust-proof paint on corroded steel members to protect from corrosion.

| Serial No | Observation | Action Plan | Timeline |
|---|---|---|---|
| 6 | Corrosion in steel members. (Production Building) | The building engineer is required to provide rust-proof paint on corroded steel members to protect from corrosion. | within 6 months |

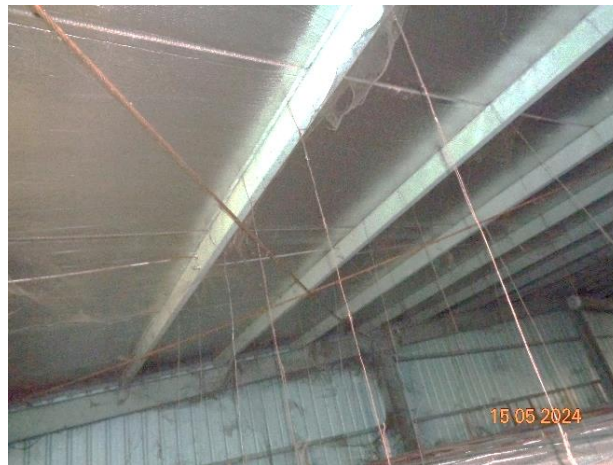
**Observation-03: Loose Cable Bracing. (Production Building)**

**Description:** During the inspection, Loose bracing was found on the roof shed. Building engineer is required to necessary actions to tighten the roof bracing.

| Serial No | Observation | Action Plan | Timeline |
|---|---|---|---|
| 7 | Loose Cable Bracing. (Production Building) | The building engineer is required to tighten the loose cable bracing. | within 6 months |

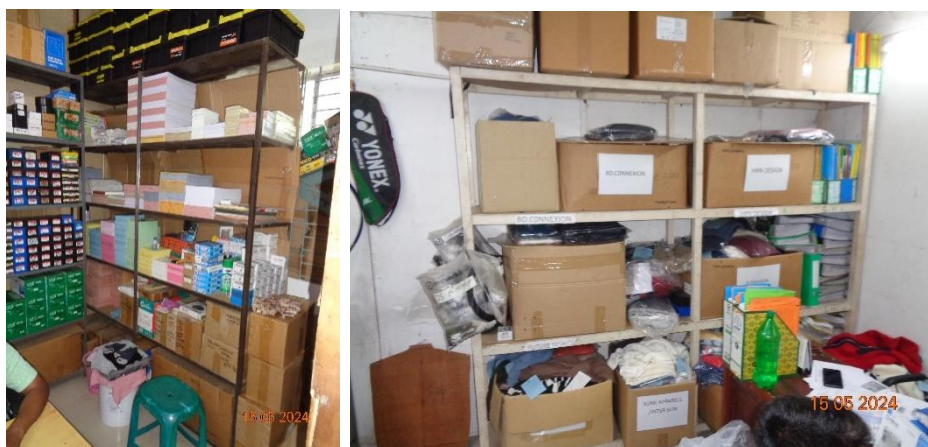
**Observation-04: Non-structural elements not anchored or braced. (Production Building)**

**Description:** Some racks on floors are not anchored or braced to resist lateral (earthquake) forces. The factory is required to anchor/brace all non-structural elements adequately to resist earthquake forces.

| Serial No | Observation | Action Plan | Timeline |
|---|---|---|---|
| 8 | Non-structural elements not anchored or braced. (Production Building) | The factory is required to anchor/brace all non-structural elements adequately to resist earthquake forces. | within 6 months |

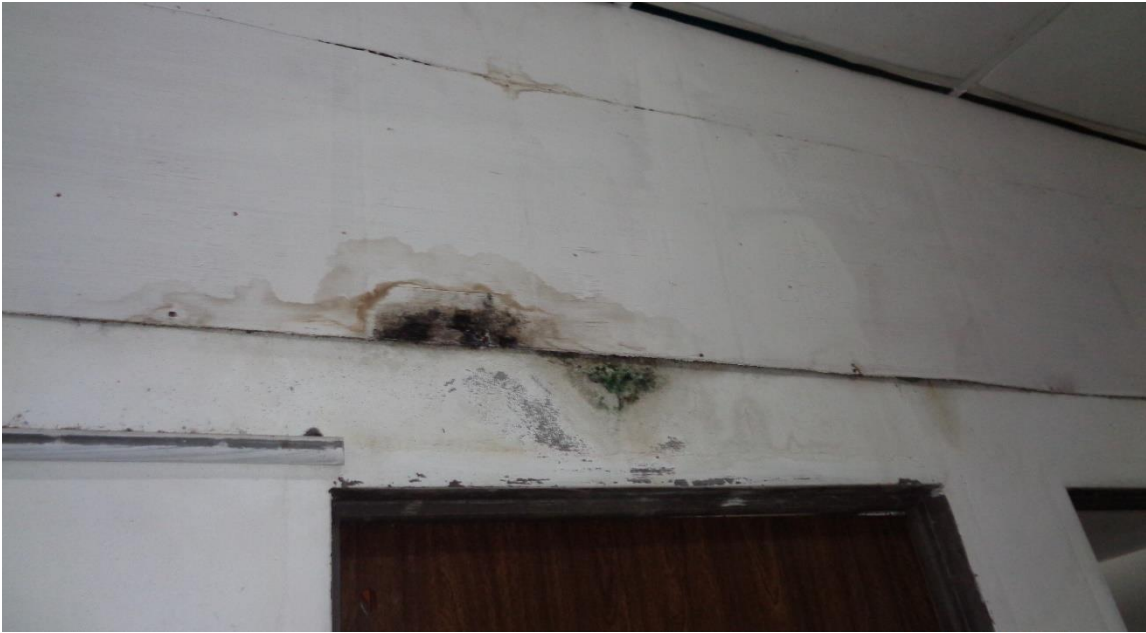
**Observation-05:** Dampness in brick wall (Production Building)

**Description:** During the inspection, dampness was found in the brick wall of the toilet zone. The building engineer is required to investigate the reasons of dampness and suggest proper methods to repair the dampness.

| Serial No | Observation | Action Plan | Timeline |
|---|---|---|---|
| 9 | Dampness in brick wall (Production Building) | The building engineer is required to investigate the reason of dampness and suggest proper repair methodology. | within 6 weeks |

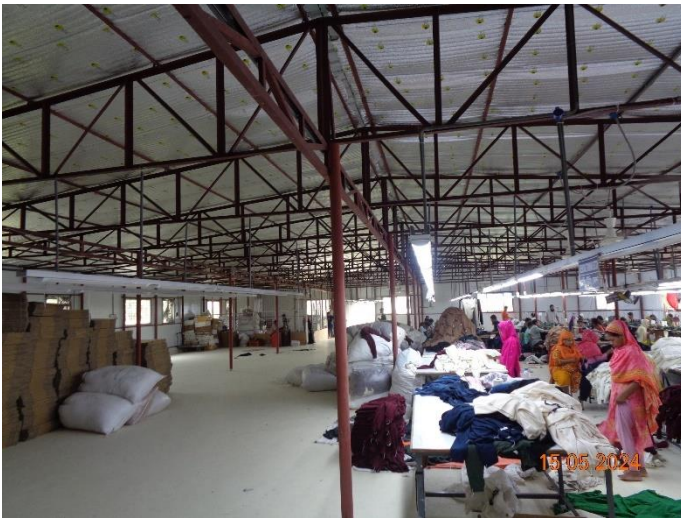
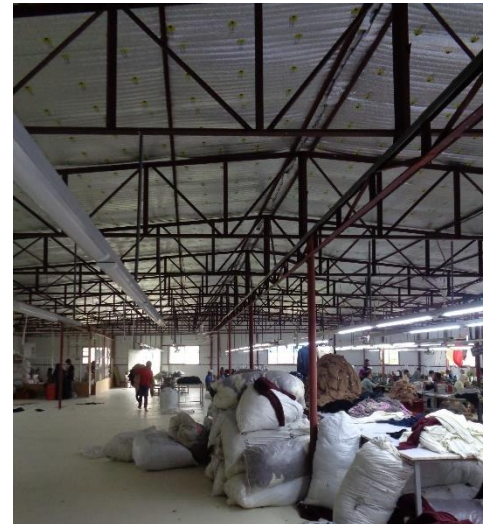
**Observation-06:** Lack of Lateral stability. (Linking Shed)

**Description** During inspection, as-built drawing was not available for the structure as well as the foundation details are unknown. Also, design documents as well as material test reports were not available. Additionally, lateral load transfer media such as wall and roof bracing is missing for the shed.

The building engineer is required to survey the whole structure and prepare accurate as-built drawing. Also building engineer is required to check the lateral stability system, connection adequacy check and foundation adequacy.

| Serial No | Observation | Action Plan | Timeline |
|---|---|---|---|
| 10 | Lack of Lateral stability. (Linking Shed) | Building engineer is required to check the connection adequacy and lateral stability of the structure. | within 6 weeks |
| 11 | Lack of Lateral stability. (Linking Shed) | Carry out remedial work if required. | within 6 months |

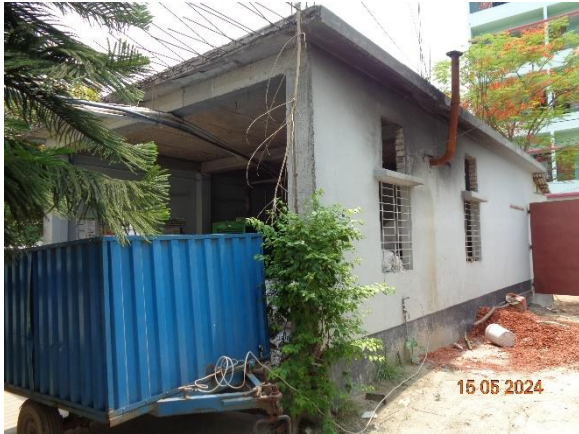
Utility Building

**Observation-07: Lack of as-built drawings. (Utility Building and Boiler Room)**

**Description:** During the inspection, as-built drawing was not available for the utility building and Boiler room. Building engineer is required to prepare a full set of as-built drawing for both structures.

| Serial No | Observation | Action Plan | Timeline |
|---|---|---|---|
| 12 | Lack of as-built drawings. (Utility Building and Boiler Room) | Building engineer is required to prepare a full set of as-built drawings for structures. | within 6 weeks |

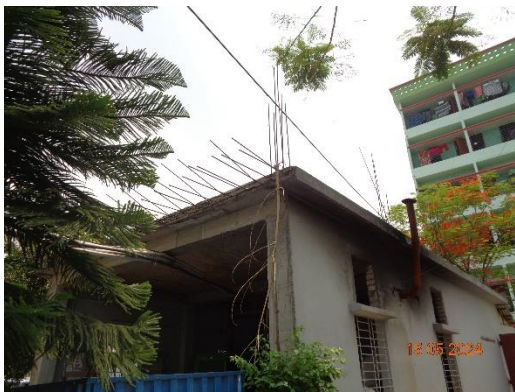
Utility Building

**Observation-08: Exposed re-bar on the roof. (Utility Building & Boiler Room)**

**Description:** Exposed reinforcement was found for columns of Boiler room and columns, beams and slab for utility building. The factory engineer is required to provide anti-corrosive coating in the rebar to prevent corrosion in exposed rebar.

| Serial No | Observation | Action Plan | Timeline |
|---|---|---|---|
| 13 | Exposed rebar at the roof. (Utility Building & Boiler Room) | All exposed reinforcement is to be protected from corrosion which may cause degradation of the concrete. | within 6 months |

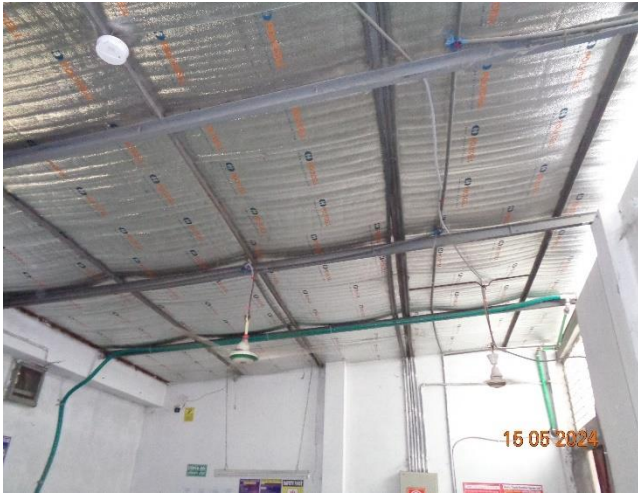
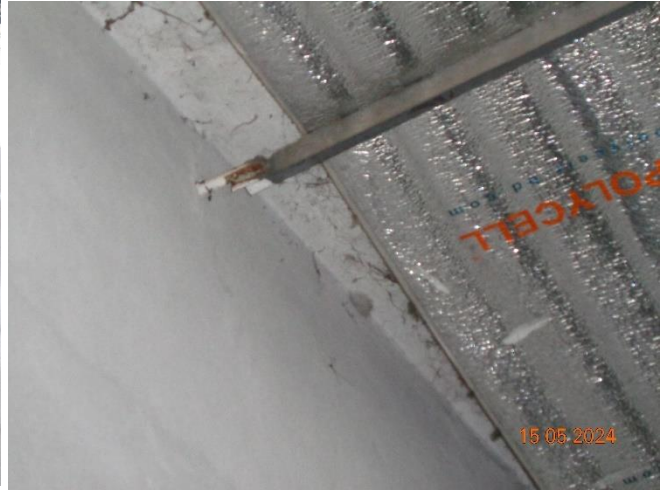
Washing Shed

**Observation-09:** Lightweight shed with poor connection (Washing shed and Walking shed)

**Description:** Inadequate connections were observed at the lightweight roof of the single-storied washing shed and walkway shed. The building engineer is required to check the connection adequacy of the lightweight roof against the uplift forces.

| Serial No | Observation | Action Plan | Timeline |
|---|---|---|---|
| 14 | Lightweight shed with poor connection (Washing shed) | The building engineer is required to check the connection adequacy of the lightweight roof against the uplift forces. | within 6 weeks |
| 15 | Lightweight shed with poor connection (Washing shed) | Carry out remedial work if required. | within 6 months |
