# INITIAL FIRE SAFETY INSPECTION REPORT

## Newtex Knit Fashion Ltd (Extension)

RSC ID: 24852

# Fire Safety Inspection Report

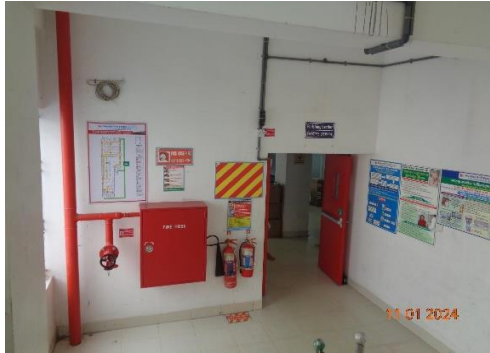
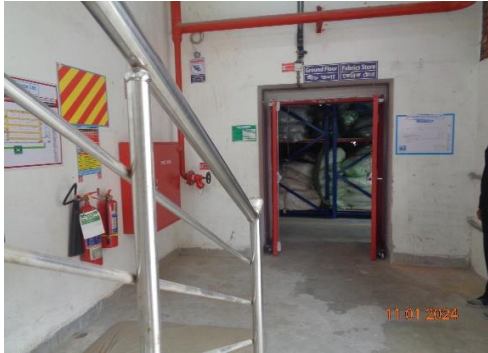
| Sl No. | Category | Findings | Required Action | Remediation Time Frame |
|---|---|---|---|---|
| 1 | Fire Rated Construction | The exit stair enclosures are not separated from work areas and other spaces on each floor by fire-rated construction.<br>Location: Building 2 | <p>The exit stair enclosure shall be provided with a minimum 1-hr fire resistance rating for buildings with 3 or fewer stories and a minimum of 2-hr. fire resistance rating for buildings 4 or more stories. Provide 0.75 hr. fire rated door and seal all penetrations and openings by 1 hr. fire rated fire rated barrier construction for building with 3 or fewer stories. Provide 1.5 hr. fire rated door and seal all penetrations and openings by 2 hr. fire rated fire rated barrier construction for building with 4 or more stories.</p> <p>Ensure that the fire doors are self-closing and positive latching and that they are provided with fire exit (panic) hardware where serving production floors. If fire doors are required to be held open for functional reasons, provide automatic closing devices tied to the fire alarm system.</p> | Within 3 months |

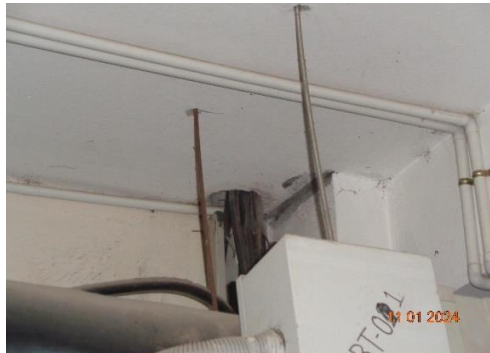
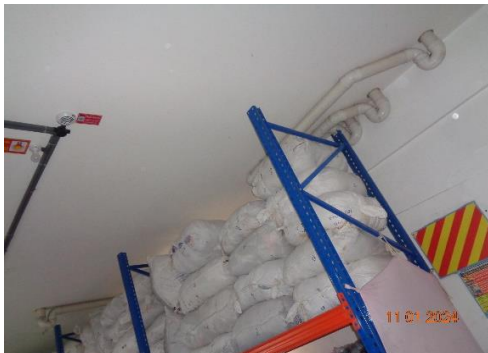
| 2 | Fire Rated Construction | <p>Unsealed penetrations and openings are located in the fire rated floor/ceiling assemblies.</p> <p>Location: Building 2.</p> | <p>Provide a minimum 2-hr fire rated shaft to separate the utility risers from each floor level or seal all penetrations and openings in floors/ceiling assemblies by 3-hr fire rated listed/certified materials. The installation of such fire rated materials shall be following certified design. The same fire rating is required to be ensured for the PVC pipe penetrations.</p> | Within 3 months |

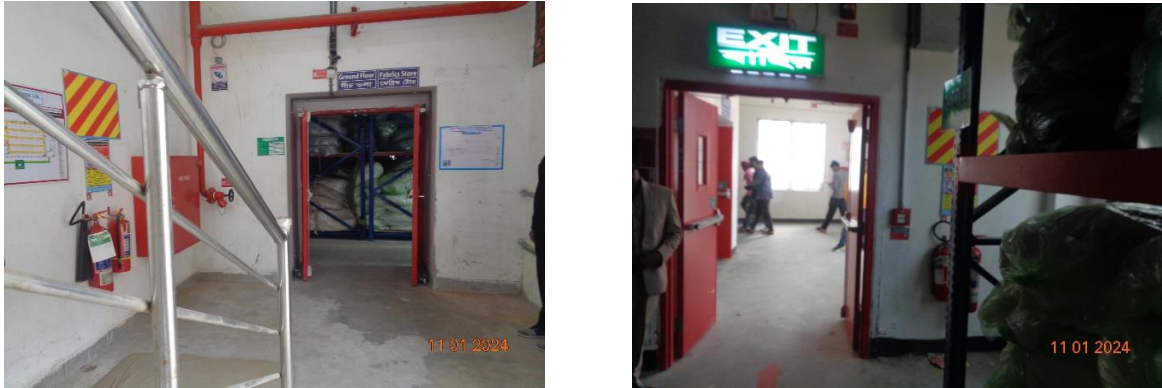
| 3 | Fire Rated Construction | Openings from exit enclosures to storage areas are not provided with vestibules. Location: Building 2: Ground floor. | Provide vestibules for openings from exit enclosures to storage areas, basements, transformer rooms, generator rooms, boiler rooms, and similar normally unoccupied spaces according to RSC Technical Guideline (Standard)- 6.14.3. | Within 3 months |

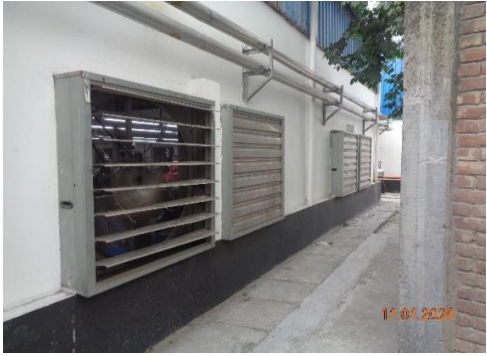
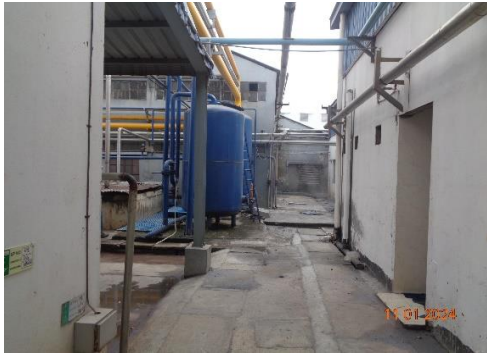
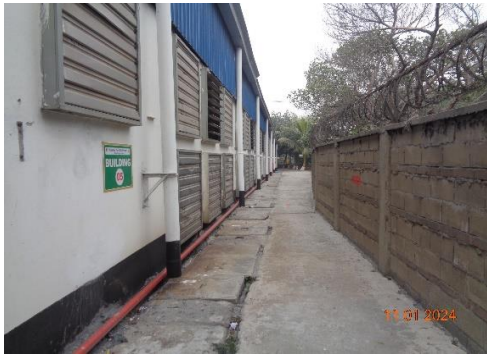
| 4 | Fire Rated Construction | The exit discharge path is less than 10 ft wide and is not separated from the building interior. Location: Shed 4 & 5. | Seal all penetrations and openings to the interior of the building along the discharge path, up to a height of 10 ft, to provide a minimum 1-hr fire separation according to the RSC technical guidelines 6.17.2 | Within 3 months |

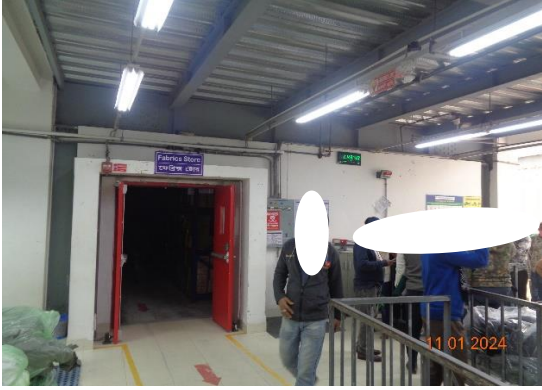
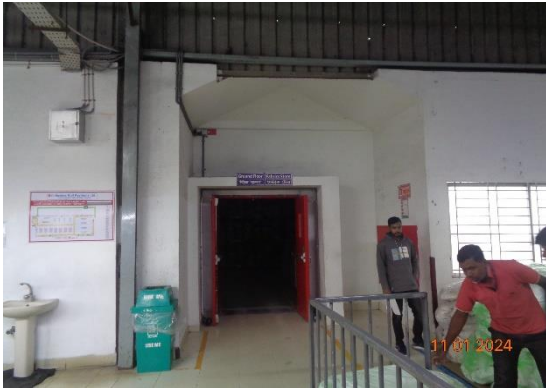
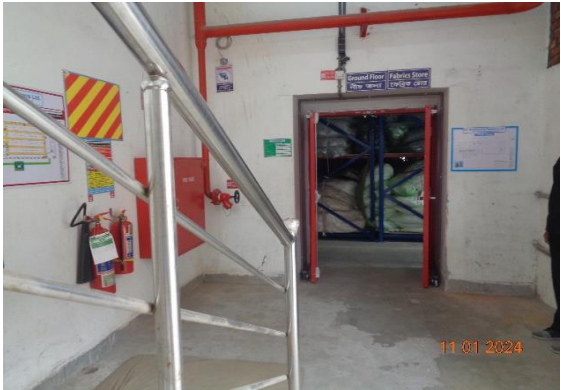
| 5 | Fire Rated Construction | <p>Rooms used for storage of combustibile materials are not separated from the surrounding occupancy/areas &amp; floors. Location: Building 02 and shed 04</p> | <p>Rooms used for storage of combustibile materials shall be separated from the surrounding occupancy with a minimum 1 hour construction according to RSC Technical Guidelines (Standard) Section 3.4.2.1.5. Store rooms directly discharge in exit stair enclosure shall be separated in accordance with the RSC Technical Guidelines (Standard) Section 6.14.3</p> | Within 3 months |

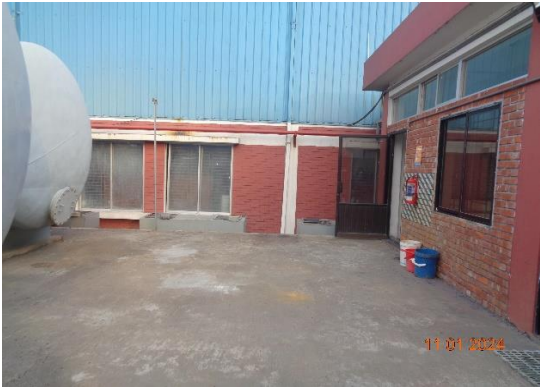
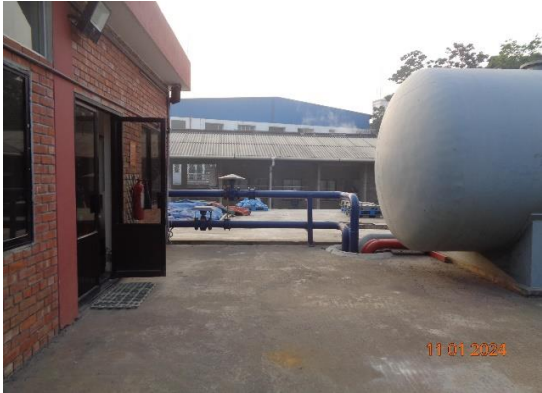
| 6 | Fire Rated Construction | The fire pump room is not provided with adequate fire separation. | <p>Provide fire pump room with 2 hr rated fire separation when not sprinklered and 1 hr rated fire separation when provided with automatic sprinklers in accordance with NFPA 20 Or, Physically separate the pump room from the protected building by a minimum of 50 ft. (15.3 m) in accordance with NFPA 20.</p> <p>Enclosed passageway from an enclosed stairway or exterior exit is required to be ensured according to section 4.12.2.1.1 of NFPA 20</p> | Within 3 months |

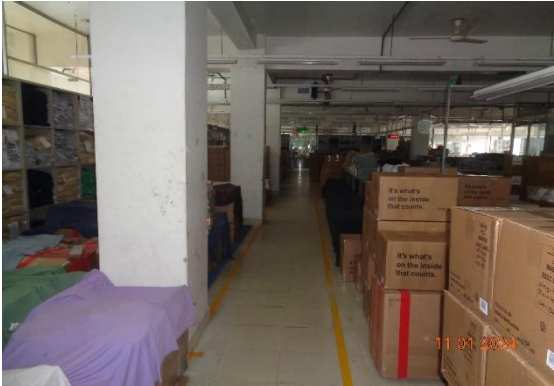
| 7 | Fire Rated Construction | Areas used for combustible storage are not separated by fire rated construction. Location: Building 2 (Packing Section). | <p>Provide defined storage areas and limit the storage arrangement as follows:-</p> <ol style="list-style-type: none"> <li>1. General Condition: Maximum height of 2.4m and maximum area of 23m<sup>2</sup>. Separate areas of unenclosed combustible storage by a minimum clear distance of 3m.</li> <li>2. If sprinkler protected: maximum height of 3.66m and maximum area of 93m<sup>2</sup>. Separate areas of unenclosed combustible storage by a minimum clear distance of 3m.</li> <li>3. Enclose the storage area from the surrounding occupancy with a minimum 1 hour construction.</li> </ol> | Within 3 months |

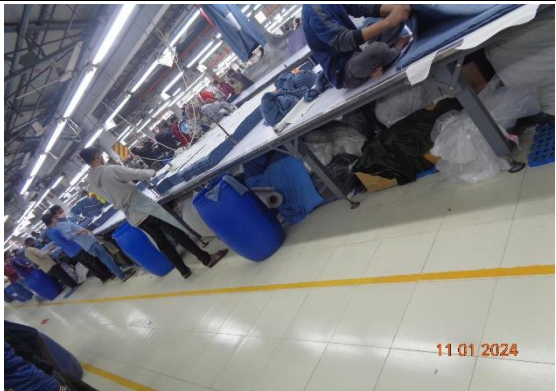
| 8 | Fire Rated Construction | Storage were observed underneath the cutting tables. | <p>Storage underneath the cutting tables shall be kept clear of combustibles at all time, except as provided for miscellaneous storage in accordance with the RSC Technical Guidelines (Standard) section 3.4.2.1.6 or where automatic sprinkler protection is installed.</p> <p>Where an automatic sprinkler system is installed sprinklers are required to be installed beneath cutting tables greater than 4 ft. in width that are used for storage of combustibles.</p> | Within 3 months |

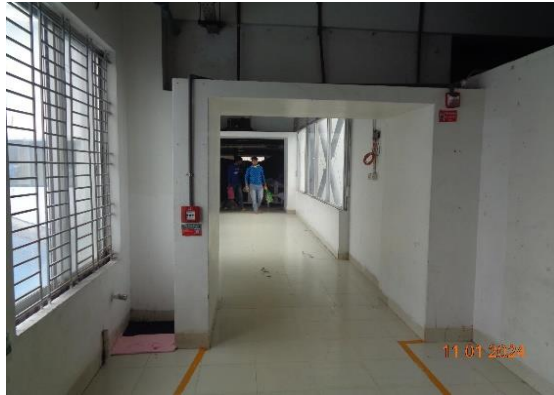
| 9 | Fire Rated Construction | Building 2 is not separated from building 1. | Exterior wall of building 02 shall have fire resistance rating not less than 1 hour with the building 01 according to table 3.2.2 BNBC 2006. | Within 3 months |

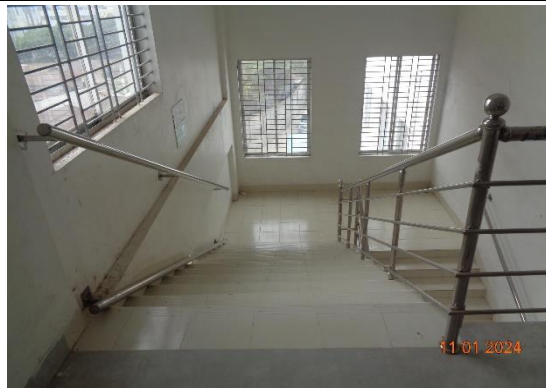
| 10 | Means of egress | The width of the exit stair is less than 1.5 m (60 in.). Location: Building 2, stair 1 & 2. | In new and interim construction and constructed stairs post 24 November 2013, stairs shall have a minimum width of 1.5 m (60 in.) for all industrial occupancies and 2.0 m (79 in.) for all assembly occupancies. For assembly use areas provided for prayer halls, dining halls and like areas that are for integral use by the factory workers, the minimum width for the primary occupancy use of the building shall be permitted to be used. | Within 3 months |

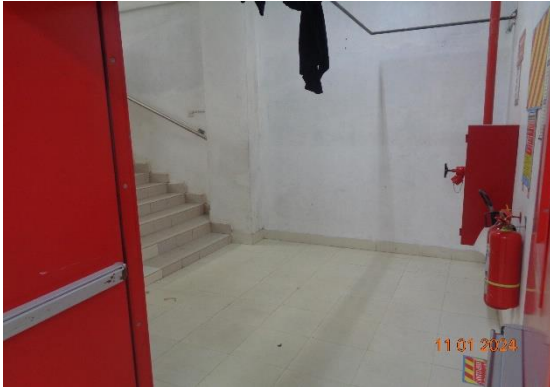
| 11 | Means of egress | Exit stairs do not discharge directly to the outside. | <p>Modify stair to discharge directly outside.</p> <p>Or</p> <p>Provide 2-hr fire-rated exit passageway leading directly outside (vestibules to separate any storage areas).</p> <p>Or</p> <p>Provide sprinkler protection for discharge floor in accordance with NFPA 13 meeting RSC 6.17.3 (all 4 options shall meet)</p> | Within 3 months |

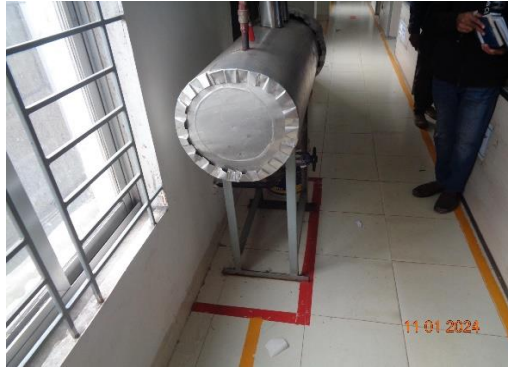
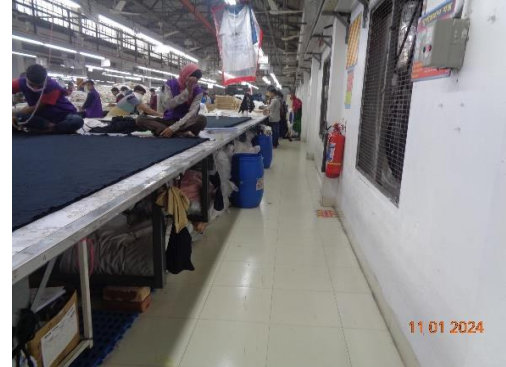
| 13 | Means of egress | Aisle are not properly marked. Location: Building 2: Ground floor and cutting shed area. | Aisles shall be properly marked and provided with a minimum unobstructed clear- width of 0.9m (36 in). | 3 months |

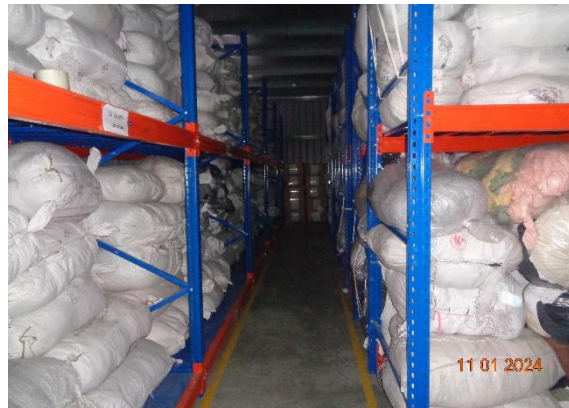
| 15 | Egress Lighting | Directional signs are not provided where direction of the path of travel to an exit has changed.<br>Location: Shed 6 | Illuminated directional signs shall be provided where there is a change in the direction for the path of travel and the direction to an exit is not obvious. | Within 1 month |

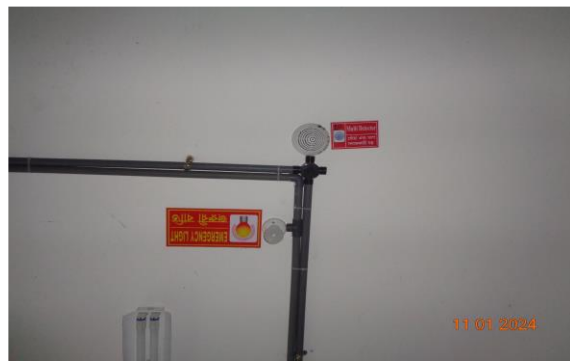
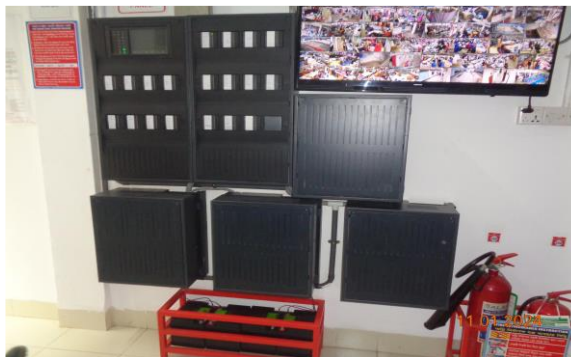
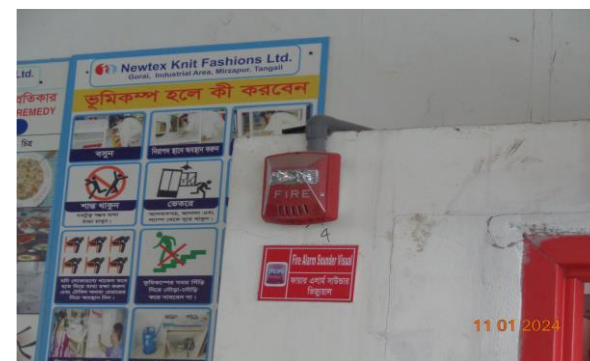
| 17 | Fire Alarm & Detection System (FADS) | Fire detection system installation has been reviewed by the RSC. Modification of the fire detection and alarm system has not been conducted in accordance with the reviewed design and NFPA72. | Modify the installed fire detection system in accordance with the reviewed design by the RSC and with NFPA 72. | Within 4 months |

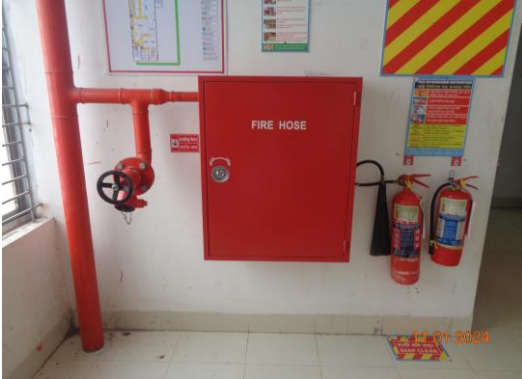
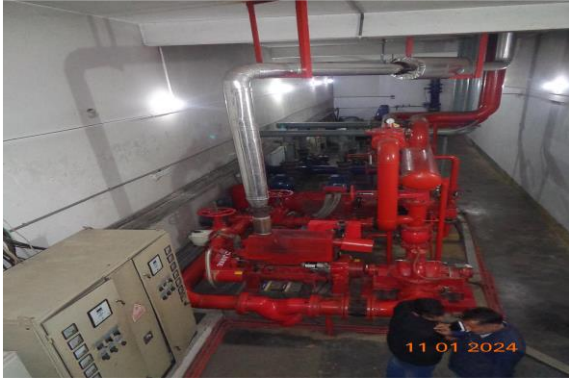
| 19 | Fire Protection System | Standpipe system is required to be installed according the reviewed drawing by the RSC and in accordance with NFPA 14, 20, 22, & 24. Location: Building 2 and connected sheds. | Install / modify the standpipe system throughout the building in accordance with review comment by the RSC and NFPA 14, 20, 22 and 24.<br>After installation the owner shall conduct internal testing and commissioning and then contact the RSC for witness of final acceptance testing. | Within 4 months |

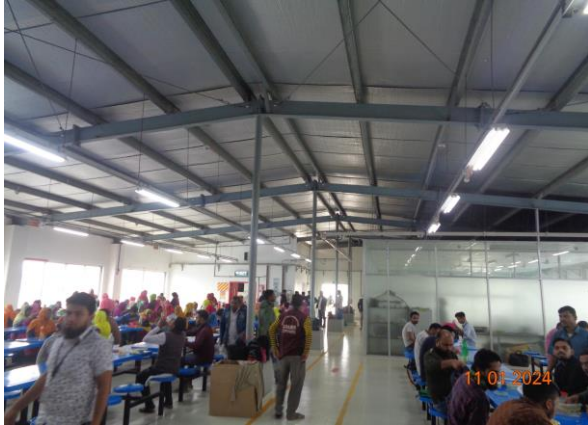
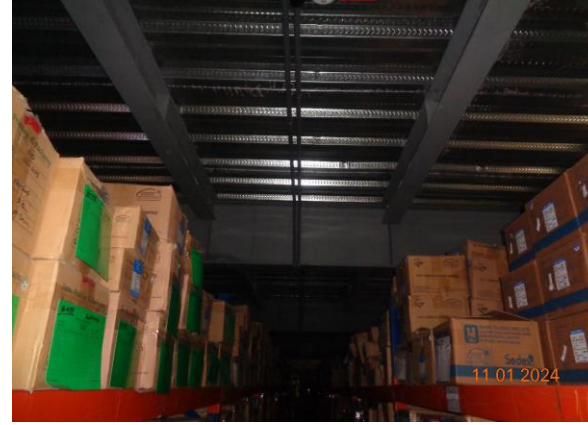
| 22 | Fire Rated Construction | The first floor is steel-composite type and a portion of the RCC panels are resting on the steel columns and girders which is in exposed condition without any fire protection. Also the dining shed on the roof is constructed with pre-fabricated column, purlin and rafter.<br>Location: Building 02 | Construction of interim non-high-rise building shall be type-1 or type-2 as required in BNBC 2006 Part 3 Table 3.2.4. Provide required fire rating on the structural elements by following Section 4.4 and Table 4.1.1 of the RSC Technical Guidelines Standard or Table 3.3.1 from BNBC Part 3 and Table 4.1.1 from BNBC Part 4. Consult a qualified fire protection engineer to design the rated construction barriers in between two floors and in structural members. | Within 6 months |
