# TEXTIL FASHIONS LTD.

Holding no6/1, Plot -168, Soydana, Gazipur

4<sup>th</sup> November, 2015

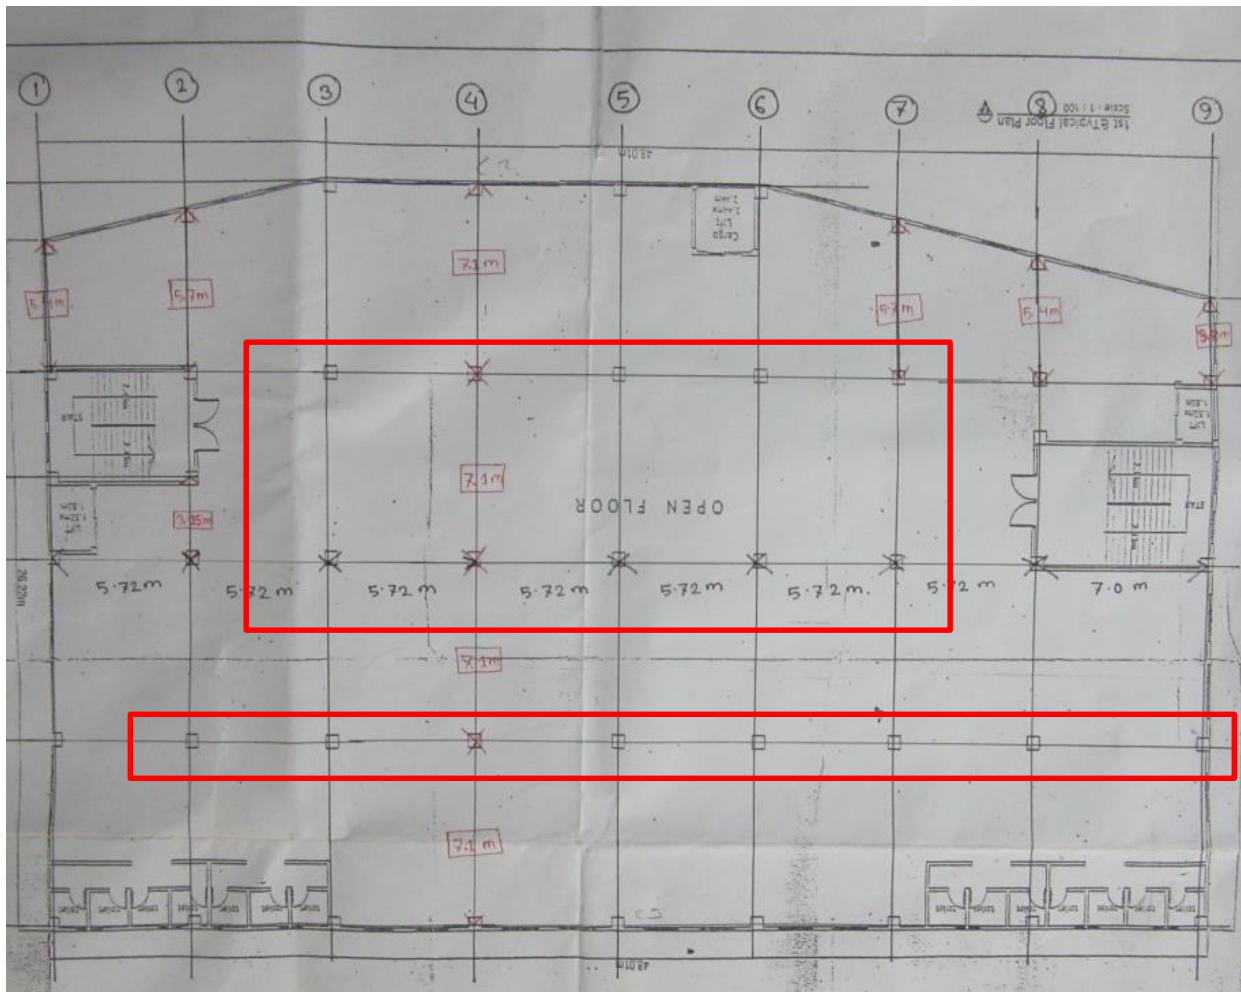
Marked columns are found to have high stresses considering the full build-out stage of the construction (8-storey building).

| Item No. | Observation | Recommended Action Plan | Recommended Timeline |
|---|---|---|---|
| 1 | Stress Level at Columns in full build-out | Stress level at most of the columns found to be high in the case of an 8-storey building. | 6-weeks |

| Item No. | Observation | Recommended Action Plan | Recommended Timeline |
|---|---|---|---|
| 2 | Stress Level at Columns in full build-out | Building Engineer to check design according to the actual state of column types and dimensions before proceeding with the construction of upper floors. Consideration should be given to reducing the number of proposed floors. | 6-weeks |
| 3 | Stress Level at Columns in full build-out | Make structural alterations if required as advised by Engineer. | 6-months |

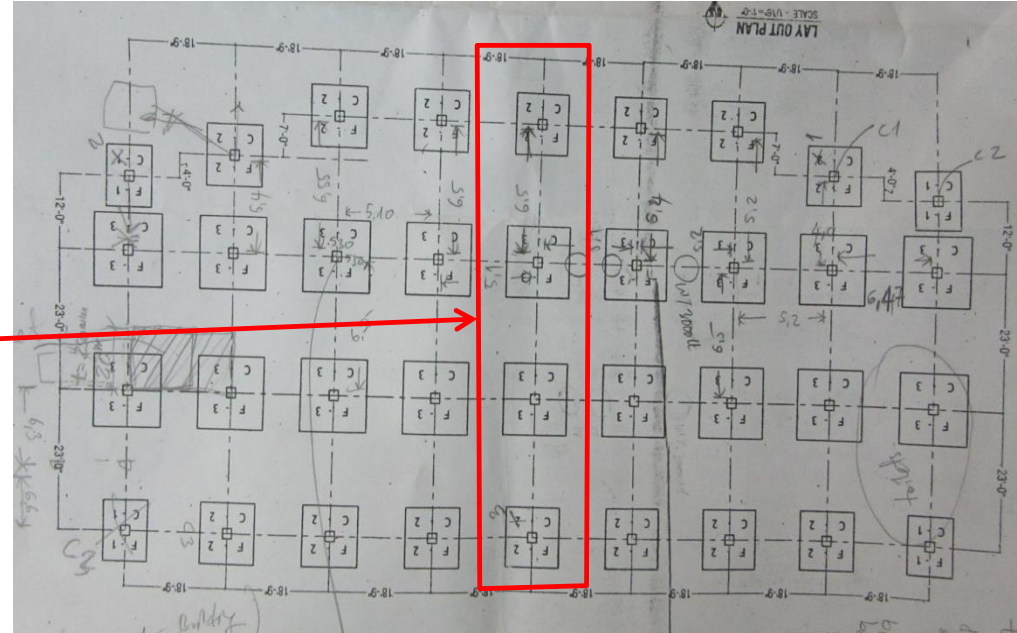
Structural Drawing

Structural drawing shows 4 columns in north–south direction instead of 5 columns which is observed at site and as shown on the architectural drawing.

| Item No. | Observation | Recommended Action Plan | Recommended Timeline |
|---|---|---|---|
| 7 | Discrepancies between Design Drawings and Observations | Building Engineer to update the structural design drawings to reflect the as-built structure. | 6-weeks |
| 8 | Discrepancies between Design Drawings and Observations | Make structural alterations if required as advised by Engineer. | 6-months |

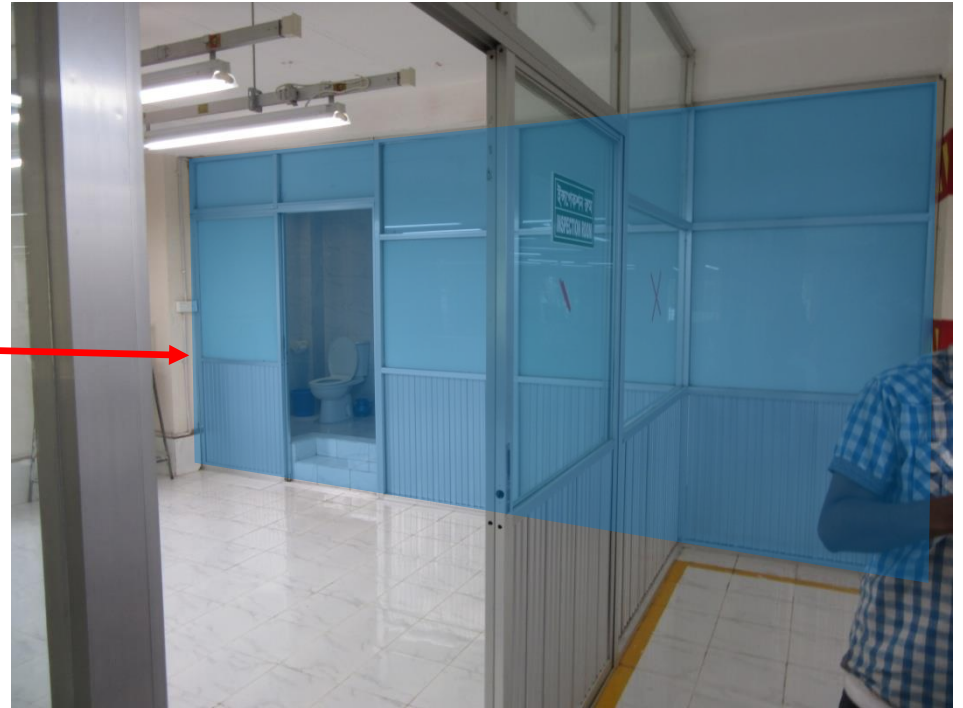
There is a toilet area at the west side of the 1<sup>st</sup> floor which is not shown in permission drawing.

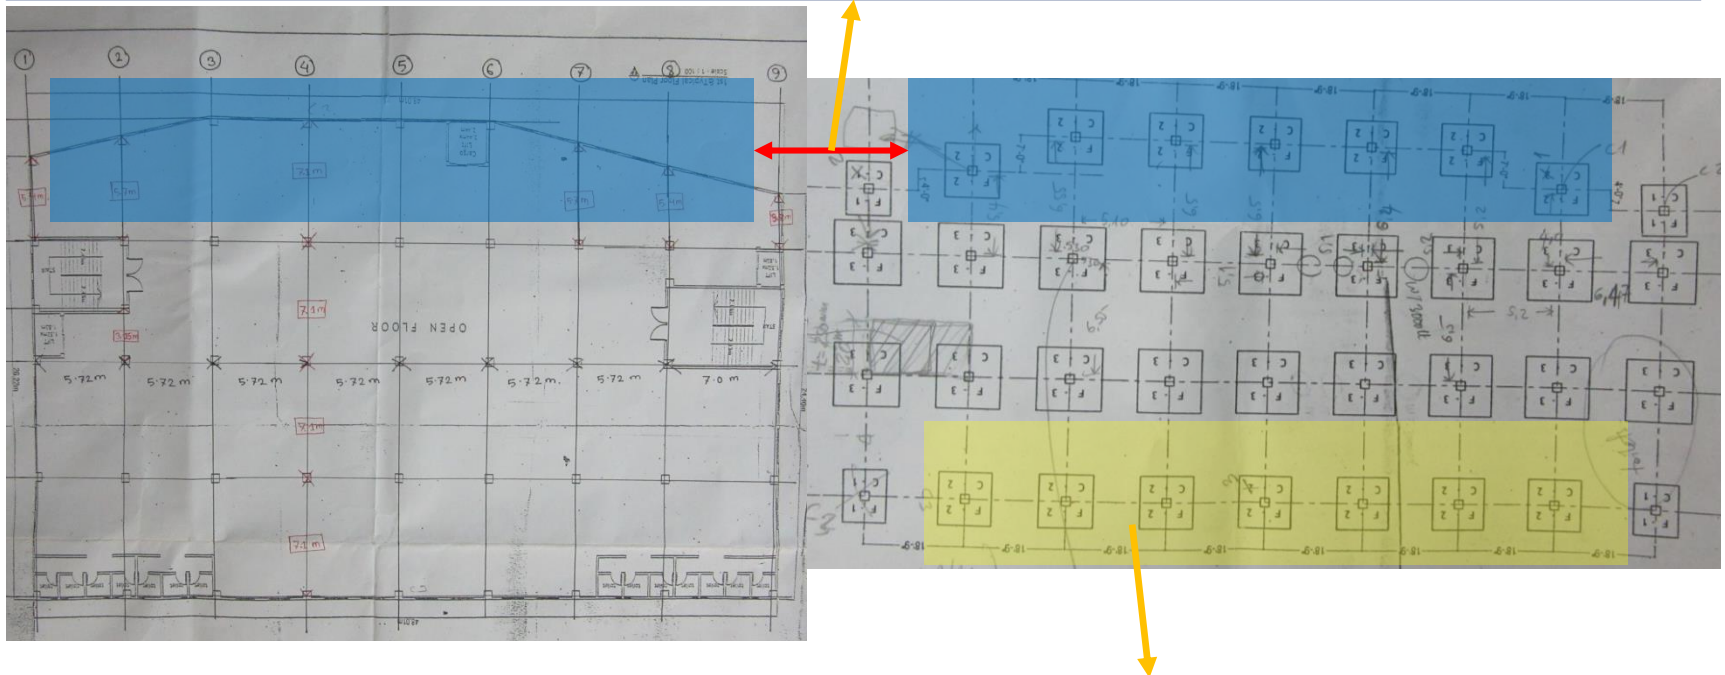
C2 type columns are only found at North edge where as the drawings shows the South edge columns also as C2.

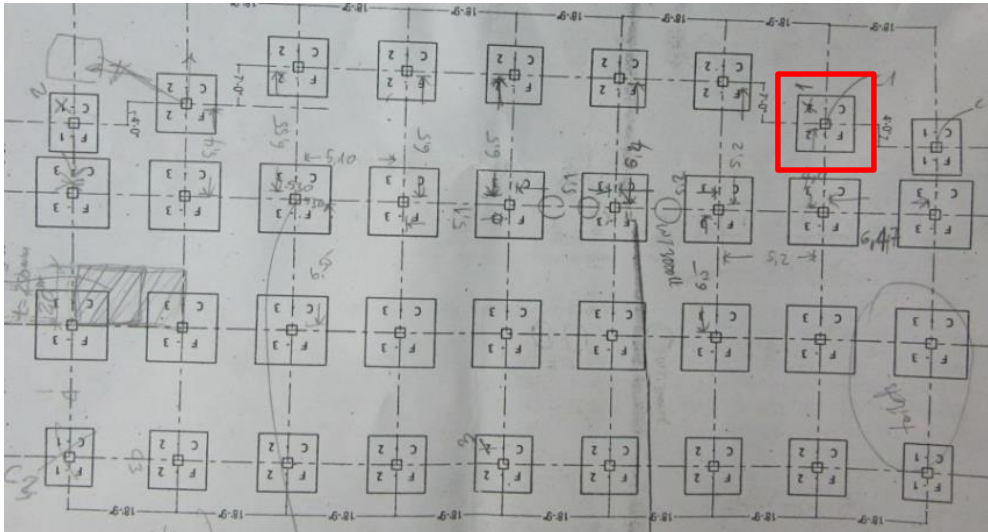
Only one C1 type column was found in the whole building.

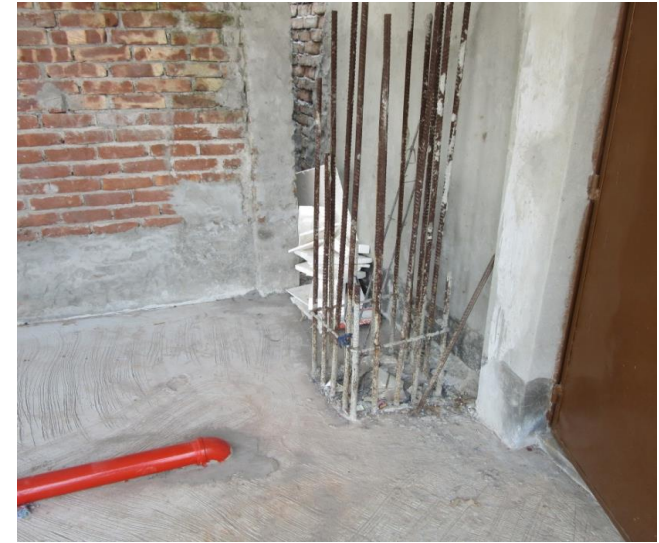
We found additional columns around staircases which were not present in any drawings.

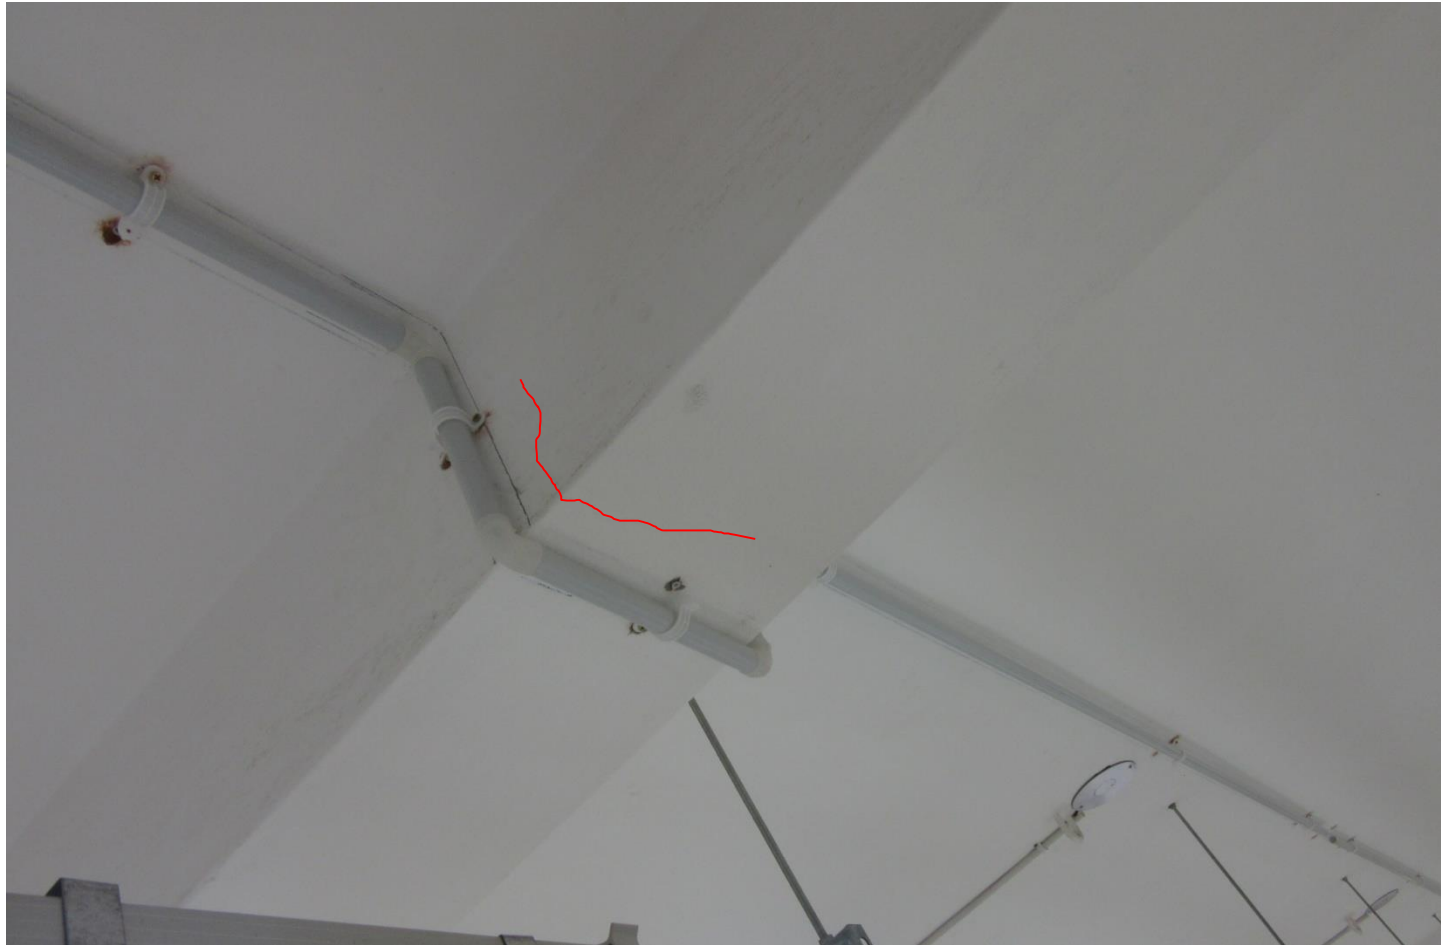
Cracks in some beams in 1<sup>st</sup> floor

| Item No. | Observation | Recommended Action Plan | Recommended Timeline |
|---|---|---|---|
| 4 | Hairline Cracks at First Floor Beams | Hairline cracks observed at several beams in plaster which might be due to large span and small size beams. | 6-weeks |

| Item No. | Observation | Recommended Action Plan | Recommended Timeline |
|---|---|---|---|
| 5 | Hairline Cracks at First Floor Beams | Building Engineer to check the capacity of the existing beams. | 6-weeks |
| 6 | Hairline Cracks at First Floor Beams | Make structural alterations if required as advised by Engineer. | 6-months |

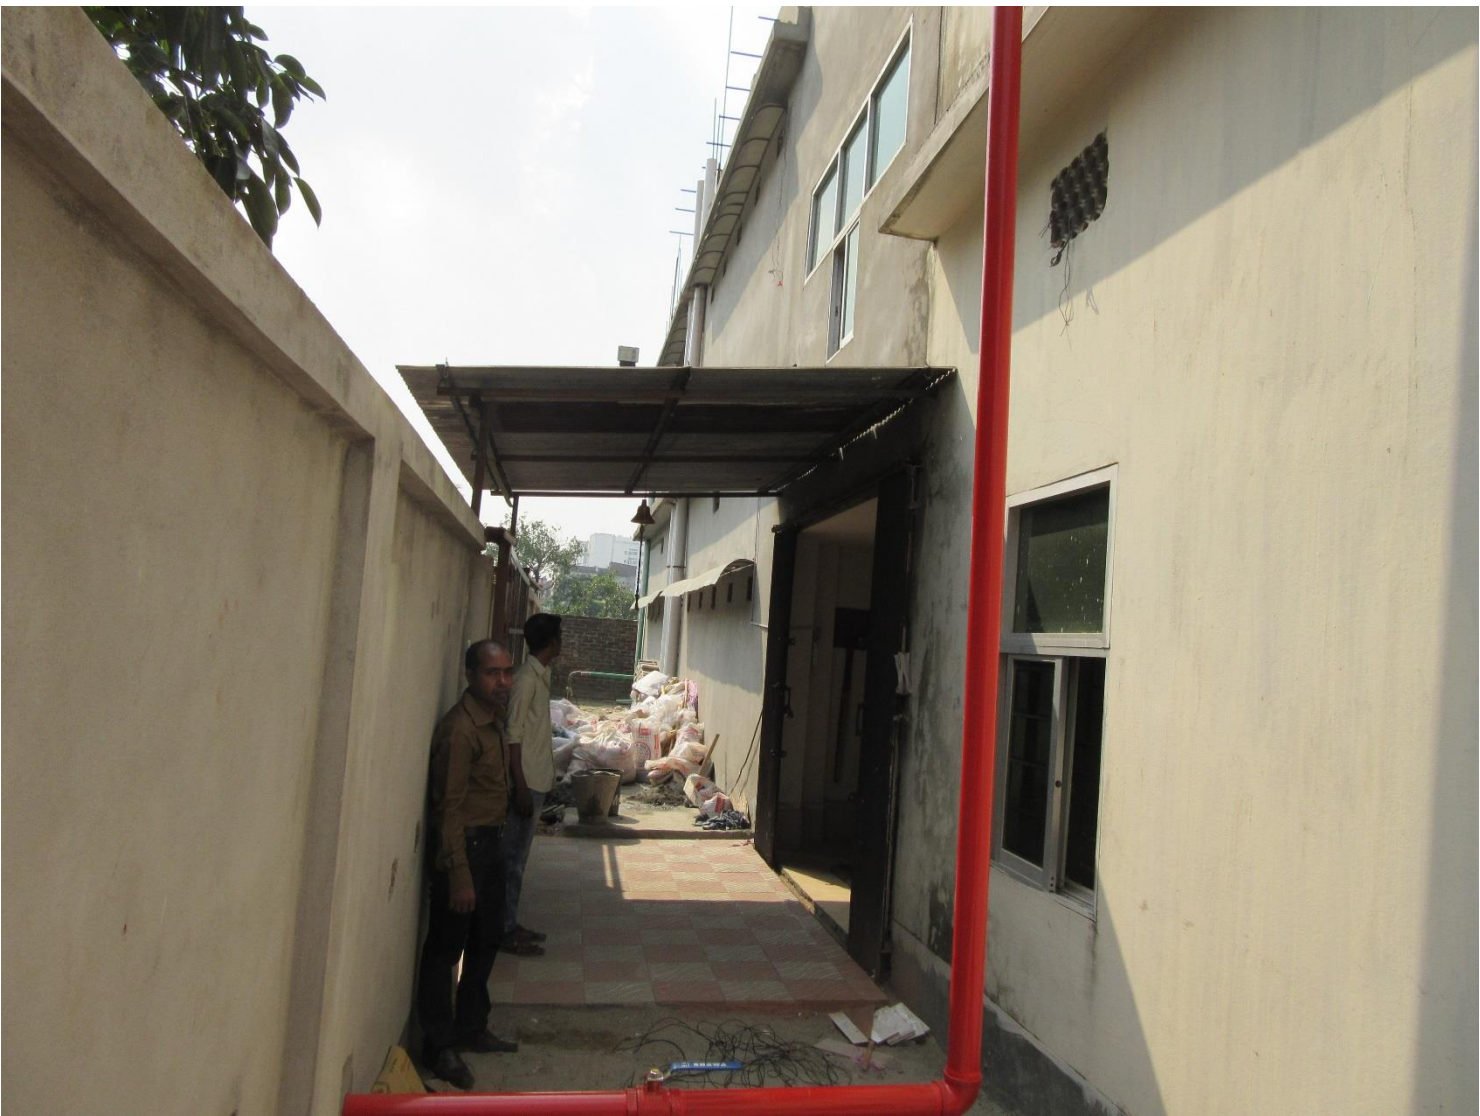
Non-Engineered roof structure attached to the building in an ad-hoc manner.

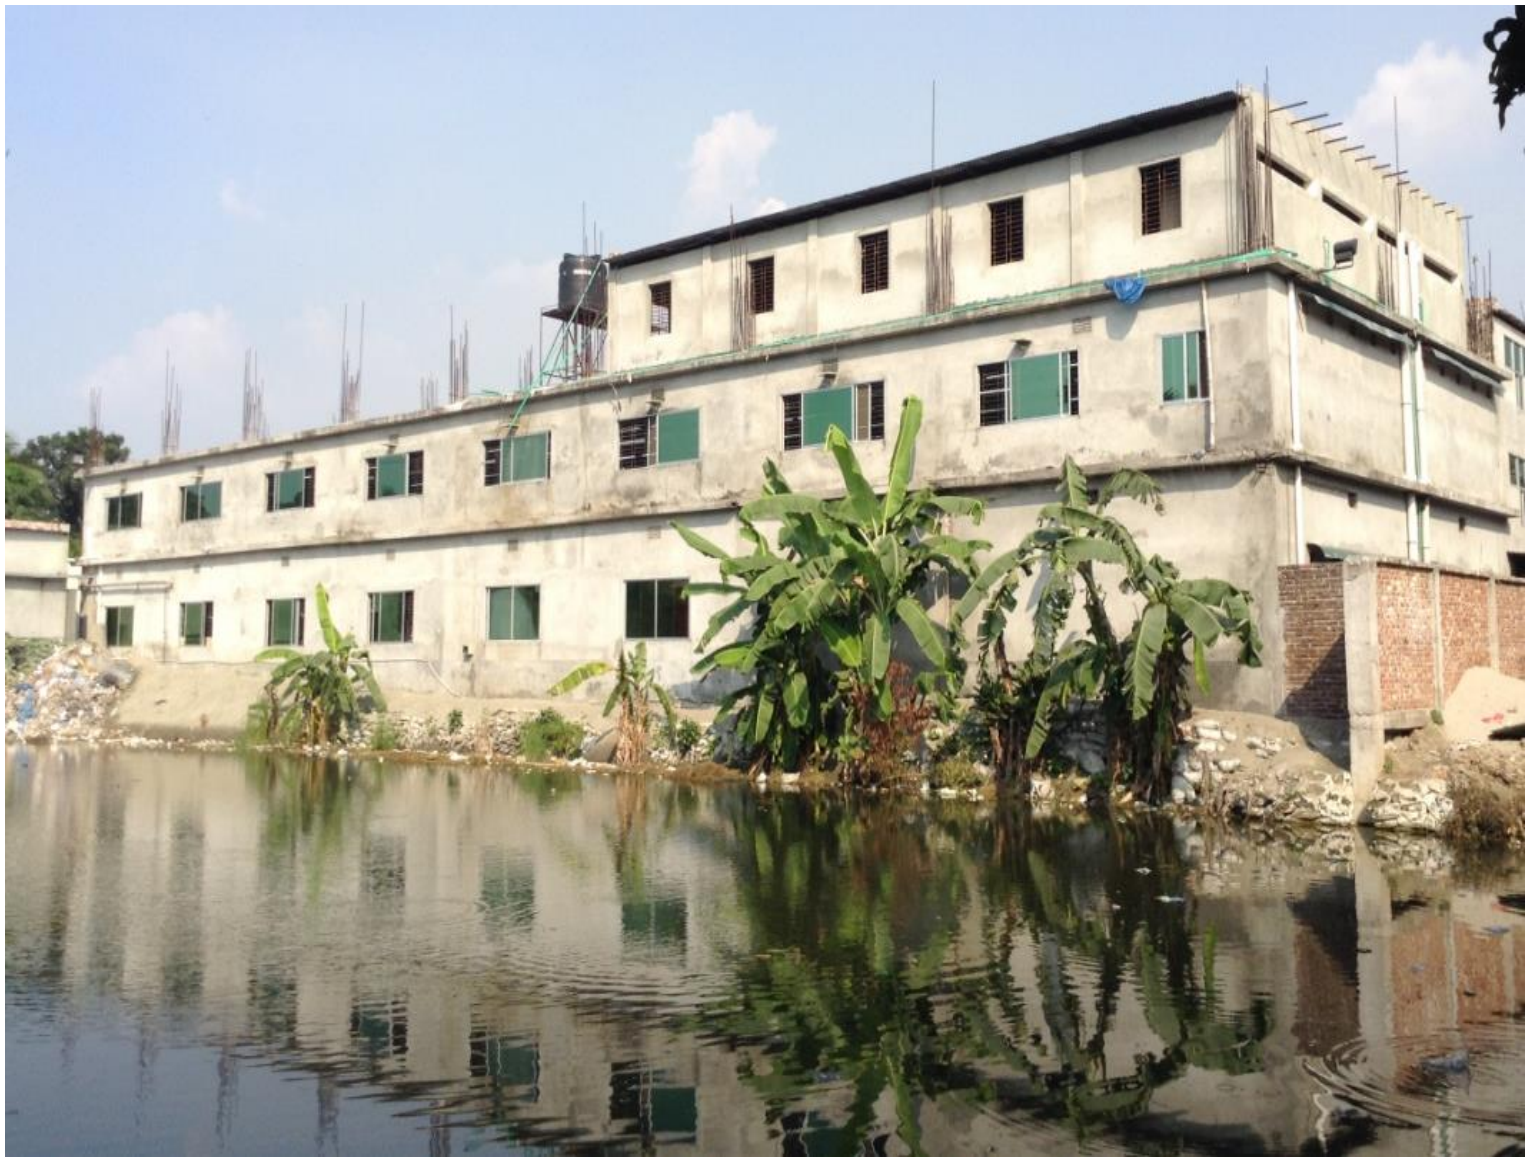
**Water pond adjacent to the building.**

| Item No. | Observation | Recommended Action Plan | Recommended Timeline |
|---|---|---|---|
| 10 | Water Pond Next to Building | Building Engineer to assess the flood risk from the nearby water pond, including consideration of impacts on the foundations. | 6-weeks |
| 11 | Water Pond Next to Building | Implement civil works as required by the Building Engineer. | 6-months |

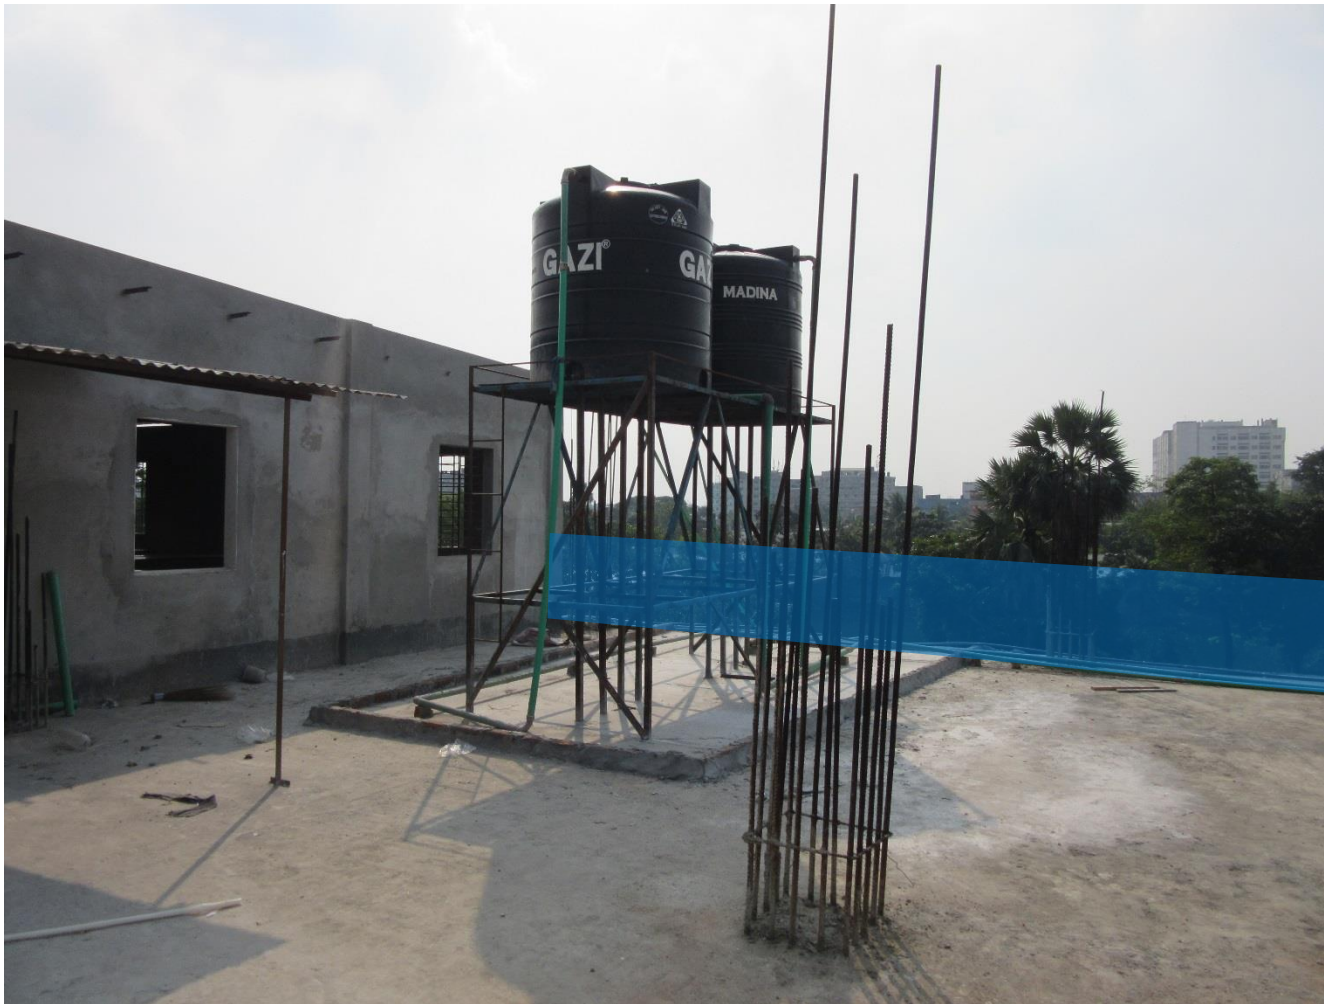
**No edge protection is provided to the floors under construction  
(Falling Hazards)**

| Item No. | Observation | Recommended Action Plan | Recommended Timeline |
|---|---|---|---|
| 9 | Lack of Safety Precautions at Roof Level | Constuction works are on-going and no edge protection is provided around the building which could cause a threat to human life. Necessary safety precautions should be taken immediately. | Immediate - Now |
