# Liz Knitting & Printing Industry (Extension)

## Structural Inspection Report

**LKP-3 Building:** Five-storied (G+4) concrete building

**Connecting Bridge:** Single-storied steel connecting bridge

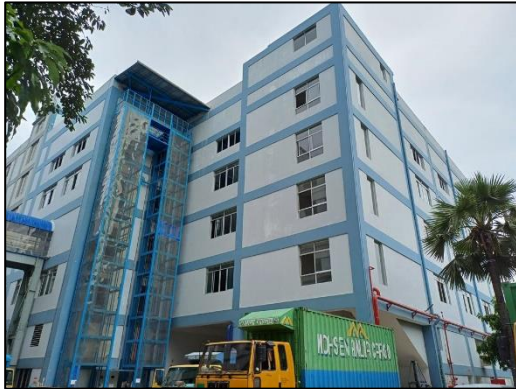
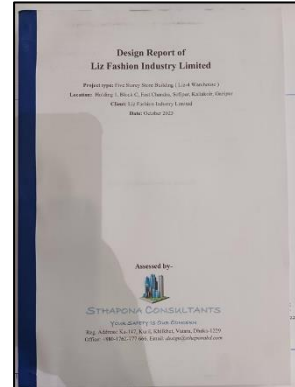
### Observation 1: Prepared design documents to be reviewed for lateral forces. (LKP-3 Building)

**Description:** A set of design documents was available onsite which are to be submitted to RSC for detailed review against lateral forces. Revise the design documents based on in-situ material strength. Submit the design documents to the RSC for review.

| Item No | Observation | Action Plan | Timeline |
|---|---|---|---|
| 1. | Prepared design documents to be reviewed for lateral forces. (LKP-3 Building) | The building engineer is required to submit the design documents to the RSC for detail review against wind & seismic forces. | within 6 weeks |
| 2. | | Carry out suggested remedial works if required. | within 6 months |

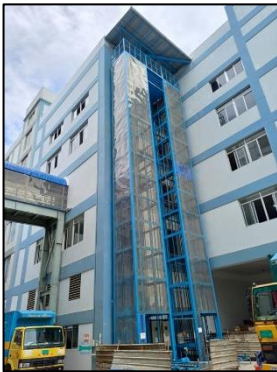
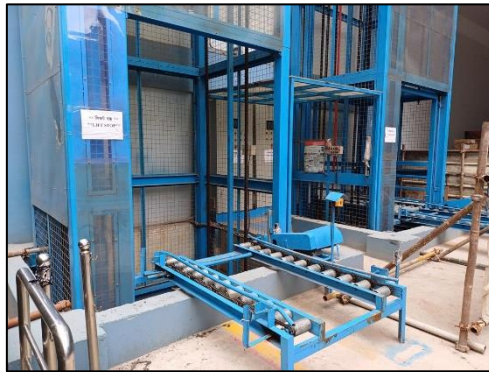
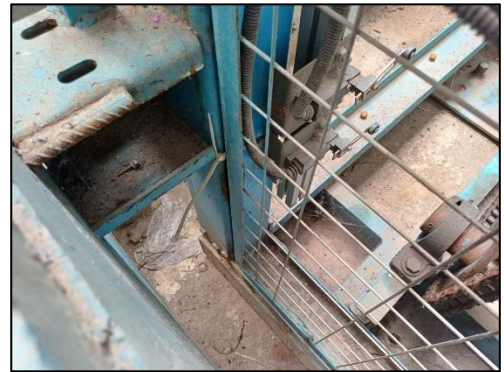
### Observation 2: Lack of lateral stability for undocumented external steel lift cores. (LKP-3 Building)

**Description:** Two steel lift cores were observed in front of the building with some anchorage at the bottom. The building engineer is required to check the lateral stability of the lift cores against wind & seismic forces and suggest necessary alternatives accordingly.

| Item No | Observation | Action Plan | Timeline |
|---|---|---|---|
| 3. | Lack of lateral stability for undocumented external steel lift cores. (LKP-3 Building) | As part of Engineering Assessment (EA), the building engineer is required to check the lateral stability of the lift cores against wind & seismic forces and suggest necessary alternatives accordingly. Submit the documents to the RSC for review. | within 6 weeks |
| 4. | | Carry out remedial work if required. | within 6 months |

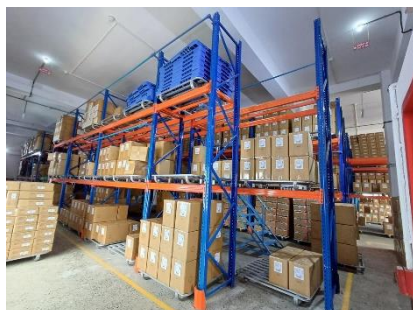
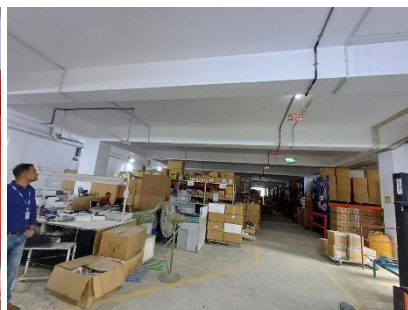
### Observation 3: Lack of floor load management program (LKP-3 Building)

**Description:** Load plan was prepared for all floors but was not posted on all floor levels.

| Item No | Observation | Action Plan | Timeline |
|---|---|---|---|
| 5. | Lack of floor load management program (LKP-3 Building) | Implement floor load management program ((posting load plan, marking area & height, and maintaining floor loading)). | within 6 weeks |

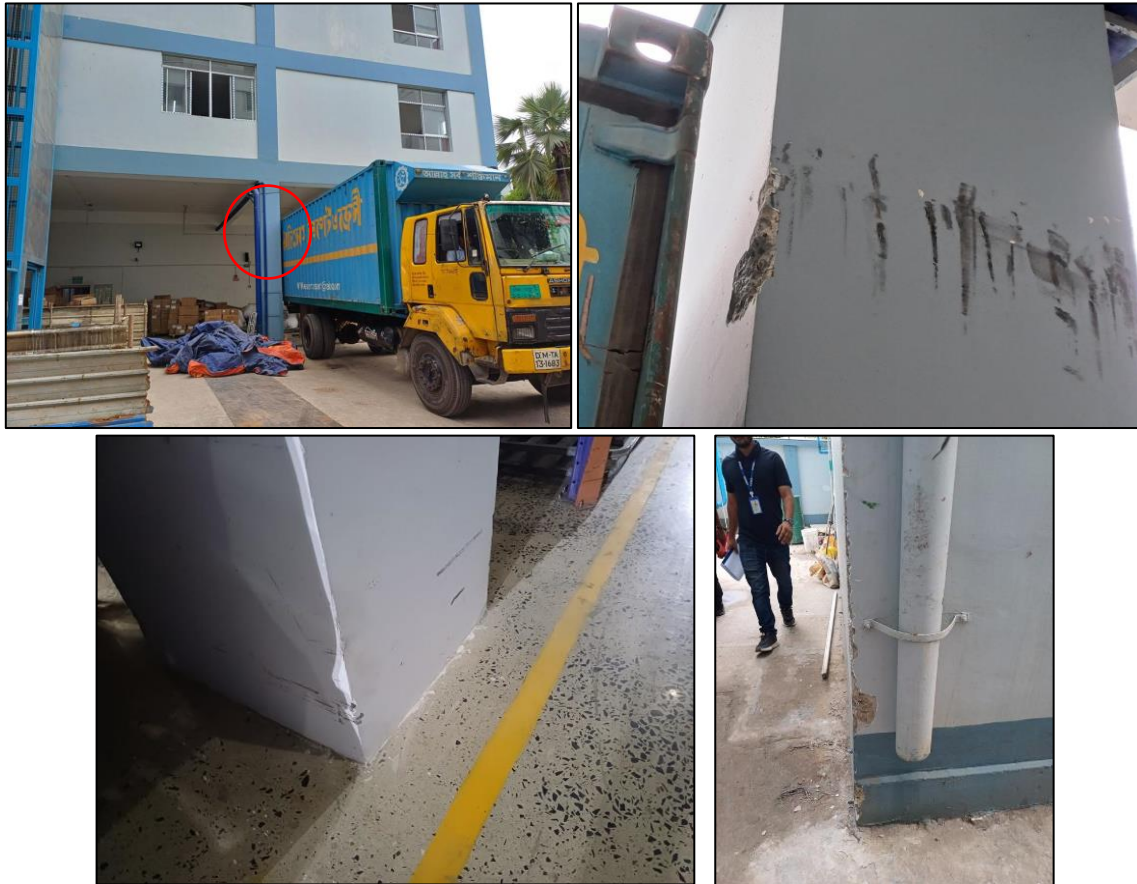
**Observation-4: Damage on the column due to vehicle & trolley impact (LKP-3 Building)**

**Description:** Damage due to vehicle impact was found on the column of the loading-unloading zone. The building engineer is required to repair the damage to the column and provide separate barriers around the susceptible ground floor columns to avoid possible vehicle impact. Also, provide column/wall guard in the floor area to protect the column/walls from trolley impact.

| Item No | Observation | Action Plan | Timeline |
|---|---|---|---|
| 6. | Damage on the column due to vehicle & trolley impact (LKP-3 Building) | The building engineer is required to repair the damage to the column and provide separate barriers around the susceptible ground floor columns to avoid possible vehicle impact. Also, provide column/wall guard in the floor area to protect the column/walls from trolley impact. | within 6 weeks |

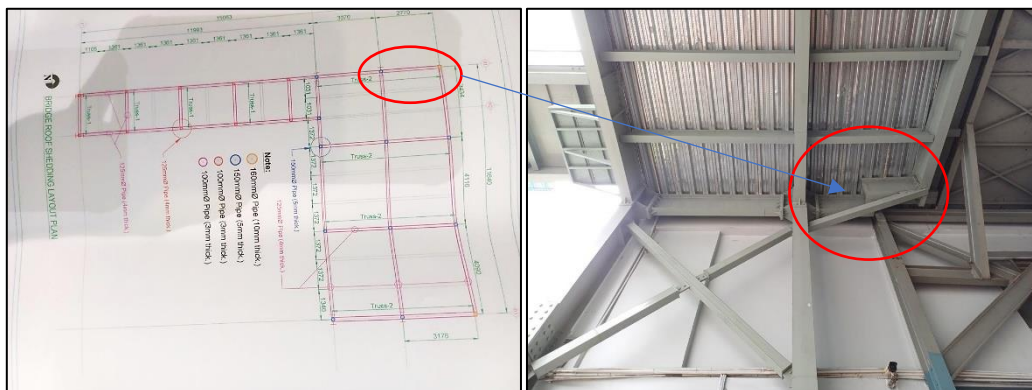
**Observation-5: Discrepancy in as-built drawing. (Connecting Bridge)**

**Description:** Zigzag beam observed onsite where drawing shows straight beam. The building engineer is required to survey the beam alignment, size & connections and prepare accurate as-built drawings accordingly.

| Item No | Observation | Action Plan | Timeline |
|---|---|---|---|
| 7. | Discrepancy in as-built drawing. (Connecting Bridge) | The building engineer is required to survey the beam alignment, size & connections and prepare accurate as-built drawings accordingly. | within 6 weeks |
