# INITIAL FIRE SAFETY INSPECTION REPORT

## Liz Knitting & Printing Industry (Extension)

RSC ID: 25624

Date: 26 May, 2024

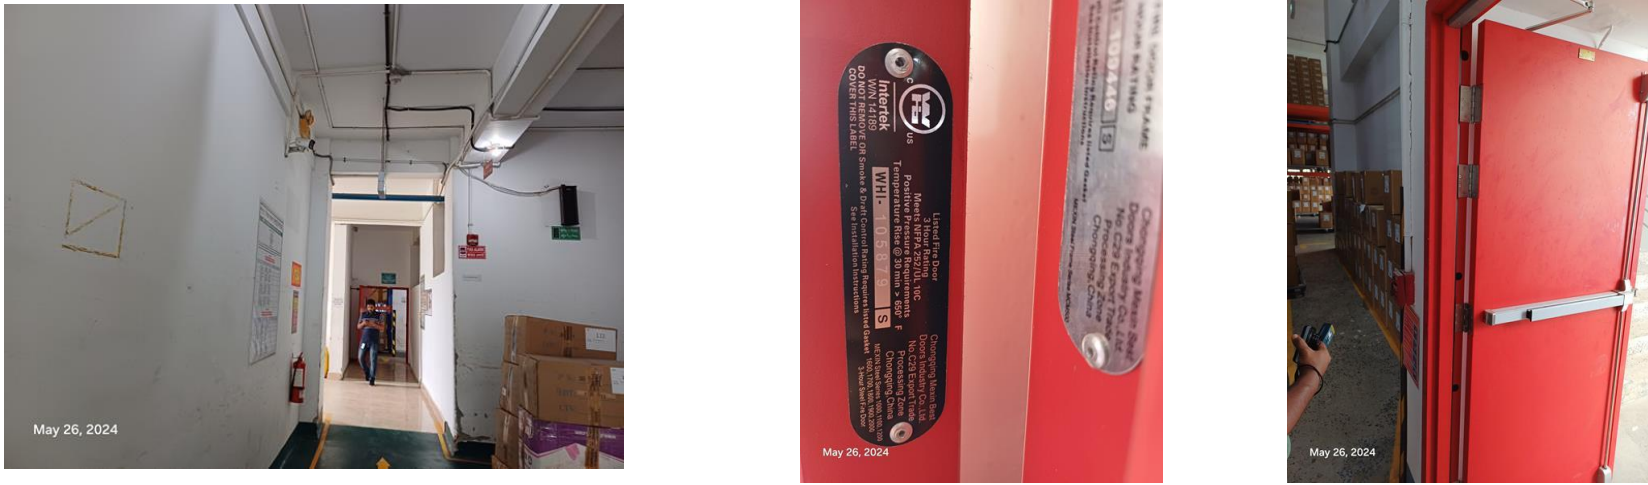
| SI No. | Category | Findings | Required Action | Remediation Time Frame |
|---|---|---|---|---|
| F-1 | Fire Rated Construction | The exit stairs are not separated from , storage areas and work areas on each floor by fire rated construction. Certificate and data sheet were not found for doors leaf, frame and accessories. Moreover, intertek certified double leaf fire doors did not have listing mark in one leaf of each door which requires further clarification. | <p>Provide minimum 2-hr rated fire wall and 1.5-hr fire rated doors for buildings that are 4 or more stories. Seal all unprotected openings to separate the exit stairs from work areas and other building spaces on all floor levels. Ensure that the fire doors are self-closing and positive latching and that they are provided with fire exit (panic) hardware where serving production floors. If fire doors are required to be held open for functional reasons, provide automatic closing devices tied to the fire alarm system. Once fire doors are installed, every door in a stair enclosure serving more than 5 stories shall be provided with re-entry.</p> <p>Ensure availability of credible documents for installed fire door during verification inspection.</p> | Within 3 Months |

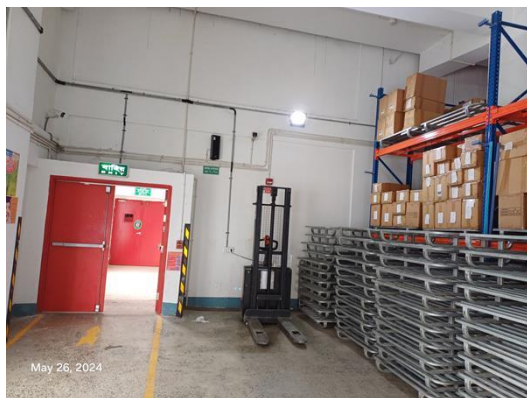
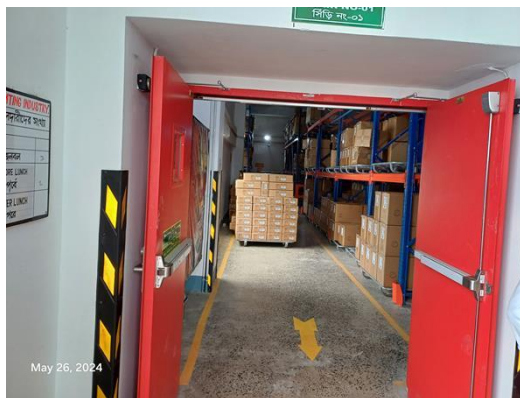
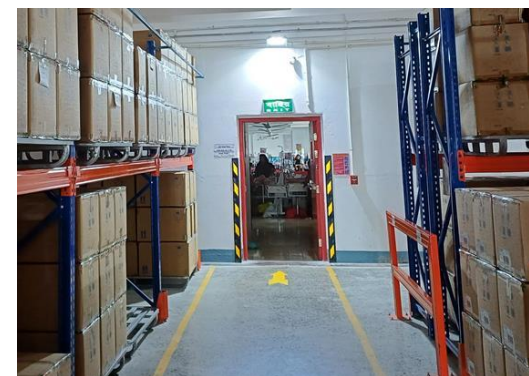
| SI No. | Category | Findings | Required Action | Remediation Time Frame |
|---|---|---|---|---|
| F-2 | Fire Rated Construction | Store room discharged directly into the exit stair enclosures. Location: All 3 exit stairs from 1st floor to 4th floor. | Openings from exit enclosure to storage shall be provided with a vestibule with fire rated construction and openings. Provide a 2 hr. fire rated door on the exit stair side and a 1- hr. fire rated door on the storage side. Ensure that the fire rating of the vestibule construction matches that of the exit stair enclosure. The minimum width for vestibules shall not be less than 1.1m and length 1.8m. | Within 3 Months |

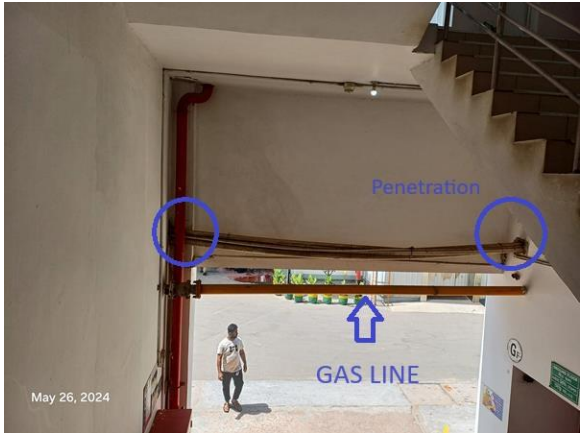
| SI No. | Category | Findings | Required Action | Remediation Time Frame |
|---|---|---|---|---|
| F-3 | Fire-Rated Construction | At ground floor north-east stair-2 enclosure , gas line and electrical wires/raceways were located which doesn't comply with following section 6.14.4 of RSC Technical Guideline (Standard) | No other penetration into and through the exit enclosure except for fire alarm equipment electrical raceway, required exit doors, sprinkler piping, standpipes, and electrical conduit serving the exit enclosure is permitted. Relocate the electrical wires/raceways to somewhere else avoiding the exit enclosure, and seal the created unprotected openings with a minimum of 1.5 hours listed/certified fire-rated materials or 2-hr masonry construction. | Within 3 Months |

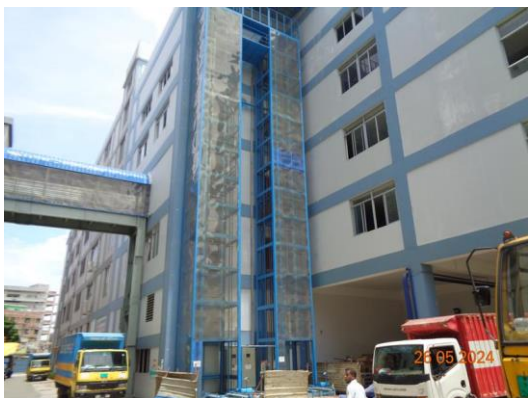
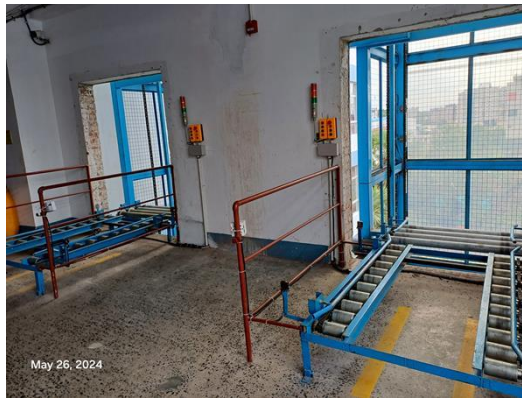
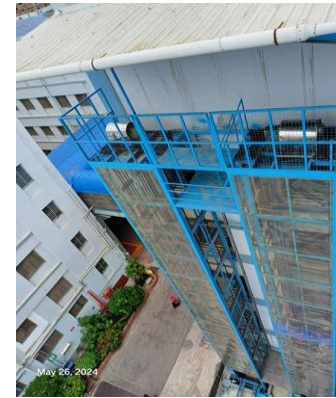
| SI No. | Category | Findings | Required Action | Remediation Time Frame |
|---|---|---|---|---|
| F-4 | Fire Rated Construction | There are 2 numbers of exterior elevator are located for transportation of goods at each floor (1st-4th). Elevator shafts are directly open into the Storage floor without proper fire separation. | Ensure minimum 1.5-hr fire rated opening protective of elevator shafts otherwise close the shafts area with 2-hr fire rated construction barrier and 1.5-hr fire rated doors. | Within 3 Months |

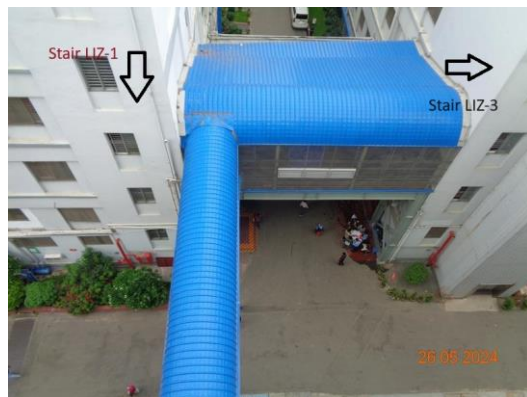
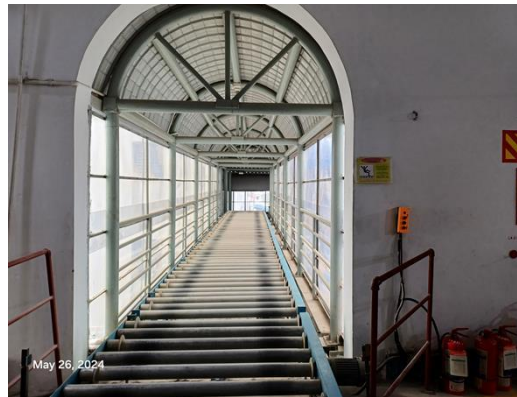
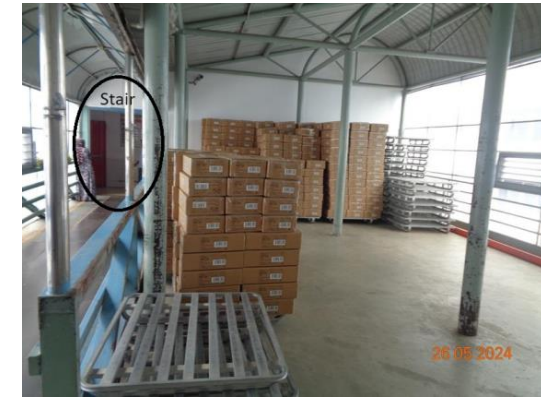
| SI No. | Category | Findings | Required Action | Remediation Time Frame |
|---|---|---|---|---|
| F-5 | Fire Rated Construction | At 2nd floor level, three way connecting steel structure/ bridge along with conveyer belt was found among LKP-3, LIZ-1 and LIZ-3 building. This structure is not separated by fire rated construction or opening protective from 2nd floor of LKP-3 building (ID-25624); from one stair serving LIZ-1 building (ID-10228) and from another stair serving LIZ-3 building (ID-11250). | Separate the buildings by minimum 2-hr fire-rated construction all three side of the steel structure/ connecting bridge. Provide 1.5 hr. fire rated opening protective and seal all penetrations and openings between the exterior connecting bridge and the building up to 10 ft. beyond the end of the connecting bridge by 2 hr. fire rated construction. | Within 3 Months |

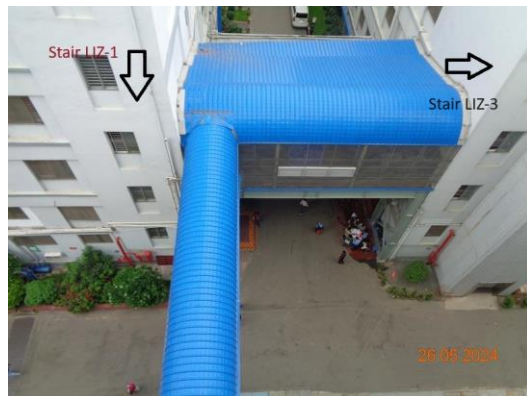
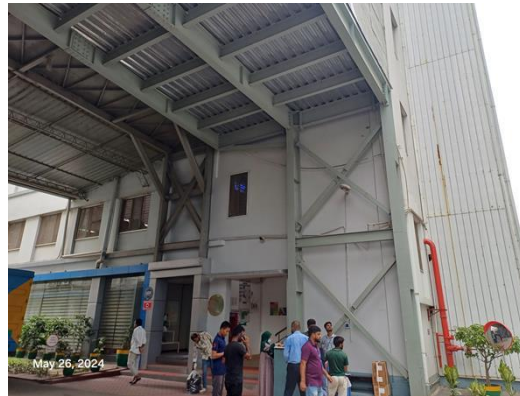
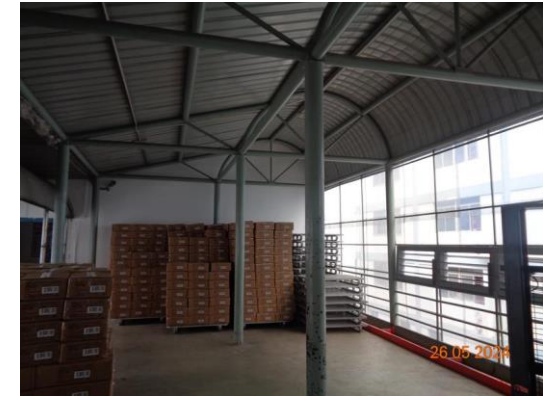
| SI No. | Category | Findings | Required Action | Remediation Time Frame |
|---|---|---|---|---|
| F-6 | Fire Rated Construction | <p>Building-2 - Connecting single storied steel structure or bridge had a total height greater than 11.0m and proximity from LIZ-1 and LIZ-3 building do not cover and its defined as "New Building".</p> <p>Structural fire protection and passive fire protection were not provided to this structure following section 3.5.4 of RSC Technical Guideline (Standard)</p> | <p>Provide required fire resistance rating of structural elements (steel column, beam, trusses etc.), exterior walls, exit enclosures satisfying the requirements of BNBC 2020 Part 3 Section 1.9.2.4, Table 3.2.4, Table 3.3.1(a), Table 3.2.2, Table 3.2.1 and Part 4 Table 4.1.1.</p> | Within 6 Months |

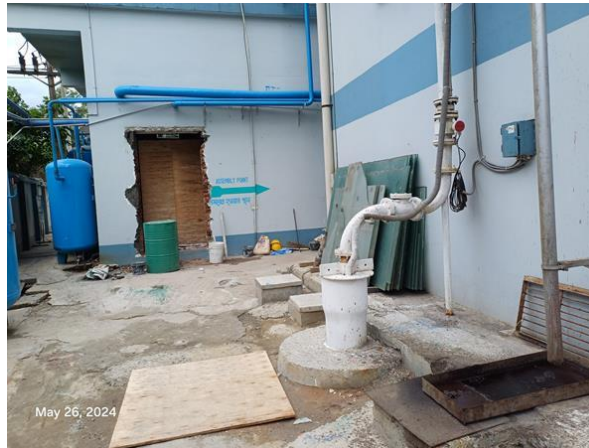
| SI No. | Category | Findings | Required Action | Remediation Time Frame |
|---|---|---|---|---|
| F-7 | Fire Rated Construction | Egress court serving exit stair-03 was found less than 10 ft & opening from compressor room of utility building was not protected by fire rated construction. | An egress court serving as a portion of the exit discharge shall be open to the sky or provided with a fire resistance rated enclosure the same as the exit enclosure. Egress courts less than 3050 mm (10 ft) in width (as measured from the building and the adjacent property line) shall be provided with walls having a 1-hr fire resistance rated construction for a distance of 3050 mm (10 ft) above the floor of the court. | Within 3 months |

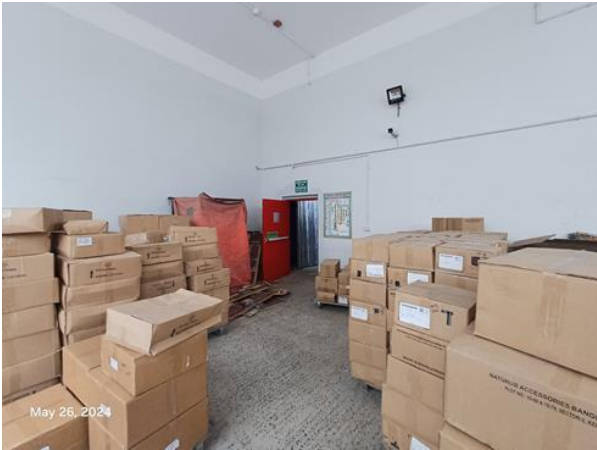
| SI No. | Category | Findings | Required Action | Remediation Time Frame |
|---|---|---|---|---|
| F-8 | Fire Rated Construction | Exit discharge from exit of Screen Keeping Store is not directed to outside of the building and exit discharge through load unloading area. | <p>Provide minimum 2-hr rated exit passageways from screen keeping area &amp; shall terminate on exit discharge.</p> <p>Or, Remove the loading-unloading area from the location &amp; keep area vacant.</p> | Within 3 months |

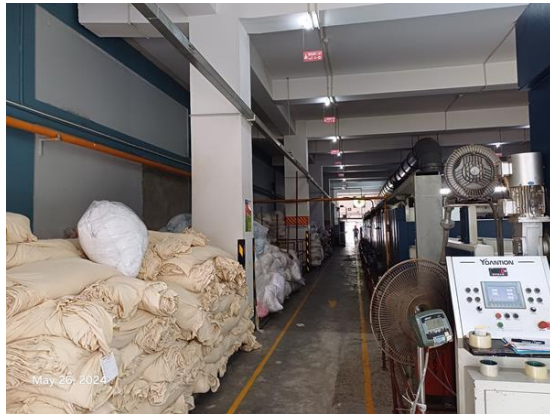
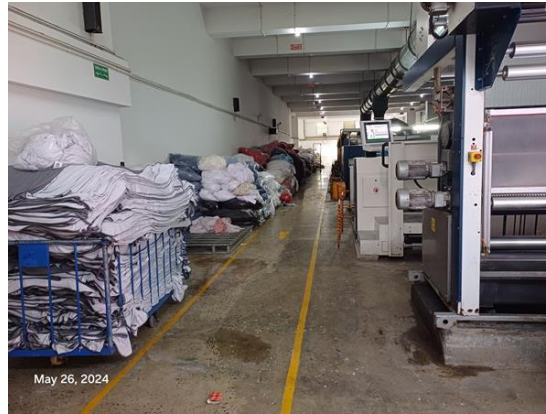
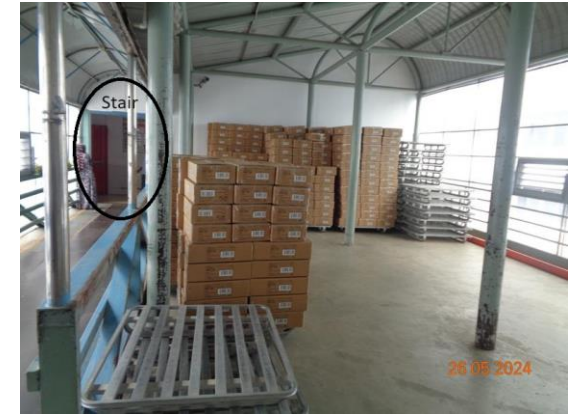
| SI No. | Category | Findings | Required Action | Remediation Time Frame |
|---|---|---|---|---|
| F-9 | Fire Rated Construction | Area used for combustible storage are not separated by fire rated construction on starter machine room located at ground floor of building-1 (LKP-3) and building-2 connecting steel structure or bridge. | <p>Separate the dedicated storage rooms by minimum 1-hr fire-rated construction. Provide 0.75 hr. fire rated door and seal all penetrations and openings by 1 hr. fire rated fire rated barrier construction.</p> <p>Where separate storage rooms are not feasible, provide defined storage areas and limit the storage arrangement as follows: -<br/> - Maximum height of 2.45m (8ft.) , maximum area of 23m<sup>2</sup> (250 ft<sup>2</sup>) and 3m (10ft.) clear distance from adjacent another unenclosed combustible storage.<br/> - If the building/floor is sprinkler protected: maximum height of 3.66m (12ft.) and maximum area of 93m<sup>2</sup> (1000 ft<sup>2</sup>) and 3m (10ft.) clear distance from adjacent another unenclosed combustible storage.</p> | Within 3 months |

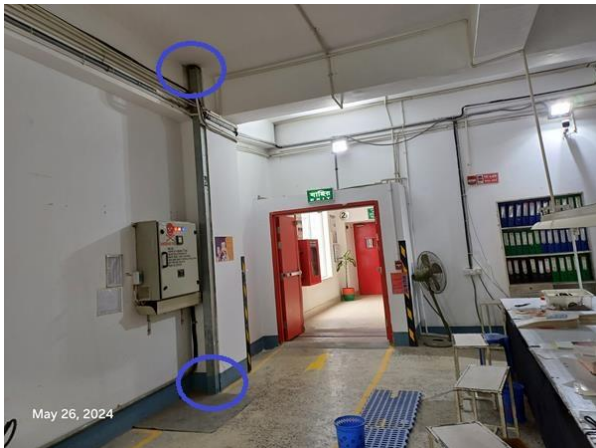
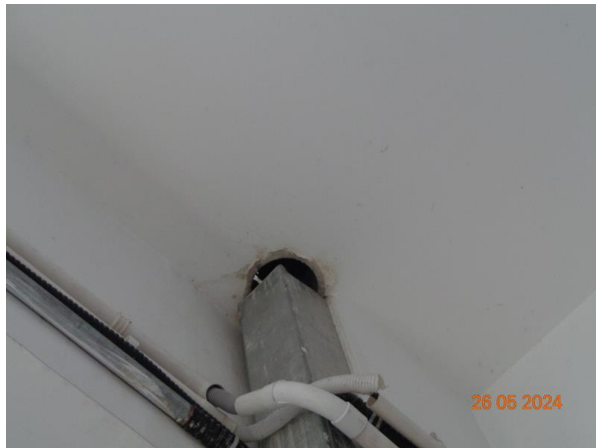
| SI No. | Category | Findings | Required Action | Remediation Time Frame |
|---|---|---|---|---|
| F-10 | Fire Rated Construction | Unsealed penetrations and openings are located in the fire rated floor/ceiling assemblies. Location: Cable penetration at all floor of building-1 LKP-3 | Seal all penetrations and openings in floor/ceiling (full thickness of the floor/ceiling) assemblies by fire rated materials to maintain the fire resistance rating.<br>or,<br>Provide a minimum 3-hr fire rated shaft to separate the cable penetration from each floor. | Within 3 Months |

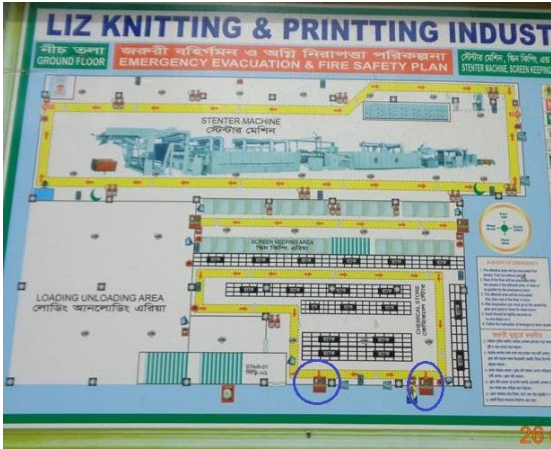
| SI No. | Category | Findings | Required Action | Remediation Time Frame |
|---|---|---|---|---|
| F-14 | Mean of Egress | The exits in the chemical store on ground floor are not remotely located from each other (less than one-half maximum diagonal distance of pace) such that a single fire event could compromise both exits. | Modify exit arrangement to provide remote exits. | Within 1 Month |

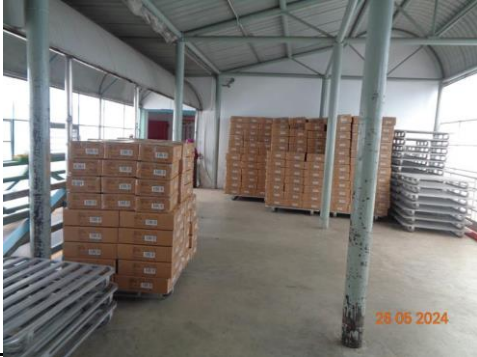
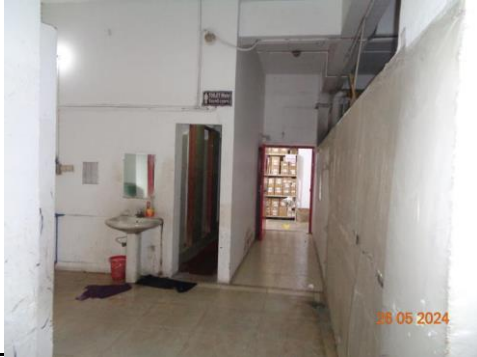
| SI No. | Category | Findings | Required Action | Remediation Time Frame |
|---|---|---|---|---|
| F-20 | Egress Lighting | <p>Inspection, testing and maintenance for the emergency lighting system was not in accordance with The RSC standard.</p> | <p>Inspect, test and maintain the emergency lighting system in the accordance with The RSC standard. Keep written records on-site.</p> | Within 3 Months |

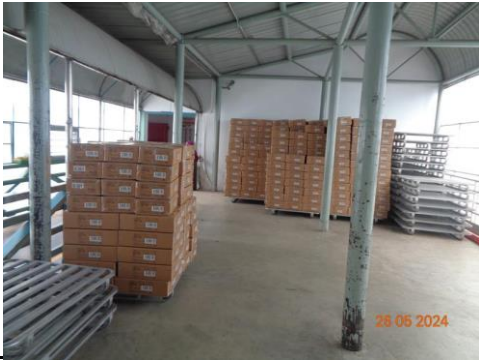
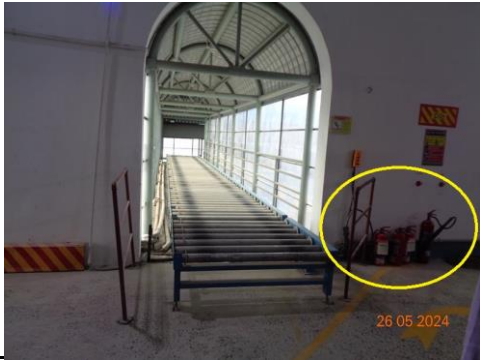
| SI No. | Category | Findings | Required Action | Remediation Time Frame |
|---|---|---|---|---|
| F-22 | ITM of Fire Extinguishers | Inspection, testing and maintenance of portable fire extinguishers is not in accordance with NFPA 10. | Inspect, test and maintain the portable fire extinguishers and keep written records onsite, in accordance with NFPA 10. | Within 1 Month |

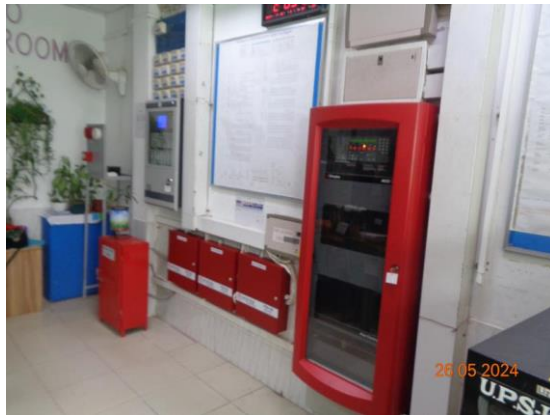
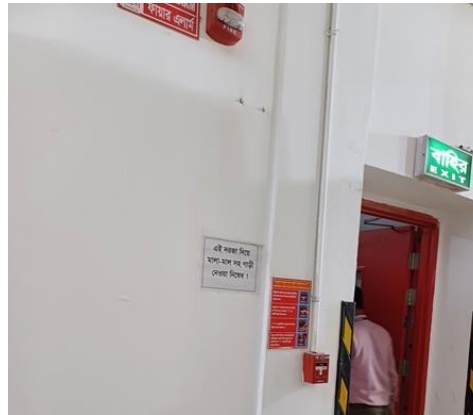
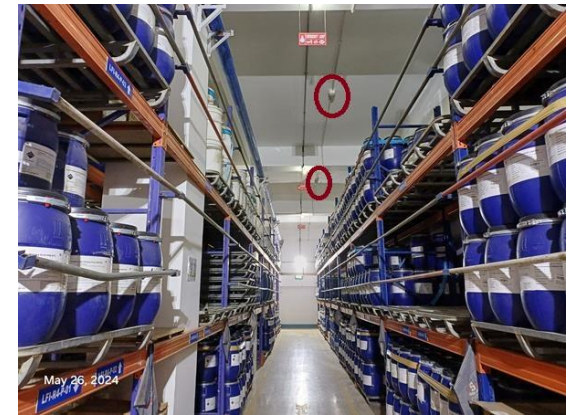
| SI No. | Category | Findings | Required Action | Remediation Time Frame |
|---|---|---|---|---|
| F-23 | Fire Alarm & Detection System (FADS) | <p>LKP-3 building (ID# 25624) and LKP-1 &amp; LKP-2 building (ID# 24319) were covered by a single automatic detection and alarm system. Automatic fire alarm &amp; detection system installation requires detailed review to confirm compliance with NFPA 72 and RSC standards.</p> <p>High piled storage (more than 12 ft height rack) was found at store at 4th floor and at chemical store at ground floor). For all rack storages in all floors, rack dimension, space between racks, type of rack or shelves, vertical and horizontal flue spaces along with aisles need to incorporate in as-built drawing.</p> | <p>Submit as-built drawings, testing records, equipment certification and other relevant documentation to the RSC for review.</p> <p>Once reviewed, install or modify the fire detection and alarm system (where required) throughout the building in accordance with RSC standard and NFPA 72. The factory management shall contact RSC to conduct the final acceptance testing after the installation, testing &amp; commissioning.</p> | <p>Design Review within 2 months and installation/modification within 4 months.</p> |

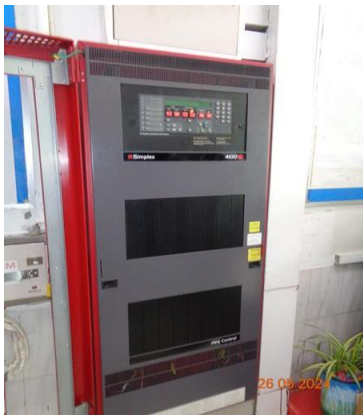
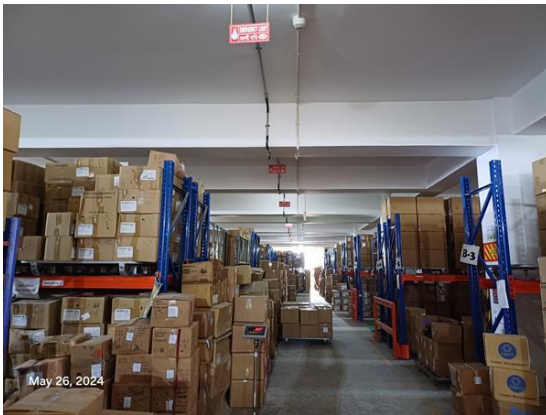
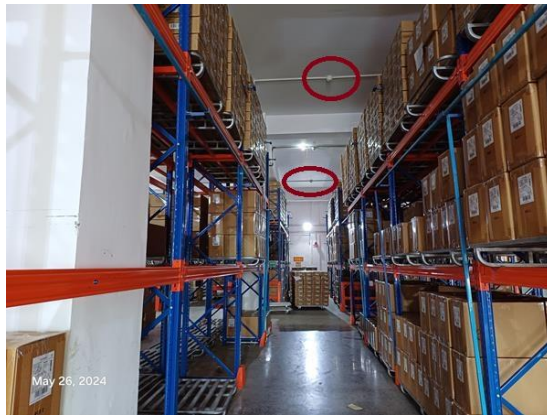
| SI No. | Category | Findings | Required Action | Remediation Time Frame |
|---|---|---|---|---|
| F-24 | Fire Detection System ( ITM of FADS) | Inspection, testing, and maintenance for the fire alarm system is not in accordance with NFPA 72. | Inspect, test and maintain the fire alarm system and keep written records on-site, in accordance with Table-14.3.1 of NFPA 72. | Within 1 Month after installation. |

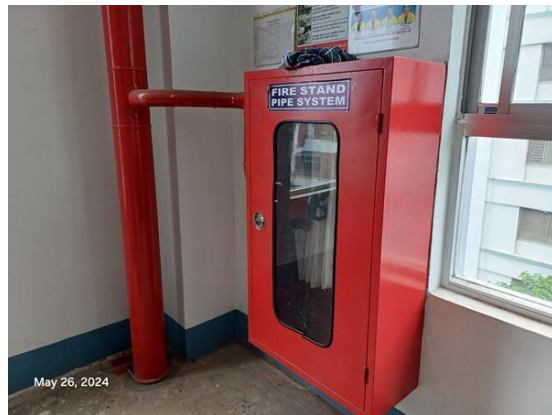
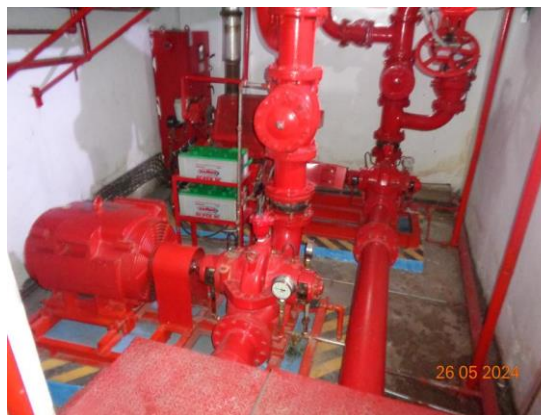
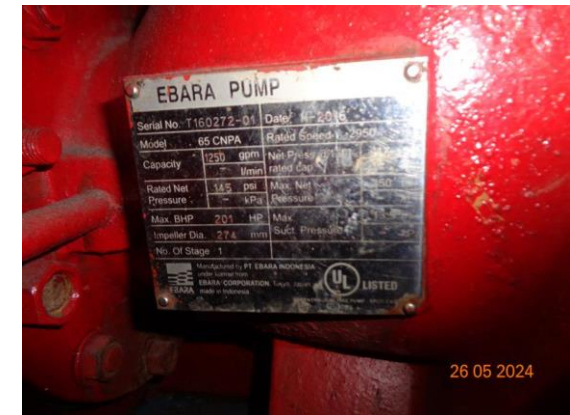
| SI No. | Category | Findings | Required Action | Remediation Time Frame |
|---|---|---|---|---|
| F-25 | Fire Protection System(Standpipe System) | <p>LKP-3 building (ID# 25624) and LKP-1 &amp; LKP-2 building (ID# 24319) were considered as single fire management system.</p> <p>Fire Protection system installation requires detailed review to confirm compliance with NFPA 13,14, 20, 22,24 and RSC standards..</p> | <p>Submit as-built drawings, testing records, equipment certification and other relevant documentation to the RSC for review.</p> <p>Once reviewed, install or modify the sprinkler, standpipe system and pump (where required) throughout the building in accordance with RSC standard and NFPA 13, 14 and 20. The factory management shall contact RSC to conduct the final acceptance testing after the installation, testing &amp; commissioning.</p> | <p>Design Review within 2 months and installation/modification within 4 months.</p> |
