KC Apparels Ltd

Plot # B 424, 425, 426 & 427. Road # 1, BSCIC Industrial Estate,
Shashongaon, Anayetnagar, Fatullah, Narayanganj -1420
(23.6245865, 90.4807325)

2 June 2024

1. Building Information

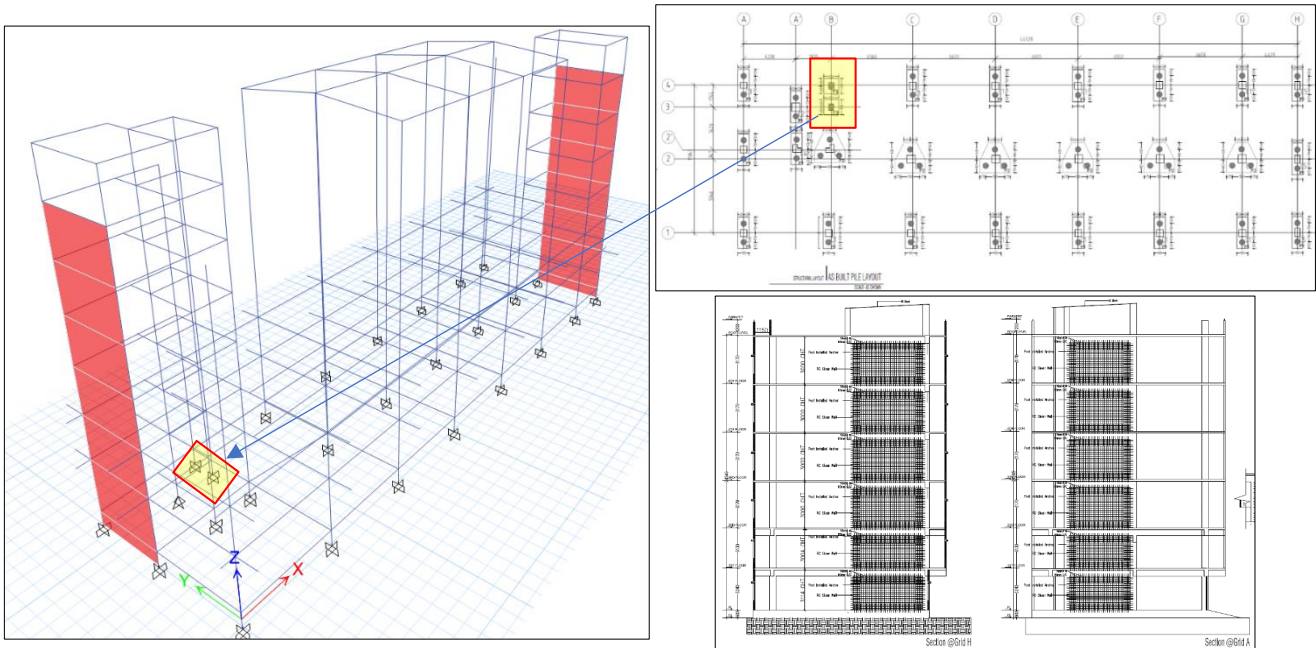
Observation 1: Inconsistencies in design documents.

Description: The building engineer assessed the structure and proposed the shear wall to resist lateral loading. As per the proposal, the shear wall was constructed between November 2021 to May 2023.

The foundation details for the shear wall have not been provided in the as-built drawing. In the FEA model, the shear wall has been assigned below the grade beam.

In the FEA model, two foundations have been considered fixed support which consists of a single pile (marked in figure). The building engineer is required to provide clarification in the report to support the consideration.

The building consists of a beam-column moment frame up to the 2nd floor and a flat plate from the 3rd floor to the roof. The shear wall has been constructed from bottom to top. The structural system and load-bearing mechanism for the lateral load need to be confirmed by the building engineer.

So, the factory is required to provide the foundation details in the drawing and check the adequacy of the foundation considering vertical loading as well as lateral loading.

Serial No	Observation	Action Plan	Timeline
1	Inconsistencies in design documents.	Building engineer is required to update the as-built drawing providing information on the shear wall foundation and check the adequacy of the foundation considering vertical loading as well as lateral loading from the shear wall.	within 6 weeks
2		The structural system and load-bearing mechanism for the lateral load need to be confirmed by the building engineer. Prepare a design report based on the structural system.	within 6 weeks
3		Carry out remedial work if required.	within 6 months
4	Flat plate to be checked against punching for in situ material strength.	Verify the in-situ concrete strength by taking at least four core samples from the flat plates.	within 6 weeks
5		Building engineer is required to check the adequacy (Punching & Flexure) of the flat plate based on in situ concrete strength.	within 6 weeks
6		Building engineer is required to prepare an accurate core test layout plan.	within 6 months

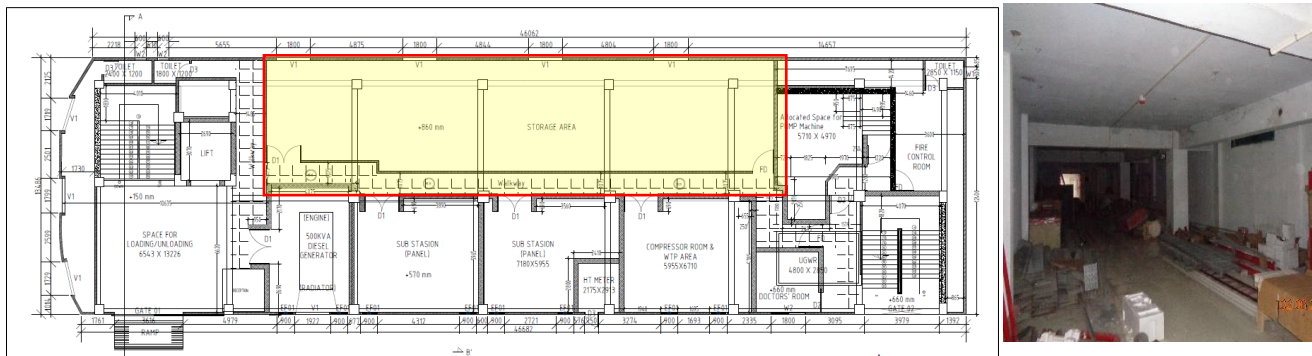
Observation 3: The adequacy of the suspended slab over the ground floor is not provided.

Ground floor layout plan. Suspend slab over the UGWT in the marked location

Description There is an underground water reservoir. The underground water reservoir's roof slab (Ground floor slab) is being used as storage. Loading has not been considered for the FEA model for the beam & slab. Also, load plan has not been prepared for the suspended slab ground floor as well as for the stair top & shed top.

The building is required to prepare a load plan as per BNBC and check the adequacy of the beam and slab.

7	Adequacy of the suspended slab on the ground floor is not provided.	The building is required to check the adequacy of the beam and slab.	within 6 weeks
8		Produce and actively manage floor loading plans for all the floors.	within 6 weeks
9		Carry out remedial work if required.	within 6 months
10		Implement the floor live load plan program.	within 6 months
11	Lack of lateral load transfer media in the long direction of the steel roof shed.	The building Engineer is required to confirm the lateral load path & verify the lateral stability of the steel shed.	within 6 weeks
12		The building engineer is required to survey the whole structure and prepare accurate as-built drawings.	within 6 weeks
13		Implement the remediation if required.	within 6 months
14	Connection gap found at steel roof shed.	The building engineer is required to survey and identify the locations and carry out suitable remedial works.	within 6 months

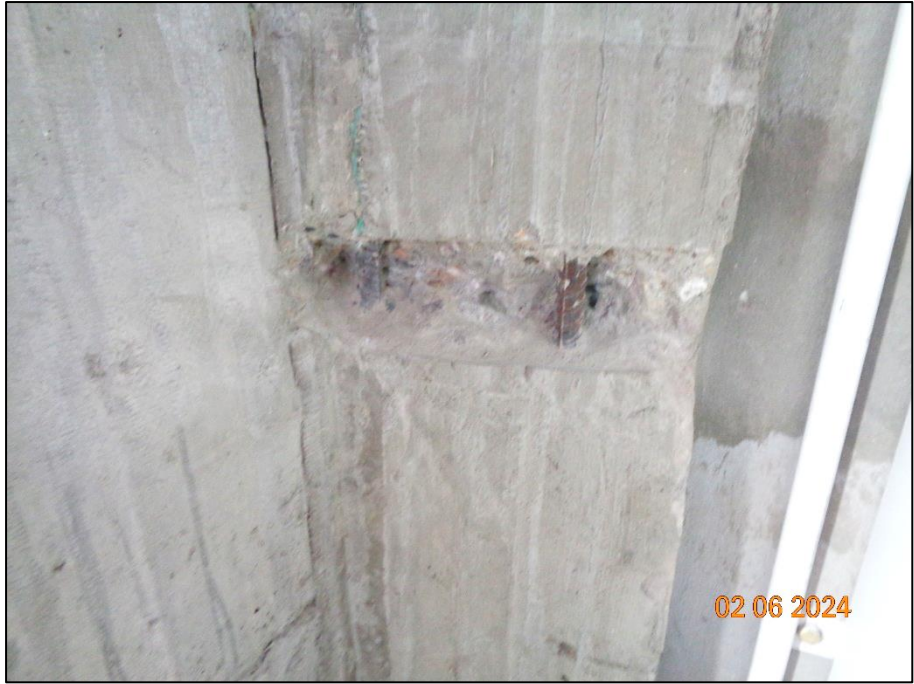
Observation-6: Exposed column re-bar in lift machine room.

Description: Exposed reinforcement was found in the column in the lift machine room. Building engineer is required to repair the column with non-shrinkable grout to cover the exposed re-bar.

15	Exposed column re-bar in the lift machine room.	Building engineer is required to repair the column with non-shrinkable grout to cover the exposed re-bar.	within 6 months

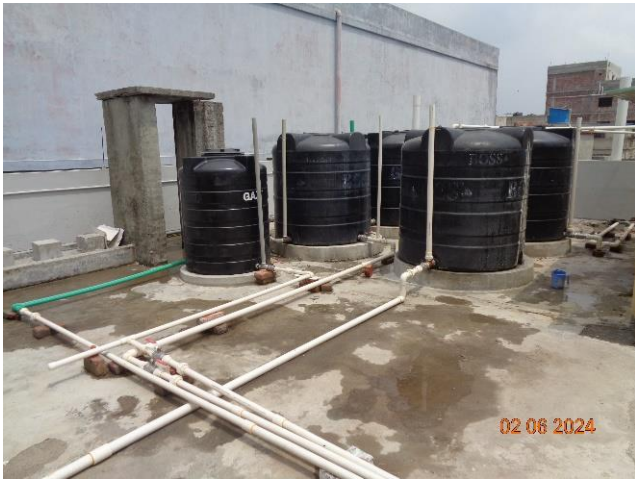
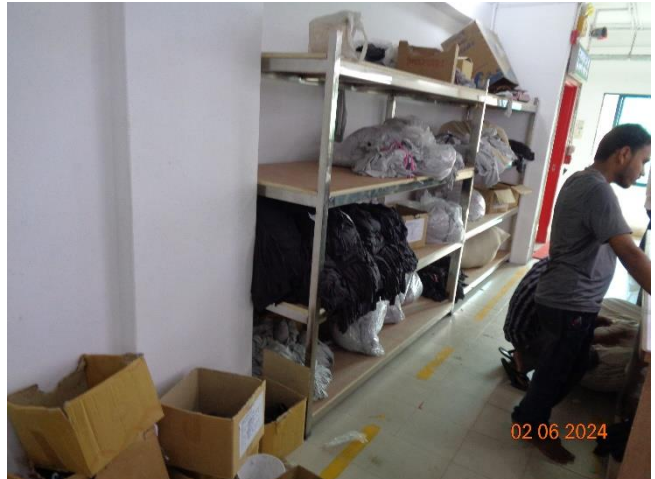
Observation-7: Non-structural elements not anchored or braced.

Description: During the inspection, PVC water tanks at the roof and storage racks on the floors were found without anchoring.

Building engineer is required to adequately anchor and brace all non-structural elements to resist earthquake forces to comply with the BNBC.

16	Non-structural elements not anchored or braced.	Building engineer is required to adequately anchor and brace all non-structural elements to resist earthquake forces to comply with the BNBC.	within 6 months
----	-------------------------------------------------	-----------------------------------------------------------------------------------------------------------------------------------------------	-----------------
