# Nextgen Style Ltd. (Relocated)

Tingaon, Duptara, Araihaaz, Narayangonj-1460

3 July 2024

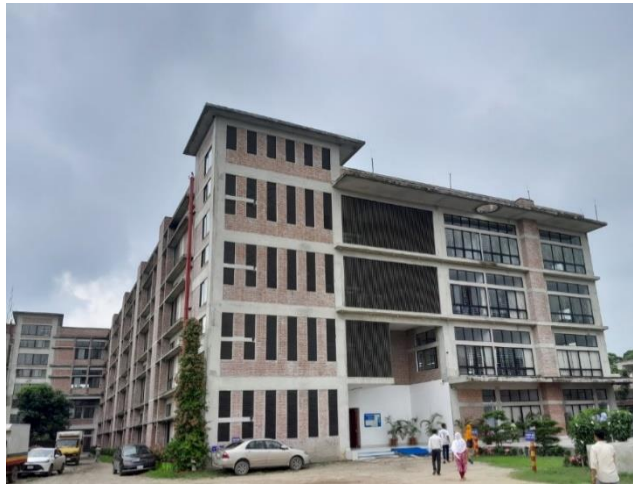
**Observation-1:** Absence of design report (Production Building).

**Description:** As per BNBC, every building or structure shall have its design documents prepared in accordance with the provision of Section 1.9.1. The design document shall include a design report, and a set of structural drawings, which shall be prepared in compliance with section 1.9.1.1 and section 1.9.1.2 as per BNBC. At the time of inspection, the design report was not available, which is required to be prepared in compliance with section 1.9.1 (part-6, BNBC-2006).

| Item No. | Observation | Action Plan | Timeline |
|---|---|---|---|
| 1. | Absence of design report (Production Building). | The building engineer is required to prepare a design report in compliance with section 1.9.1 (part-6, BNBC-2006). | within 6 weeks |
| 2. | Absence of design report (Production Building). | Implement remediation work if required. | within 6 months |

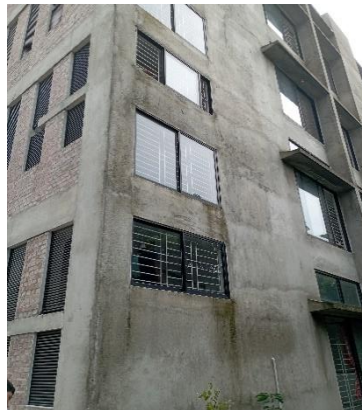
**Observation-2:** Dampness on the exterior façade, exterior face of column. (Production Building).

**Description:** Dampness was found on the exterior façade, exterior face of column (south-west corner). The building engineer is required to seal the source of water and repair the dampness with a suitable method.

| Item No. | Observation | Action Plan | Timeline |
|---|---|---|---|
| 3. | Dampness on the exterior façade, exterior face of column (Production Building). | The building engineer is required to seal the source of water and repair the dampness with a suitable method. | within 6 weeks |

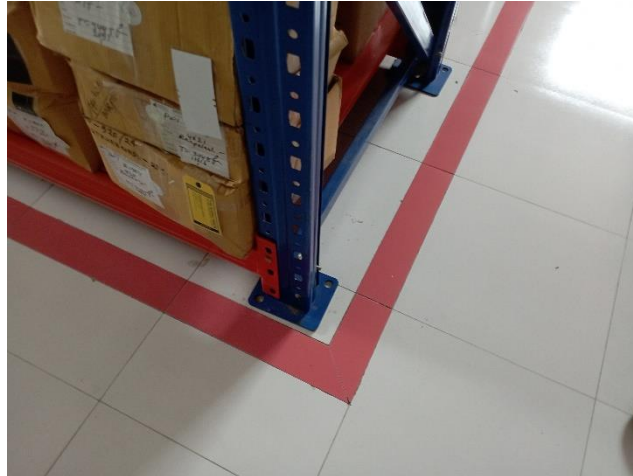
**Observation-3:** Nonstructural elements (storage racks) found not anchored/braced (Production Building).

**Description:** Nonstructural elements (storage racks) were found not anchored/braced. The building engineer is required to anchor/brace all nonstructural elements within the factory.

| Item No. | Observation | Action Plan | Timeline |
|---|---|---|---|
| 4. | Nonstructural elements (storage racks) found not anchored/braced (Production Building). | The building engineer is required to anchor/brace all nonstructural elements within the factory. | within 6 months |

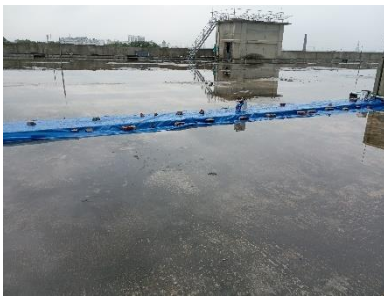
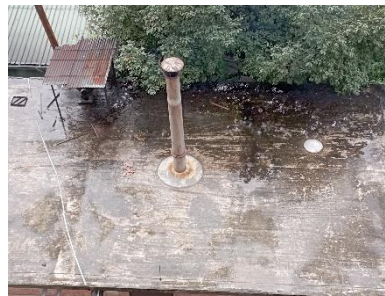
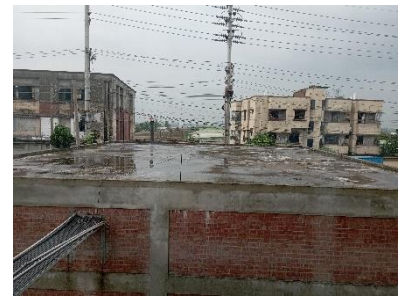
**Observation-4:** Water ponding on roof slab (Production Building, Boiler-Compressor-Fire Alarm Control Room, Generator & Substation Room).

**Description:** Water ponding was found at Production Building, Boiler-Compressor-Fire Alarm Control Room, and Generator & Substation Room. The building engineer is required to improve the drainage system on the roof by providing proper slope, adequate number of water outlets and water proofing (if MCAC of roof slab).

| Item No. | Observation | Action Plan | Timeline |
|---|---|---|---|
| 5. | Water ponding on roof slab (Production Building, Boiler-Compressor-Fire Alarm Control Room, Generator & Substation Room). | The building engineer is required to improve the drainage system on the roof by providing proper slope, adequate number of water outlets and water proofing (if MCAC of roof slab). | within 6 weeks |
