INITIAL FIRE SAFETY INSPECTION REPORT

KC Apparels Limited

RSC ID: 24991

Date: 11-Jun-2024

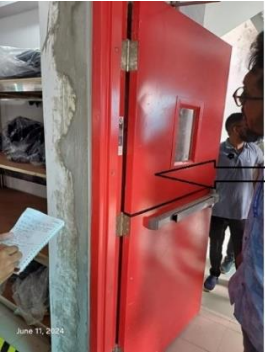
<p>Missing Listing Marks in Door Leaf</p> <p>June 11, 2024</p>

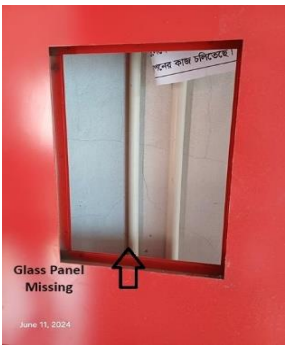
<p>Glass Panel Missing</p> <p>June 11, 2024</p>

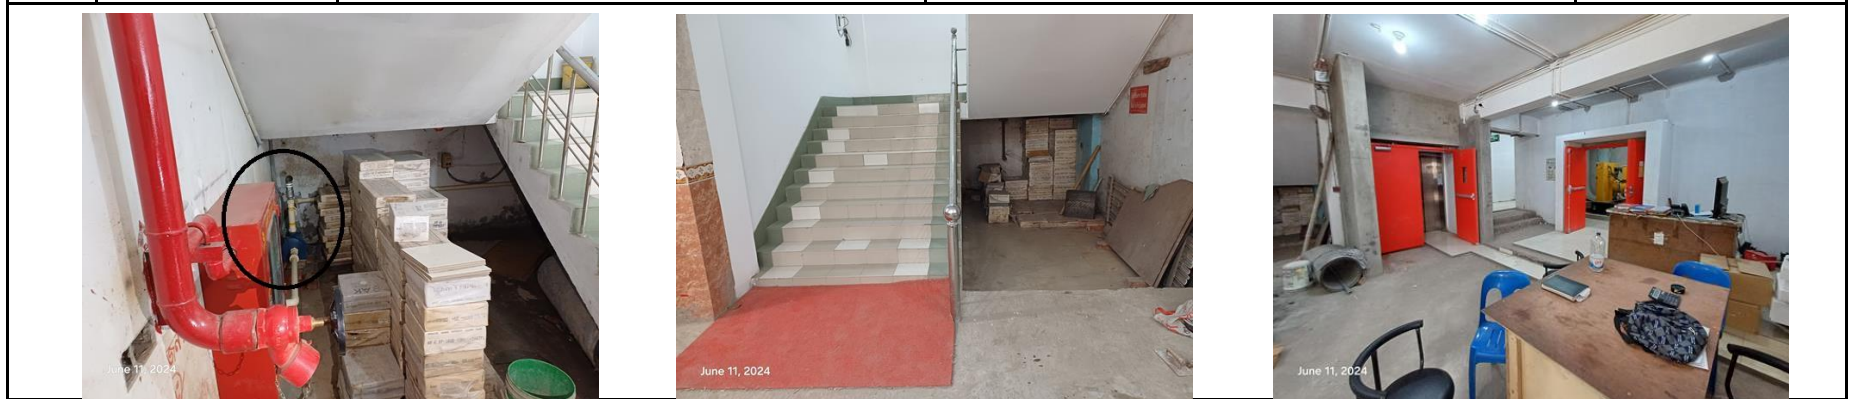
SI No.	Category	Findings	Required Action	Remediation Time Frame
F-2	Fire Rated Construction	Water pump was located in the south exit stair enclosure. Storage is found beneath stair landing at ground floor discharge North Stair and South Stair.	Remove and re-locate water pumps from exit stair enclosures or provide 2.0 hour fire rated construction and 1.5 hour opening protective. Remove storage beneath stair landing.	Within 1 Month

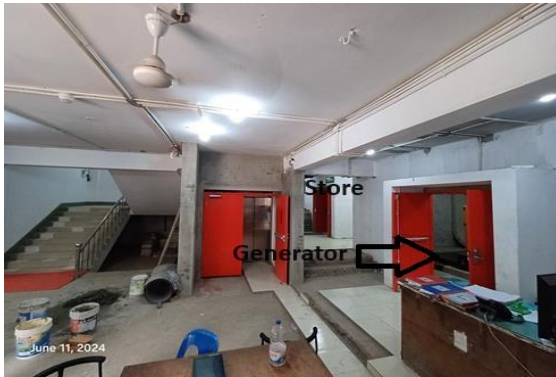
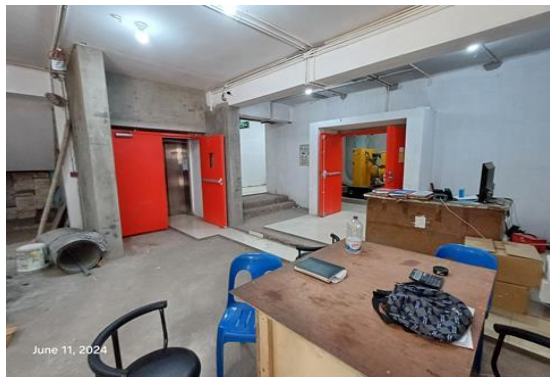
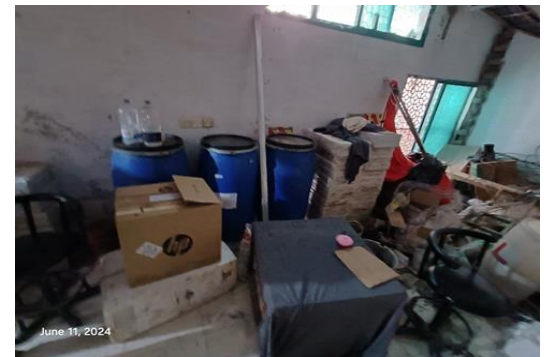
SI No.	Category	Findings	Required Action	Remediation Time Frame
F-3	Fire Rated Construction	<p>At ground floor, high hazard occupancies like storage room, generator room etc. directly discharge to exit stair enclosure without vestibules.</p> <p>Location: North and South Stair Enclosure at Ground floor of main building-1</p>	<p>Openings from exit enclosure to storage and machine room spaces shall be provided with a vestibule with fire rated construction and openings. Provide a 1.5- hr. fire rated door on the exit stair side and a 0.75- hr. fire rated door on the storage and machine room side. Ensure that the fire rating of the vestibule construction matches that of the exit stair enclosure. The minimum width for vestibules shall not be less than 1.1m and length 1.8m.</p>	Within 3 Months

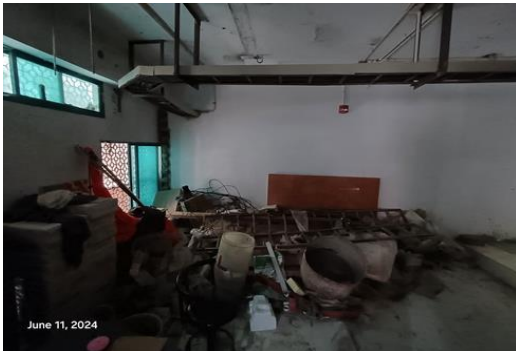
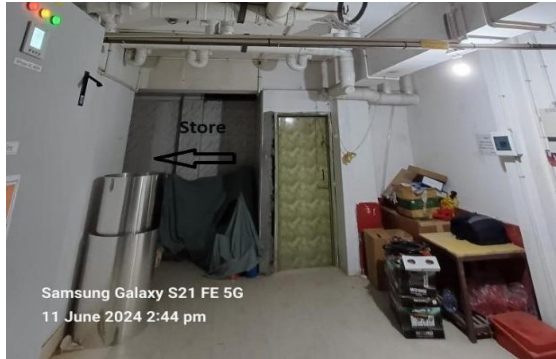
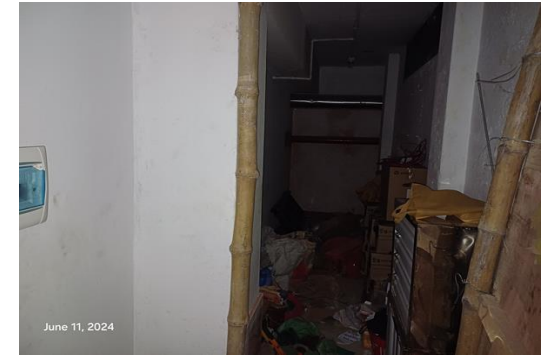
SI No.	Category	Findings	Required Action	Remediation Time Frame
F-4	Fire Rated Construction	Temporary storage are kept room adjacent to south staircase and room adjacent FACP room located at ground floor.	<p>Either remove temporary storage from room adjacent to south staircase and FACP.</p> <p>Or,</p> <p>Separate the dedicated storage rooms by minimum 1-hr fire-rated construction. Provide 0.75 hr. fire rated door.</p> <p>Seal all penetrations and openings by 0.75 hr. (45 Minutes) fire rated fire rated barrier construction.</p>	Within 3 Months

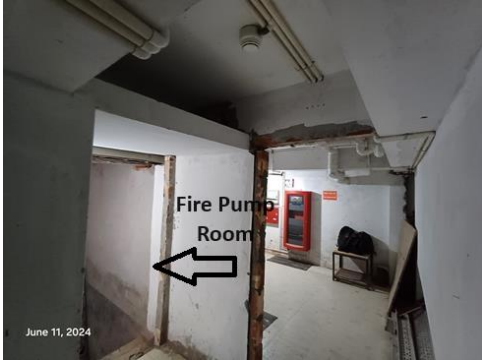
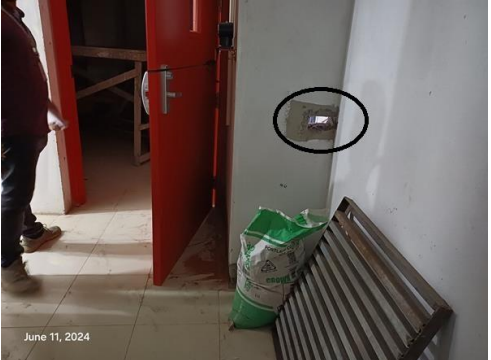
SI No.	Category	Findings	Required Action	Remediation Time Frame
F-5	Fire Rated Construction	<p>The fire pump room is not provided with adequate fire separation as the fire door is not installed yet and penetrations. Penetration with electric cables, water lines for lavatories purpose and feed mains of hydrant system are found in walls, penetration of plumbing pipes are found in ceilings and other penetrations are also not provided with required fire resistance rating.</p> <p>Fire pump rooms construction work is ongoing during the visit. Ventilation is also not provided yet.</p>	<p>Provide fire pump room with 2 hr rated fire separation when not sprinklered and 1 hr rated fire separation when provided with automatic sprinklers, in accordance with NFPA 20.</p> <p>Provide 3.0 hour fire resistance rating for ceiling penetration, 2.0 hour fire resistance rating for wall penetration.</p> <p>Provide 1.5 hour fire resistance rating for opening protectives.</p>	Within 3 Months

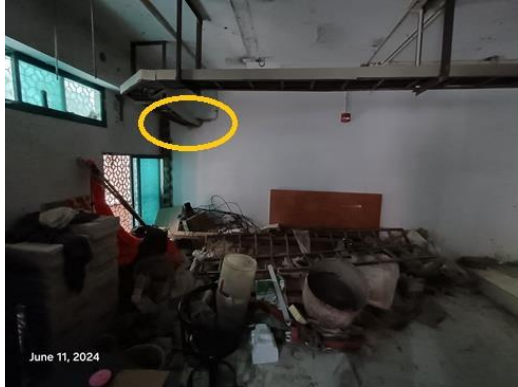
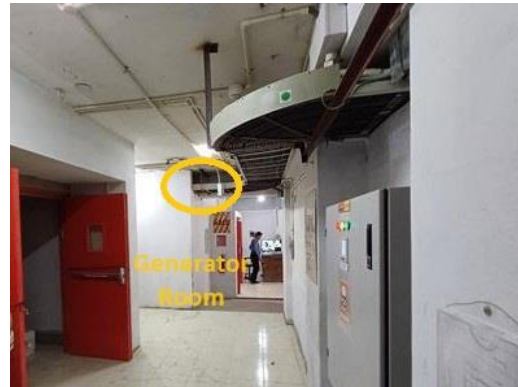
SI No.	Category	Findings	Required Action	Remediation Time Frame
F-7	Fire Rated Construction	<p>The compressor room is not separated by fire rated construction due to penetrations in wall by electrical cable trays from temporary storage room located at ground floor.</p> <p>The generator room is not separated by fire rated construction due to penetrations in wall by electrical cable trays from egress corridor located at ground floor.</p>	<p>Seal all penetrations and openings in wall assemblies by 1-hr and 2-hr fire-rated listed/certified materials in compressor room and generator room respectively. The installation of such fire-rated materials shall be following certified design and manufacturer's guidelines.</p>	<p>Within 3 Months</p>

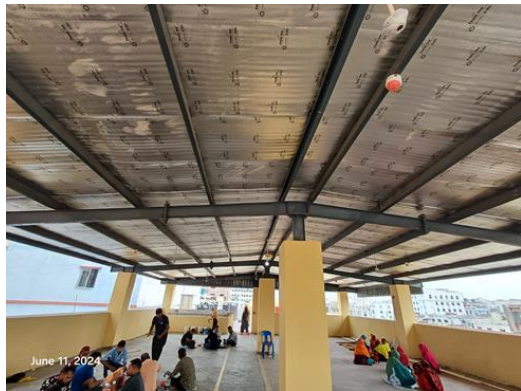
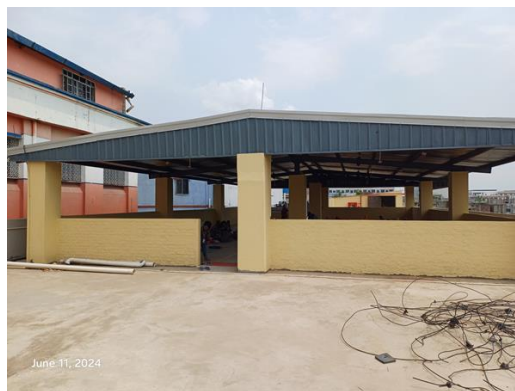
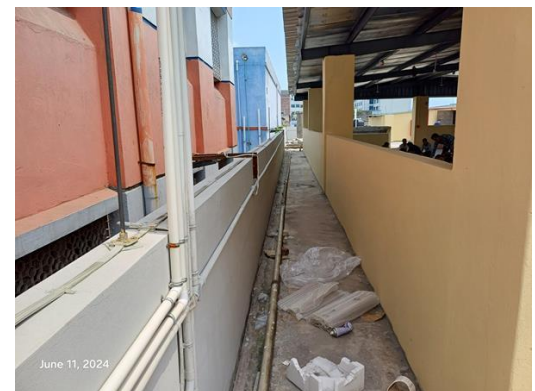
SI No.	Category	Findings	Required Action	Remediation Time Frame
F-8	Fire Rated Construction	The main structural element (column, Bracing, rafter etc.) of Dining shed located at occupied roof of Main production building (High rise building) are constructed by steel without providing any fire resistance rating assemblies. Exterior wall is also not fully constructed with required fire resistance rating where other occupancies/ building very close to shed.	<p>The High-rise building shall be type-I construction as per RSC Technical Guidelines (Standard) 3.5.2 & 3.6.2. Provide required rating in the structural elements of the building. Proximity between group of occupancies and exterior wall rating shall be ensured according to BNBC 2006 Part 3 Table 3.2.2. Consult with a qualified fire protection engineer.</p> <p>Submit the proposed drawing/design to RSC for review. Once reviewed, install passive fire protection as per reviewed design.</p>	Within 6 Months

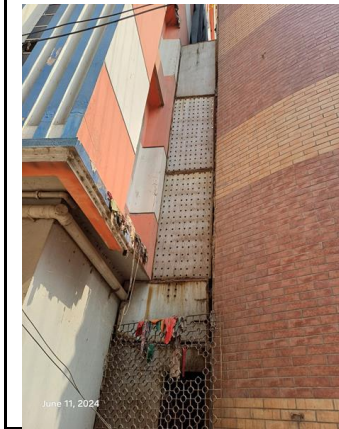
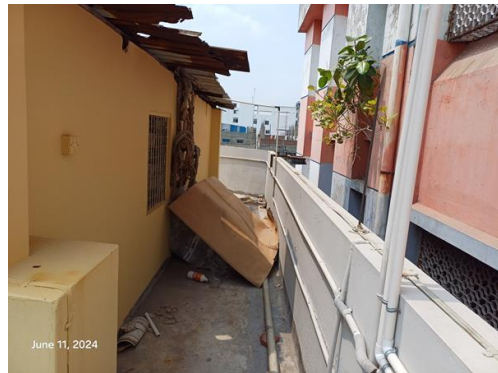
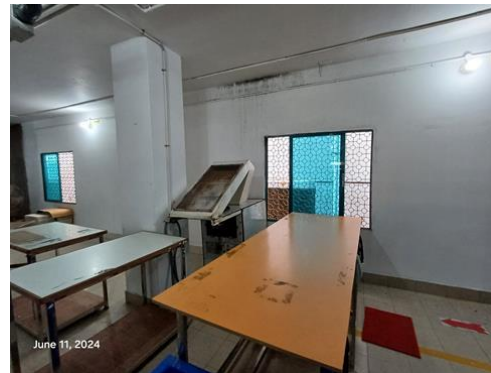
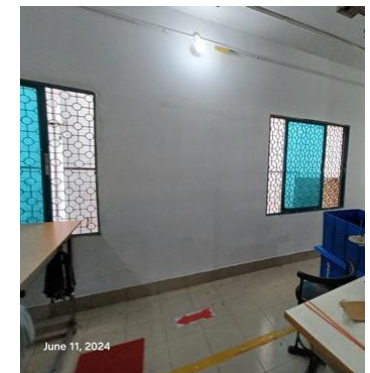
SI No.	Category	Findings	Required Action	Remediation Time Frame
F-9	Fire Rated Construction	<p>Another RMG building of different owner is located at approximately 3'-6" feet distance from RCC building-1 in south side. There are non-rated openings (windows/ high windows/ exhaust fan) at all floor level for both the buildings. Openings of building-1 which are within 10 ft distance from openings of other owners building are not provided with required fire resistance rating.</p>	<p>Exterior wall rating shall be ensured according to BNBC 2006 Part 3 Table 3.2.2 and Table 3.3.1. Consult with a qualified fire protection engineer. Either, seal the non-rated openings of building-1 which are within 10 ft distance from openings of other owner building by 3 hour rated construction assemblies.</p> <p>Or, Replace non-rated openings of building-1 by 3-hr fire-rated listed/certified assemblies glass assemblies/ louvers/dampers etc. The installation of such fire-rated assemblies shall be following certified design and manufacturer's guidelines.</p>	Within 6 Months

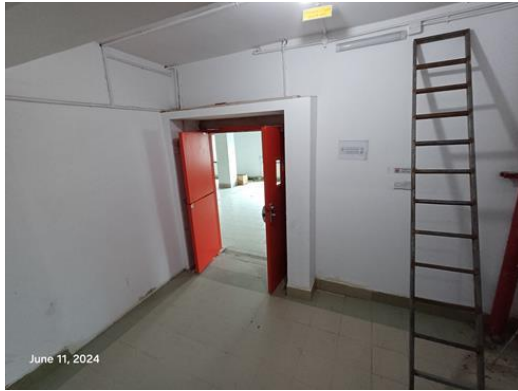
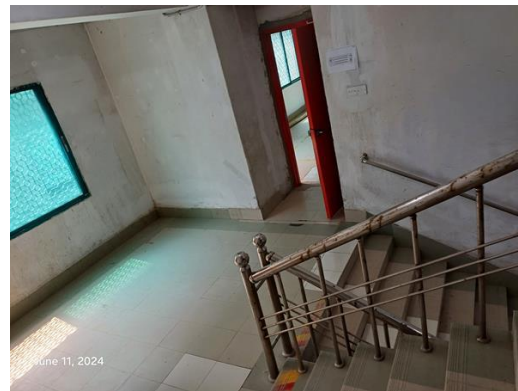
SI No.	Category	Findings	Required Action	Remediation Time Frame
F-10	Means of Egress	<p>RCC Building# 01 did not have stair designation signs and occupant load signs at each floor level of both the staircase.</p> <p>NB: Operation was not found in 3rd and 4th floor. Equipment setup is partial in rest of floors.</p>	<p>Provide stair designation signs and occupant load signs at required locations.</p>	<p>Within 1 Months</p>

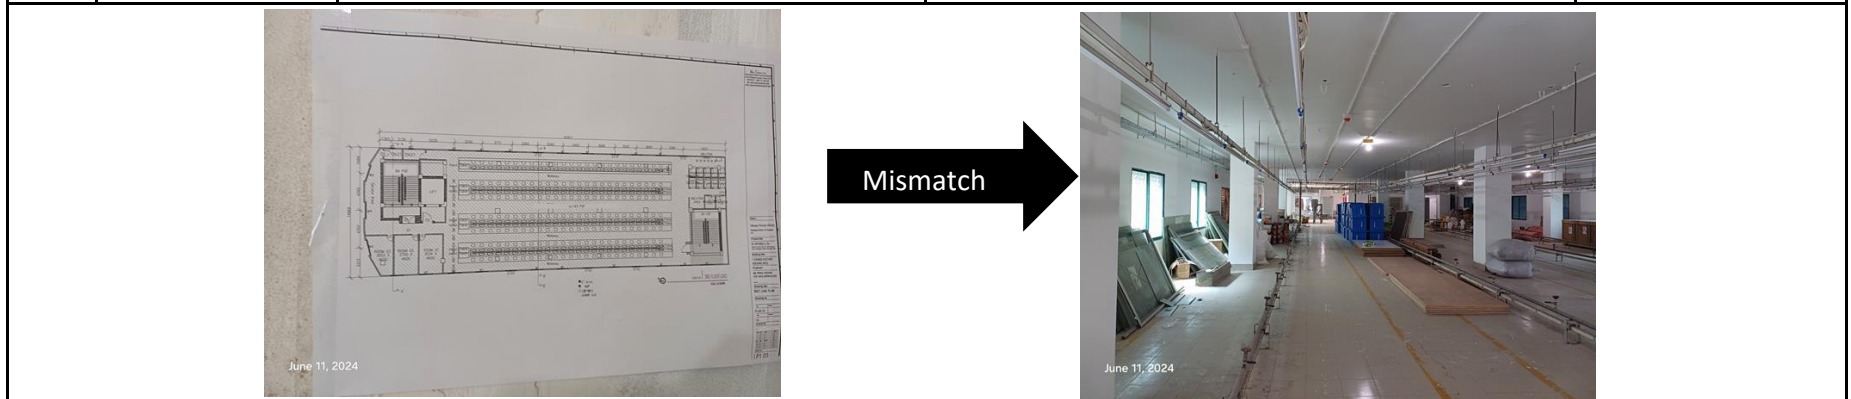
SI No.	Category	Findings	Required Action	Remediation Time Frame
F-11	Means of Egress	<p>As-built drawings are posted near exits from ground floor to 5th floor but evacuation maps are not provided in all required locations. Moreover, as-built drawing does not match with current evacuation routes and occupancies etc.</p> <p>NB: Operation was not found in 3rd and 4th floor. Equipment setup is partial in rest of floors.</p>	<p>Fire evacuation maps shall be posted at the entrance to each exit stair as per RSC Technical Guidelines (Standard) Art# 13.3 and BNBC 2006 Part 4 Appendix A Section A 4.</p>	<p>Within 1 Months</p>

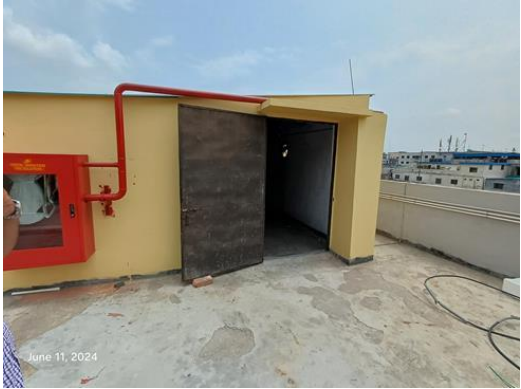
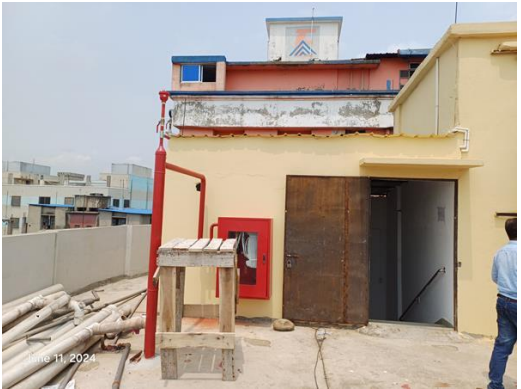
SI No.	Category	Findings	Required Action	Remediation Time Frame
F-12	Means of Egress	Both the doors are inward side-swinging type in the north and south staircase located at 6th floor of RCC building # 01. Occupant load of dining and accessories store is 130.	Doors serving an occupant load of more than 50 shall swing in the direction of egress travel.	Within 2 Months

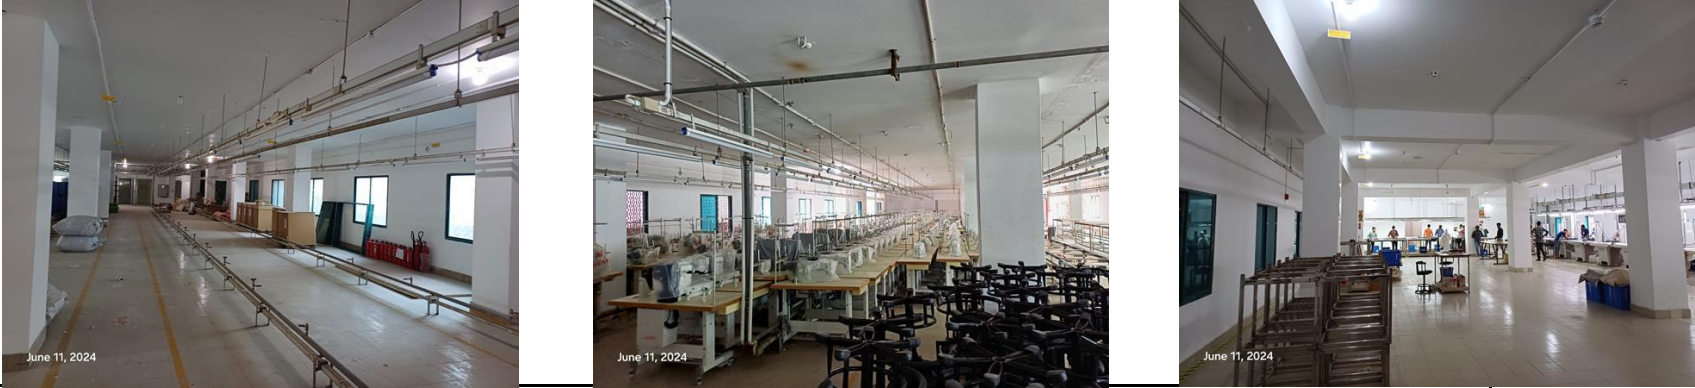
SI No.	Category	Findings	Required Action	Remediation Time Frame
F-13	Means of Egress	Machine layout is not finalized in 1st, 3rd and 4th floor of RCC building # 01. Aisles are missing on sewing section located at 3rd and 4th floor and finishing section located at 1st floor.	Provide minimum aisle widths of 36-in throughout the factory. Aisles mark shall be clearly visible.	Within 1 Month

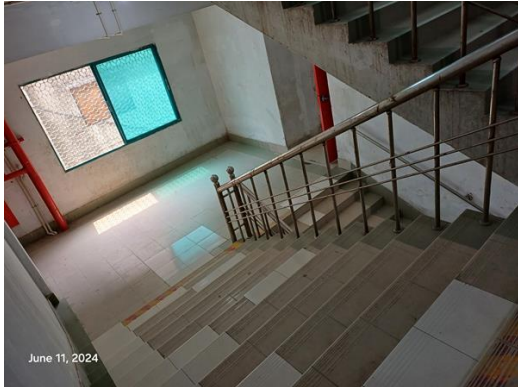
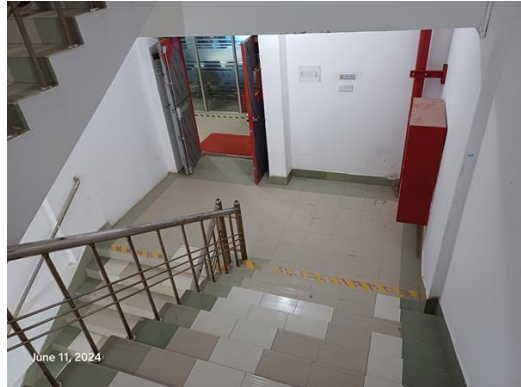
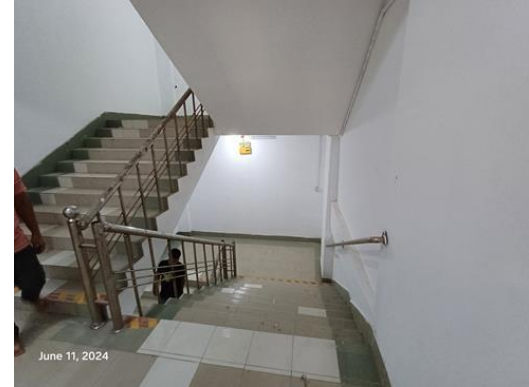
SI No.	Category	Findings	Required Action	Remediation Time Frame
F-15	Means of Egress	In each floor one flight out of two flight of stair, handrails are not provided on both sides of the north and south exit stair.	Provide handrails on both sides of the exit stair throughout all flights on all floors. Intermediate handrails shall be provided when the stair width exceeds 2.2 m (87 in.)	Within 1 Month

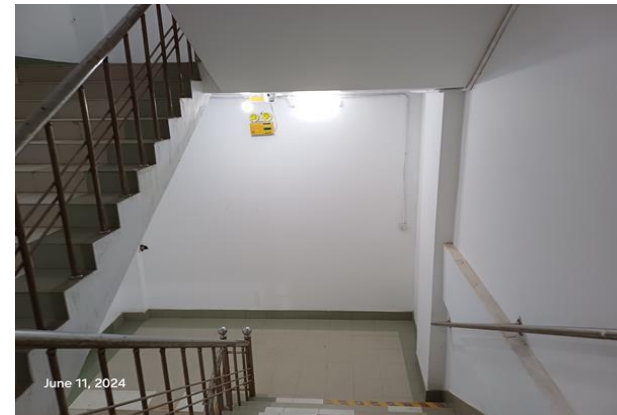
SI No.	Category	Findings	Required Action	Remediation Time Frame
F-16	Means of Egress	Handrails are not provided as per standard as maximum height less than the limit. (30") Location: RCC Building- 01 Production Building	Handrails shall have a minimum height of 865 mm (34 in.) and a maximum height of 965 mm (38 in.) as measured from the leading edge of the tread.	Within 1 Month

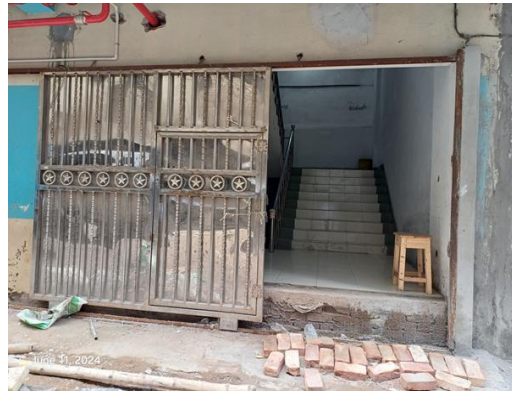
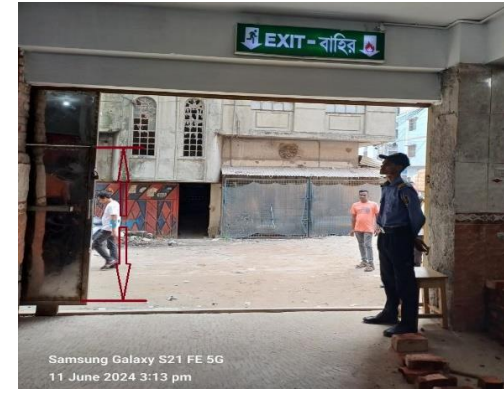
SI No.	Category	Findings	Required Action	Remediation Time Frame
F-17	Means of Egress	Height of south final exit is 4'-7" as it is obstructed at bottom. Height of north final exit is 5'-4". Both the final exit height is less than the minimum height requirement of door in a means egress	Provide doors in a means of egress having a minimum height of 2.0 m (79 in.).	Immediate

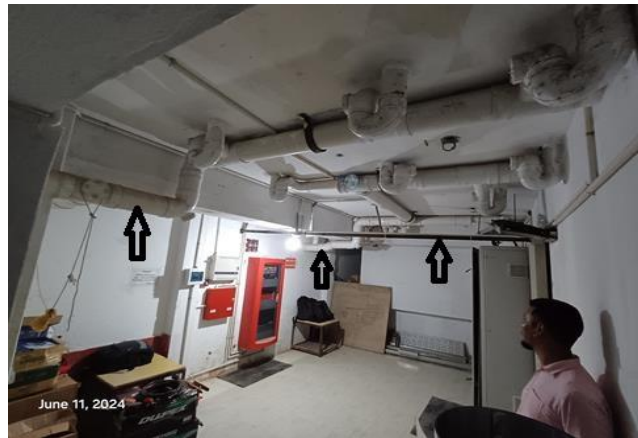
SI No.	Category	Findings	Required Action	Remediation Time Frame
F-18	Means of Egress	Headroom measured less than the 80 inch (2.03 m) in egress path located in FACP room located at ground floor of RCC building-1.	All means of egress shall have a minimum ceiling height of 2.3 m (7 ft 6 in.) with projections from the ceiling not less than 2.03 m (6 ft 8 in.). The minimum ceiling height shall be maintained for at least 2/3 of the space or room as long as the remaining area shall be not less than 2.03 m (6 ft 8 in.).	Within 3 Months

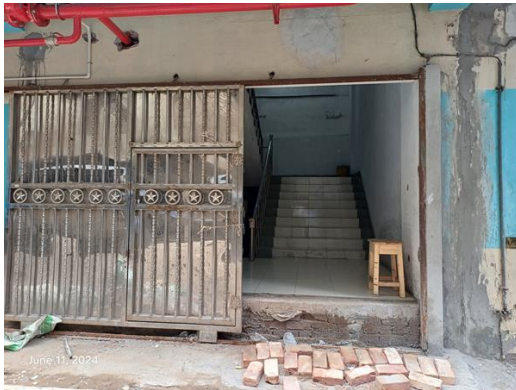
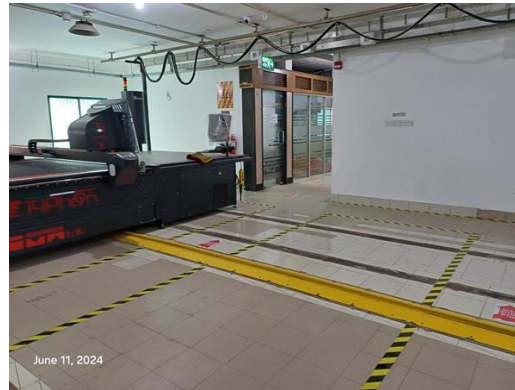
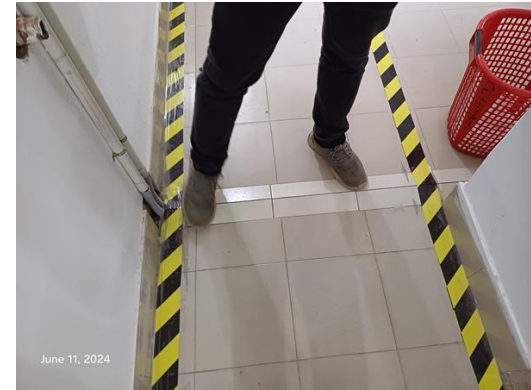
SI No.	Category	Findings	Required Action	Remediation Time Frame
F-19	Means of Egress	<p>In south stair final exit abrupt change in elevation has been observed. Neither stair nor ramp is provided along with handrail.</p> <p>In 2nd floor of RCC building-1, changes in elevation in walking surface have been observed in several location because of electrical wire concealed in tiles and movable cutting table.</p>	<p>Provide beveled slope of 1 in 2 when the changes in elevation is greater than 1/4 in and is less than 1/2 in.</p> <p>Either, provide ramps shall not have a running slope greater than 1 in 12 (8 percent) or, provide aisles shall not exceed a slope of 1 in 20 in the direction of travel, when the changes in elevation exceed 1/2 in.</p> <p>Provide stairs as per section 6.9 or ramps as per section 6.10 when changes in level exceeding 535 mm (21 in.) in elevation .</p> <p>The change in level shall be readily apparent and if not, marked with additional signage or floor markings.</p>	Within 3 Months

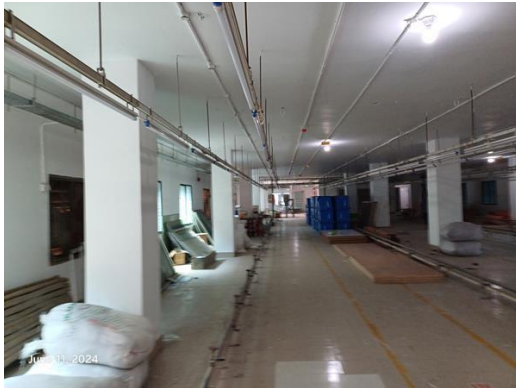
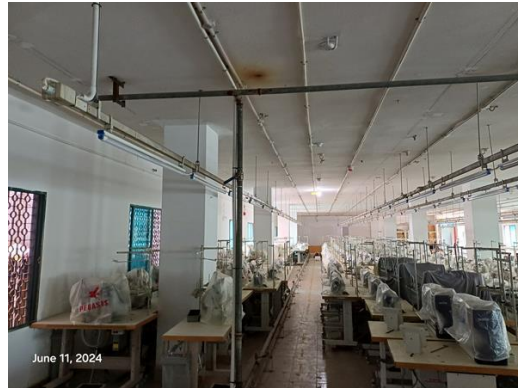
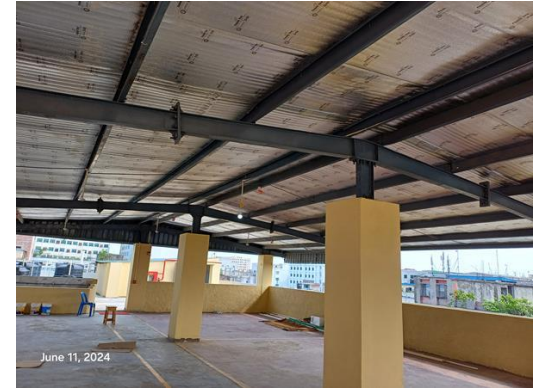
SI No.	Category	Findings	Required Action	Remediation Time Frame
F-20	Fire Protection System	At 3rd, 4th and 6th floor level, machine layout and dining table chairs are not placed yet. Fire extinguishers are also not installed in these floors yet.	Portable Fire Extinguishers shall install as per RSC Technical Guidelines 5.6. Extinguishers shall be placed so that maximum travel distance to the nearest unit shall not exceed 30 m (100 ft). Mounting height shall meet RSC Technical Guidelines 5.6.2.1 & 5.6.2.2.	Within 3 Months

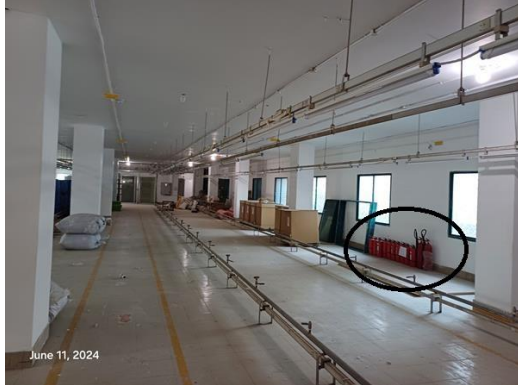
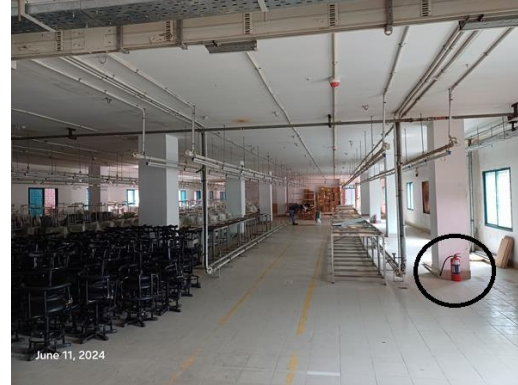
SI No.	Category	Findings	Required Action	Remediation Time Frame
F-21	Fire Protection System	Fire extinguishers were found in floors rather than hanging in wall at 3rd and 4th floor of RCC building-1.	In no case shall the clearance between the bottom of the fire extinguisher and the floor be less than 4 in.(102 mm). As per NFPA 10 section 6.1.3.8.3	Within 1 Month

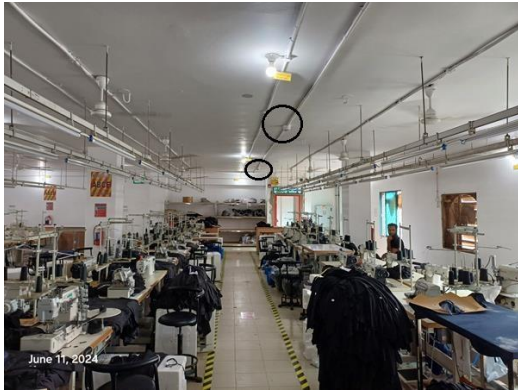
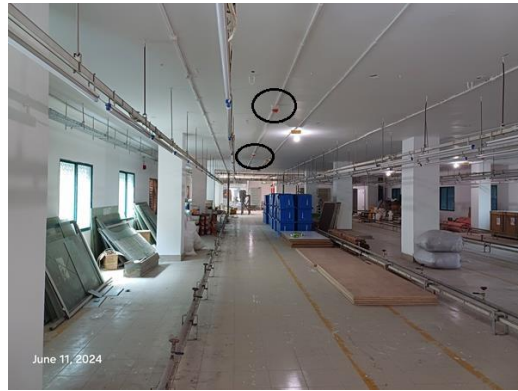
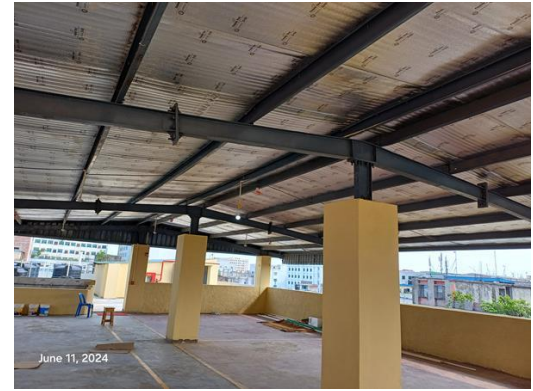
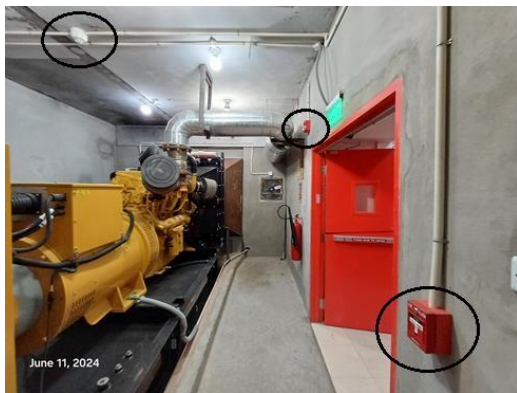
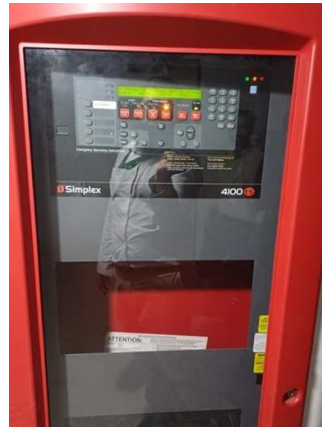
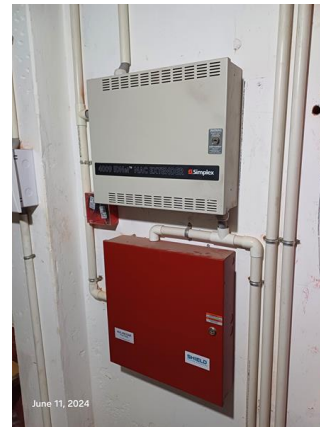
SI No.	Category	Findings	Required Action	Remediation Time Frame
F-23	Fire Alarm & Detection System (FADS)	<p>Fire alarm and detection system installation work is on-going. At 3rd and 4th floor, without defining the occupancy installation work is ongoing. Proposed design is not found during the inspection. After completion of installation as-built FADS system requires detailed review to confirm compliance with NFPA 72 and RSC Technical Guidelines (Standard).</p> <p>Location: All floors of RCC building-1</p>	<p>Install the fire detection and alarm system throughout the building in accordance with RSC Technical Guidelines (Standard) and NFPA 72. Complete the fire alarm installation as per NFPA 72.</p> <p>After installation the owner shall conduct internal testing and commissioning and then contact the RSC for witness of final acceptance testing. Submit as-built drawings, testing records, equipment certification and other relevant documentation to the RSC for review and approval. Modification (if required) shall have to done as per the reviewed design and NFPA- 72. Upon approval & modification (if required) the factory shall inform RSC to conduct final testing and commissioning verification of the system for final acceptance.</p>	<p>Design within 2 Months, installation/modification on within 4 Months</p>

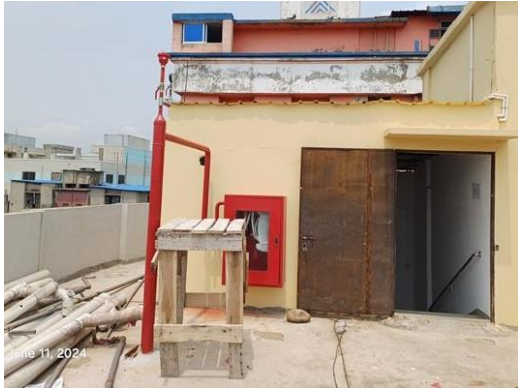
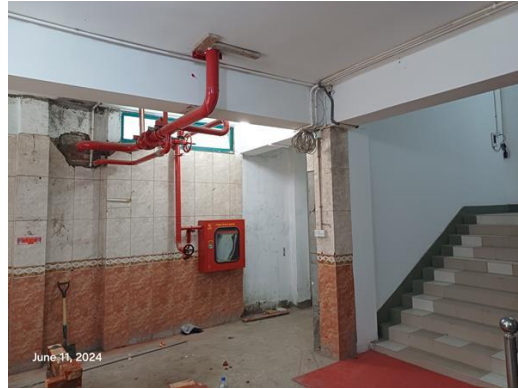
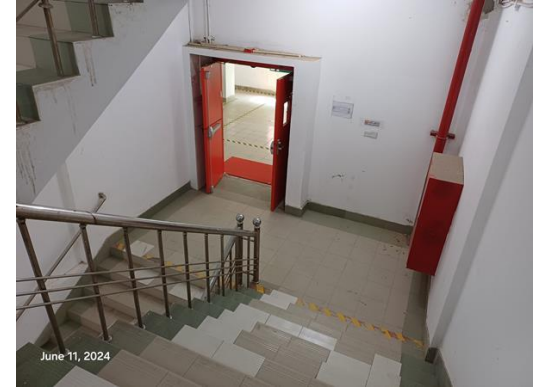
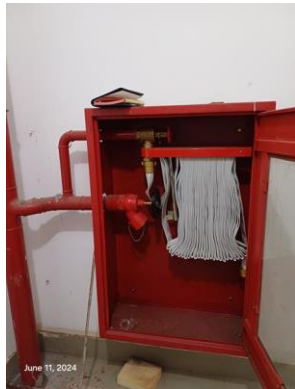
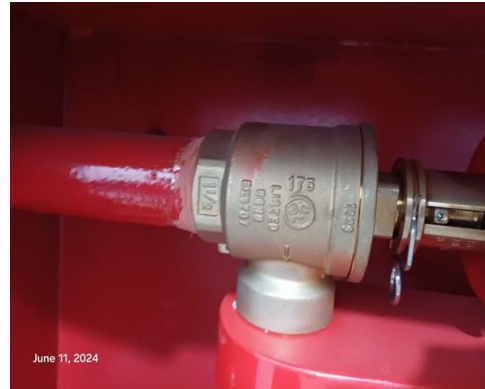
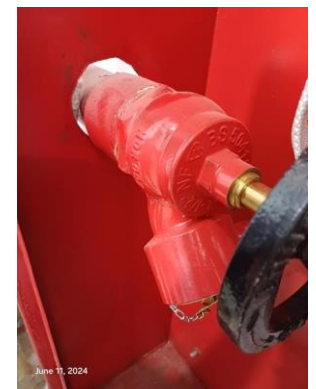
SI No.	Category	Findings	Required Action	Remediation Time Frame
F-24	ITM FADS	Inspection, testing and maintenance for the fire detection and alarm system was not in accordance with standard.	Inspect, test and maintain the fire alarm system and keep written records on-site, in accordance with Table-14.3.1 of NFPA 72.	1 Month after installation
F-25	Fire Protection System	<p>Installation work of the required standpipe system is on-going. Proposed drawing is not found during the visit.</p> <p>Standpipe installation requires detailed review to confirm compliance with NFPA 14, 20 and RSC standards.</p> <p>Location: All floors of RCC building-1</p>	<p>Install a standpipe system in accordance with RSC standard 5.4 and NFPA 14. A class III system shall be installed in buildings with the highest occupiable floor 10 m (33 ft.) above grade or more. A class I system shall be permitted in buildings protected throughout by an approved automatic sprinkler system.</p> <p>Submit the as-built standpipe system drawing to RSC for review. Once reviewed, install or modify the standpipe system throughout the building in accordance with RSC standard and NFPA 14,20,22 and 24. After installation the owner shall contact the RSC for witness of conducting the final acceptance testing of the standpipe system.</p>	Design within 2 Months, installation/modification on within 4 Months

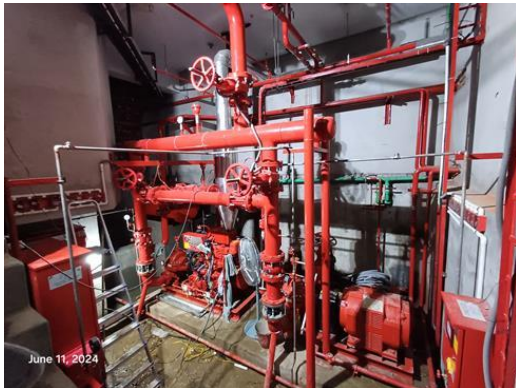
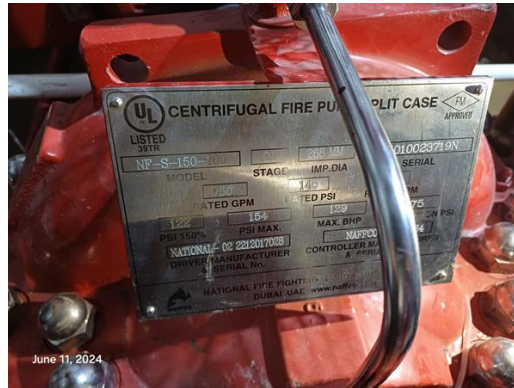
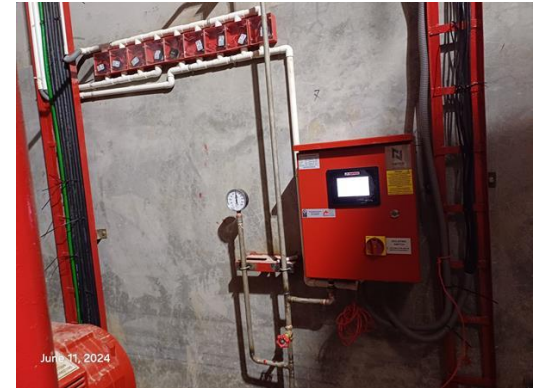
SI No.	Category	Findings	Required Action	Remediation Time Frame
F-26	Fire Protection System	Installation work of fire pump is on-going. Fire pump installation requires detailed review to confirm compliance with NFPA 20 and RSC standards.	<p>Submit as-built drawings, testing records, equipment certification and other relevant documentation to the RSC for review and approval.</p> <p>Submit the standpipe system drawing to RSC for review. Once reviewed, install or modify the standpipe system throughout the building in accordance with RSC standard and NFPA 14 and 20. The factory management shall contact RSC to conduct the final acceptance testing after the installation, testing & commissioning.</p>	Design within 2 Months, installation/modification on within 4 Months

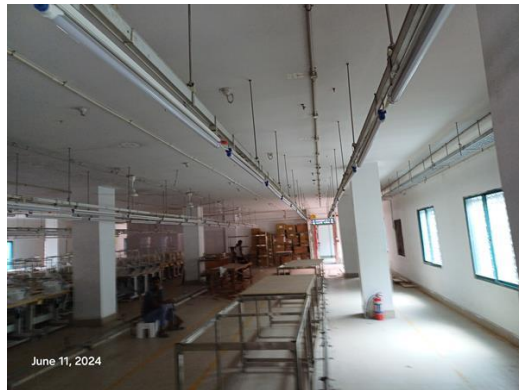
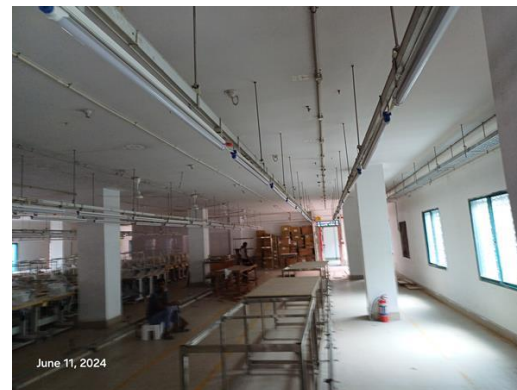
SI No.	Category	Findings	Required Action	Remediation Time Frame
F-29	Egress Lighting	<p>Machines along with aisles, chairs and tables are not installed or partially installed at 1st, 3rd, 4th and 6th floor. Based on the number and location of emergency lights observed, adequate illumination levels are not anticipated along egress routes.</p> <p>Location: Ground, 1st, 3rd, 4th and 6th floor of building-1</p>	<p>Test the emergency lighting system on each floor and provide additional emergency fixtures to provide adequate illumination along the means of egress. Provide a minimum illumination of 10 lux at the floor level within exit stairs and exit discharge paths and minimum 2.5 lux along exit access aisles.</p>	<p>Within 3 Months</p>

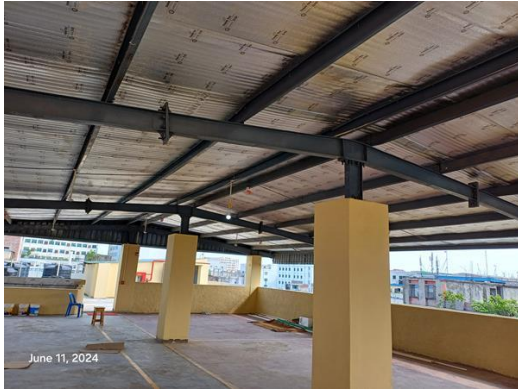
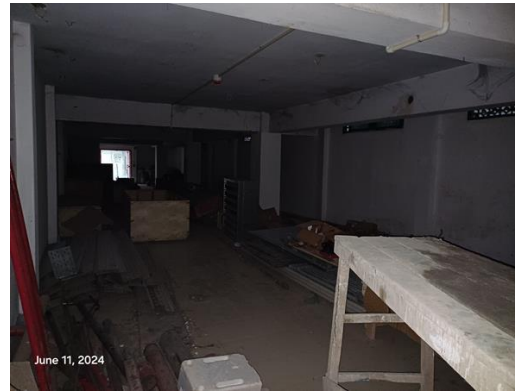
SI No.	Category	Findings	Required Action	Remediation Time Frame
F-30	Egress Lighting	<p>Exit signage is not provided at dining section in 6th floor and at storage area, fire pump room and FACP room in ground floor of factory buildings.</p> <p>Location: Ground floor & 6th floor of RCC building-1</p>	<p>Provide exit signs above all building exits to the exterior, all doors to the exit stairs and along all paths of travel where a change of direction is not obvious.</p>	<p>Within 2 Months</p>

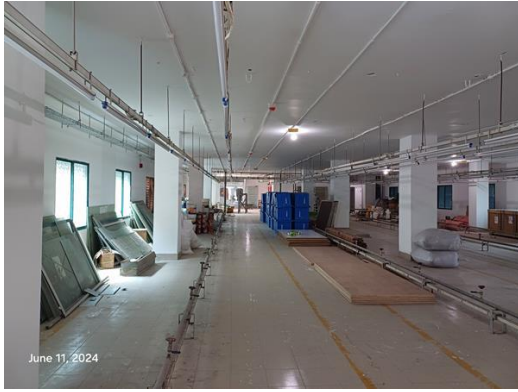
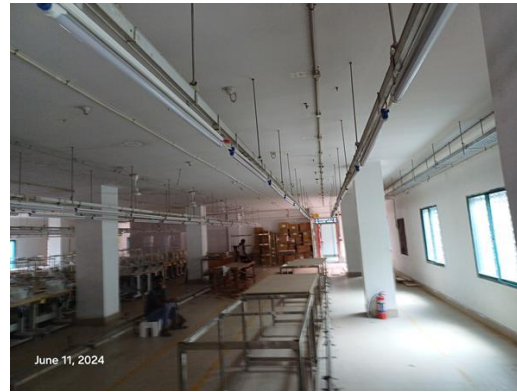
SI No.	Category	Findings	Required Action	Remediation Time Frame
F-31	Egress Lighting	Machines along with aisles, chairs and tables are not installed or partially installed at 1st, 3rd, 4th and 6th floor. Directional Exit signage are not provided along the path of egress where there is a change in the direction for the path of travel and the direction to an exit is not obvious.	Provide directional exit signs above all building exits to the exterior, all doors to the exit stairs and along all paths of travel where a change of direction is not obvious. Lighted directional signs shall be provided with either battery backup or uninterruptable power supply systems and shall be continuously illuminated.	Within 2 Months
