York Composite Ltd.

Plot# 08,09,10 BSCIC Industrial Estate, Kanchpur, Sonargaon, Narayanganj
(23.697660, 90.527756)

2 July 2024

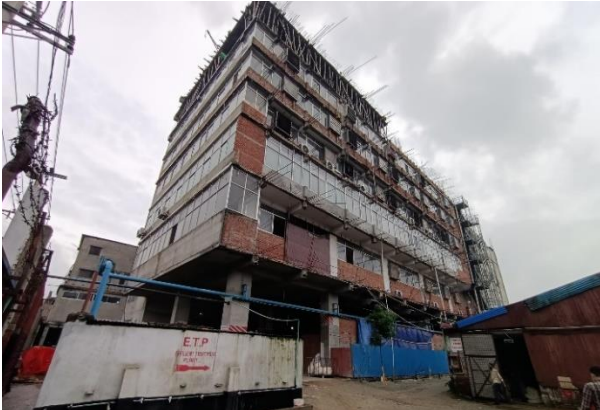
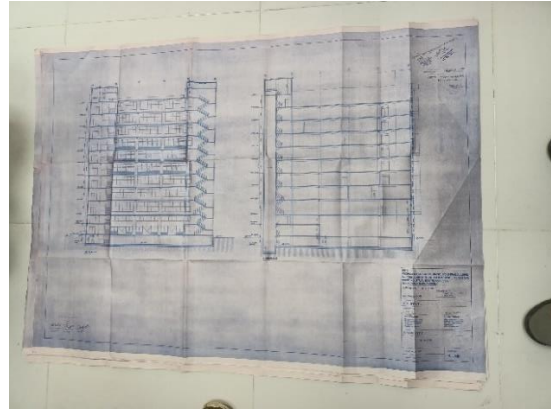
Observation-02: Foundation and column stressed above normal design limit for further construction. (Main Building)

Description: Few columns and foundations are found to be stressed above normal design limit considering minimum concrete strength and 10-storied RC building. The building engineer is required to carry out Detailed Engineering Assessment (DEA) before conducting any extension work.

Item No.	Observation	Action Plan	Timeline
1.	Foundation and column stressed above normal design limit for further construction. (Main Building)	The building engineer is required to carry out Detail Engineering Assessment (DEA) before conducting any extension work.	within 6 weeks

2.		Verify in situ concrete strength (100mm dia. cores from 4 columns) from the lower tier of the building.	within 6 weeks
3.		Carry out the suggested remedial work if required.	within 6 months

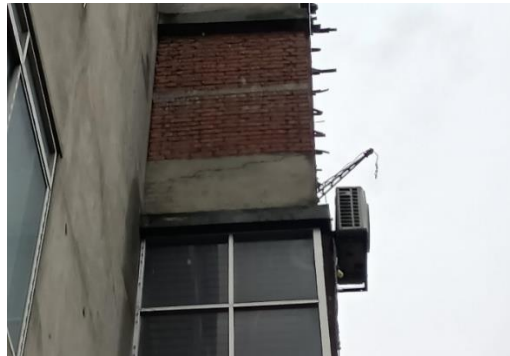
Observation-02: Hairline cracks on facade walls. (Main Building)

Description: Crack was found on brick wall at top floor. The building engineer is required to investigate the cracked area and repair with a suitable method.

4.		Implement floor loading plan.	within 6 months
5.	Hairline cracks on facade walls. (Main Building)	The building engineer is required to investigate the cracked area and repair with a suitable method	within 6 weeks

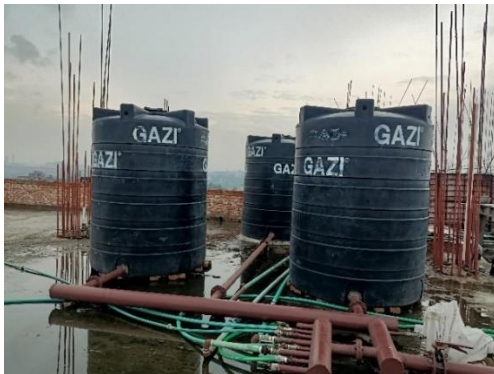
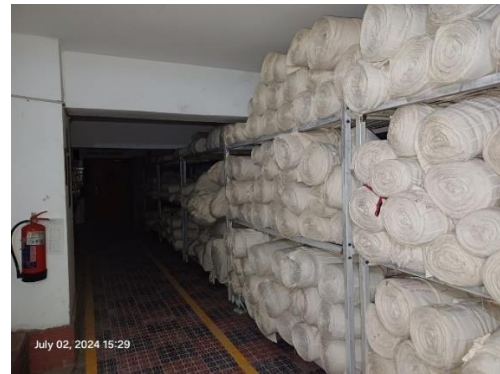
Observation-03: Nonstructural elements found not anchored/braced. (Main Building)

Description: Plastic water tanks and storage rack were found not anchored/braced. The building engineer is required to anchor/brace all nonstructural elements to avoid falling hazards during earthquake.

6.	Non-structural elements found not anchored/braced. (Main Building)	The building engineer is required to anchor/brace all non-structural elements to avoid falling hazards during earthquakes.	within 6 weeks

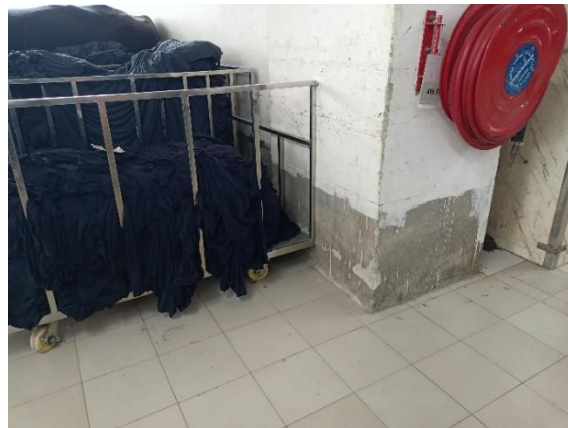
Observation-04: Trolley impact on RC pedestal columns. (Main Building)

Description: Trolley impact was observed on RC pedestal columns. The building engineer is required to repair the damaged plaster and provide protection to prevent trolley impact on RC pedestal columns.

7.	Trolley impact on RC pedestal columns. (Main Building)	The building engineer is required to repair the damaged plaster and provide protection to prevent trolley impact on RC pedestal columns.	within 6 weeks

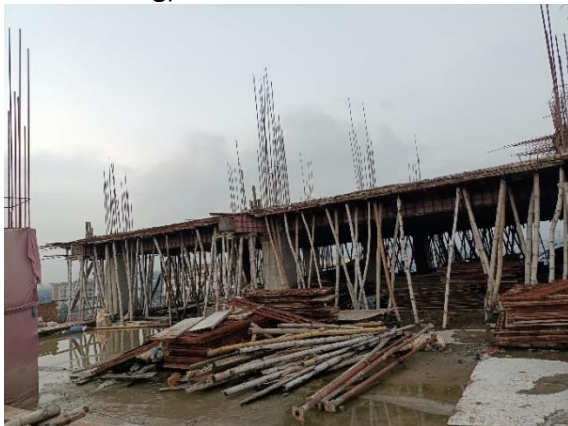
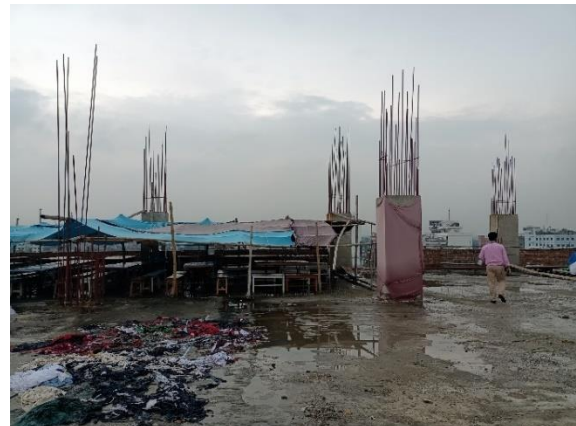
Observation-05: Construction materials, temporary bamboo frame and water clogging on the roof. (Main Building)

Description: Construction materials and bamboo frames were found almost everywhere on the roof. Building engineer is required to remove all kind of construction materials and bamboo frame from the roof. Also, provide adequate drainage to avoid water clogging on roof.

8.	Construction materials, temporary bamboo frame and water clogging on the roof. (Main Building)	Building engineer is required to remove all kind of construction materials and the bamboo frame from the roof and keep the roof clean.	within 6 weeks

9.		Provide adequate discharge and drainage to avoid water clogging on roof.	within 6 months
10.	Undocumented single-storied masonry shed adjacent to Main building at South. (Main Building)	Building engineer is required to separate the roof structure from Main Building and provide adequate support & connection for roof frame.	within 6 weeks

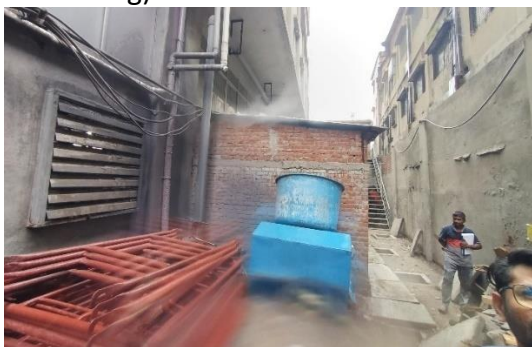
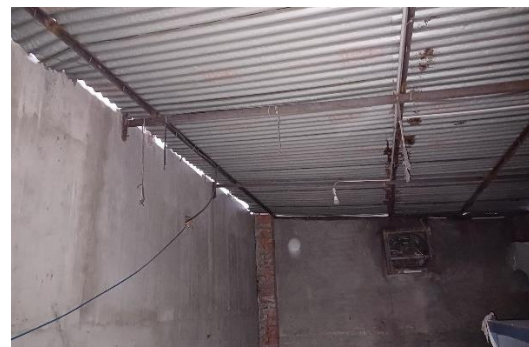
Observation-06: Undocumented single-storied masonry shed adjacent to Main building at South. (Main Building)

Description: An undocumented single-storied shed was found at the south side of the building. The roof frame is connected with the façade of Main Building on GF. Building engineer is required to separate the roof structure from Main Building and provide adequate support & connection for roof frame. Also, prepare as-built drawings.

11.		Prepare full set of as-built drawings.	within 6 weeks
12.	Adequacy of external steel stair for vertical and lateral loading. (Main Building and Utility Building)	Building engineer is required to check the adequacy of the external steel stair for vertical and lateral loading. Also, suggest suitable repair method.	within 6 weeks

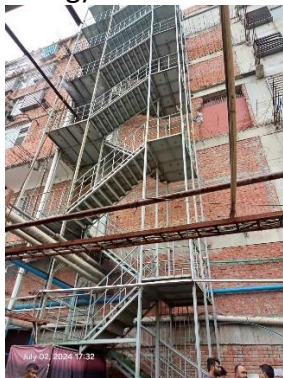
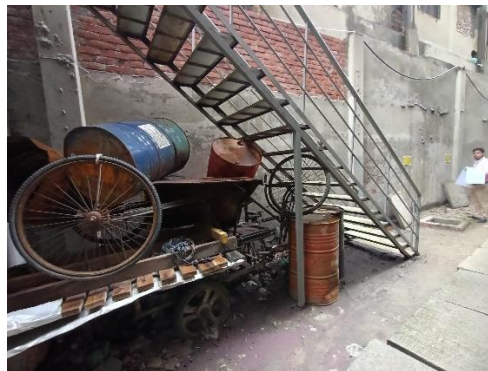
Observation-07: Adequacy of external steel stair for vertical and lateral loading. (Main Building and Utility Building)

Description: Lateral load-resisting system was not found in the external steel stair. Also, vertical members are found to be inadequate. Building engineer is required to check the adequacy of the external steel stair for vertical and lateral loading.

13.		Carry out the suggested remedial work.	within 6 months

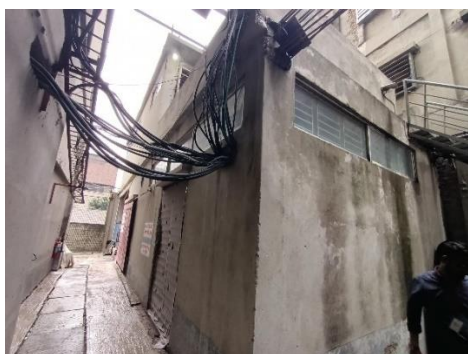
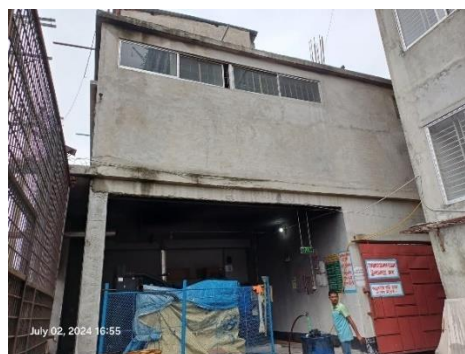
Observation-08: Lack of design report. (Utility Building)

Description: As per BNBC, every building or structure designed shall have its design documents prepared in accordance with the provision of Section 1.9.1. During inspection, the design report was not available on site.

The building engineer is required to prepare a set of design documents including as-built drawings, live load plan, and software-based analysis which shall be prepared in compliance with section 1.9.1, part-6 of BNBC.

Item No.	Observation	Action Plan	Timeline
14.	Lack of design report. (Utility Building)	The building engineer is required to prepare a set of design documents including as built drawings, live load plan and software-based analysis which shall be prepared in compliance with section 1.9.1, part-6 of BNBC.	within 6 weeks

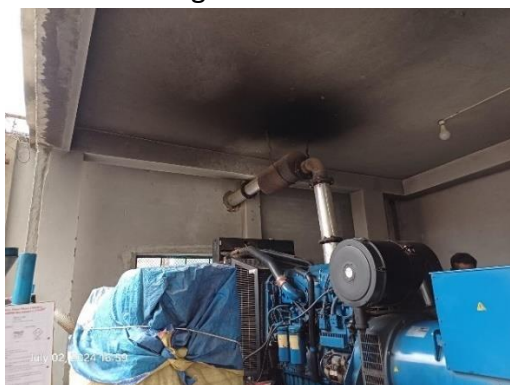
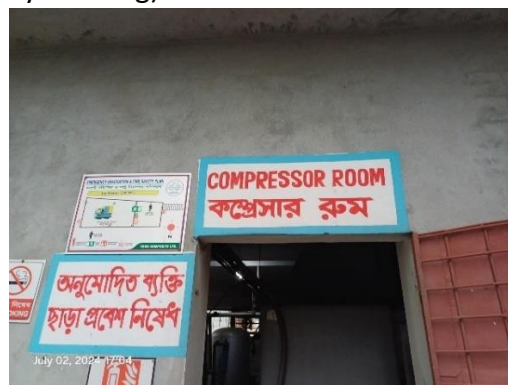
Observation-09: Significant vibration on 1st floor. (Utility Building)

Description: Significant vibration was felt on the first floor due to operation of heavy machineries. Building engineer is required to investigate the long-term effect of the vibration and suggest remediation.

15.		Carry out the suggested remedial work if required.	within 6 months
16.		Implement floor loading plan.	within 6 months
17.	Significant vibration on 1 st floor. (Utility Building)	Building engineer is required to investigate the long-term effect of the vibration and suggest remediation.	within 6 weeks

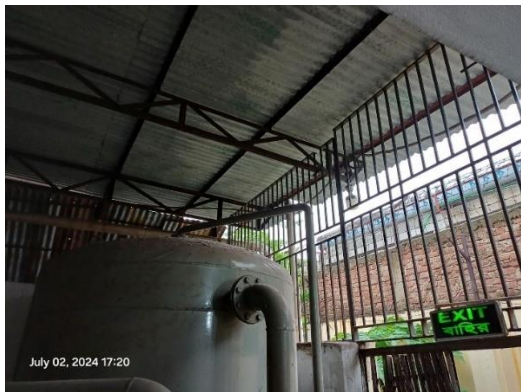
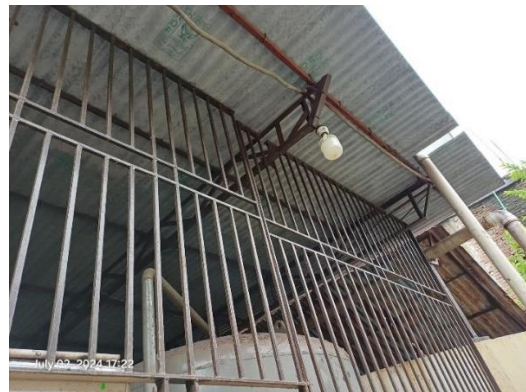
Observation-10: Improper connection and inadequate truss member on GF. (ETP Building)

Description: Improper connection and inadequate truss members were found on the ground floor extension roof shed of ETP building. Trusses are resting on the grill with poor welding. The building engineer is required to proposed remediation design of the inadequate members, connections and structural system.

18.	Improper connection and inadequate truss member on GF. (ETP Building)	The building engineer is required to proposed remediation design of the inadequate members, connections and structural system.	within 6 weeks

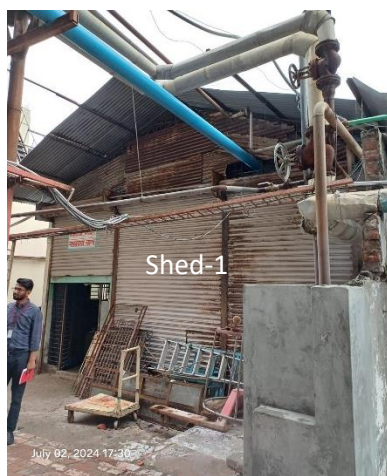
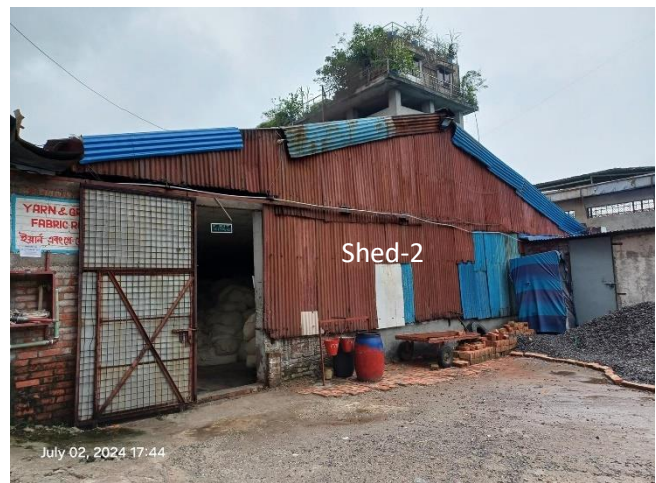
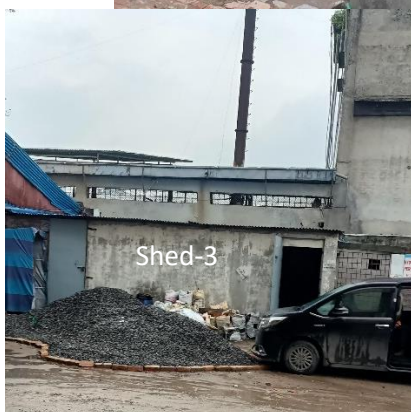
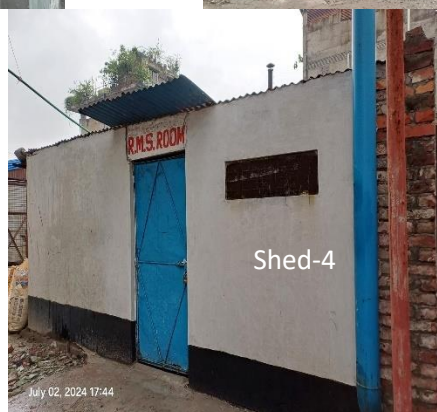
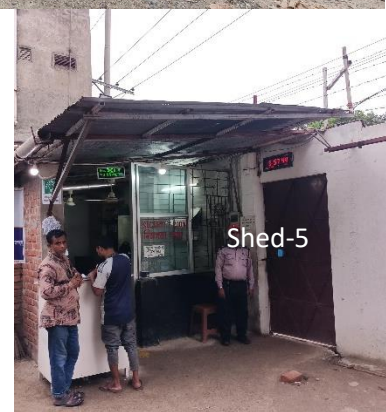
Observation 11: Lack of as-built drawing (Shed-1, 2, 3, 4 & 5).

Description: As-built drawings were not available for the ancillary structures. The building engineer is required to prepare as-built drawings for all the structures.

19.		Carry out the suggested remedial work where required.	within 6 months
20.	Lack of as-built drawing. (Shed-1, 2, 3, 4 & 5)	The building engineer is required to prepare as-built drawings for all the structures.	within 6 weeks

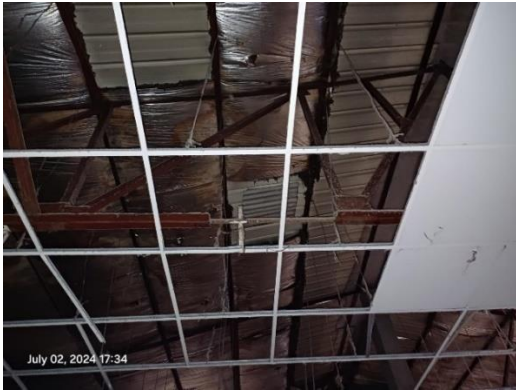
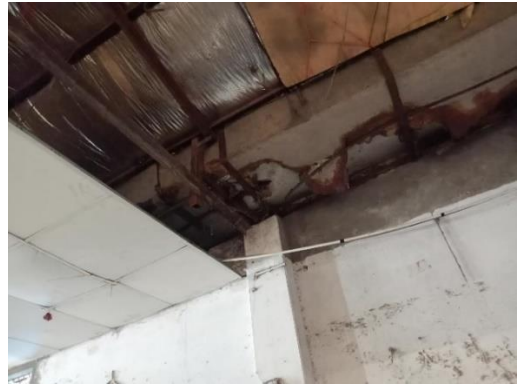
Observation-12: Lack of lateral stability. (Shed-2)

Description: Lateral load transfer media was found missing in the perpendicular direction of the truss frame. Also, one truss frame was found discontinue to the column. Also, truss bottom member was found discontinue at middle. Building engineer is required to check the connection adequacy and lateral stability of the structure. Also, repair the bottom member of the truss with same materials.

21.	Lack of lateral stability. (Shed-2)	Repair the discontinued bottom member of the truss with same materials.	within 6 weeks
22.		Building engineer is required to check the connection adequacy and lateral stability of the structure.	within 6 weeks

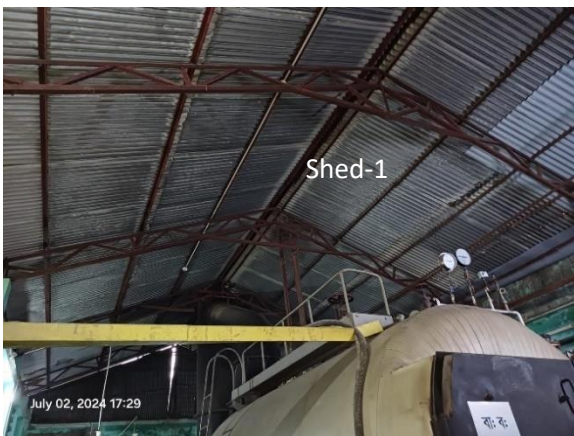
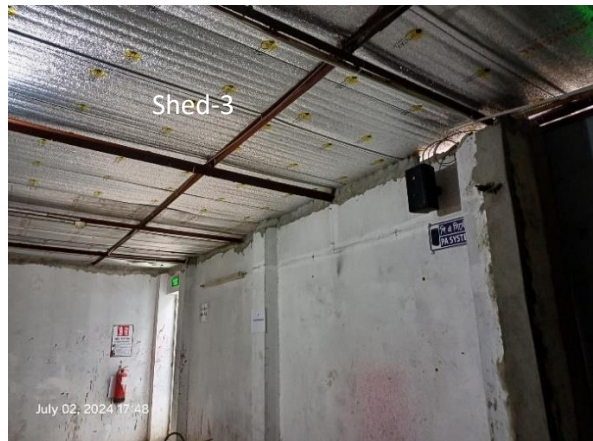
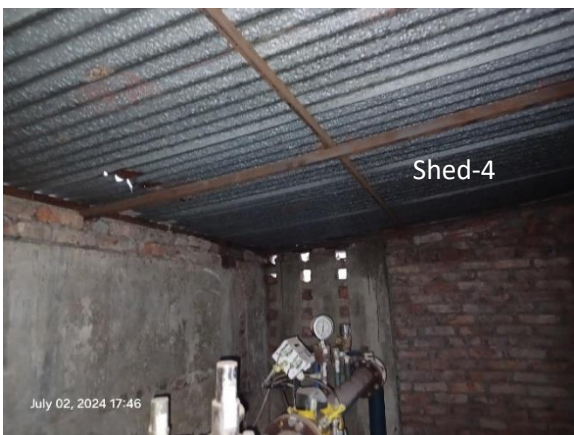
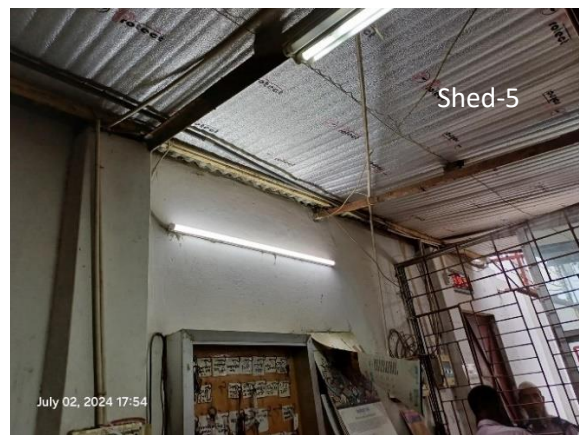
Observation 16: Improper connection, inadequate roof framing members and support. (Shed-1, 3, 4 & 5).

Description: Inadequate roof framing members and vertical support members were found in these sheds. Also, the connection between the truss/rafter and columns was found improper. The building engineer is required to proposed remediation design of the inadequate members and connections.

23.		Carry out the suggested remedial work where required.	within 6 months
24.	Improper connection, inadequate roof framing members and support. (Shed-1, 3, 4 & 5).	The building engineer is required to proposed remediation design of the inadequate members and connections.	within 6 weeks

25.		Carry out the suggested remedial work where required.	within 6 months
