# **FIRE SAFETY INSPECTION REPORT**

**A-ONE POLAR LIMITED**  
**VULTA, RUPGONJ**

**ACCORD**  
on Fire and Building Safety in Bangladesh

June 3, 2014

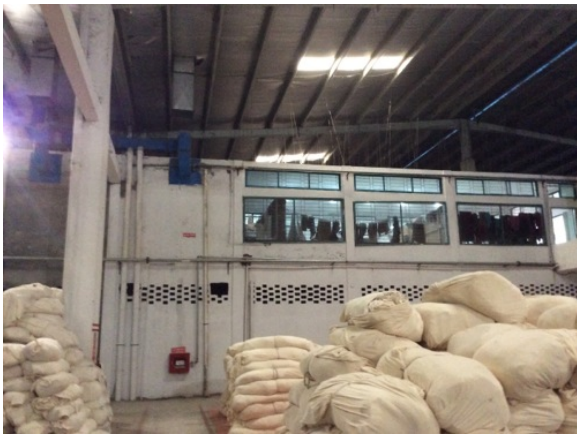
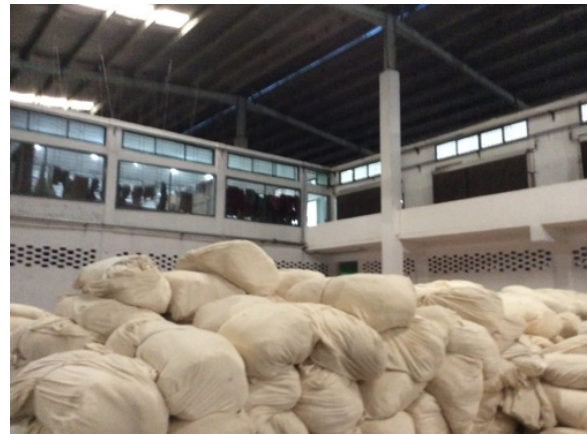
No.	Category	Finding	Recommendation	Remediation Timeframe
F-1	Fire Rated Construction	The 2-story warehouse was non-separated from all areas of the building on both floors due to unprotected window, door and vent openings.	Either remove combustible storage from warehouse area, or provide dedicated storage rooms separated by minimum 1-hr fire-rated construction.	Within 3 months

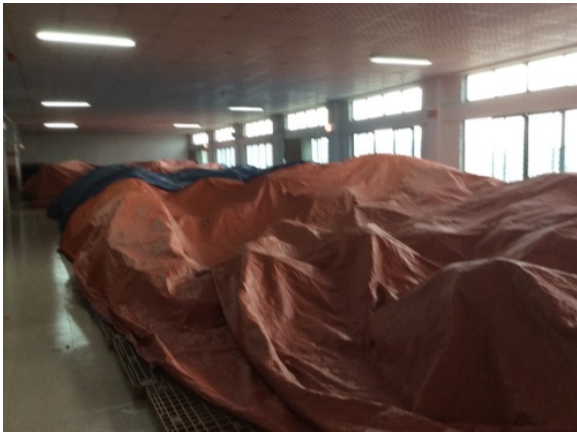
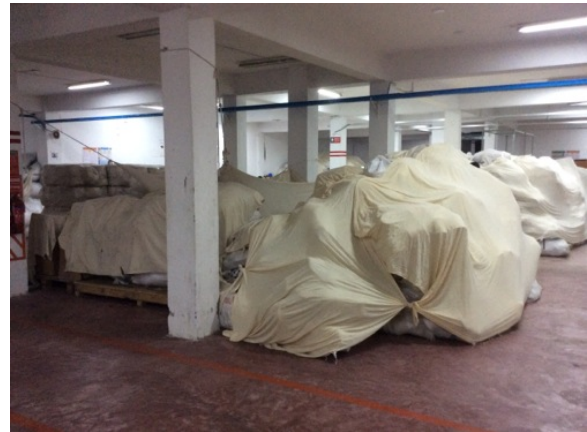
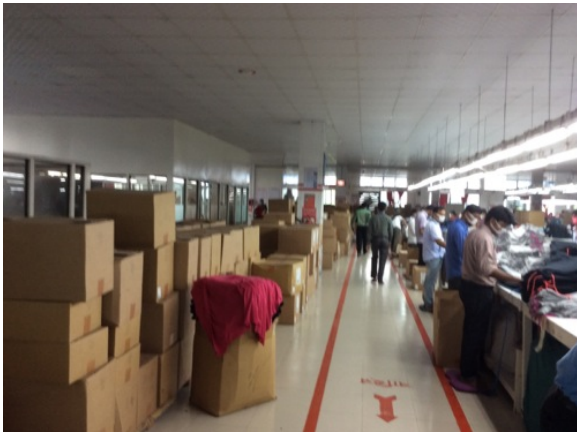
F-2	Fire Rated Construction	<p>Areas used for combustible storage are not separated by fire-rated construction.</p> <p>A significant amount of process and finished goods storage was observed on or adjacent to the work areas on both floors.</p>	<p>Provide dedicated storage rooms separated by minimum 1-hr fire-rated construction.</p> <p>Where separate storage rooms are not feasible, provide defined storage areas and limit the storage arrangement as follows:</p> <ul style="list-style-type: none"> <li>- Maximum height of 2.4m and maximum area of 23m<sup>2</sup></li> <li>- If sprinkler protected: maximum height of 3.66m and maximum area of 93m<sup>2</sup></li> </ul> <p>Separate areas of unenclosed combustible storage by a minimum clear distance of 3m.</p>	Within 3 months
-----	-------------------------	---	--	-----------------

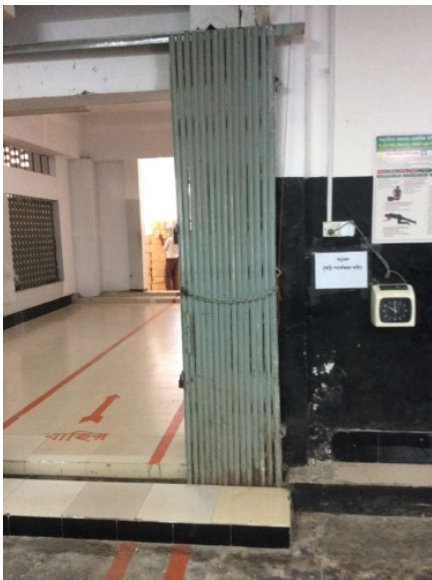
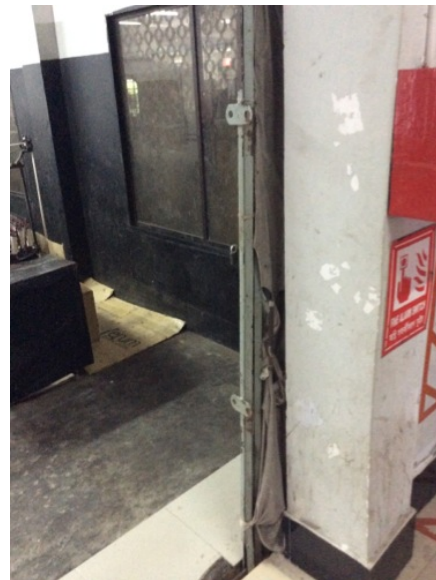
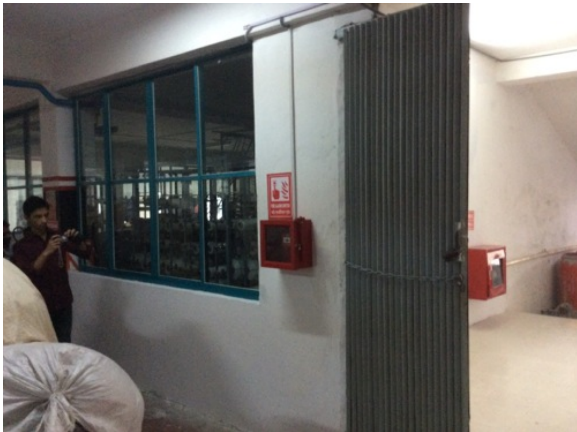
F-3 Egress

Egress gates with locking features are provided at building exits and some exit discharge. All doors and gates were open and unlocked during the inspection.

Remove locking features from all egress doors / gates.

If locks are required for security reasons, utilize special door locking features complying with NFPA 101.

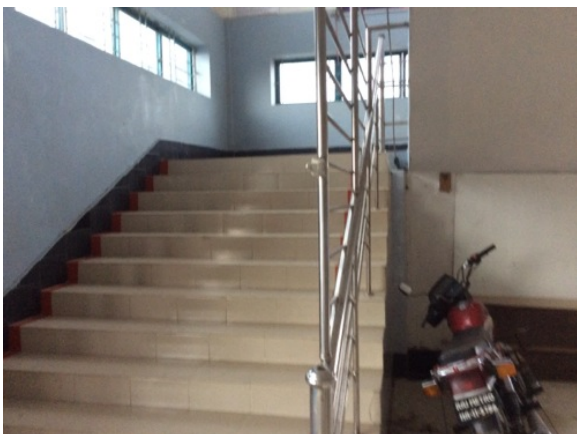
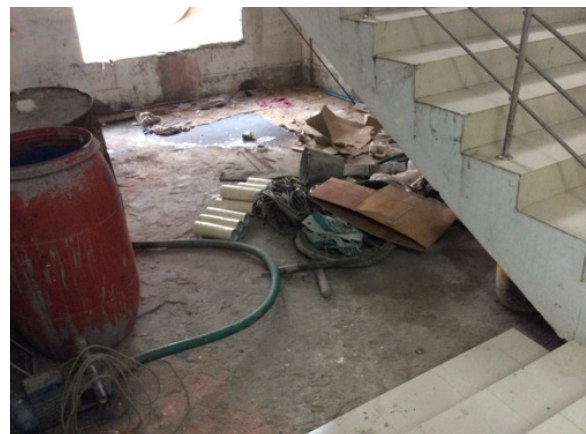
F-4 Egress

Storage was located in the exit stair. A motorcycle was stored at the base of the Northeast stair. Debris was located underneath the Northwest stair.

Remove all storage from exit stairs and egress paths.

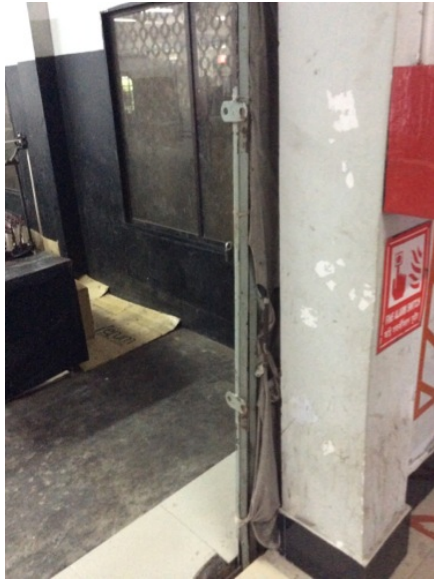
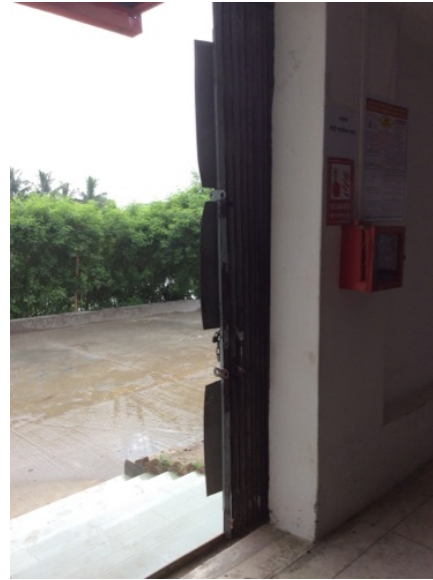
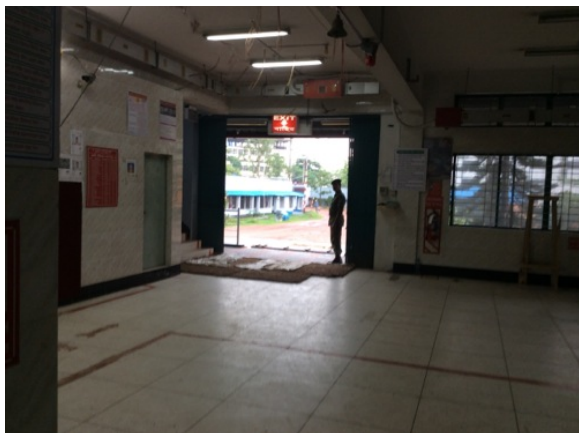
F-5	Egress	Collapsible gates are provided at all building exits.	Replace all gates / sliding doors along the means of egress with side-hinged, swinging egress doors.	Within 1 month
-----	--------	---	--	----------------

If locks are required for security reasons, utilize special door locking features complying with NFPA 101.

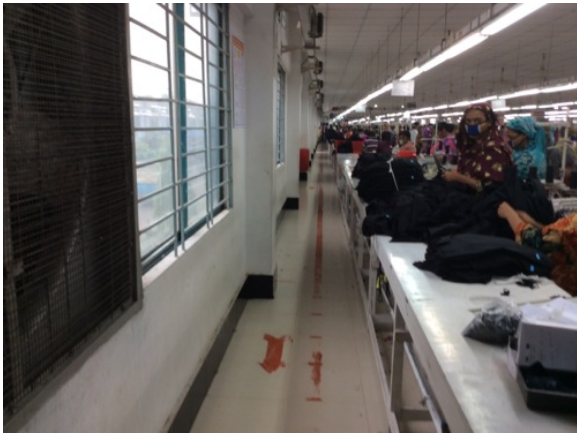
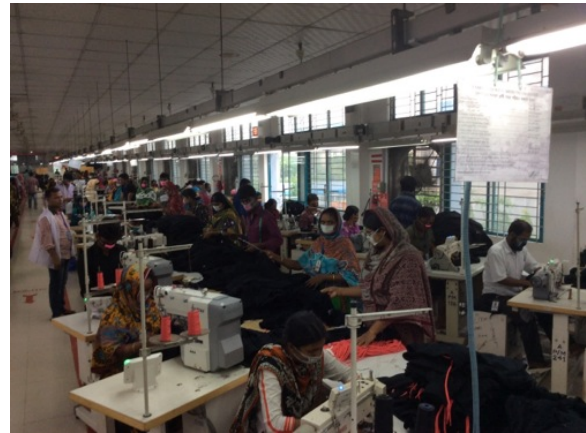
F-6	Egress	Two (2) exterior stairs on the South side of the 1st floor are accessed by a 2 foot wide egress aisle.	Provide minimum aisle widths of 36-in.	Within 3 months
-----	--------	--	--	-----------------

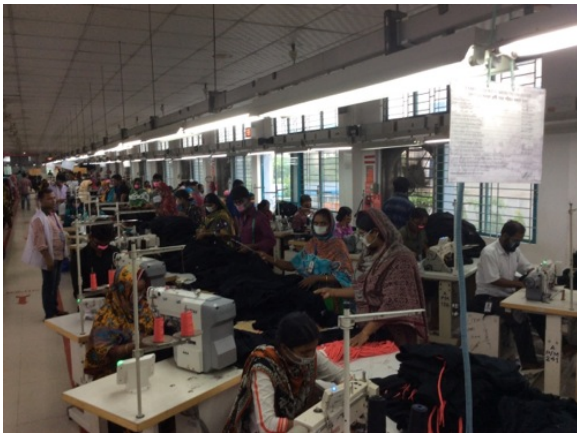
F-9	Egress	Exit travel distance on the 1st floor exceeds 60 m. The two exterior exit stairs on the South side of the 1st floor currently cannot be accessed from the center of the work area, because they are blocked by long work tables. This can create an exit travel distance of over 90 m. on that side of the building.	Reconfigure the work table arrangement to provide North-South oriented aisles leading directly to each exterior stair from the opposite side of the South 1st floor work area.	Within 3 months
-----	--------	--	--	-----------------

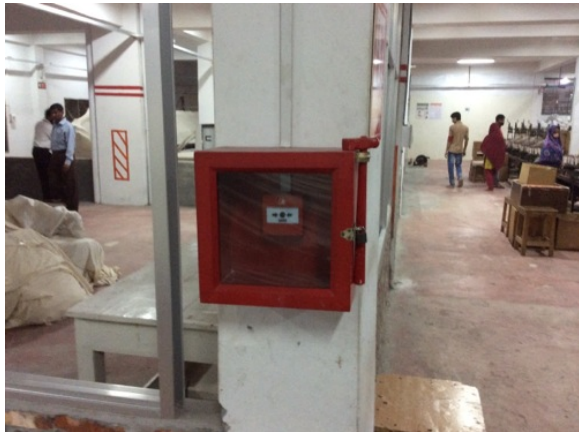
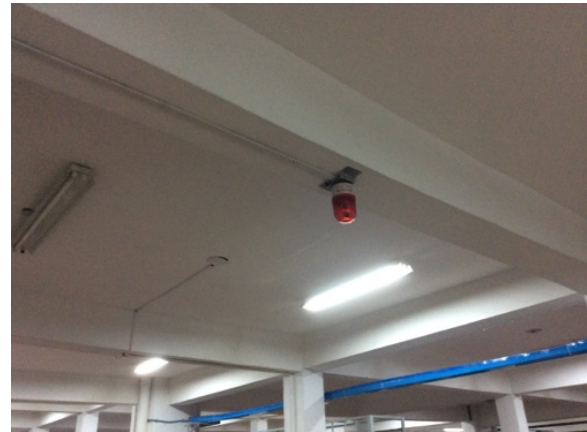
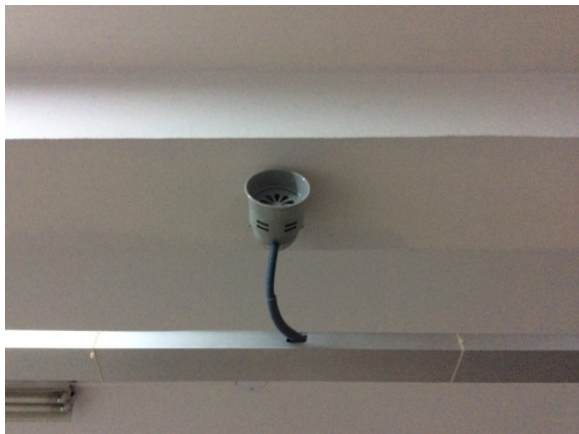
F-10	Fire Protection	The fire alarm system is antiquated, not a listed system, and does not provide alarm and notification features consistent with acceptable standards.	Replace the fire alarm system with a new, listed addressable fire alarm system in accordance with NFPA 72.	Design within 4 months, install within 9 months
------	-----------------	--	--	---

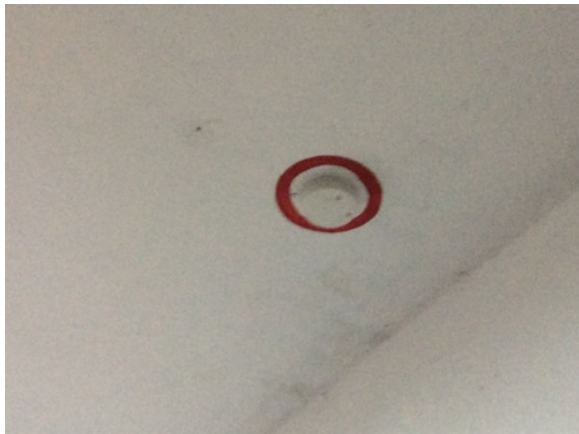
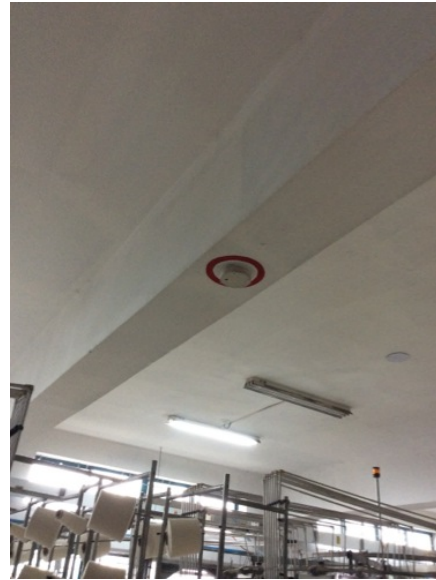
F-12	Fire Protection	The building is equipped with single-station smoke alarms. Smoke alarm activation sounds only a local alarm and does not provide automatic fire alarm notification of occupants.	Remove single-station smoke alarms. Provide automatic smoke detection throughout the building in accordance with NFPA 72.	Within 6 months
------	-----------------	--	---	-----------------
