# **FIRE SAFETY INSPECTION REPORT**

**INTERSTOFF CLOTHING LTD.  
KALAMESHWER, NATIONAL UNIVERSITY, BOARD  
BAZER**

**ACCORD**  
on Fire and Building Safety in Bangladesh

June 7, 2014

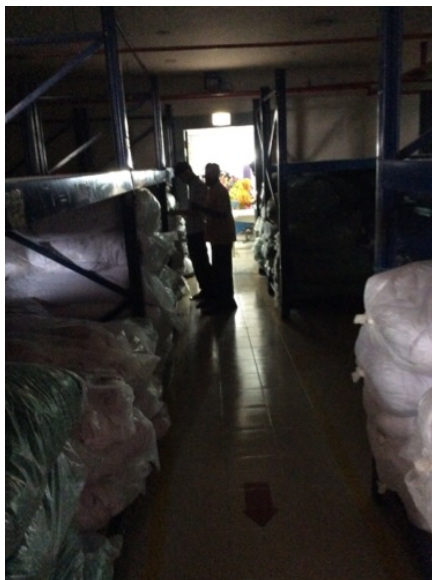
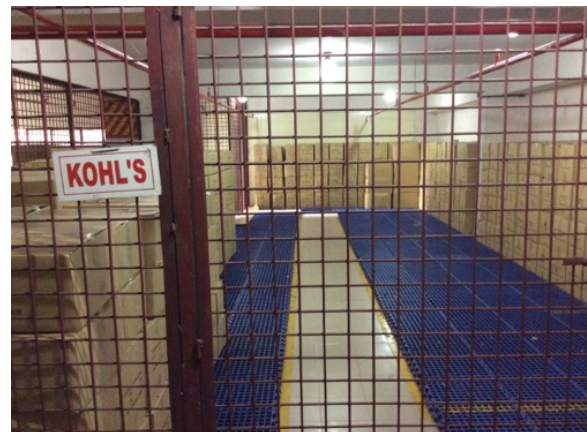
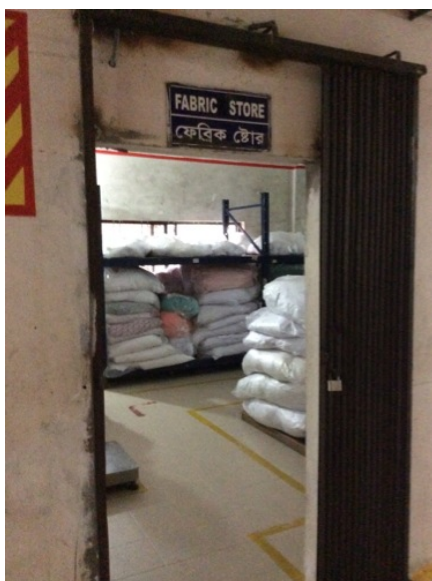
| No. | Category | Finding | Recommendation | Remediation Timeframe |
|---|---|---|---|---|
| F-1 | Fire Rated Construction | Storage rooms used for combustible storage were not separated by fire-rated construction on Floors G, 1, and 5. | Provide dedicated storage rooms separated by minimum 1-hr fire-rated construction. | Within 3 months |

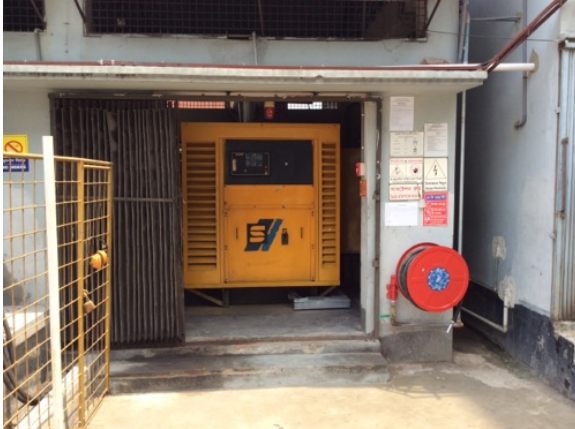
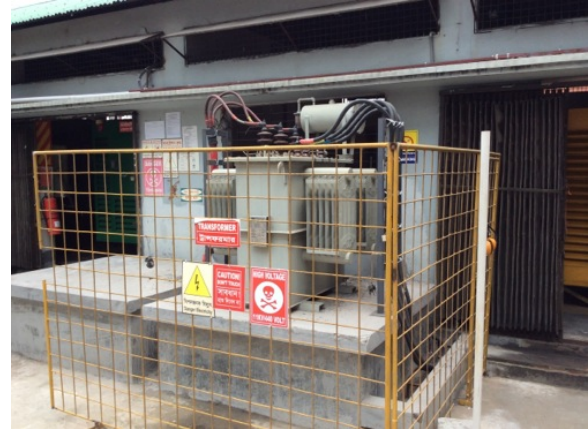
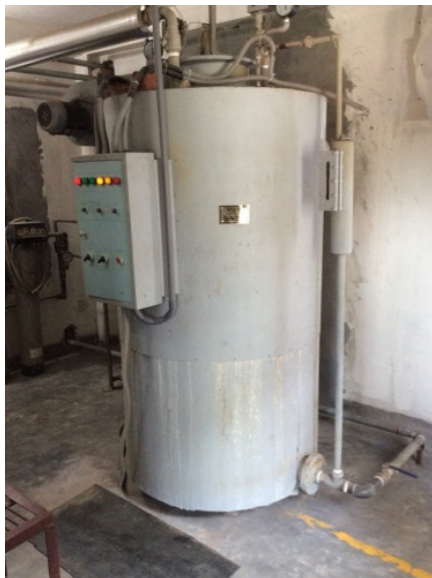
| F-2 | Fire Rated Construction | The boiler, generator and transformer were not separated from the egress paths by fire-rated construction. | Separate the boilers, generator and gas dryers by a minimum 2-hr fire-rated construction. Seal and/or protect all openings to maintain the required fire separations | Within 3 months |

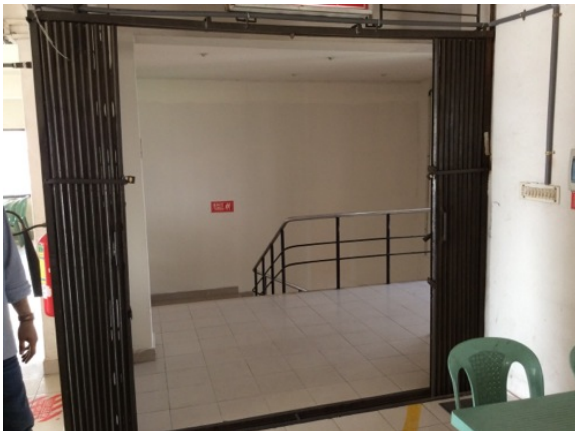
| F-3 | Fire Rated Construction | The exit stairs were not separated from work or storage areas on each floor by fire-rated construction. | Provide minimum 1.5-hr fire rated doors and seal all unprotected openings to separate the exit stairs from work areas and other building spaces on all floor levels. Provide vestibules to separate storage areas from egress paths. Ensure that the fire doors are self-closing and positive latching and that they are provided with fire exit (panic) hardware where serving production floors.<br><br>If fire doors are required to be held open for functional reasons, provide automatic-closing devices tied to the fire alarm system. | Within 3 months |

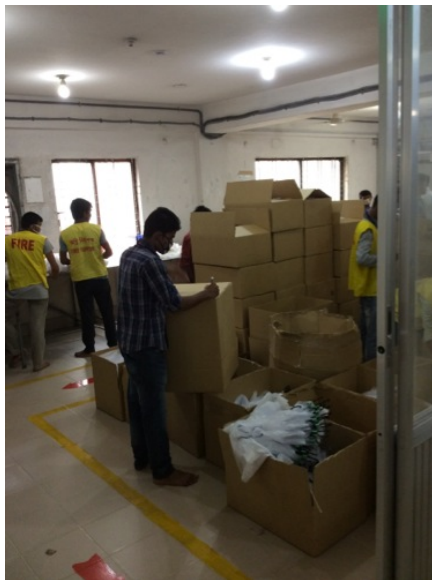
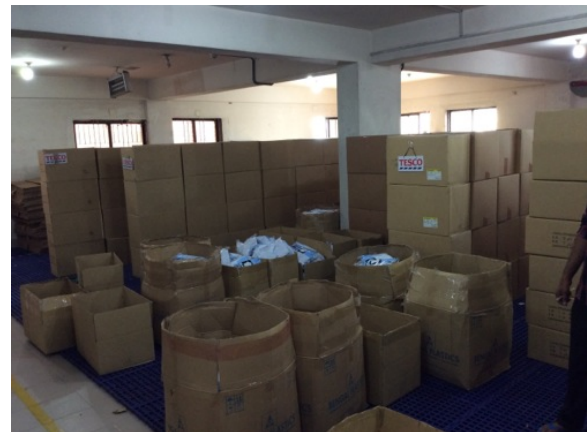
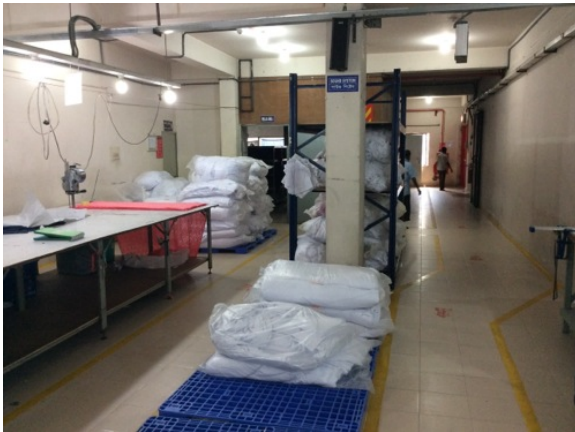
| F-4 | Fire Rated Construction | Areas used for combustible storage were open to the factory floor on Floors G and 3. | <p>Provide dedicated storage rooms separated by minimum 1-hr fire-rated construction.</p> <p>Where separate storage rooms are not feasible, provide defined storage areas and limit the storage arrangement as follows:</p> <ul style="list-style-type: none"><li>- Maximum height of 2.4m and maximum area of 23m<sup>2</sup></li><li>- If sprinkler protected: maximum height of 3.66m and maximum area of 93m<sup>2</sup></li></ul> <p>Separate areas of unenclosed combustible storage by a minimum clear distance of 3m.</p> | Within 3 months |

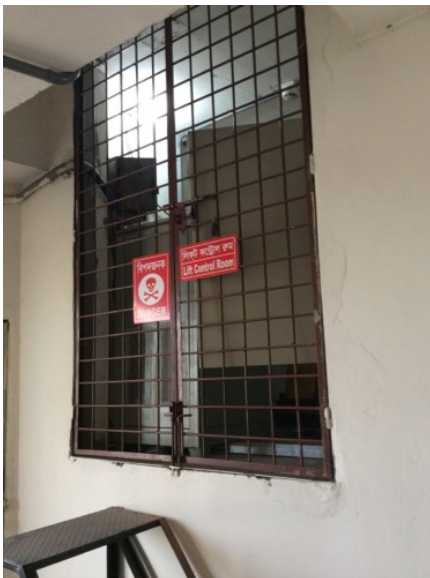
| F-5 | Fire Rated Construction | Unsealed penetrations and openings are located in exit stair enclosures. The elevator control equipment is open to the Southwest stair at roof level. | Seal all penetrations and openings in exit stair enclosure walls to maintain the fire separation. | Within 3 months |

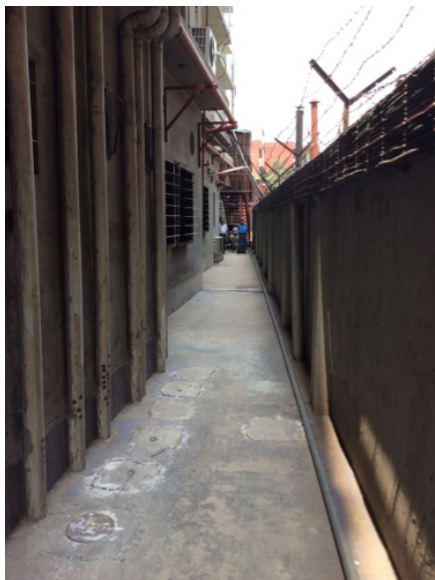
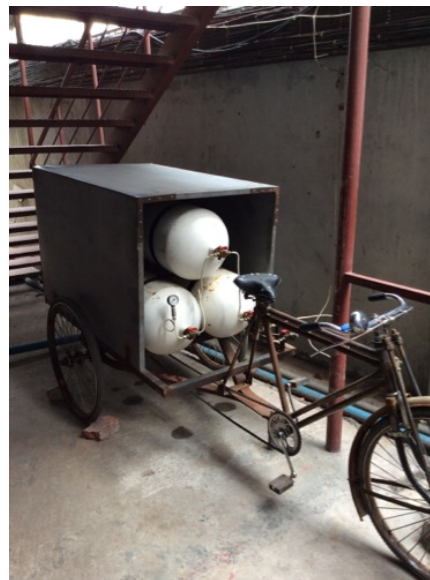
| F-6 | Fire Rated Construction | Flammable gas storage area is not separated by fire-rated construction (openings, non-rated doors, penetrations) from the North exit stair discharge path. | Separate the flammable liquid storage room by a minimum 2-hr fire-rated construction. Seal and/or protected all openings to maintain the required fire separations. | Within 3 months |

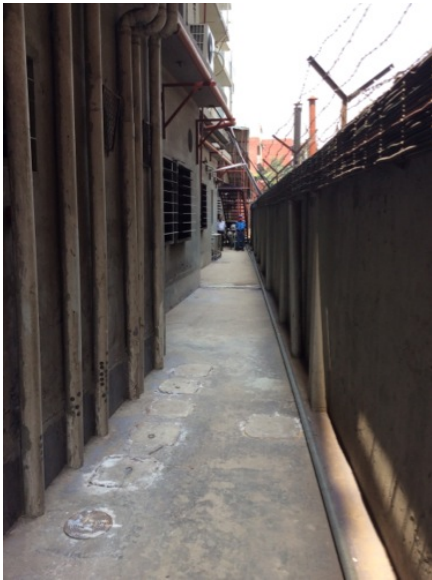
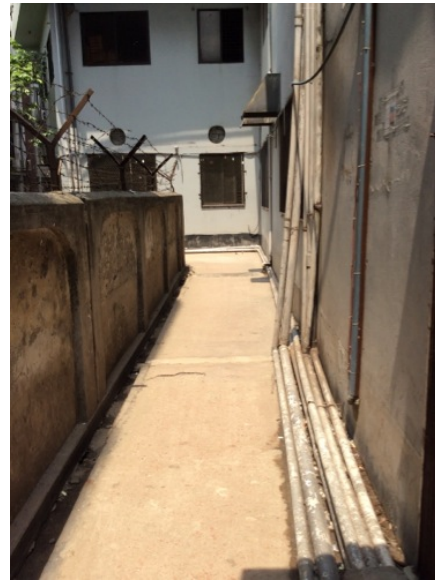
| F-7 | Fire Rated Construction | The exit discharge paths serving the North and Southeast exit stairs were less than 10 ft wide and were not separated from the building interior. | Seal all penetrations and openings to the interior of the building along the discharge path, up to a height of 10 ft., to provide a minimum 1-hr fire separation.<br><br>Alternatively, provide a second remote discharge path to the public way (only include this if feasible). | Within 6 months |

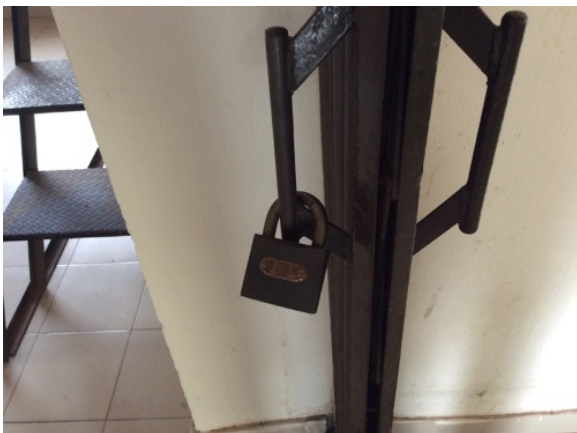
| F-8 | Egress | <p>Egress doors / gates with locking features are provided at building exits, exit stairs, and exit discharge.</p> <p>All gates/doors were open and unlocked during the inspection.</p> | <p>Remove locking features from all egress doors / gates.</p> <p>If locks are required for security reasons, utilize special door locking features complying with NFPA 101.</p> | Immediate |

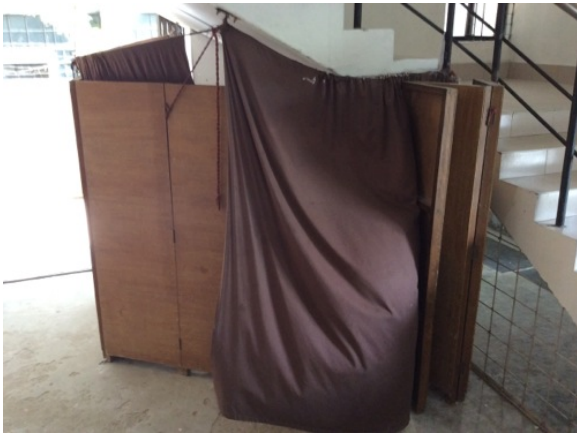
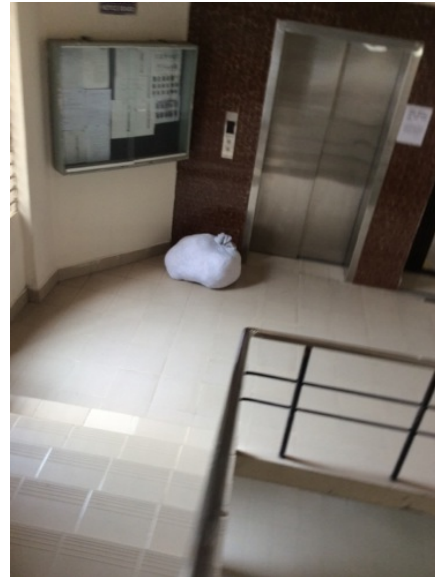
| F-9 | Egress | Storage was located on the ground floor of the Southwest exit stair, as well as some transient storage on various floors. | Remove all storage from exit stairs. | Immediate |

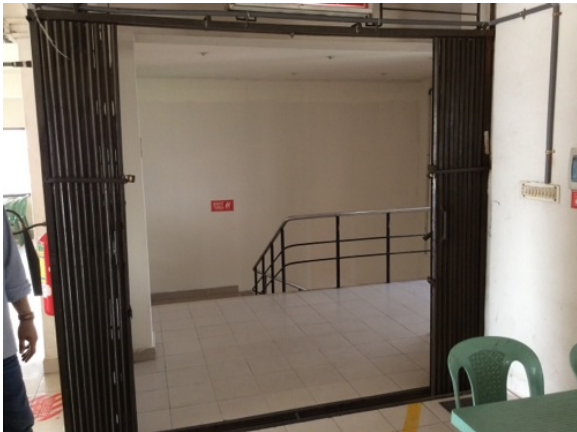
| F-10 | Egress | Collapsible gates were provided at the North and Southwest exit stairs, all ground floor exit discharges and building exits. | <p>Replace all gates / sliding doors along the means of egress with side-hinged, swinging egress doors.</p> <p>If locks are required for security reasons, utilize special door locking features complying with NFPA 101.</p> | Within 1 month |

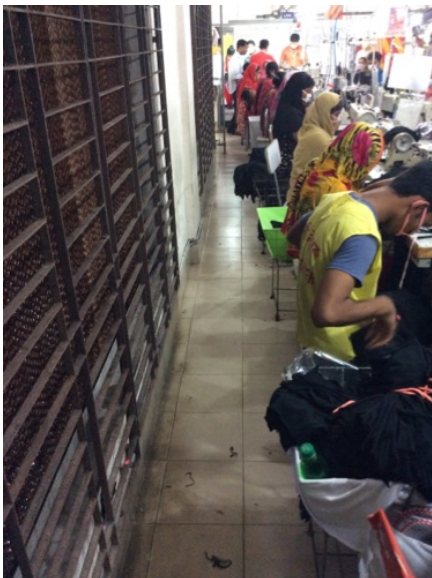
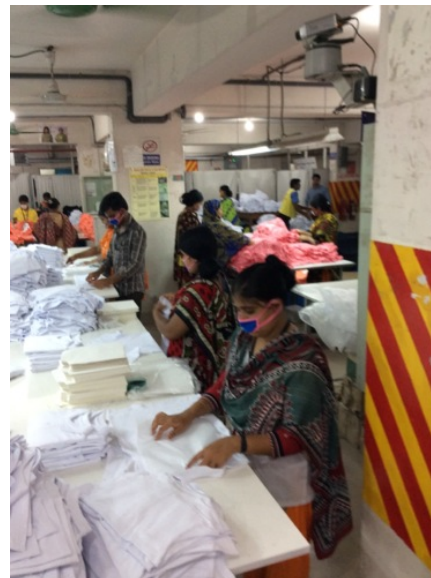
| F-11 | Egress | The width of egress aisles was less than 36-in on Floors 3 and 4. In some areas production stations were too close to walls and in some locations columns impeded egress. | Provide minimum aisle widths of 36-in. | Within 3 months |

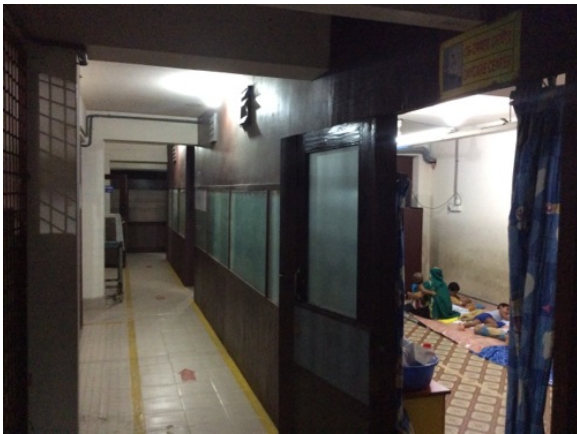
| F-12 | Egress | The day-care room does not have direct access to an exit stair and was not separated from the storage area. | Provide a minimum 2-hr fire-rated exit corridor between the day-care room and exit stair.<br><br>-OR-<br><br>Relocate day-care room to ground floor with maximum travel distance of 9m (30 ft). | Within 3 months |

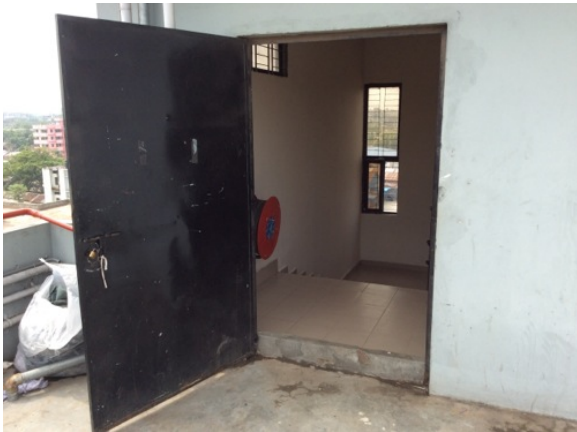
| F-13 | Egress | Southeast exit stair door does not swing in the direction of egress travel at the roof level. | Modify the egress door to swing in the direction of egress travel. | Within 3 months |

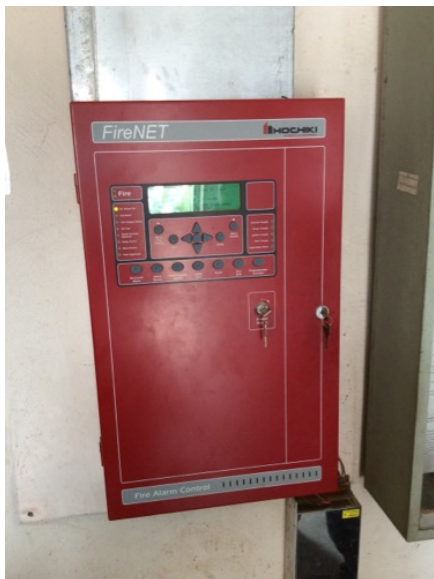
| F-14 | Fire Protection | Inspection, testing, and maintenance for the fire alarm system was not in accordance with NFPA 72. | Inspect, test and maintain the fire alarm system, and keep written records on-site, in accordance with NFPA 72. | Within 3 months |

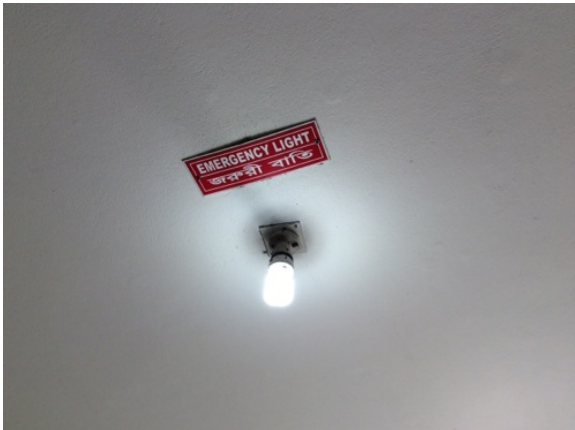
| F-16 | Egress Lighting | Inspection, testing, and maintenance for the emergency lighting system was not in accordance with The ACCORD Standard. | Inspect, test and maintain the emergency lighting system in accordance with The ACCORD standard. Keep written records on-site. | Within 3 months |
