# H.B. KNITEX LTD.

Plot # B26 (P) & B27, Faujdarhat BSCIC Industrial Area, Block-A, Sagorika Road, Custom Academy, South Kattali,  
Pahartoli, Chittagong  
(22.355954N, 91.773893E)

10 November, 2015

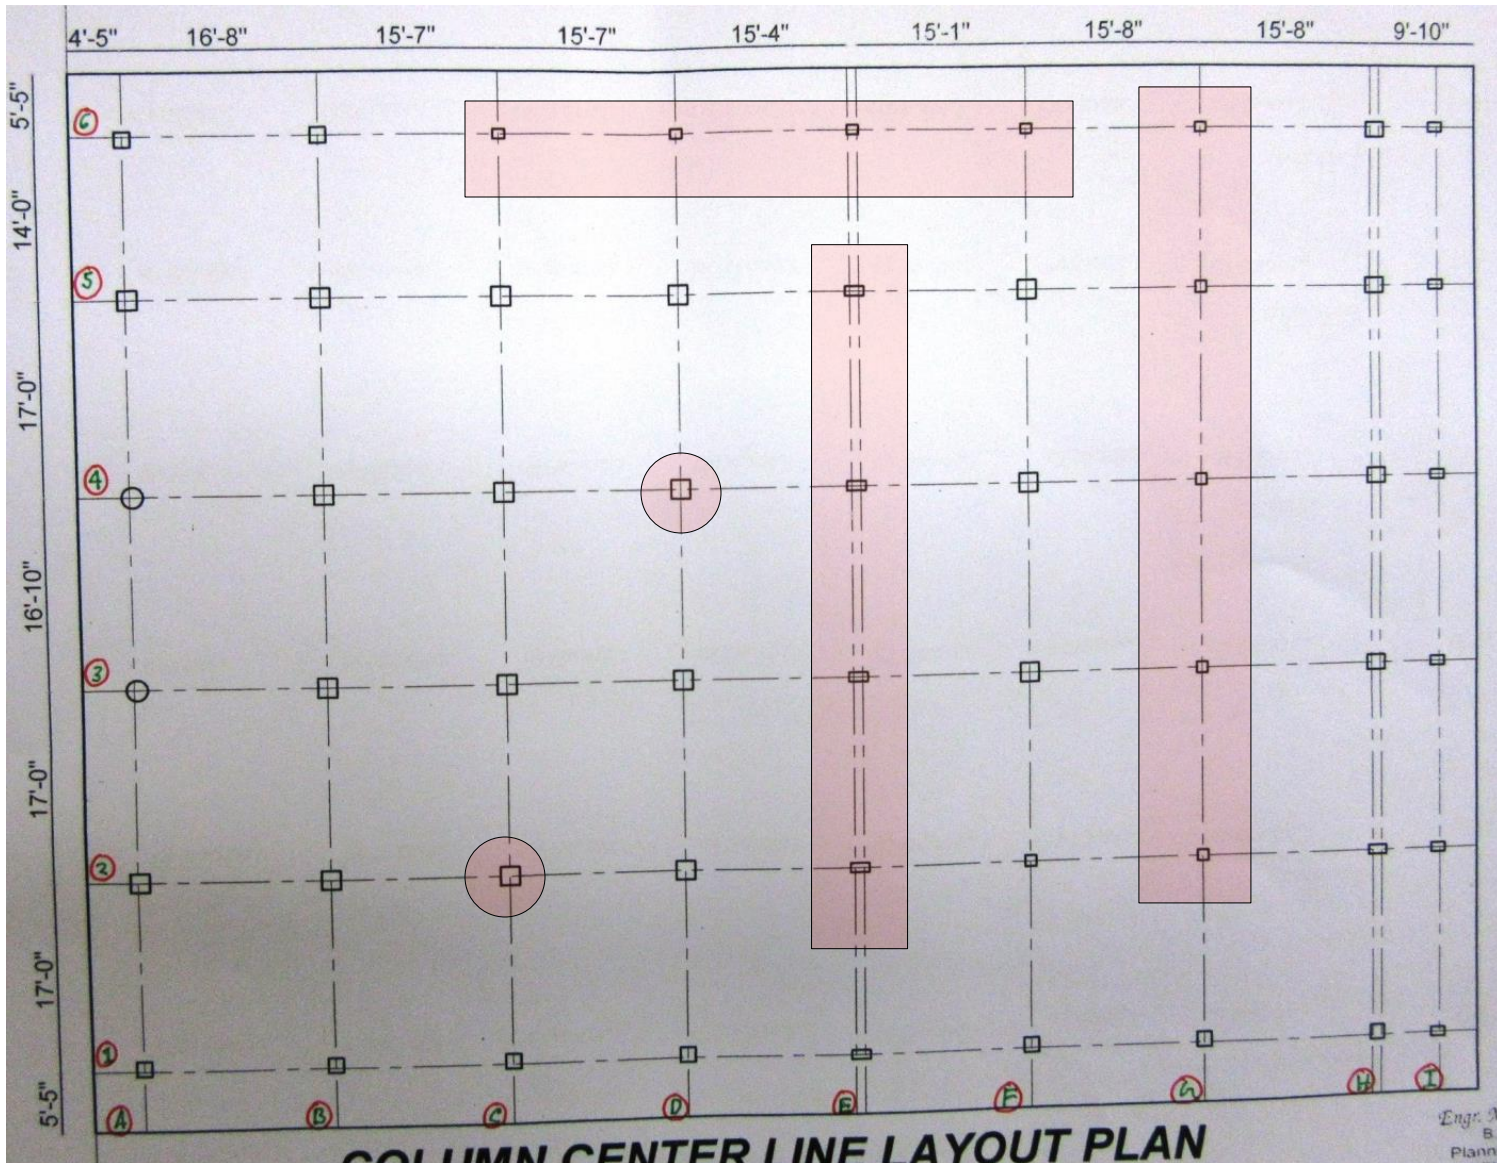
Primary calculation shows the marked columns are highly stressed under gravity loads

| Item No. | Observation | Recommended Action Plan | Recommended Timeline |
|---|---|---|---|
| 1 | Highly Stressed Columns | Qualified Structural Engineer is to review the design, loads and stresses in all columns as part of a Detailed Engineering Assessment (DEA) (see scope below). | <b>Immediate - Now</b> |
| 2 | Highly Stressed Columns | Engineer is to verify in-situ concrete strength by testing 100mm diameter cores taken from 4 no. columns (minimum). Qualified Structural Engineer to determine safe locations for coring. Prior to coring, the floor beams supported by the column should be propped through all levels to ground floor. The column reinforcement should be exposed to ensure that it will not be damaged during coring. Following coring, the column should be repaired using suitable repair mortar before de-propping the floor beams. | <b>Immediate - Now</b> |
| 3 | Highly Stressed Columns | Live load must not be increased on any floor. Fitting out works must stop on any incomplete floors until DEA complete. | <b>Immediate - Now</b> |
| 4 | Highly Stressed Columns | Consideration should be given to strengthening the 250x250 and 300x300 columns. | <b>Immediate - Now</b> |

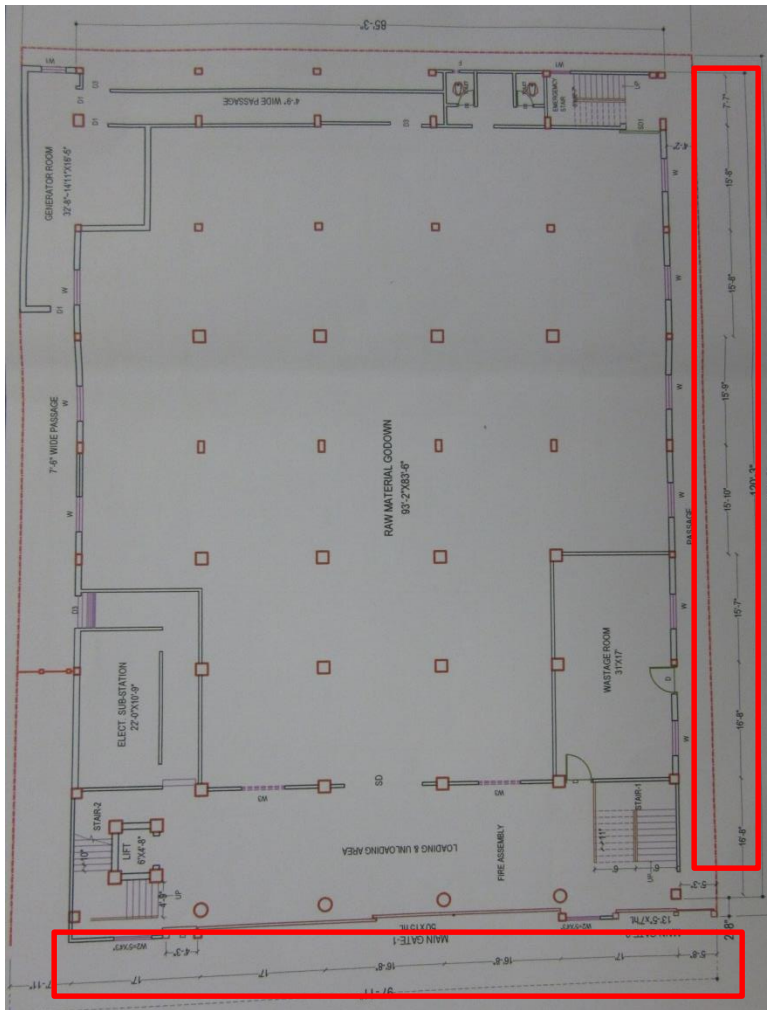
AS built Architectural Drawing

Grid dimensions shown on as-built architectural drawing, do not match with structural drawing. Site observations match with as-built architectural drawing.

| Item No. | Observation | Recommended Action Plan | Recommended Timeline |
|---|---|---|---|
| 10 | Discrepancies Between Design Drawings and As Built Structure. | As part of the DEA comprehensive As-Built drawings are to be produced. | 6-weeks |

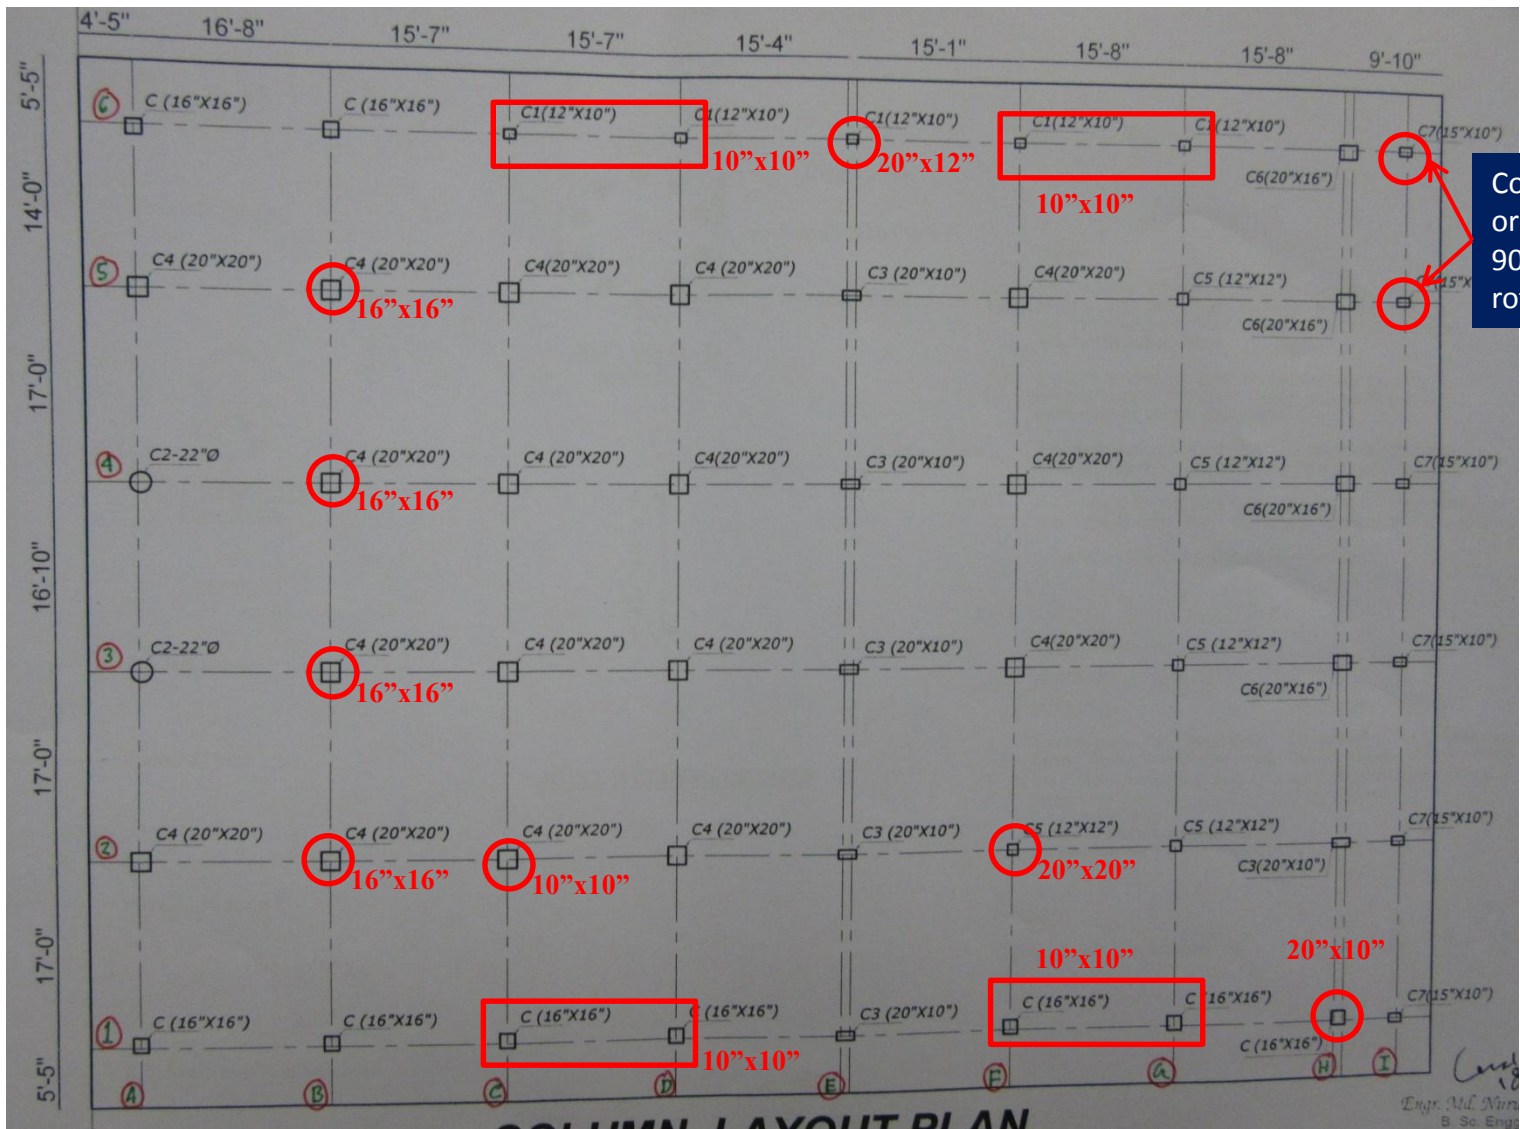
Observed dimension and orientation of many columns do not match with structural drawings.

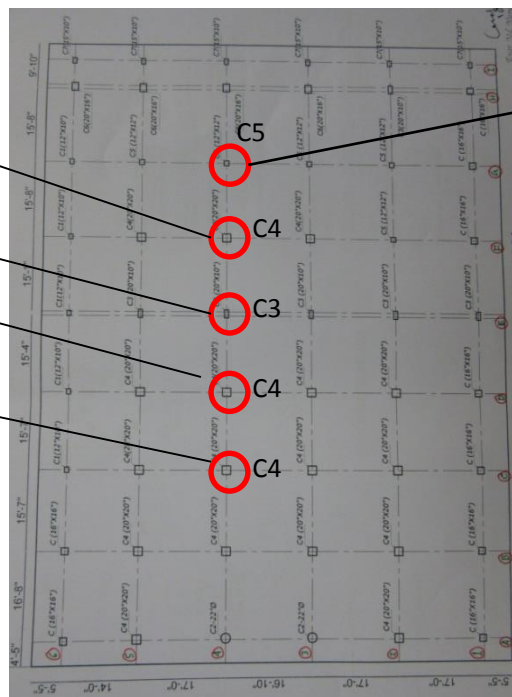
Found reinforcement

Ferroscope test executed at several columns at ground floor.

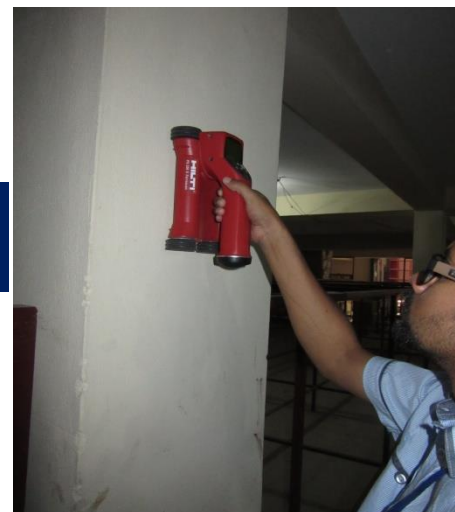
Found reinforcement

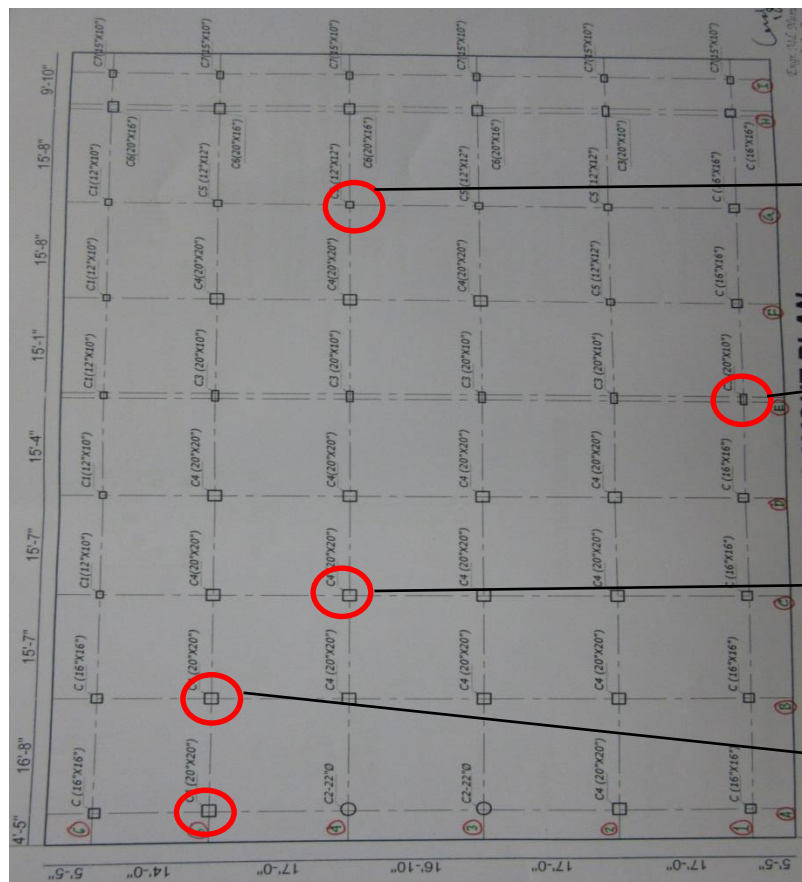
The design reinforcement did not match with ferroscreening data

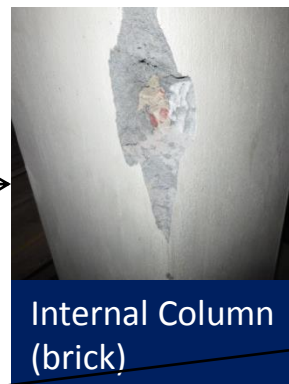
Internal Column  
(brick)

Some ground floor columns had brick aggregate and some had stone. Structural drawings indicated all RC members to be cast with stone aggregates.

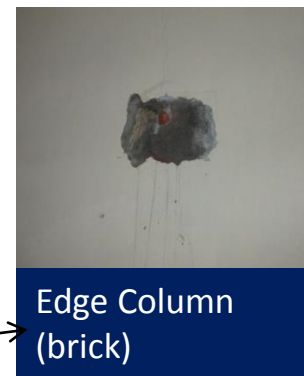
Edge Column  
(brick)

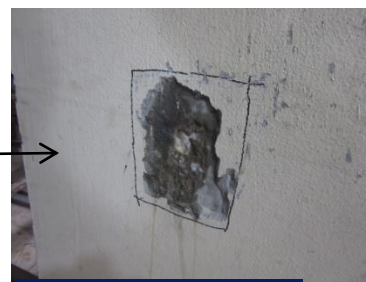
Internal Column  
(Stone)

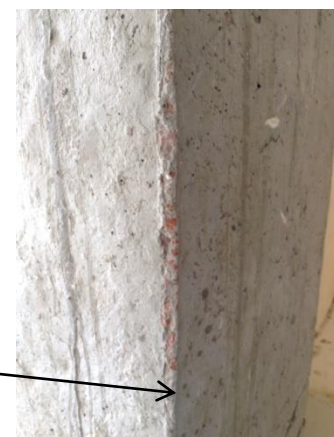
Lift core Column  
(brick)

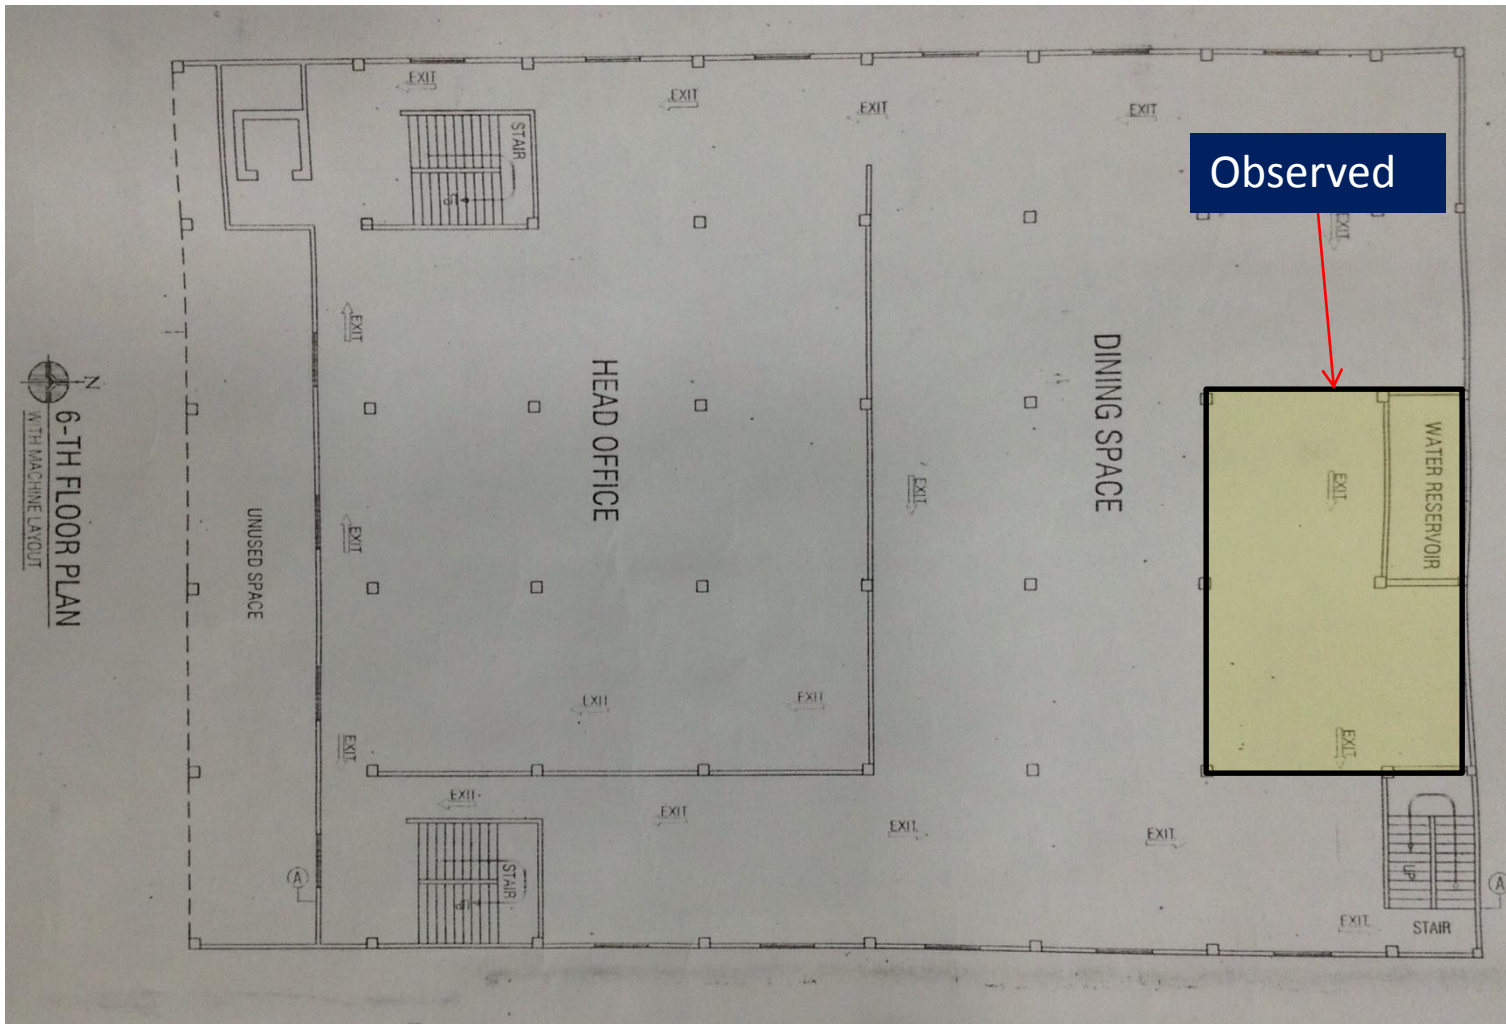
Over head water tank dimensions did not match with the Permission Drawing.

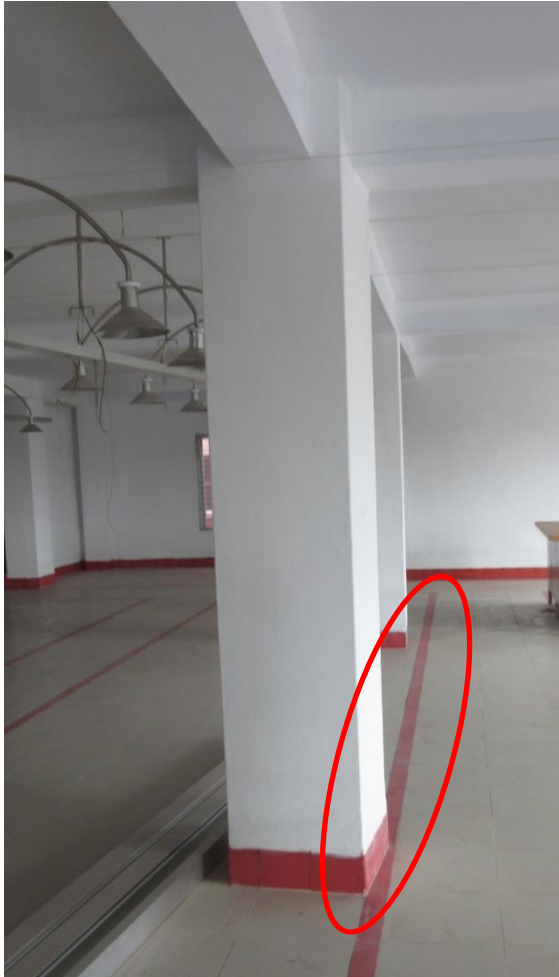
Column was twisted on 5<sup>th</sup> floor

| Item No. | Observation | Recommended Action Plan | Recommended Timeline |
|---|---|---|---|
| 11 | Errors due to Poor Workmanship. | As part of the DEA workmanship errors are to be identified and assessed & appropriate remedial action taken. | 6-weeks |

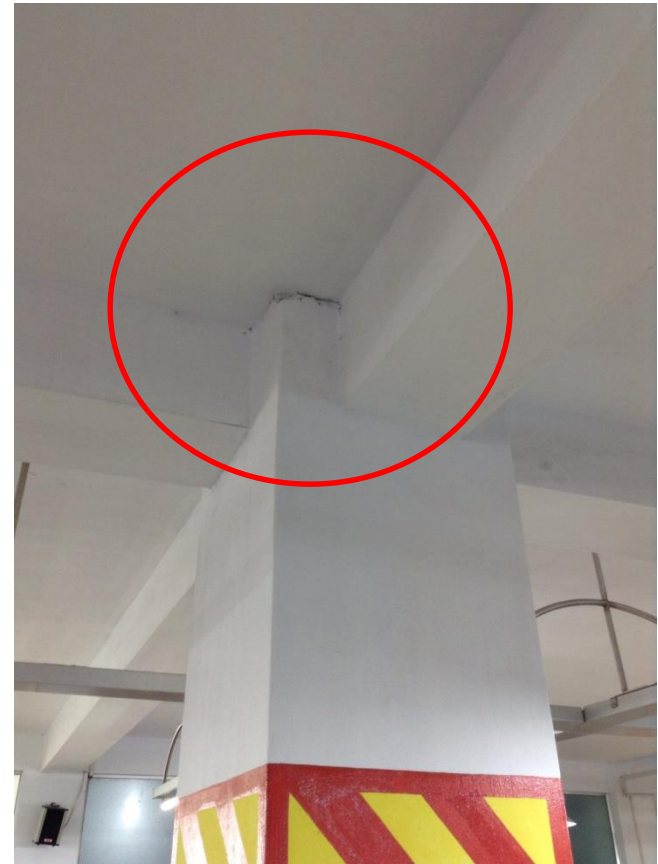
Gap was found between column and slab

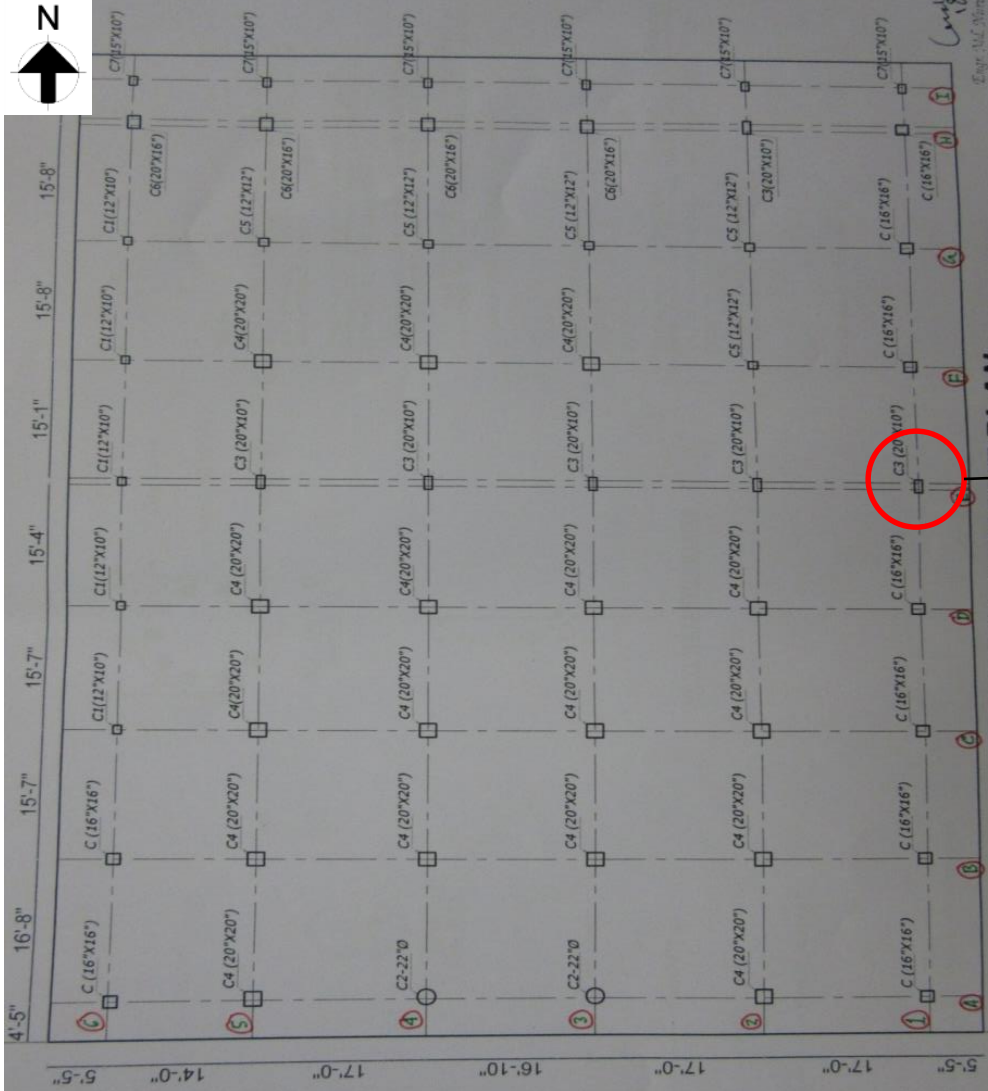
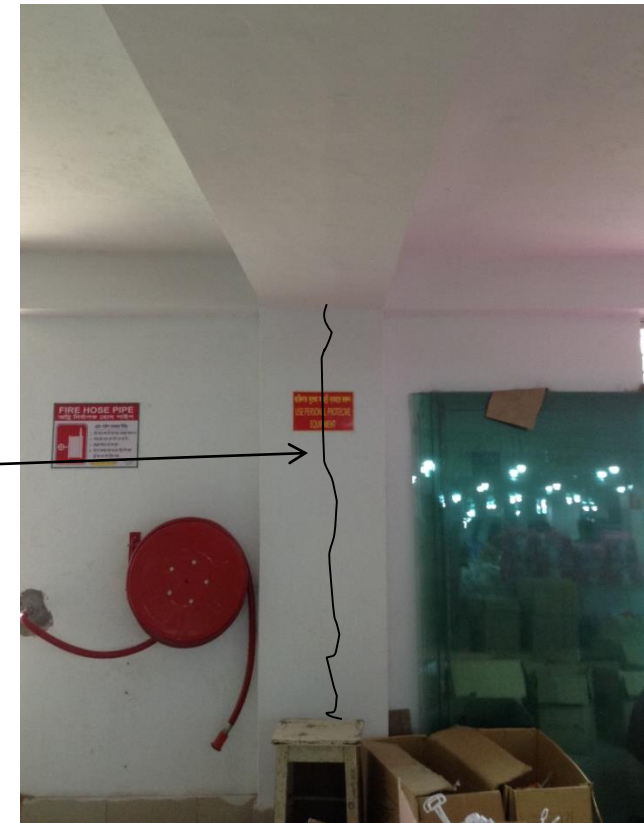
At ground and 1<sup>st</sup> floors column at grid E1 had plaster crack on outer and inner face. (Crack confirmed not to penetrate into concrete.)
