# BD DESIGNS PRIVATE LTD

Plot No: 48-49, sector: 03, Karnaphuli EPZ, Chittagong-4204, Bangladesh  
(22.276610N, 91.794507E)

7<sup>th</sup> November 2015

# Observations

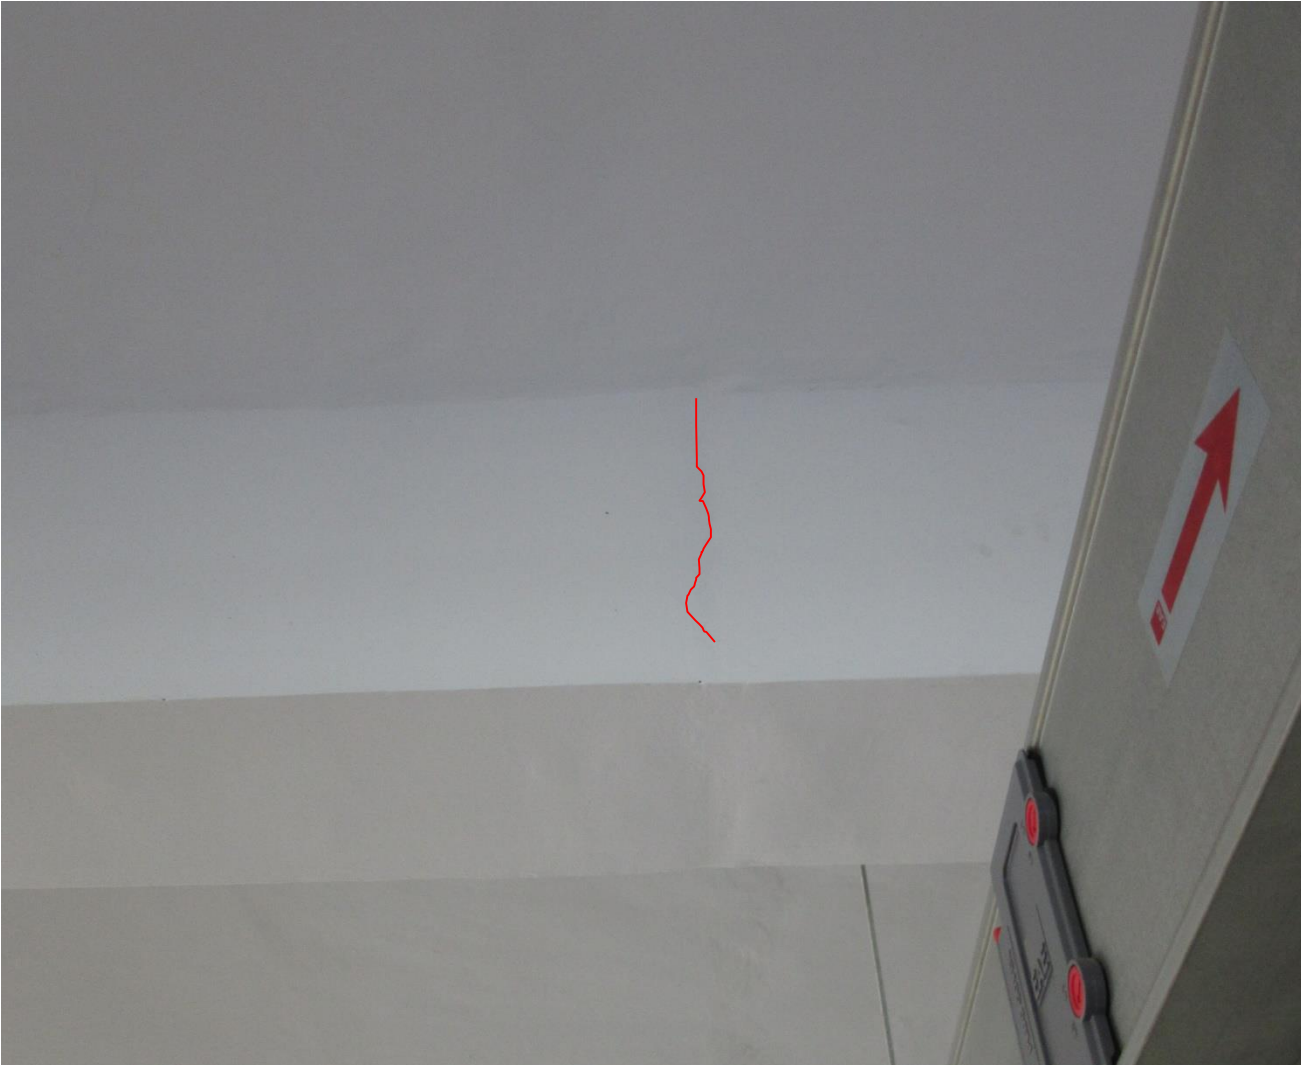
# Hairline Crack on a Beam at 5<sup>th</sup> Floor Ceiling

Hairline crack observed on a beam at 5<sup>th</sup> floor ceiling.

**ITEM 1:** Hairline Crack on a Beam at 5<sup>th</sup> Floor Ceiling

| Item No. | Observation | Recommended Action Plan | Recommended Timeline |
|---|---|---|---|
| 1 | Hairline Crack on a Beam at 5th Floor Ceiling | Building Engineer to get the crack properly repaired. | 6-months |
| 2 | Hairline Crack on a Beam at 5th Floor Ceiling | Building Engineer to monitor the repaired beam to check if new cracks occur. | 6-months |

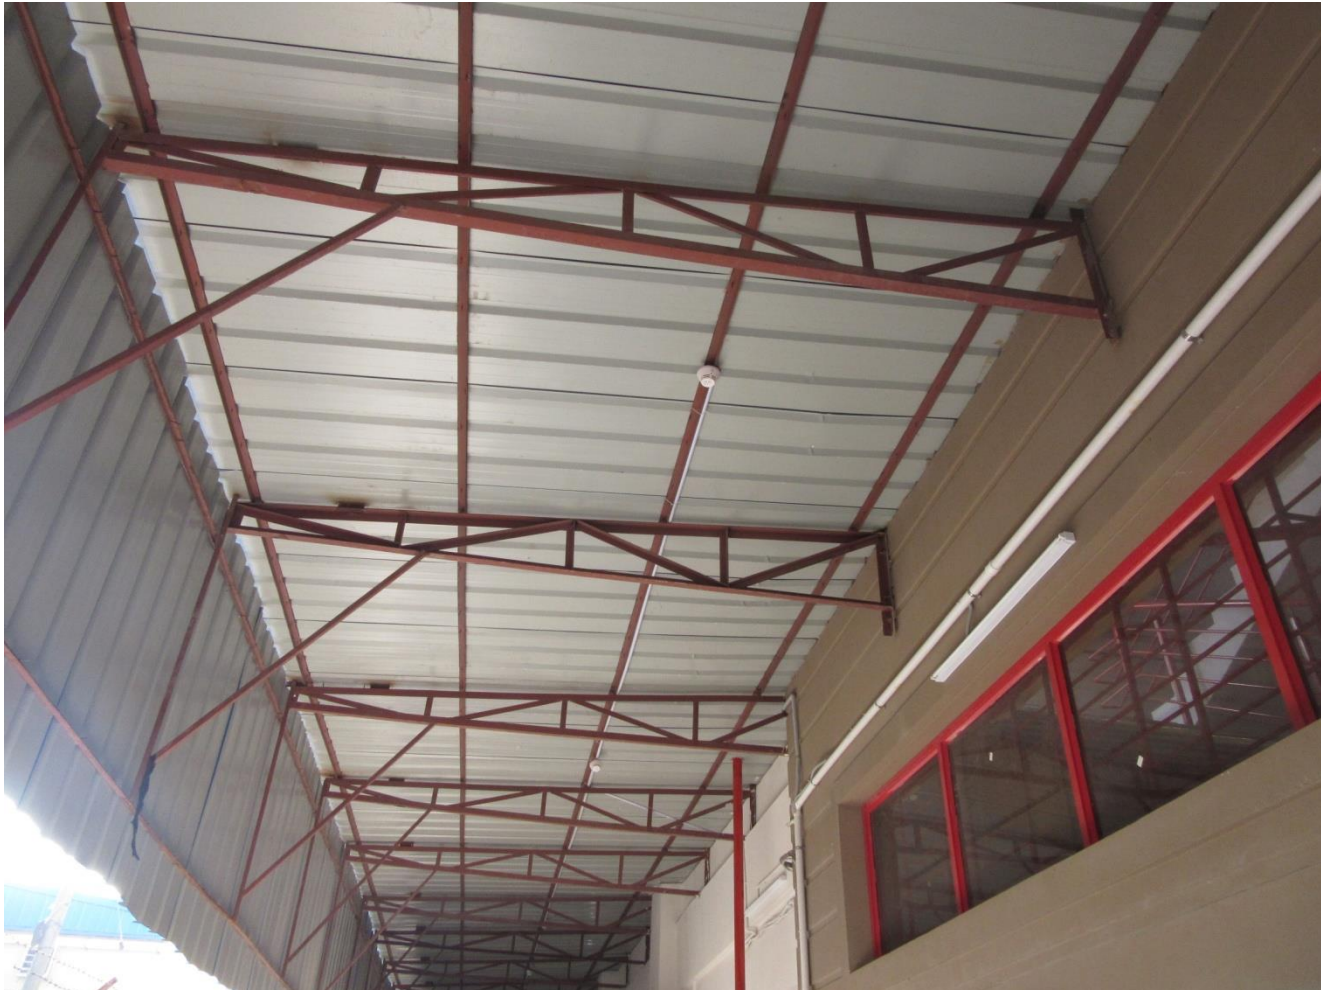
# Canopy at the East Side of the Building

The design and connections of the canopy at the east side of the building lacks proper detailing.

**ITEM 2:** Stability of the Canopy at East End of the Building

| Item No. | Observation | Recommended Action Plan | Recommended Timeline |
|---|---|---|---|
| 3 | Stability of the Canopy at East Side of the Building | Stability and the connection details of the canopy at the East side of the building to be checked by the Building Engineer. | 6-months |
| 4 | Stability of the Canopy at East Side of the Building | Make necessary alterations to the structural members of the canopy, if required. | 6-months |
