# Fuli Industrial Ltd.

Plot # 148-151, Dhaka EPZ (Old Zone), Ashulia-1349, Savar, Dhaka.

25 August 2024

## 2. Observation:

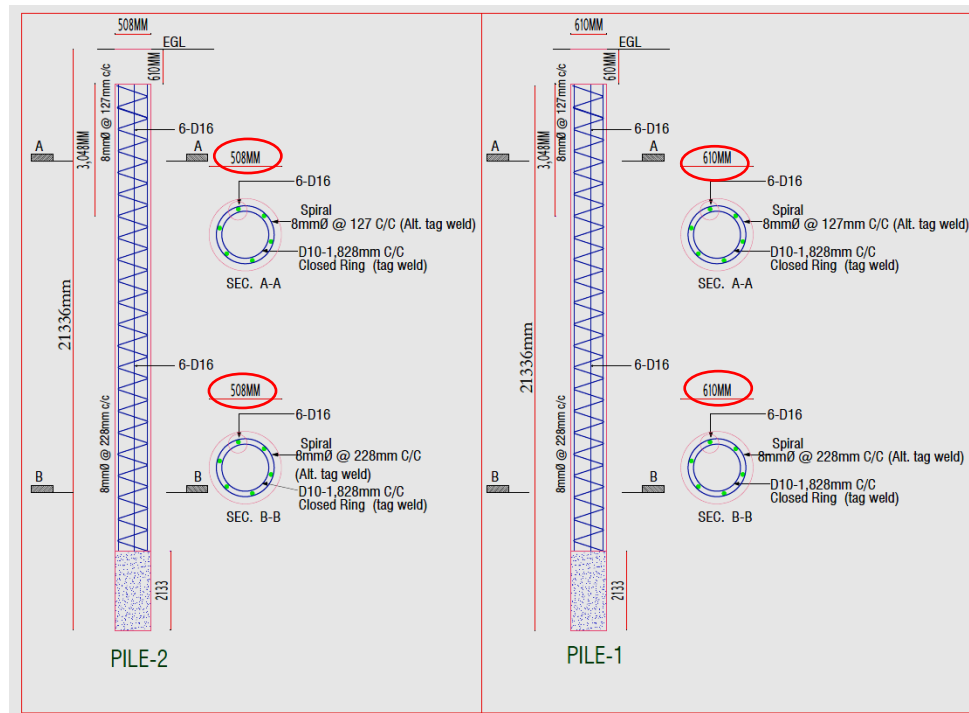
### Observation-1: Inconsistencies in DEA report. (Production Building)

**Description:** The drawing provided shows two different diameter piles (508 mm and 610 mm). However, in the pile capacity checks, capacity was taken only for one type of pile (610 mm).

| Item No. | Observation | Action Plan | Timeline |
|---|---|---|---|
| 1. | Inconsistencies in DEA report. (Production Building) | The building engineer is required to address the inconsistencies in the revised DEA report; submit the revised DEA to the RSC. | within 6 weeks |
| | | Carry out suggested remedial works if required. | within 6 months |

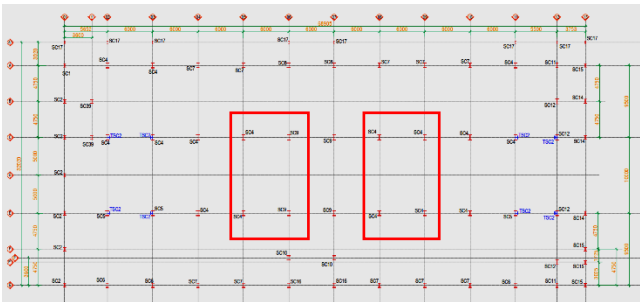
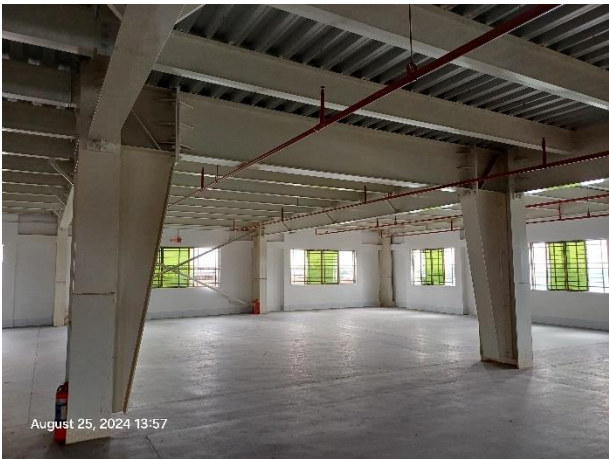
Observation-2: Lack of information in as-built drawings. (Production Building)

Portal frame layout

Portal frame

**Description:** In the provided as-built drawing portal frame was shown only at four locations. However, the portal frame was found in twelve locations on each floor.

| Item No. | Observation | Action Plan | Timeline |
|---|---|---|---|
| 2. | Lack of information in as-built drawings. (Production Building) | The building engineer is required to survey the full structure and prepare complete as-built structure drawings. | within 6 weeks |

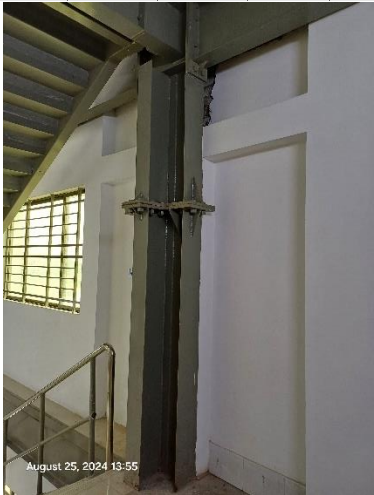
**Description:** In the marked locations an extra column was found connected to regular 'I' section.

The building engineer is required to survey the full structure and prepare complete as-built structure drawings. Also, provide construction drawings as the reference for the foundation.

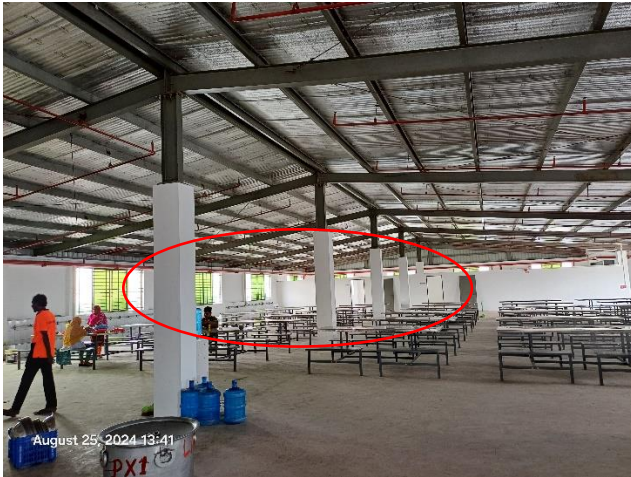
**Description:** Marked columns are RC columns at the roof level. But immediate below level columns are steel I-sections. No connection details were provided for the steel to RC column connections.

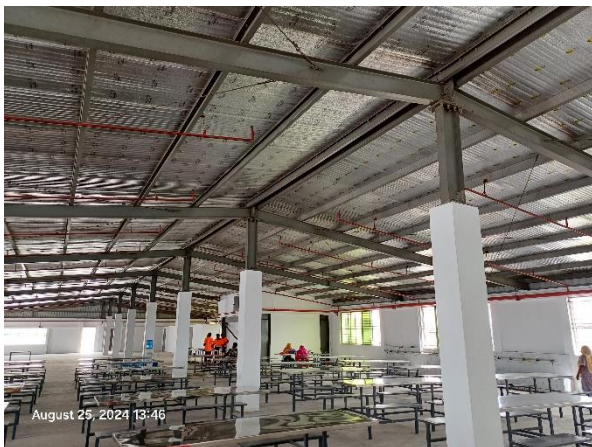
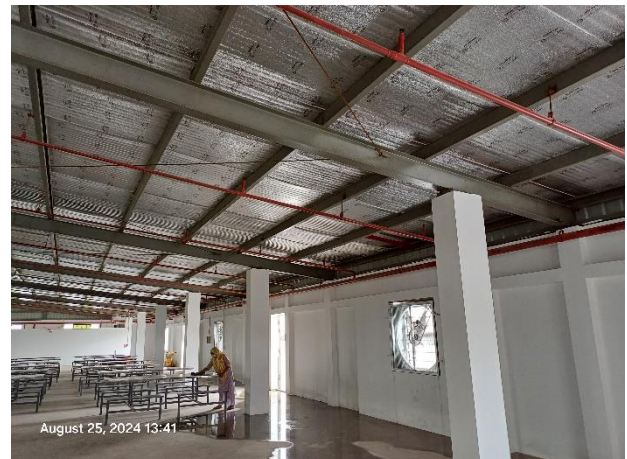
### **Observation-3: Lack of lateral stability. (Production Building)**

**Description:** Lateral load transfer media compression struts were missing along the ridge. So, the lateral stability system of the structure is incomplete. No structural evaluation is provided in the DEA report. However, the DEA report needs to be updated against lateral loading and submitted to the RSC for detailed review. Once the review of DEA documents is finalized, implement the proposed remedial works.

| Item No. | Observation | Action Plan | Timeline |
|---|---|---|---|
| 3. | Lack of lateral stability. (Production Building) | The DEA report needs to be updated against lateral loading and submitted to the RSC for detailed review. | within 6 weeks |
| 4. | | Implement the proposed remedial work (if required). | within 6 months |

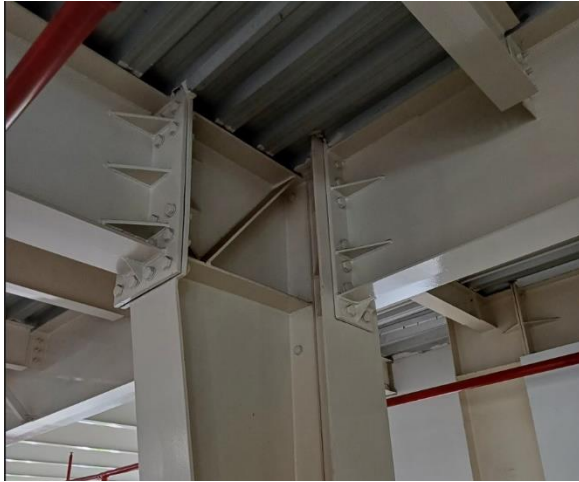
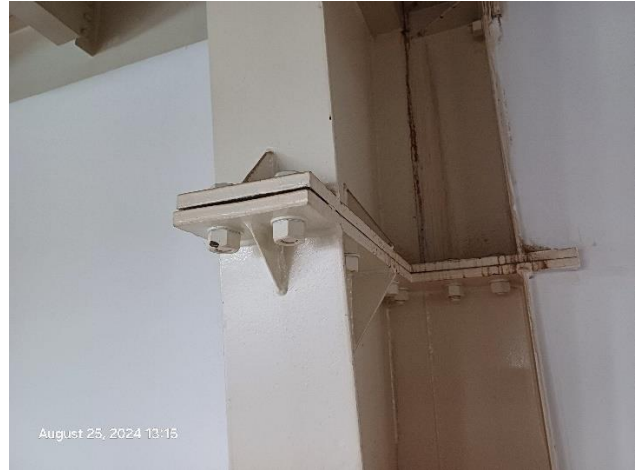
**Observation-04: Connection gap. (Production Building)**

**Description:** Connection gaps were observed in the steel joint. The building engineer is required to identify the locations and carry out suitable remedial works.

| Item No. | Observation | Action Plan | Timeline |
|---|---|---|---|
| 5. | Connection gap. (Production Building) | The building engineer is required to identify the locations and carry out suitable remedial work. | within 6 weeks |

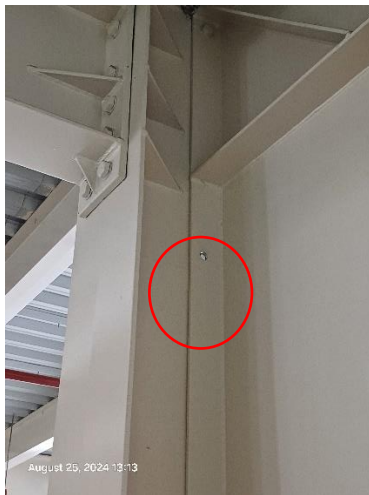
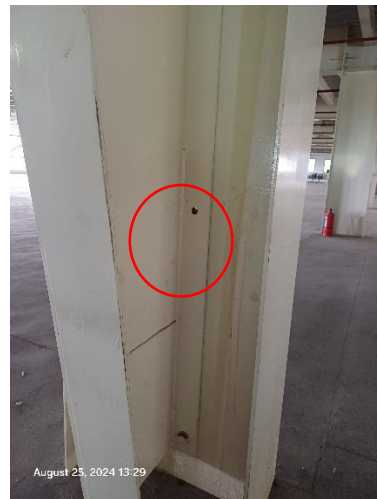
**Observation-05: Missing bolts. (Production Building)**

**Description:** Bolts are missing in several connections. The building engineer is required to identify the locations and install the missing bolts where necessary.

| Item No. | Observation | Action Plan | Timeline |
|---|---|---|---|
| 6. | Missing bolts. (Production Building) | Building engineer is required to identify the locations and install the missing bolts where necessary. | within 6 weeks |

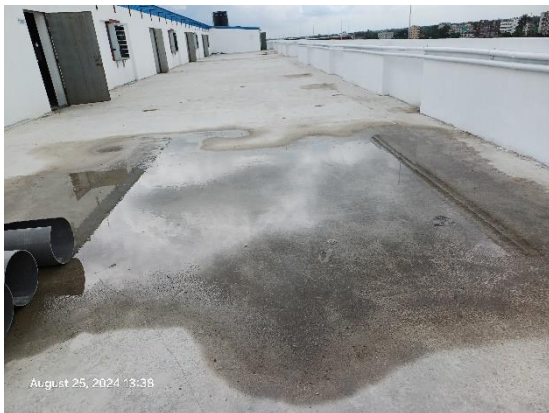
Standing water on the roof level

**Description:** Standing water observed on the roof and dining floor. The factory engineer is required to improve the drainage system on the roof with proper slopes & provide an adequate number of water outlets.

| Item No. | Observation | Action Plan | Timeline |
|---|---|---|---|
| 7. | Standing water on the roof and floor of Dining. (Production Building) | The factory engineer is required to improve the drainage system on the roof with proper slopes & provide an adequate number of water outlets. | within 6 months |

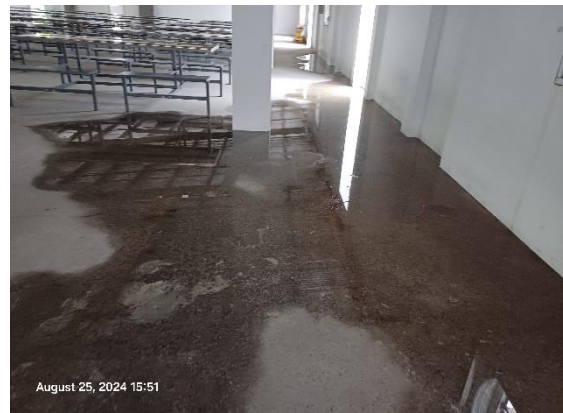
Standing water on the floor of the Dining

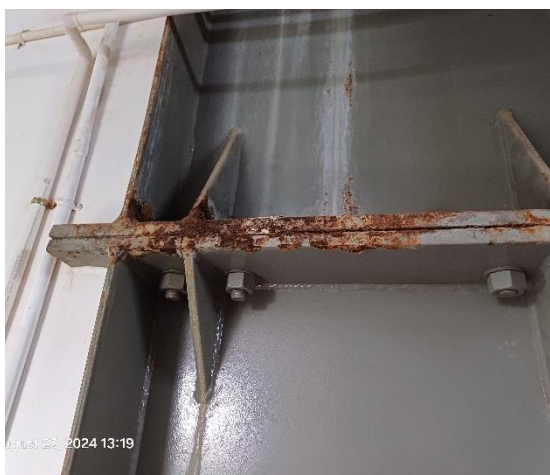
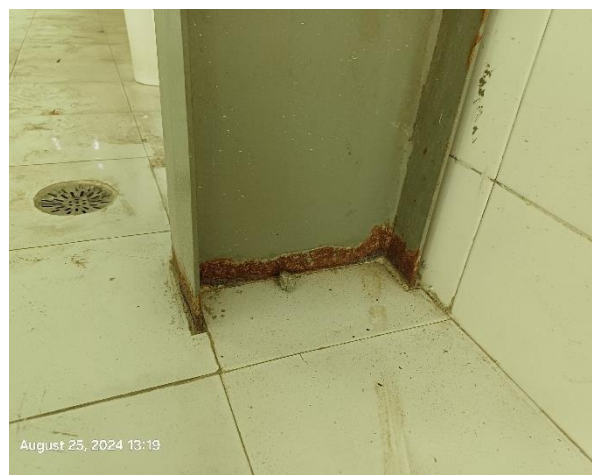
**Observation-07: Corrosion on steel member. (Production Building)**

**Description:** Corrosion was observed on steel columns. The building engineer is required to remove the corrosion and provide rust-proof coating on corroded steel members to protect them from corrosion.

| Item No. | Observation | Action Plan | Timeline |
|---|---|---|---|
| 8. | Corrosion on steel member. (Production Building) | The building engineer is required to remove the corrosion and provide rust-proof coating on corroded steel members to protect them from corrosion. | within 6 weeks |

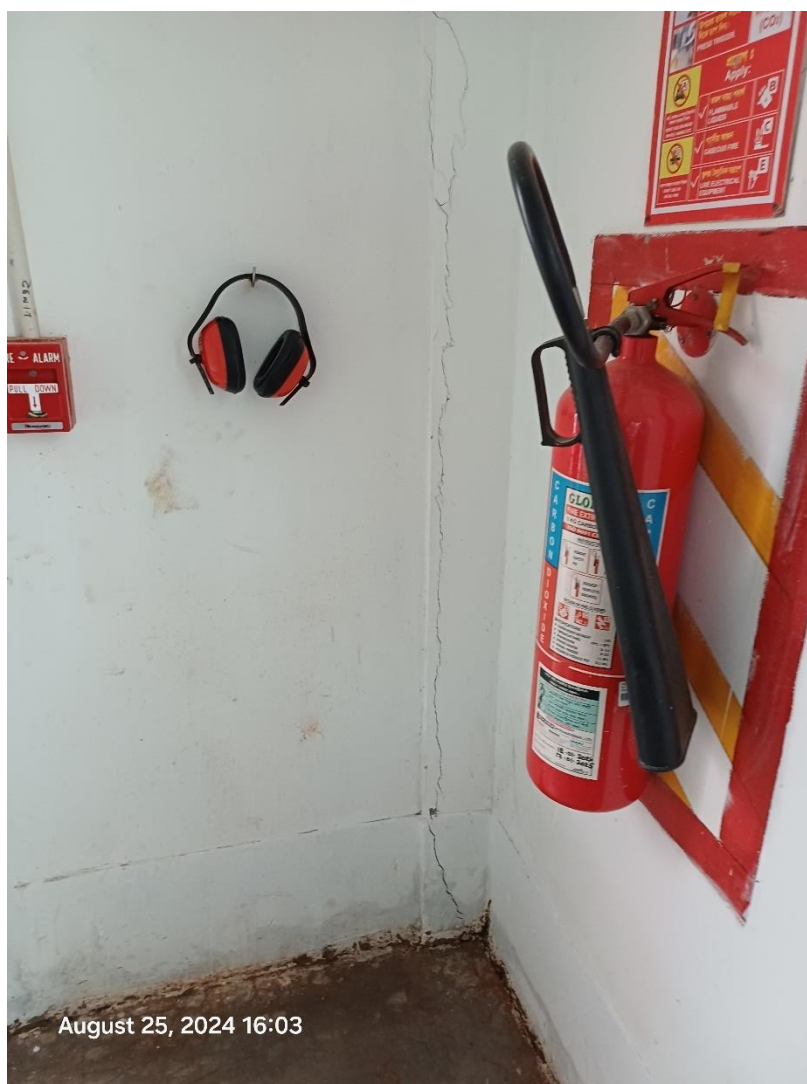
**Observation-08: Crack on the brick wall. (Utility building)**

**Description:** Crack was observed on the façade wall of the utility building. The building engineer is required to investigate the reason for the crack and repair with suitable method.

| Item No. | Observation | Action Plan | Timeline |
|---|---|---|---|
| 9. | Crack on the brick wall. (Utility building) | The building engineer is required to investigate the reason for the crack & carry out suitable remedial works accordingly. | within 6 weeks |

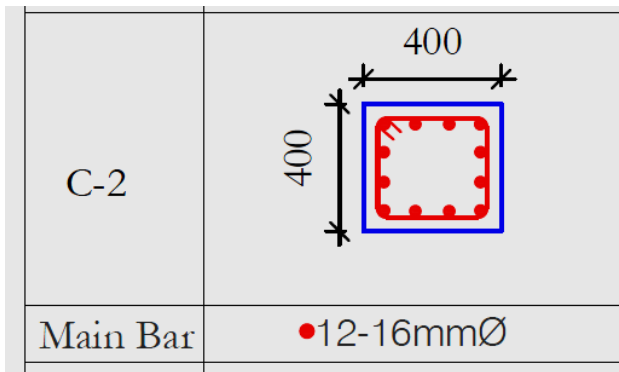
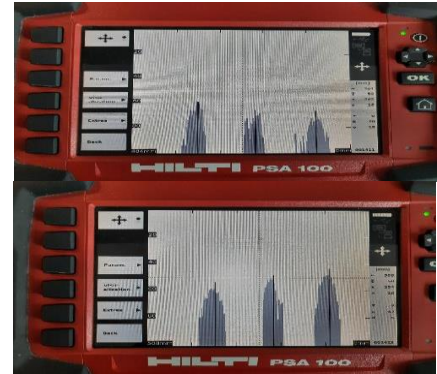
**Observation-09: Mismatches in as-built drawings. (Fire Pump Shed)**

**Description:** C-2 type column rebar not matched with drawings. Three rebars were found at both faces instead of four. Building engineer is required to confirm the amount of re-bar in the column and update the drawing.

| Item No. | Observation | Action Plan | Timeline |
|---|---|---|---|
| 10. | Mismatches in as-built drawings. (Fire pump shed) | Building engineer is required to confirm the amount of re-bar in the column and update the drawing. | within 6 weeks |

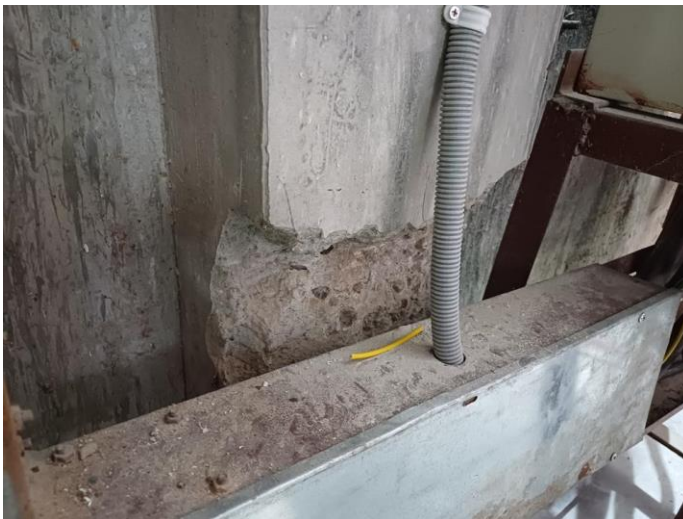
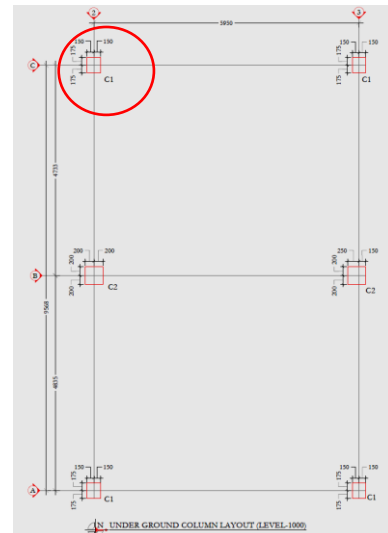
**Observation-10: Damaged RC column. (Fire Pump Shed)**

**Description:** A damaged column was found in the fire pump room. The building engineer is required to carry out suitable remedial work.

| Item No. | Observation | Action Plan | Timeline |
|---|---|---|---|
| 11. | Damaged RC column. (Fire pump shed) | The building engineer is required to carry out suitable remedial work. | within 6 weeks |

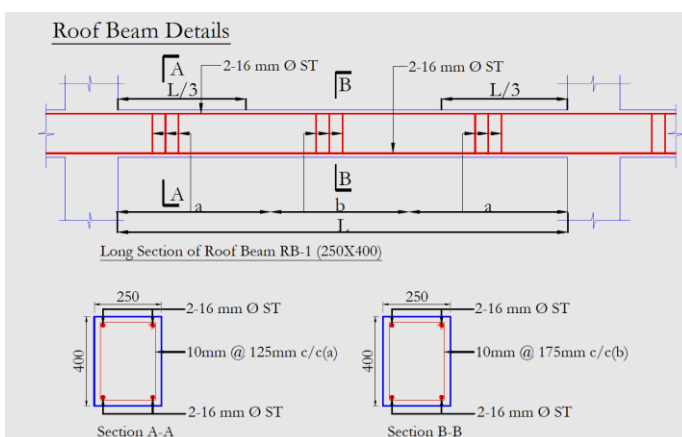
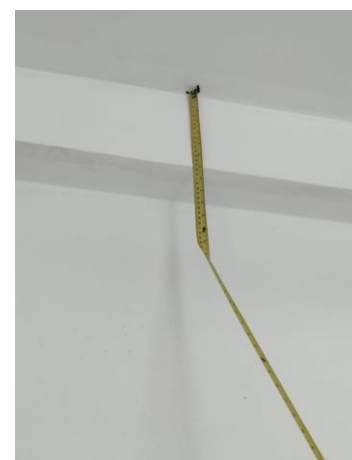
**Observation-11: Mismatches in as-built drawings. (Guard Room)**

**Description:** Roof beam down stand (without slab) measured 175 mm. But the provided drawing is shown 250 mm. Building engineer is required to confirm the size of the roof beam and update the drawing.

| Item No. | Observation | Action Plan | Timeline |
|---|---|---|---|
| 12. | Mismatches in as-built drawings. (Guard room) | The building engineer is required to confirm the size of the roof beam and update the drawing. | within 6 weeks |
