BOILER SAFETY REPORT

Apex Spinning & Knitting Mills

Factory ID: 9472

Number of Boilers : 2

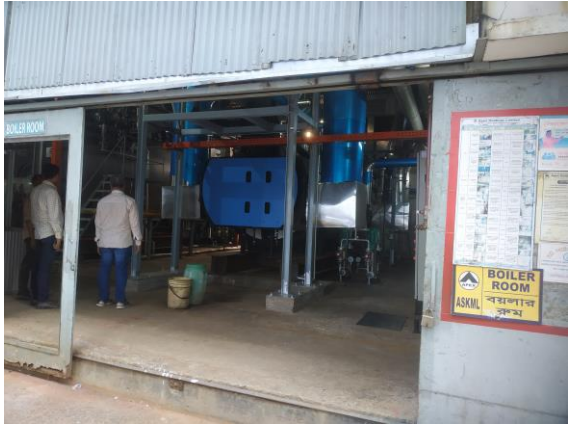
FINDING NO:	B-1	
CATEGORY:	ELECTRICAL WIRING SYSTEM	
BOILER REGISTRATION NO:	BB 13168	
FINDING:	No emergency stop push switch was available near the entrance outside of the boiler room.	
RECOMMENDATION:	An emergency stop push switch must be installed outside of the boiler room near the entrance door.	
PRIORITY:	P3	
REMEDATION TIME FRAME:	2 MONTHS
