# Habitus Fashion Limited- Extension Building

Gazariapara, Bhawal, Mirzapur, Gazipur

3 September 2024

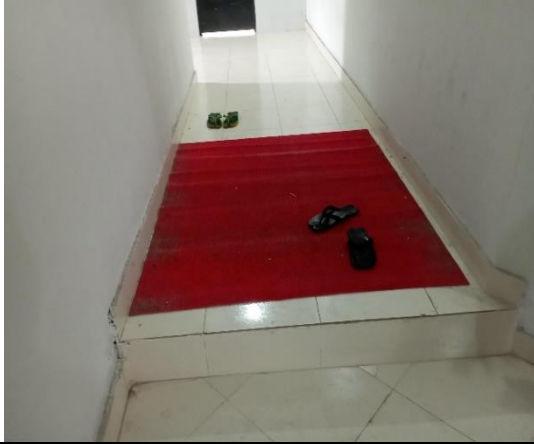
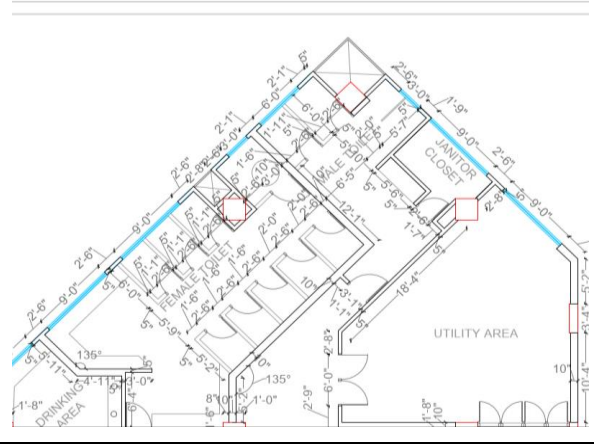
**Observation 3:** Missing information in as-built drawing (Finishing Building).

**Description:** Built-up (175 mm) was found in the toilet area but not shown in the as-built drawing. Also, an undocumented solar panel was observed on the roof slab. The building engineer is required to update the as-built drawing.

| Item No. | Observation | Action Plan | Timeline |
|---|---|---|---|
| 3. | Missing information in as-built drawing (Finishing Building). | The building engineer is required to survey the structure and update the as-built drawing. | within 6 weeks |

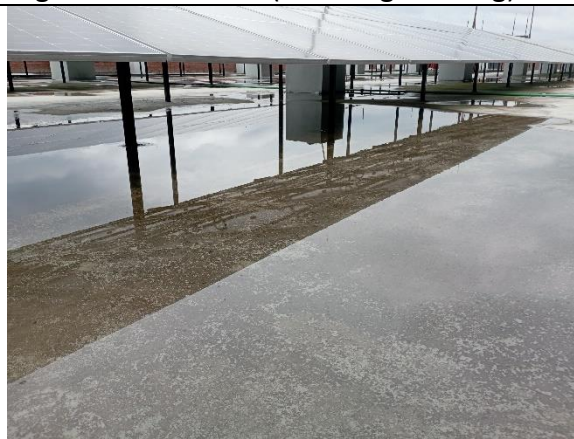
**Observation 4:** Water ponding on the roof slab (Finishing Building).

**Description:** Water ponding was found on the roof slab. The building engineer is required to improve the drainage system on the roof slab with proper slope & adequate water outlets.

| Item No. | Observation | Action Plan | Timeline |
|---|---|---|---|
| 4. | Water ponding on the roof slab (Finishing Building). | The building engineer is required to improve the drainage system on the roof slab with proper slope & adequate water outlets. | within 6 weeks |

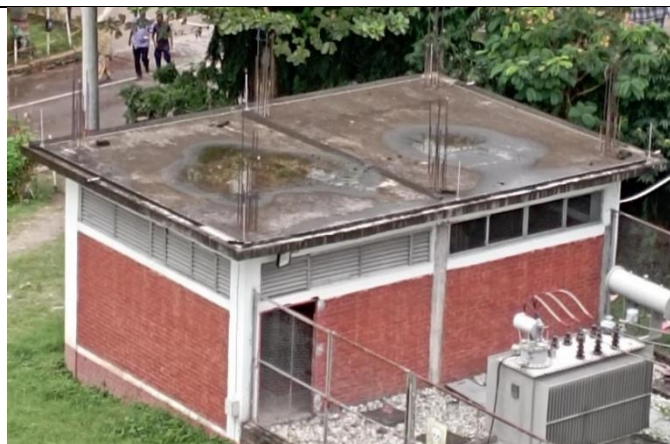
**Observation 5:** Exposed reinforcement and water ponding on the roof slab (Outdoor Substation Room).

**Description:** Exposed reinforcement and water ponding were found on the roof slab. The building engineer is required to provide rust-proof coating on the exposed rebar to protect it from corrosion. Also, improve the drainage system on the roof slab with proper slope & adequate water outlets.

| Item No. | Observation | Action Plan | Timeline |
|---|---|---|---|
| 5. | Exposed reinforcement and water ponding on the roof slab (Outdoor Substation Room). | The building engineer is required to provide rust-proof paint on the exposed rebar to protect it from corrosion. | within 6 weeks |
| | | Also, improve the drainage system on the roof slab with proper slope & adequate water outlets. | within 6 weeks |
