# Rowa Fashions Limited Unit-2

Hatiab, Post-BOF, Gazipur Sadar

2 September 2024

## 1. Building Information

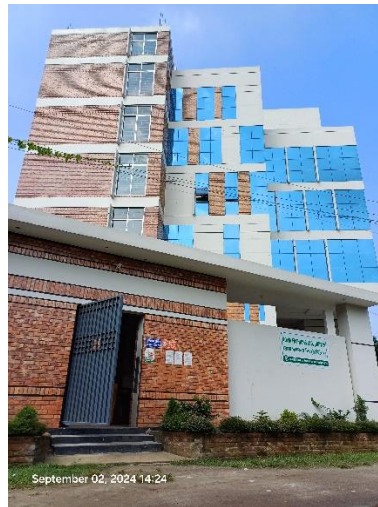
### Observation-1: Lack of design documents. (Main Building)

As-built drawings, load plans, and some test reports were available at the time of inspection. However, the design report was not available, which is required to be prepared in compliance with section 1.9.1 (part-6, BNBC).

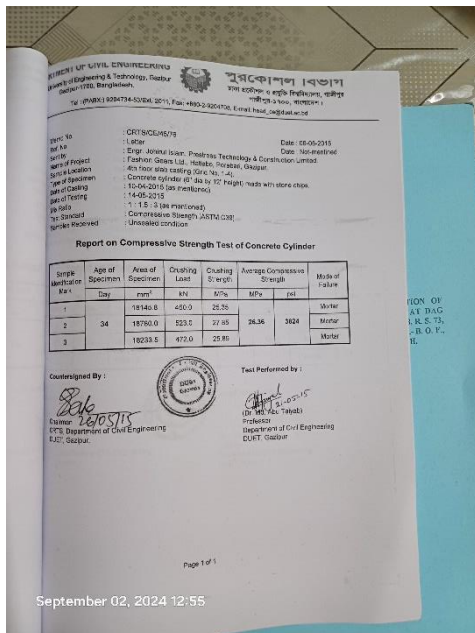
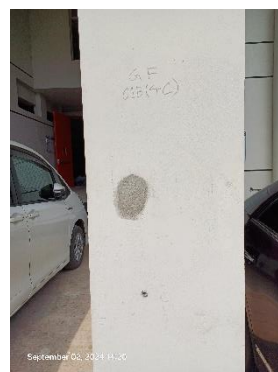
**Description:** The number of concrete cylinder test reports didn't meet BNBC's frequency of testing requirements (section 5.12.2). The design strength for the beam is 3500 psi but no design strength was mentioned in the drawing for columns.

Moreover, some cores (beam & column) were taken but no test reports were available. The building engineer is required to verify in-situ concrete strength to confirm the design strength.

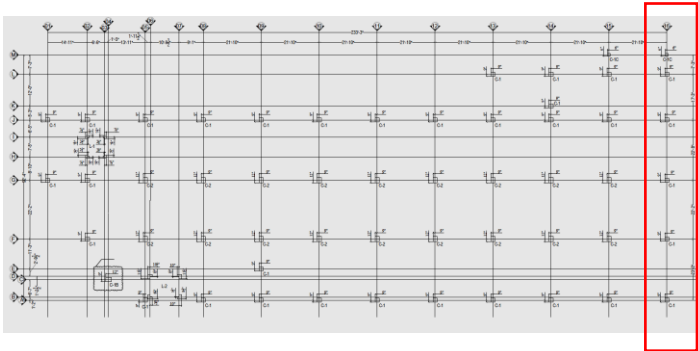
Typical column layout

**Observation-2: Mismatches in structural drawings. (Main Building)**

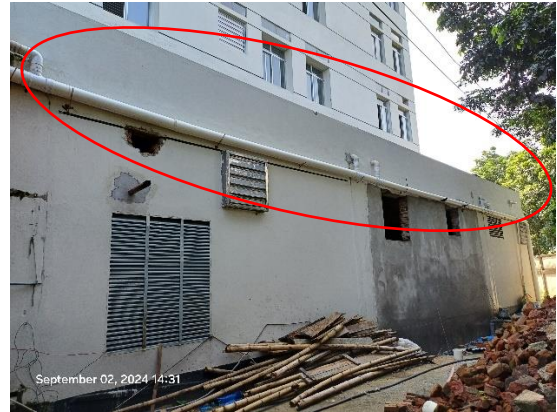
Utility portion columns only ground level

**Description:** In the provided as-built drawing column layout and schedule shows that marked columns (Utility portion) run from top to bottom. But practically these columns are only at ground level.

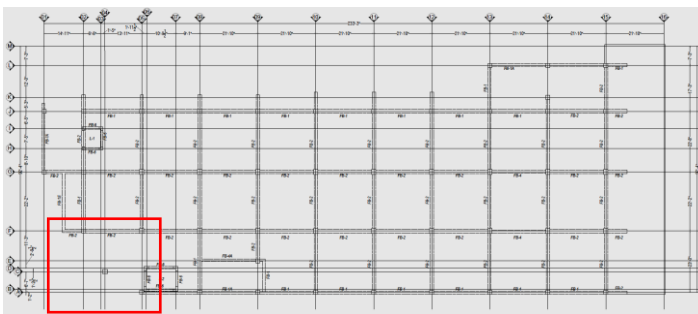
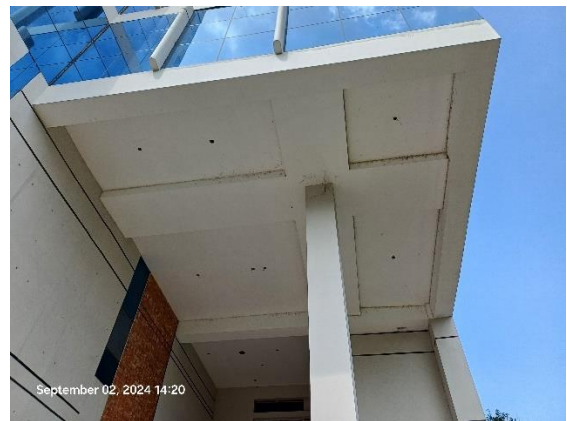
**Description:** The first-floor beam layout is different than shown in the provided drawings. The building engineer is required to survey the full structure and prepare complete as-built structural drawings. Also, provide construction drawings as the reference for the foundation.

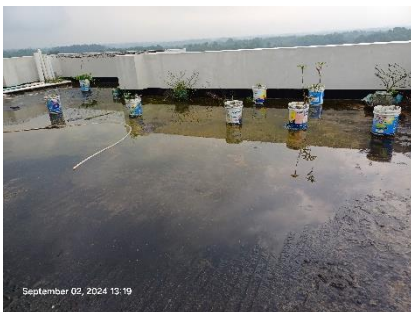
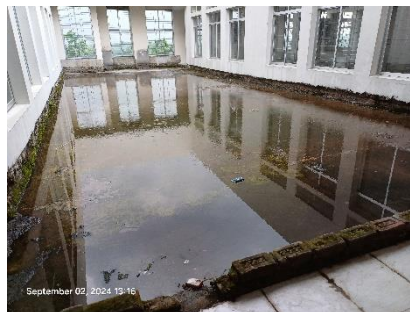
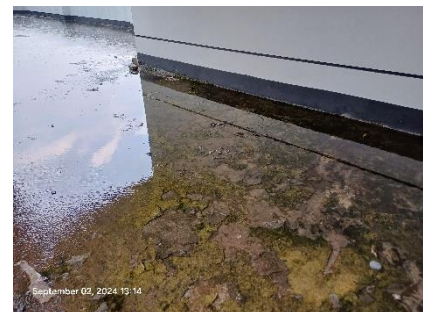
**Observation-3: Standing water on the roof. (Main Building)**

**Description:** Standing water was observed almost all over the roof. The building engineer is required to improve the drainage system on the roof with proper slopes & provide an adequate number of water outlets.

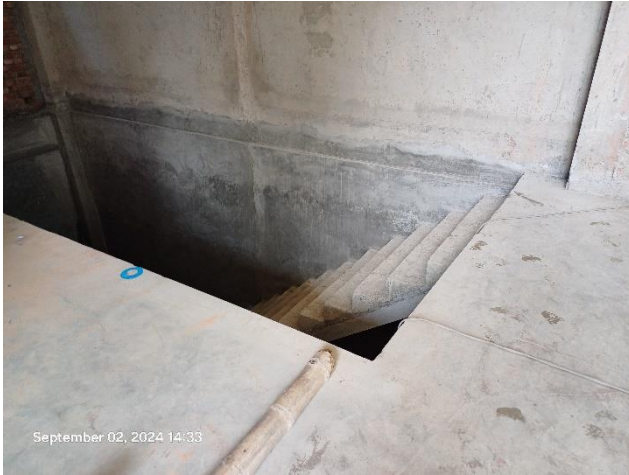
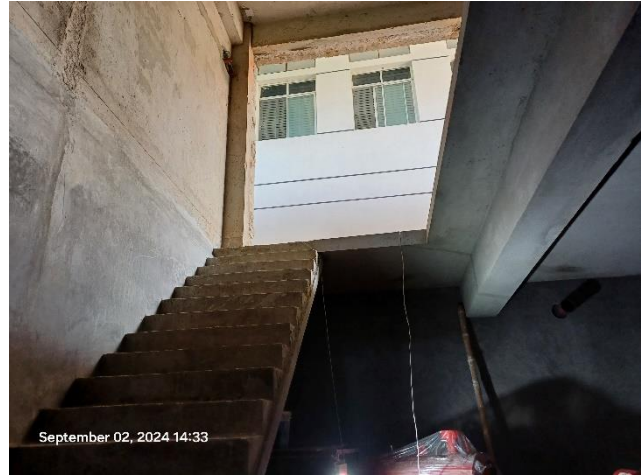
**Observation-4: Falling Hazard. (Main Building)**

**Description:** Falling hazard was observed in the underground pump room at the utility portion. Building engineer is required to take necessary measures to avoid possible falling hazards.

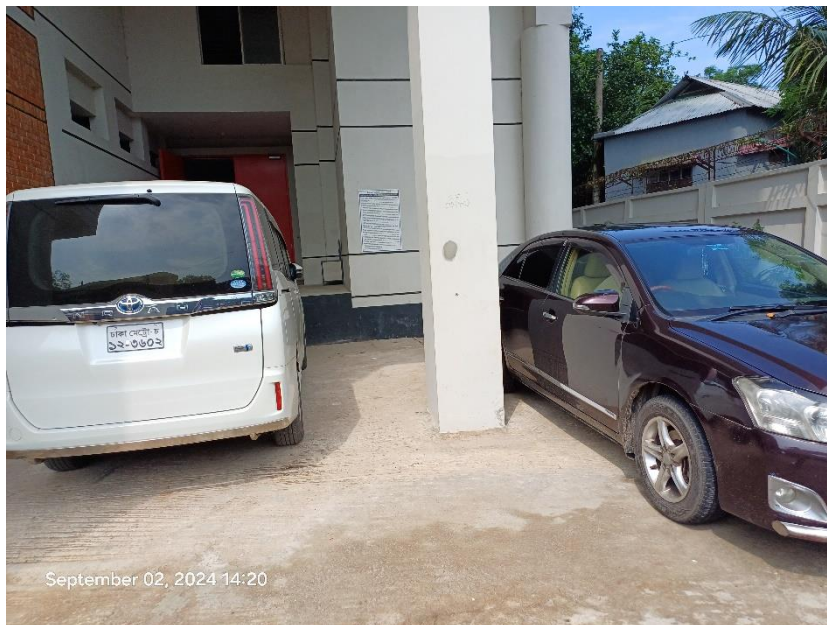
**Observation-5: Column susceptible to vehicle impact. (Main Building)**

**Description:** Column at the ground floor loading/unloading area was found susceptible to vehicle impact. The building engineer is required to provide barriers around the column to prevent vehicle impact.

07	Column susceptible to vehicle impact. (Main Building)	Building engineer is required to provide barriers around the columns to prevent vehicle impact.	within 6 weeks
08	Lack of as-built drawing. (Childcare building, Fire control room, and Security post)	Building engineer is required to prepare a full set of structural drawings in compliance with section 1.9.1.2, part 6 of BNBC.	within 6 weeks

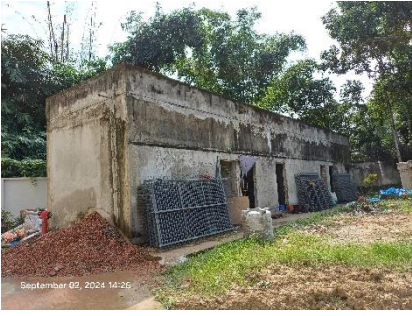
Childcare building

**Observation-6:** Lack of as-built drawing. (Childcare building, Fire control room, and Security post)

**Description:** As-built drawings of the Childcare building, Fire control room, and Security post were not available on-site at the time of inspection. The building engineer is required to prepare as-built drawings for the ancillary structures.
