# Knit Radix Limited (Extension)

Shasongaon, Panchabati to Boktaboli Road, Enayatnagar,  
Fatullah, Narayanganj, Dhaka, Bangladesh.

12 September 2024

## **1. Building Information**

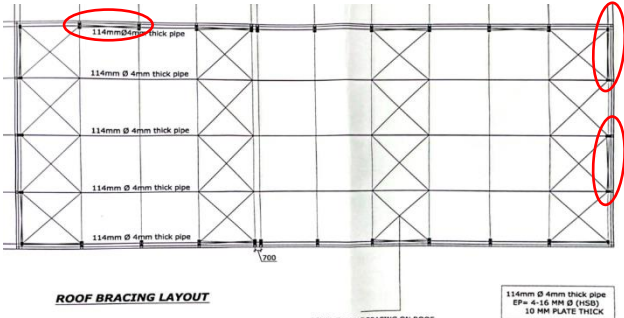
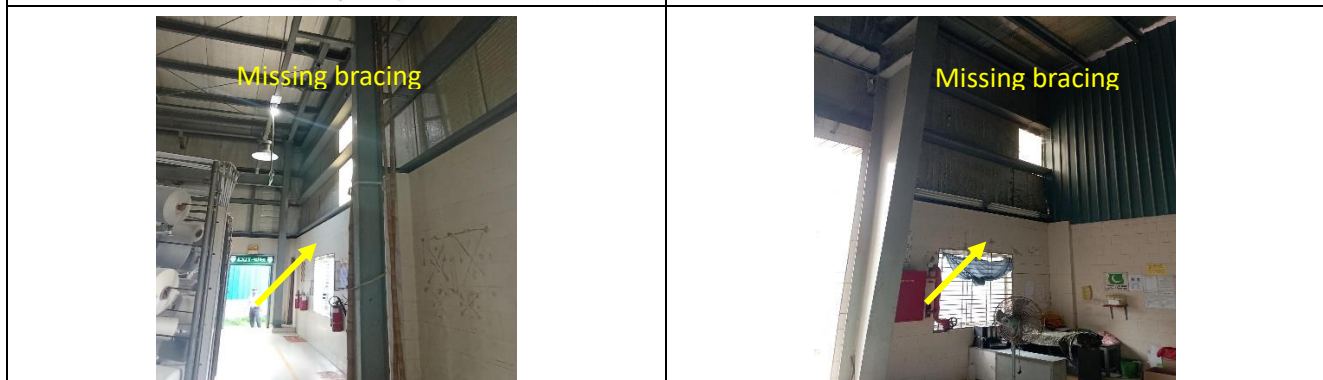
### Observation 1: Discrepancy and missing information in the provided drawing (Shed-1).

**Description:** Vertical bracing was missing at marked locations therefore bracing system was not found symmetric. Besides, RC details of the substructure were missing from the provided drawing. The building engineer is required to update the as-built drawings as per 1.9.1 BNBC (Part 6). Also, check the lateral stability of the structure and propose a remediation plan.

| Item No. | Observation | Action Plan | Timeline |
|---|---|---|---|
| 1. | Discrepancy and missing information in the provided drawing (Shed-1). | The building engineer is required to update the as-built drawings as per 1.9.1 BNBC (Part 6). | within 6 weeks |
| | | Also, check the lateral stability of the structure and propose a remediation plan. | within 6 weeks |

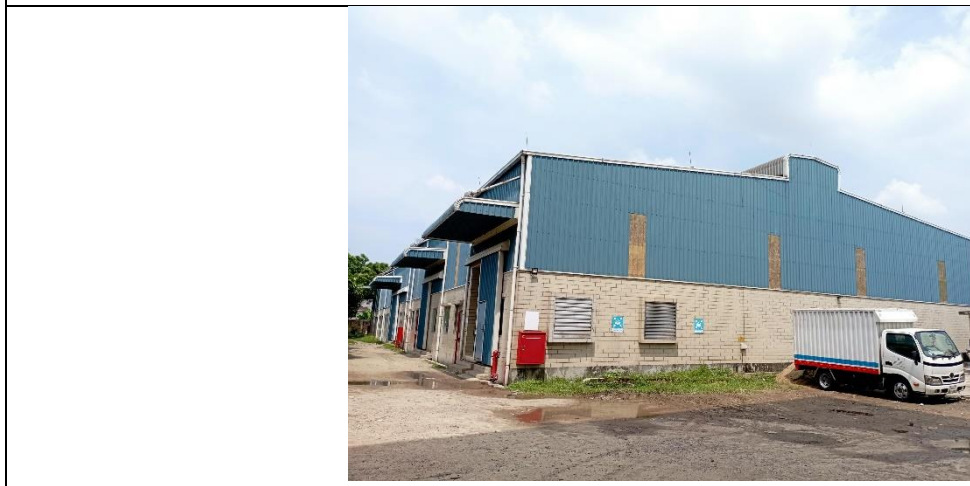
### Observation 2: Lack of design documents (Shed-1).

**Description:** As per BNBC, every building or structure designed shall have its design documents prepared in accordance with the provision of Section 1.9.1. The design document shall include a design report, and a set of structural drawings, which shall be prepared in compliance with section 1.9.1.1 and section 1.9.1.2 as per BNBC. At the time of inspection, the design report and soil test report were not available. The factory is required to engage a geotechnical engineer to prepare a set of soil test reports. Also, the building engineer is required to prepare a set of design reports as per 1.9.1 BNBC (Part 6).

| Item No. | Observation | Action Plan | Timeline |
|---|---|---|---|
| 2. | Lack of design documents (Shed-1). | The factory is required to engage a geotechnical engineer to prepare a set of soil test reports. | within 6 weeks |
| | | Also, the building engineer is required to prepare a set of design reports as per 1.9.1 BNBC (Part 6). | within 6 weeks |
| | | Implement remediation work if required. | within 6 months |

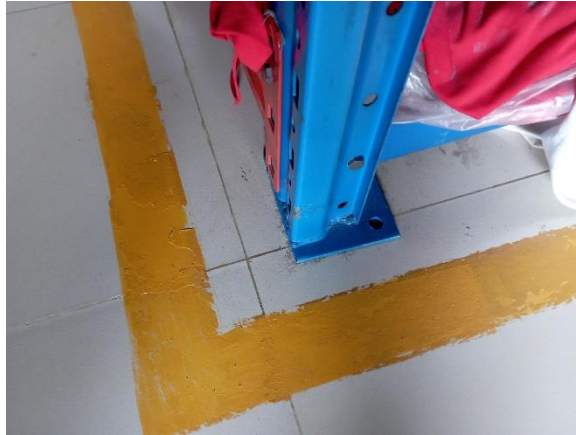
**Observation-3:** Nonstructural elements found not anchored/braced (Shed-1).

**Description:** Nonstructural elements (storage racks and plastic water tank) were found not anchored/braced. The building engineer is required to anchor/brace all nonstructural elements within the factory.

| Item No. | Observation | Action Plan | Timeline |
|---|---|---|---|
| 3. | Nonstructural elements found not anchored/braced (Shed-1). | The building engineer is required to anchor/brace all nonstructural elements within the factory. | within 6 weeks |
