# Nafa Apparels Ltd. 2 (Extension)

Village: Joyapura, Union: Shombag, Upazila: Dhamrai, District: Dhaka  
(23.912710, 90.183601)

10 September 2024

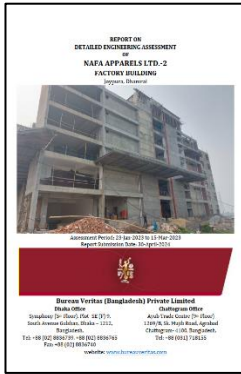
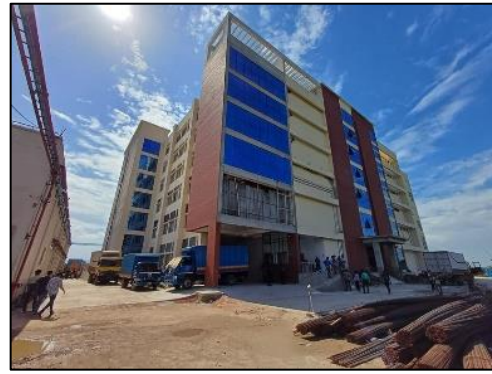
**Observation-1:** Prepared DEA needs to be reviewed against lateral forces.

(Six Storied New RCC Building-1)

**Description:** Cursory calculation shows that column & pile are adequate for service loadings. However, capacity against lateral loadings could not be verified onsite. The building engineer is required to submit the prepared DEA documents to the RSC for detailed review against lateral forces.

| Item No. | Observation | Action Plan | Timeline |
|---|---|---|---|
| 1. | Prepared DEA needs to be reviewed against lateral forces. (Six Storied New RCC Building-1) | The building engineer is required to submit the DEA to RSC for review. | within 6 weeks |
| | | Carry out suggested remedial works if required. | within 6 months |

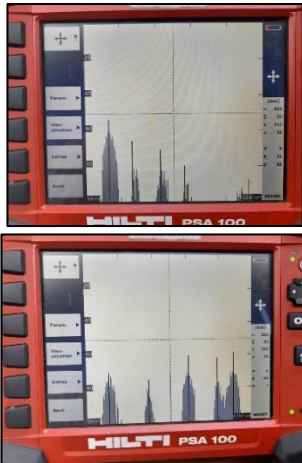
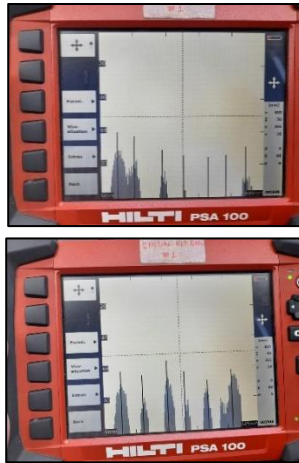
Column C-2 & C-3 rebar scan

**Observation-2:** Discrepancies in as-built drawings. (Six Storied New RCC Building-1)

**Description:** The number of rebars in the C2 columns found 20 instead of 24 and the amount of rebar in the C3 column found 18 instead of 20. The building engineer is required to survey the whole structure and prepare a full set of as-built drawings.

| Item No. | Observation | Action Plan | Timeline |
|---|---|---|---|
| 2. | Discrepancies in as-built drawings. (Six Storied New RCC Building-1) | The building engineer is required to survey the whole structure and prepare a full set of as-built drawings. | within 6 weeks |

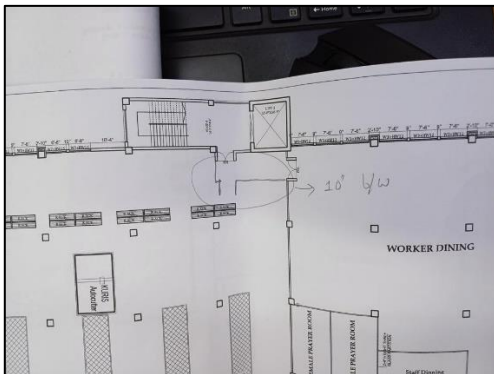
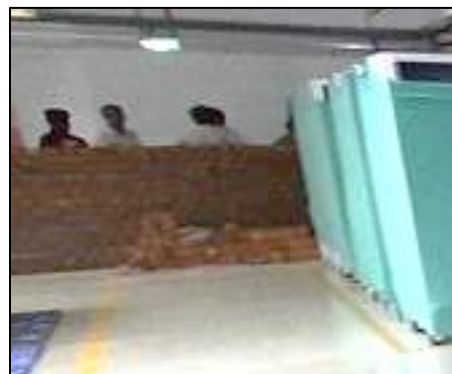
**Description:** In the marked location on the 4<sup>th</sup> floor 250 mm brick wall was found on site. But in the as-built drawing, no brick layout was mentioned. The building engineer is required to survey the whole structure and prepare a full set of as-built drawings with brick wall legends.

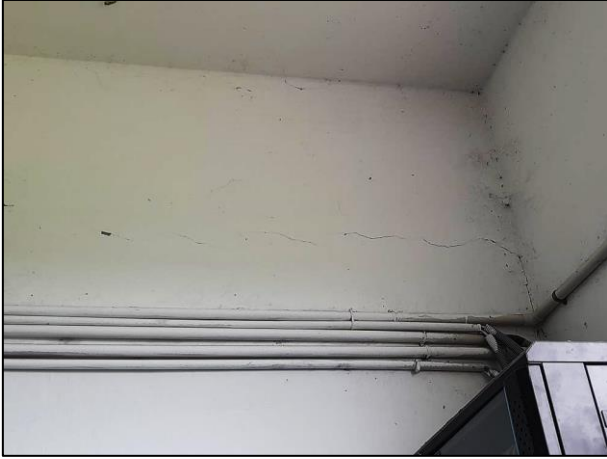
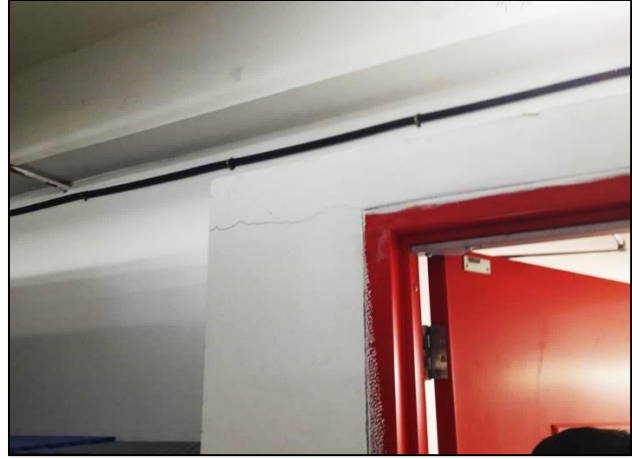
**Observation-3:** Crack on the brick wall. (Six Storied New RCC Building-1)

**Description:** Crack was observed on the brick wall on the 5<sup>th</sup> floor. The building engineer is required to investigate the reason for the crack and repair the crack accordingly.

| Item No. | Observation | Action Plan | Timeline |
|---|---|---|---|
| 3. | Crack on the brick wall. (Six Storied New RCC Building-1) | The building engineer is required to investigate the reason for the crack and suggest proper remedial action accordingly. | within 6 weeks |

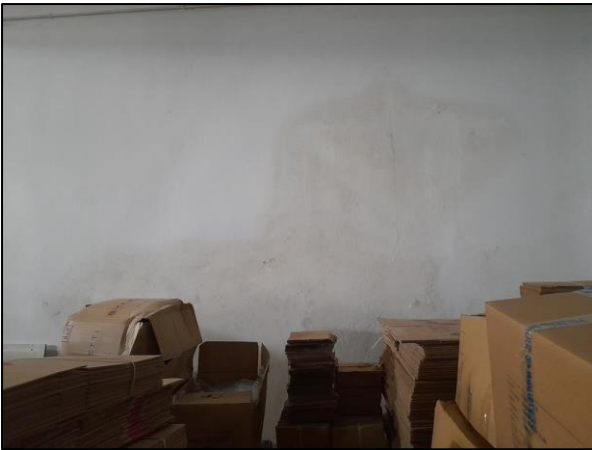
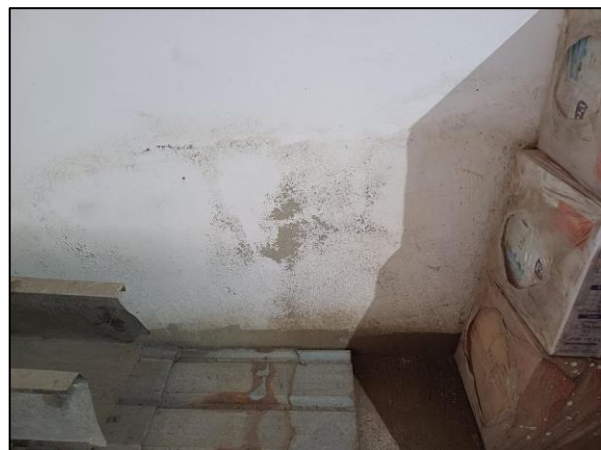
**Observation-4:** Dampness was found on the basement RC wall. (Six Storied New RCC Building-1)

**Description:** Dampness was found on the basement RC wall. The building engineer is required to investigate the cause of the dampness and repair it using a suitable method.

| Item No. | Observation | Action Plan | Timeline |
|---|---|---|---|
| 4. | Dampness was found on the basement RC wall. (Six Storied New RCC Building-1) | The building engineer is required to investigate the cause of the dampness and repair it using a suitable method. | within 6 weeks |

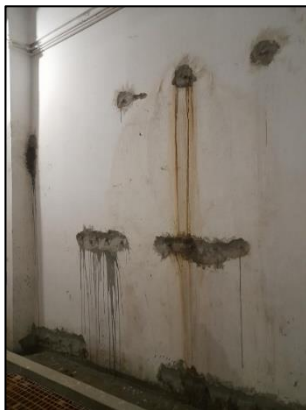
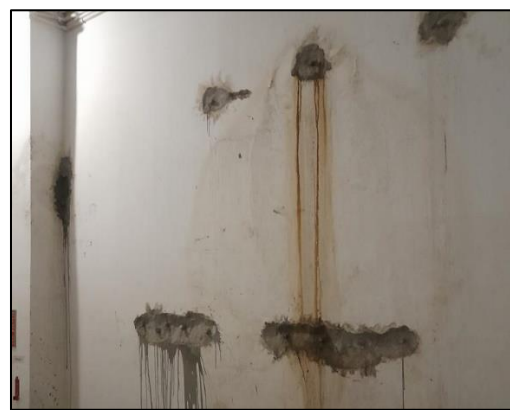
**Observation-5:** Water intrusion in the basement RC wall. (Six Storied New RCC Building-1)

**Description:** During the inspection, water intrusion was found on the basement RC wall. The building engineer is required to seal the crack/leakage of the RC wall to stop water intrusion and repair it with suitable methods.

| Item No. | Observation | Action Plan | Timeline |
|---|---|---|---|
| 5. | Water intrusion in the basement RC wall. (Six Storied New RCC Building-1) | The building engineer is required to seal the water intrusion and repair it using a suitable method. | within 6 weeks |

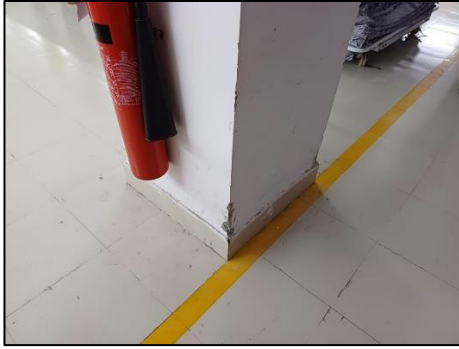
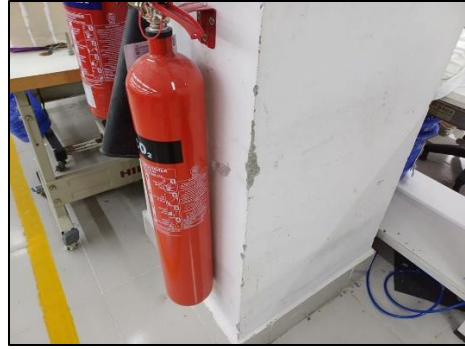
**Observation-6:** Column susceptible to trolley impact. (Six Storied New RCC Building-1)

**Description:** Damage due to trolley impact observed on the column surface on different floors. The building engineer is required to provide a column guard to protect the trolley impact.

| Item No. | Observation | Action Plan | Timeline |
|---|---|---|---|
| 6. | Column susceptible to trolley impact. (Six Storied New RCC Building-1) | The building engineer is required to provide the column guard to avoid trolley impact. | within 6 months |

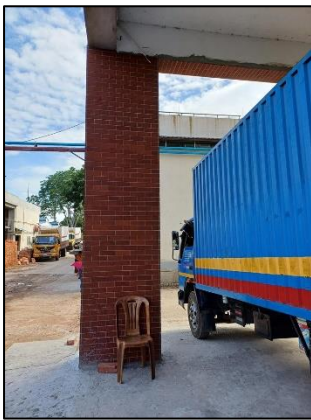
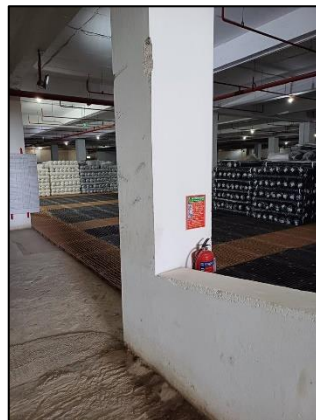
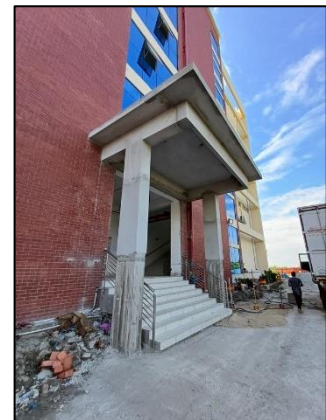
**Observation-7:** Column susceptible to vehicle impact. (Six Storied New RCC Building-1)

**Description:** RC columns on the ground floor & basement were susceptible to vehicle impact. The building engineer is required to provide a barrier around the column to avoid vehicle impact.

| Item No. | Observation | Action Plan | Timeline |
|---|---|---|---|
| 7. | Column susceptible to vehicle impact. (Six Storied New RCC Building-1) | The building engineer is required to provide a barrier around the column to avoid vehicle impact. | within 6 months |

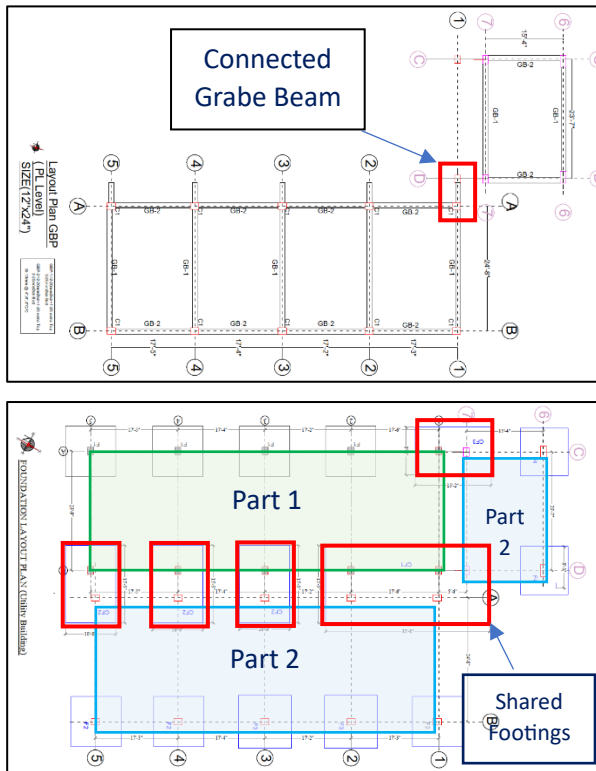
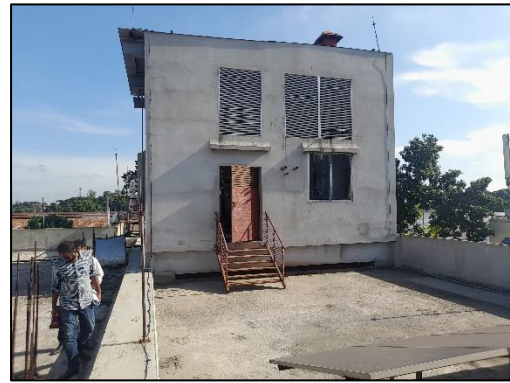
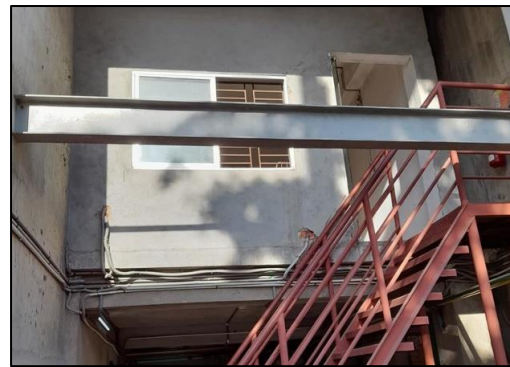
**Observation-8: Lack of structural assessment report. (Utility Building Part 1 & 2)**

**Description:** The Utility building consists of three parts- Part 1, Part 2, and Part 3. Part 1 is a partially two-storied. The partial upper story is a steel shed. There is a self-supported RC mezzanine on the ground floor of Part 1. The upper steel story was constructed after retrofitting the ground floor columns. Part 2 is a single-storied RC structure. Part-1 and Part-2 are structurally connected with footing and grade beam which were connected during retrofitting construction. The building engineer is required to prepare an Engineering Assessment (EA) of the utility building and submit the required documents to the RSC for review.

| Item No. | Observation | Action Plan | Timeline |
|---|---|---|---|
| 8. | Lack of structural assessment report. (Utility Building Part 1 & 2) | The building engineer is required to prepare the EA of the utility building and submit it to RSC for review. | within 6 weeks |
| | | Carry out suggested remedial works if required. | within 6 months |

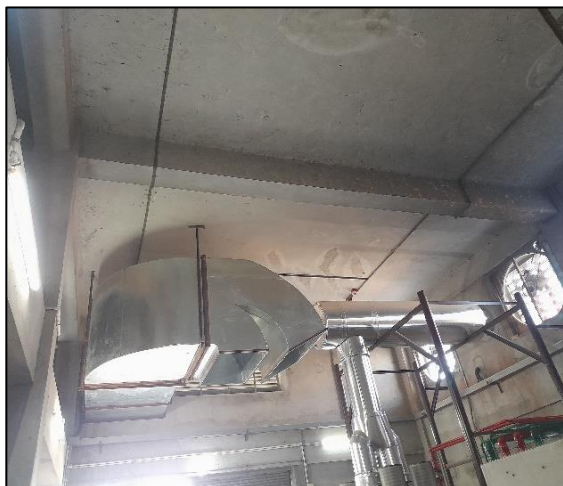
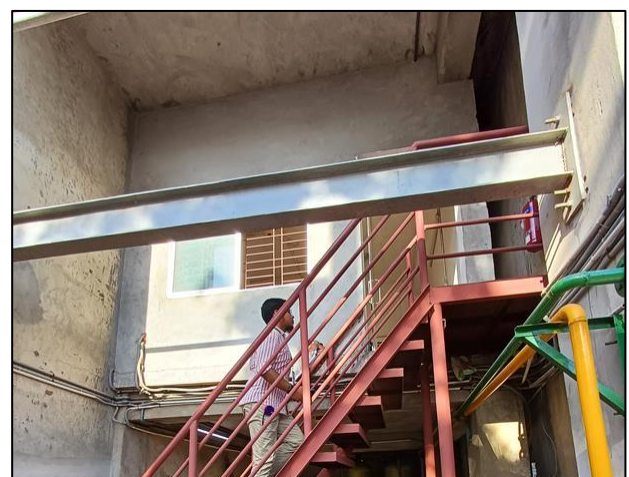
**Observation-9: Lack of information in as-built drawing. (Utility Building Part 1 & 2)**

**Description:** Details of the roof beam of part 2 and details of the mezzanine floor of part 1 were missing in the as-built drawing. The building engineer is required to survey the structures and prepare the complete as-built drawings with connection details of the building.

| Item No. | Observation | Action Plan | Timeline |
|---|---|---|---|
| 9. | Lack of information in as-built drawing. (Utility Building Part 1 & 2) | The building engineer is required to prepare accurate as-built drawings. | within 6 weeks |

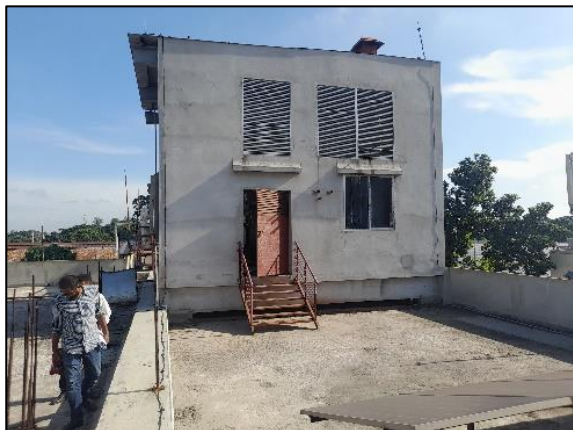
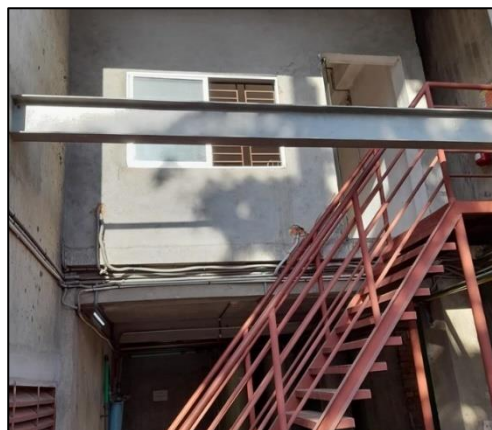
**Observation-10:** Missing load plan of the mezzanine floor and EGB Boiler. (Utility Building Part 1)

**Description:** The load plan of the self-supported mezzanine floor at Utility Part 1 ground floor was missing. Also, the Load plan of the EGB Boiler at the roof of Utility Part 1 was missing. The building engineer is required to prepare the load plan and maintain floor loading accordingly.

| Item No. | Observation | Action Plan | Timeline |
|---|---|---|---|
| 10. | Missing load plan of the mezzanine floor and EGB Boiler. (Utility Building Part 1) | The building engineer is required to prepare the load plan and maintain loading accordingly. | within 6 weeks |

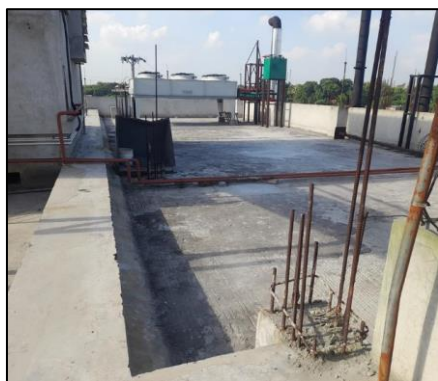
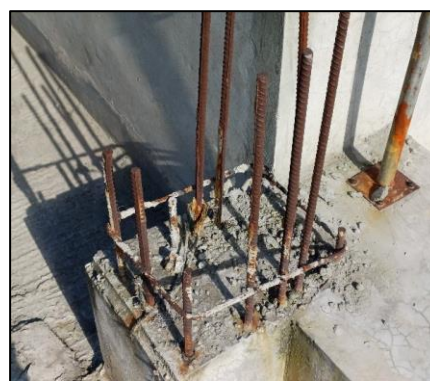
**Observation-11:** Exposed rebar was found on the roof. (Utility Building Part 2)

**Description:** Exposed rebar was found on the roof of Utility Building part 2. The building engineer is required to apply rust-proof coating on the exposed rebar.

| Item No. | Observation | Action Plan | Timeline |
|---|---|---|---|
| 11. | Exposed rebar was found on the roof. (Utility Building Part 2) | The building engineer is required to apply rust-proof coating on the exposed rebar. | within 6 months |

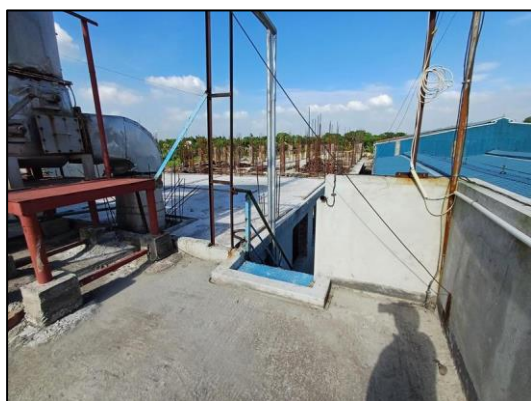
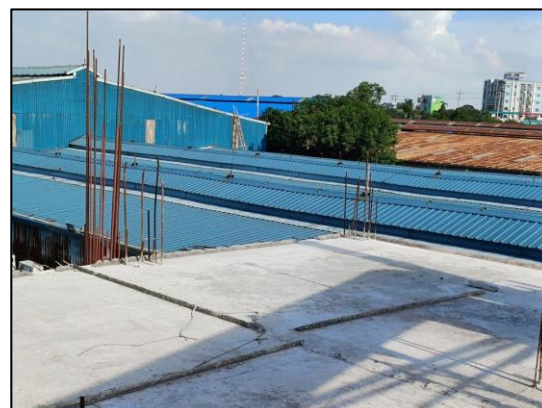
**Observation-12:** Falling hazard on the roof. (Utility Building Part 3)

**Description:** A possible falling hazard was found on the roof of utility part 3. The building engineer is required to provide a barrier to mitigate falling hazards.

| Item No. | Observation | Action Plan | Timeline |
|---|---|---|---|
| 12. | Falling hazard on the roof. (Utility Building Part 3) | The building engineer is required to provide a barrier to mitigate falling hazards. | within 6 months |
