# INITIAL FIRE SAFETY INSPECTION REPORT

## Knit Radix Limited (Extension)

**RSC ID: 25764**

**Date: 12-Sep-2024**

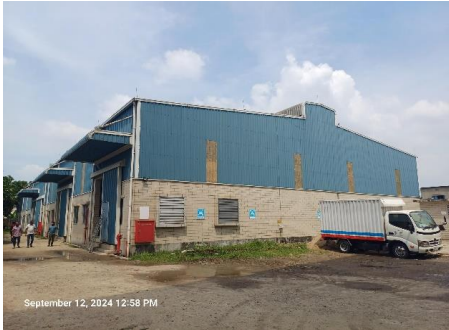
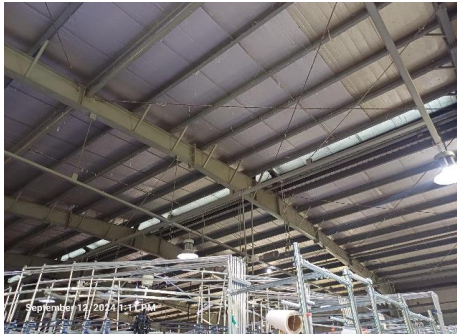
| SI No. | Category | Findings | Required Action | Remediation Time Frame |
|---|---|---|---|---|
| F-1 | Fire rated Construction | The main structural elements of the shed-01 are constructed by steel which is non-rated and were found in exposed condition without any fire protection. | The building shall be constructed as required in BNBC 2006 Part 3 Table 3.2.4. So, provide require rating for the structural elements of the building following BNBC 2006-Table 3.2.4, 3.1.9 and 3.3.1. | Within 6 months |

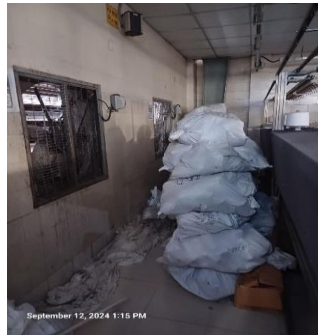
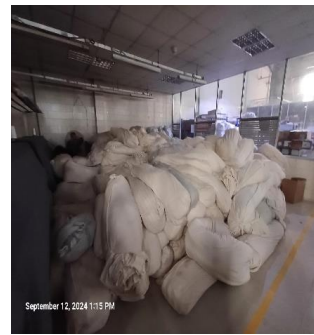
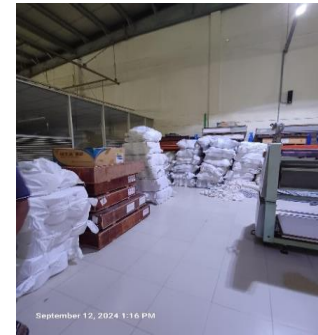
| F-2 | Fire Rated Construction | Storage area are not maintained properly, and not separated from the knitting section on the shed-01. | <p>Provide defined storage areas and limit the storage arrangement as follows:</p> <ul style="list-style-type: none"> <li>- Maximum height of 2.45m (8ft.) , maximum area of 23m2 (250 ft2) and 3m (10ft.) clear distance from adjacent another unenclosed combustible storage.</li> <li>- If the building/floor is sprinkler protected: maximum height of 3.66m (12ft.) and maximum area of 93m2 (1000 ft2) and and 3m (10ft.) clear distance from adjacent another unenclosed combustible storage.</li> <li>- In process storage shall be limited to 10 percent of the building area of the story in which they occur.</li> </ul> | Within 1 month |

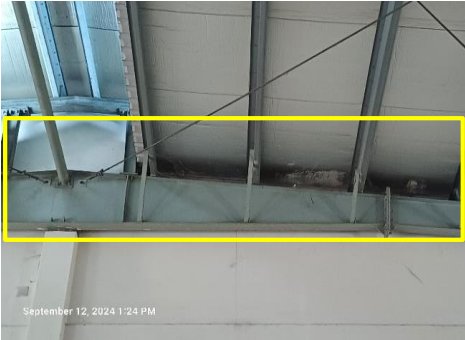
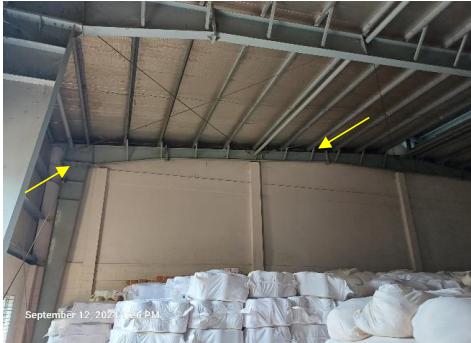
| F-3 | Fire rated Construction | Rooms (bonded warehouse) used for combustible storage are not separated by fire rated construction with the knitting area. | Separate the dedicated storage rooms by minimum 1-hr fire-rated construction. Provide 0.75 hr. fire rated door and seal all penetrations and openings by 0.75 hr. (45 Minutes) fire rated fire rated barrier construction. | Within 3 months |

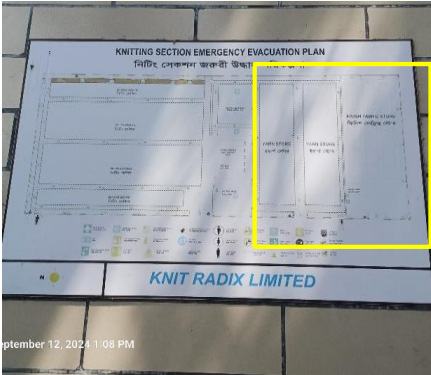
| F-4 | Mean of Egress | The common path of egress travel exceed 30 meter in the Bonded Warehouse and Finished Fabric Store in the shed-01. | The common path of egress travel for Group H (storage) occupancies with not more than 30 occupants shall not exceed 30 m (100 ft). | Within 3 months |

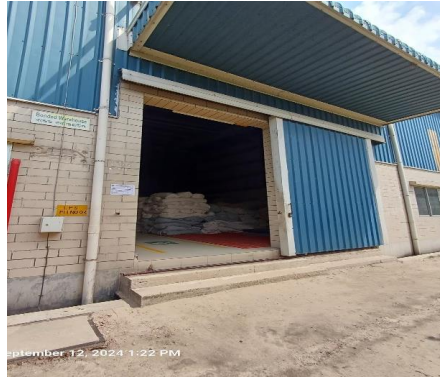
| F-5 | Mean of Egress | Sliding doors are provided at exit of the bonded warehouse. | All doors in a means of egress shall be of the side-hinged swinging type. Roll-down and sliding gates and shutters shall not be allowed. Doors serving an occupant load of more than 50 shall swing in the direction of egress travel. | Within 2 months |

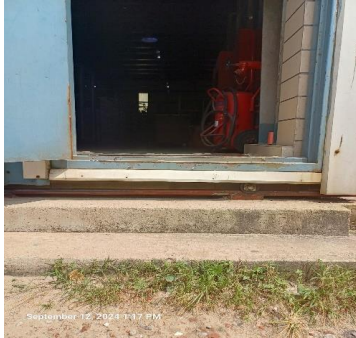
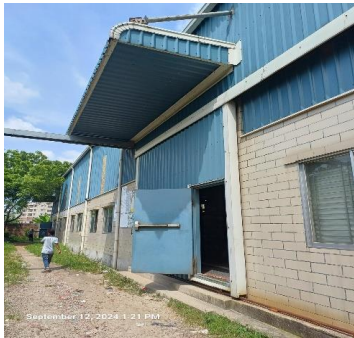
| F-6 | Means of egress | Landing are not provided at the west exits of the shed-01. | A landing shall be provided on both sides of doors used in the means of egress. Door shall not swing out over stairs. | Within 2 months |

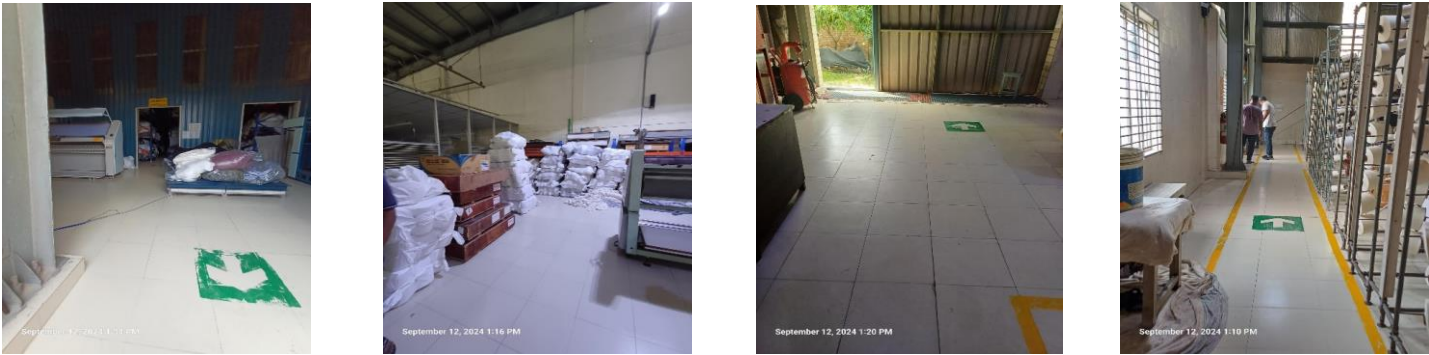
| F-8 | Means of Egress | Aisles were found less than 36 inch (found 28 inch) in the knitting area and aisles were not provided at the few area of the knitting section, bonded warehouse area & finished fabric store. | Aisles shall be provided with a minimum unobstructed clear-width of 0.9 m (36 in.). Aisles mark shall be clearly visible on required places. | Within 1 month |

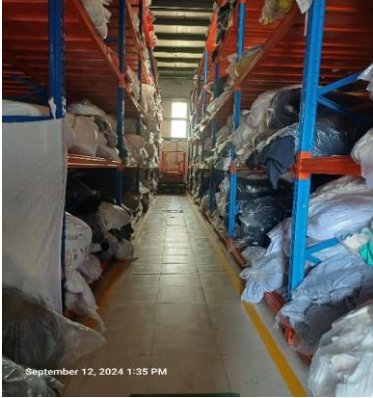
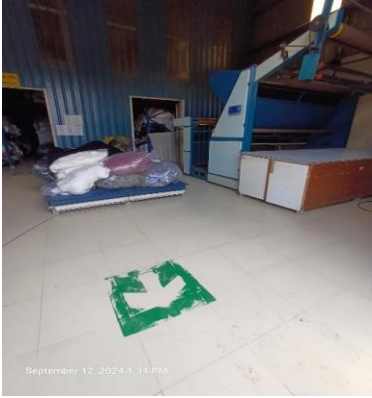
| F-9 | Egress Lighting | Based on the number and location of emergency lights observed, adequate illumination levels are not anticipated along egress routes in the bonded warehouse and finished fabric store in the shed-01. | Test the emergency lighting system on each floor and provide additional emergency fixtures to provide adequate illumination along the means of egress. Provide a minimum illumination of 10 lux at the floor level within exit stairs and exit discharge paths and minimum 2.5 lux along exit access aisles. | Within 3 months |

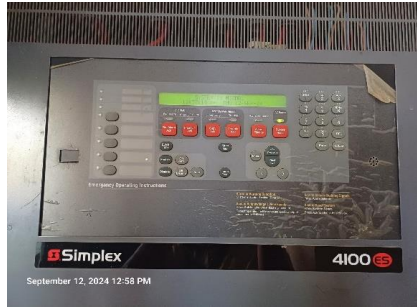
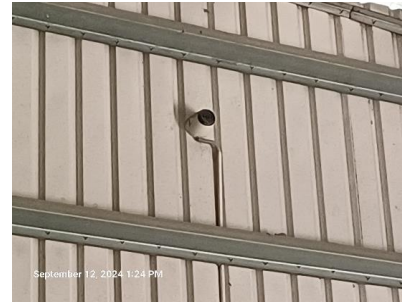
| F-11 | Fire Alarm &<br>Detection System<br>(FADS) | Automatic fire alarm and detection system has been found installed which requires detailed review and approval to confirm compliance with NFPA 72 and The RSC Technical Guidelines (Standard). | Install or modify the fire detection and alarm system (where required) throughout the building in accordance with RSC standard and NFPA 72. The factory management shall contact RSC to conduct the final acceptance testing after the installation, testing & commissioning. | Within 4 months |
