# **FIRE SAFETY INSPECTION REPORT**

**OEKO-TEX LTD.**

**SOUTH PANISHAIL, ZIRANI BAZAR, B.K.S.P,  
GAZIPUR, BANGLADESH**

April 19, 2014

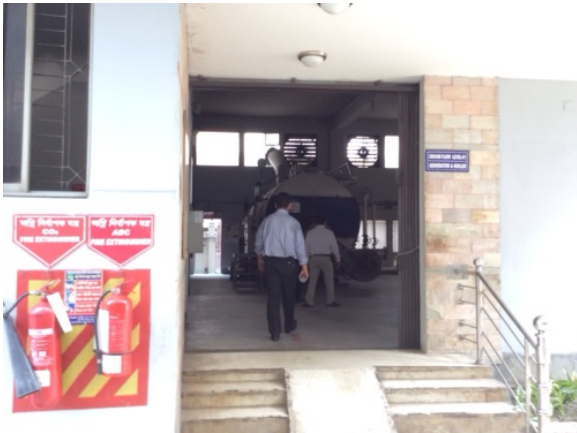
| No. | Category | Finding | Recommendation | Remediation Timeframe |
|---|---|---|---|---|
| F-1 | Fire Rated Construction | The room containing the generator and boiler is not separated form the exit discharge of the utility building by means of fire rated construction (non-rated doors). | Separate the generator room from the discharge pathway by a minimum 2-hr fire-rated construction. Seal and/or protected all openings to maintain the required fire separations. | Within 3 months |

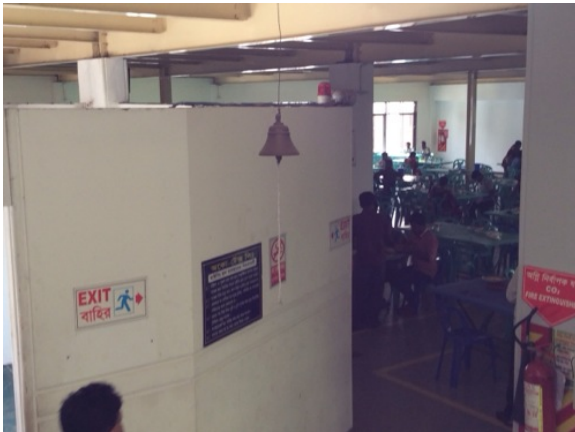
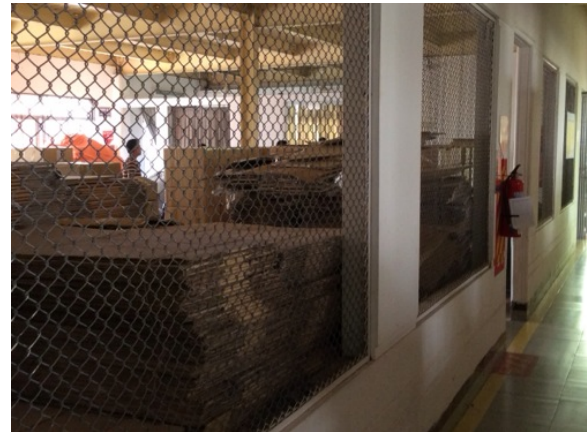
| No. | Category | Finding | Recommendation | Remediation Timeframe |
|---|---|---|---|---|
| F-2 | Fire Rated Construction | The dedicated storage areas on the 5th floor and ground floor were not separated by fire-rated construction (unprotected openings and non-rated doors). | Provide dedicated storage rooms separated by minimum 1-hr fire-rated construction. | Within 3 months |

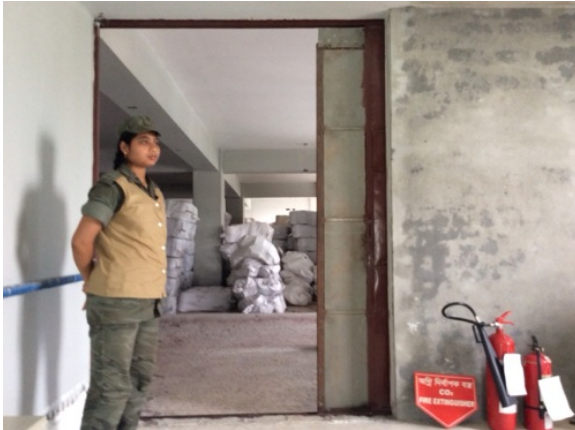
| F-3 | Fire Rated Construction | Exit stairs on all floors are not separated from working areas by fire-rated construction. | Provide minimum 1.5-hr fire rated doors and seal all unprotected openings to separate the exit stairs from work areas and other building spaces on all floor levels. Ensure that the fire doors are self-closing and positive latching and that they are provided with fire exit (panic) hardware where serving production floors.<br><br>If fire doors are required to be held open for functional reasons, provide automatic-closing devices tied to the fire alarm system. | Within 3 months |

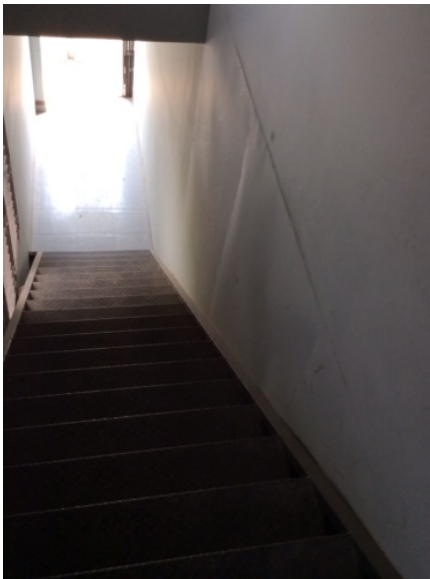
| F-4 | Fire Rated Construction | The southern exit stair of the chemical storage building was not separated from the storage area by fire rated construction. | Provide minimum 2-hr fire rated construction and seal all unprotected openings to separate the exit stairs from work areas and other building spaces on all floor levels. | Within 3 months |

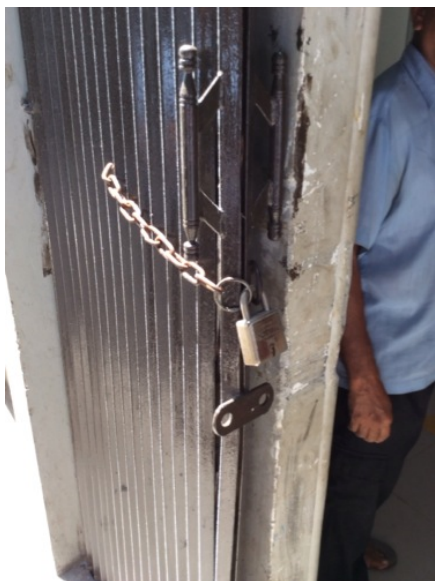
| F-6 | Egress | Egress doors and gates with locking features are provided at all building exits, exit stairs and exit discharges. | <p>Remove locking features from all egress doors / gates.</p> <p>If locks are required for security reasons, utilize special door locking features complying with NFPA 101.</p> | Immediate |

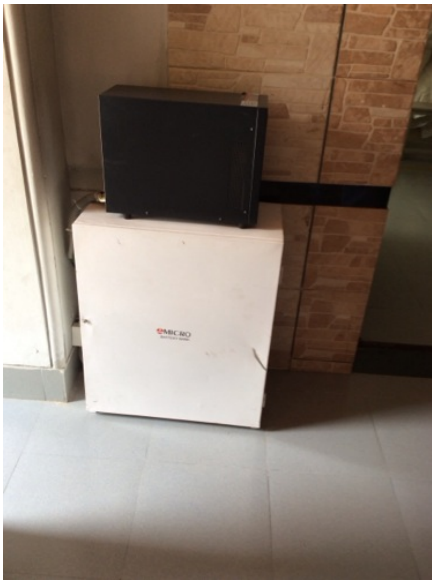
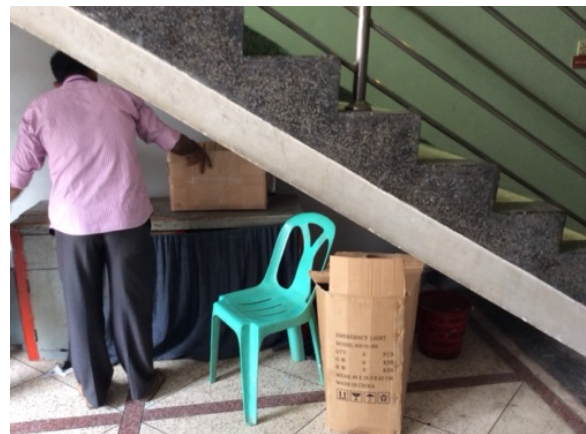
| F-7 | Egress | <p>Storage was located in the both the exit stair enclosures on the 5th, 4th and ground floor.</p> <p>Storage was also located inside the exit stair enclosures of other buildings in the complex.</p> | Remove all storage from exit stairs and egress paths. | Immediate |

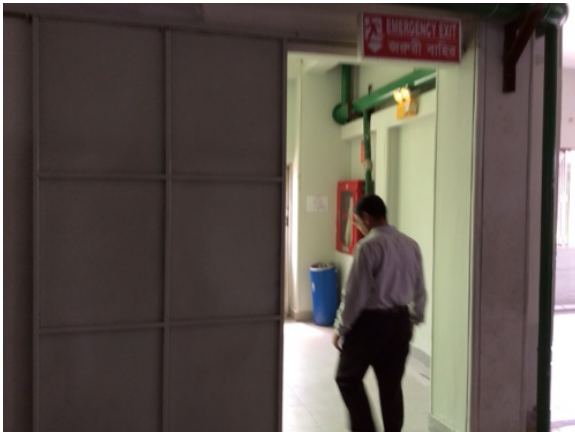
| F-8 | Egress | <p>Collapsible gates and sliding doors are provided at all building exits, exit stairs and exit discharges.</p> | <p>Replace all gates / sliding doors along the means of egress with side-hinged, swinging egress doors.</p> <p>If locks are required for security reasons, utilize special door locking features complying with NFPA 101.</p> | Within 1 month |

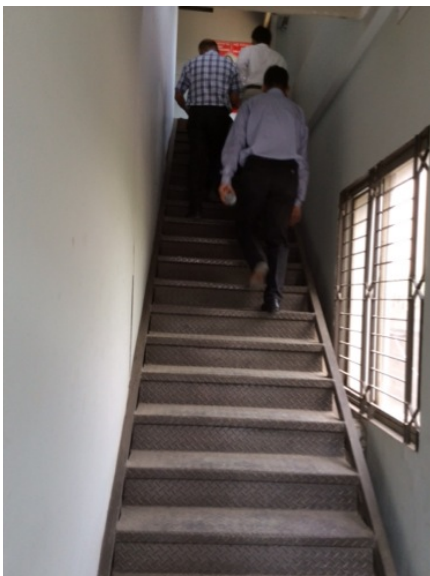
| F-10 | Egress | Handrails are not provided in the southern exit stair of the two storied chemical storage building. | Provide handrails on at least one side of exit stair. | Within 3 months |
