NAYEM KNITWEAR LTD - Extension (Previously UNION KNITTING AND DYEING LTD)

42 & 44 BORO RANGAMATIA, ZIRABO, SAVAR, DHAKA, BANGLADESH.

25 September 2024

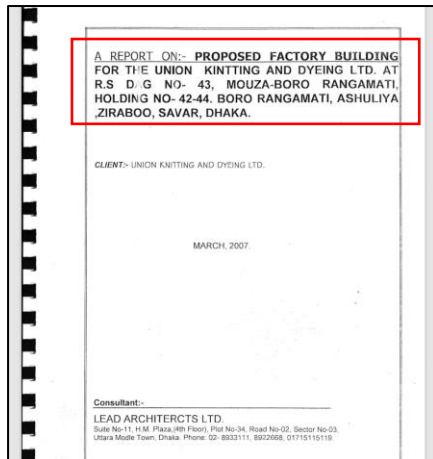
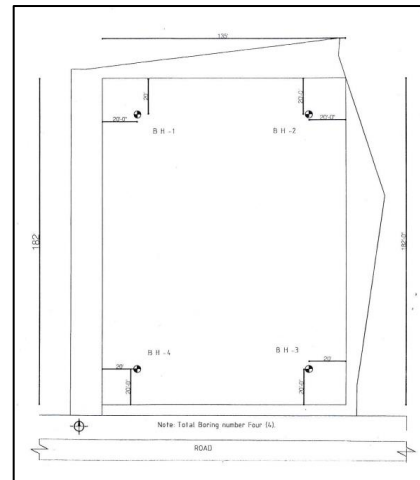
Soil test report provided by Factory

Observation-2: Inconsistencies in geotechnical investigation report. (Factory Building (New))

Description: During the inspection, the factory provided soil test report for the factory building (New). However as per the factory name and bore layout, it was found that the soil test report was for the Main factory shed (covered in the previous ID) not for this structure. The building engineer is required to prepare the geotechnical investigation report for this structure and check the design accordingly.

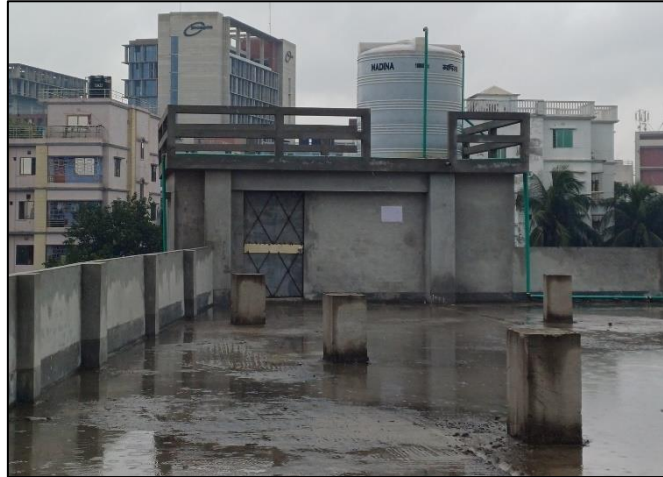
Observation-3: Lack of anchorage of non-structural elements. (Factory Building (New))

Description: On the roof top, PVC water tank was not found anchored/braced. The building engineer is required to anchor/brace all the non-structural elements within this building.

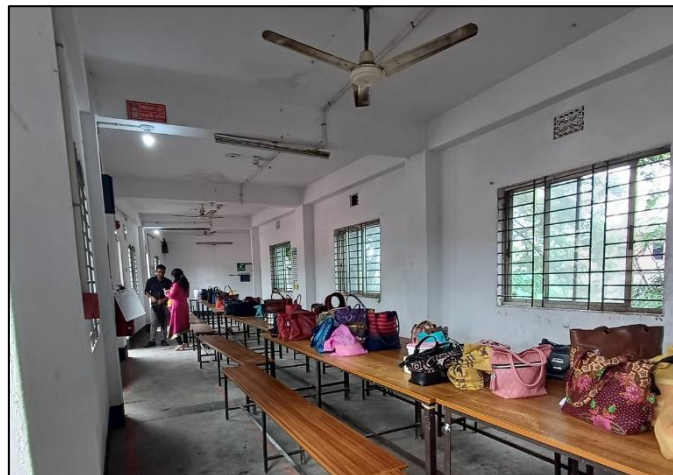
Observation-4: Absence of design documents. (Dinning Building)

Description: As per BNBC, every building or structure designed shall have its design documents prepared in accordance with the provision of Section 1.9.1. The design document shall include a design report, and a set of structural drawings, which shall be prepared in compliance with section 1.9.1.1 and section 1.9.1.2 as per BNBC. At the time of inspection, only a set of as-built drawings were available, but the design report, load plan, and geotechnical investigation report were not available. The building engineer is required to prepare the design report, load plan, and geotechnical investigation report in compliance with section 1.9.1 (Part 6, BNBC).

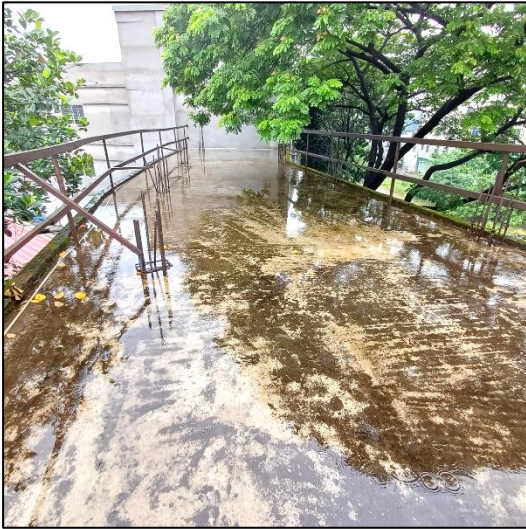
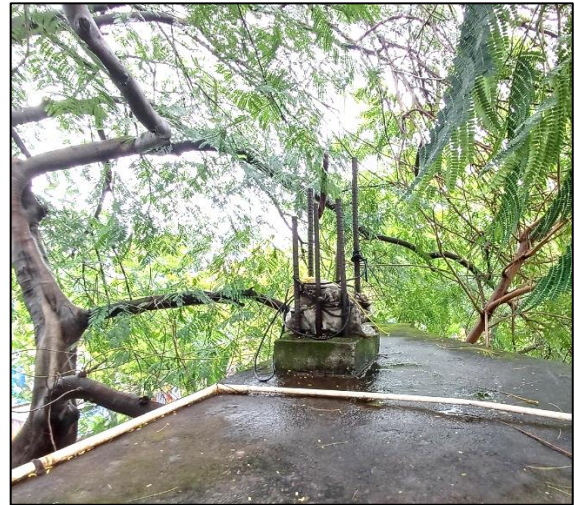
Observation-5: Exposed rebar on roof. (Dinning Building)

Description: Exposed reinforcement is left at roof, which was prone to corrosion. The building engineer is required to provide rust proof coating on the exposed reinforcement to protect from corrosion.

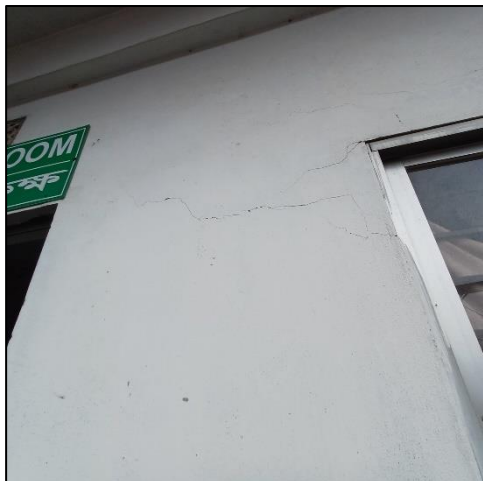
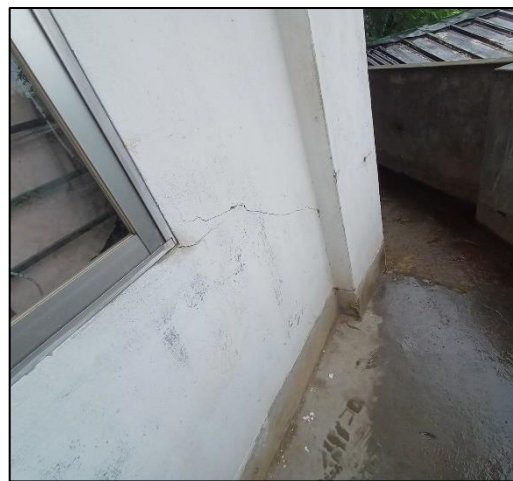
Observation-6: Crack on Brick wall. (Dinning Building)

Description: Crack found on 1st floor brick wall of Dinning Building. The building engineer is required to investigate the cause of wall cracks and repair with a suitable method.

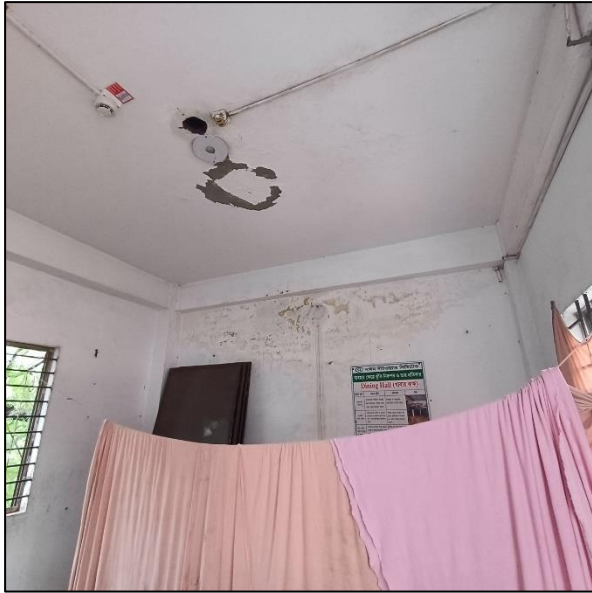
Dampness on roof slab

Description: Dampness found on roof slab and brick wall of Dinning Building. The building engineer is required to investigate the cause of dampness and repair with a suitable method.

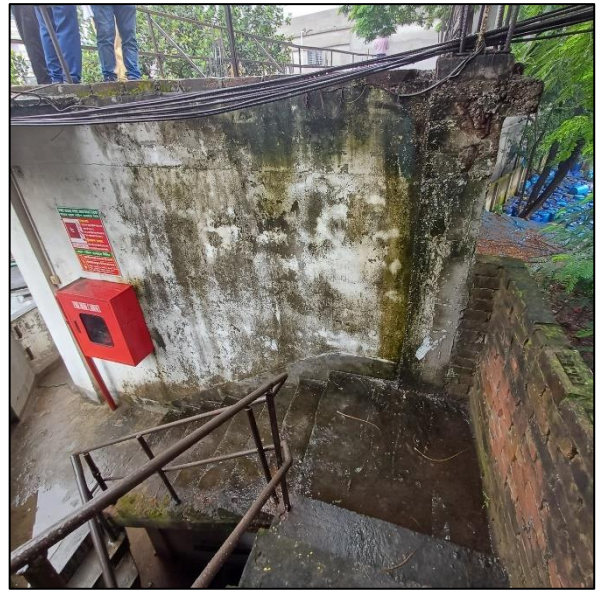
Dampness on wall

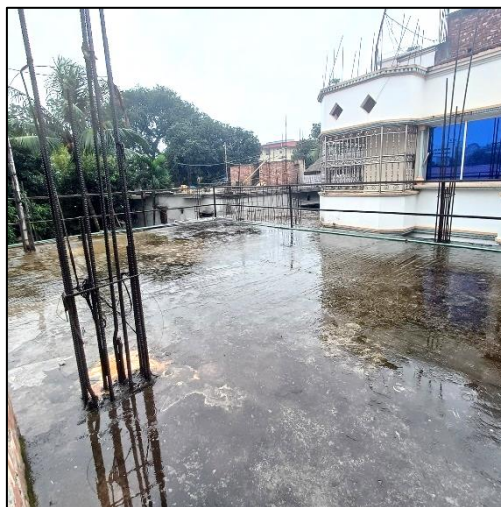
Observation-8: Exposed rebar on roof. (Office Building)

Description: Exposed reinforcement is left on roof, which was prone to corrosion. The building engineer is required to provide a rust-proof coating on the exposed reinforcement to protect it from corrosion.

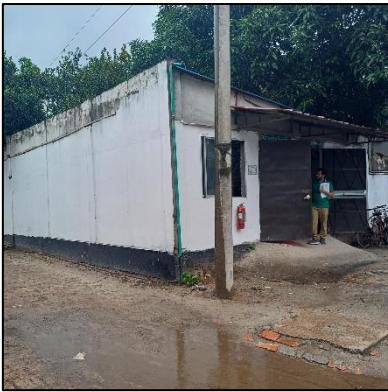
Doctor & Childcare

Observation-9: Incomplete as-built drawing. (Doctor & Childcare, Fire Control Room; and Boiler & Compressor Building)

Description: During the inspection, as-built drawings of super structure were found for these structures. But the foundation and connection details were not available in the provided drawings. The building engineer is required to conduct an onsite investigation and produce complete as-built drawings for all structures including foundation and connection details.
