# Cutting Edge Industries Ltd. (Extension)

1612, South Salna, Salna Bazar, Gazipur Sadar, Gazipur -1702

19 September 2024

## **1. Building Information**

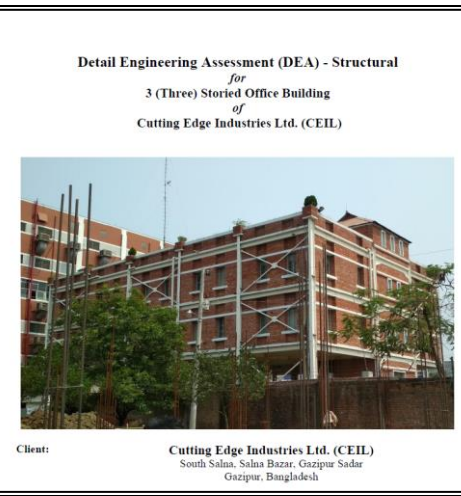
| Observation 1: Prepared DEA needs to be revised (Building-03 (Office Building)). | |
|---|---|
| <p><b>Description:</b> A DEA report was available onsite where NTPA Load combination has been considered. Construction of this structure was completed in Nov 2014 and permit layout drawing was dated 26 August 2013. The building engineer is required to update the DEA report considering load combination as per BNBC 2006.</p> | |

| Item No. | Observation | Action Plan | Timeline |
|---|---|---|---|
| 1. | Prepared DEA needs to be revised (Building-03 (Office Building)). | The building engineer is required to update the Detail Engineering Assessment (DEA) as per BNBC 2006. | within 6 weeks |

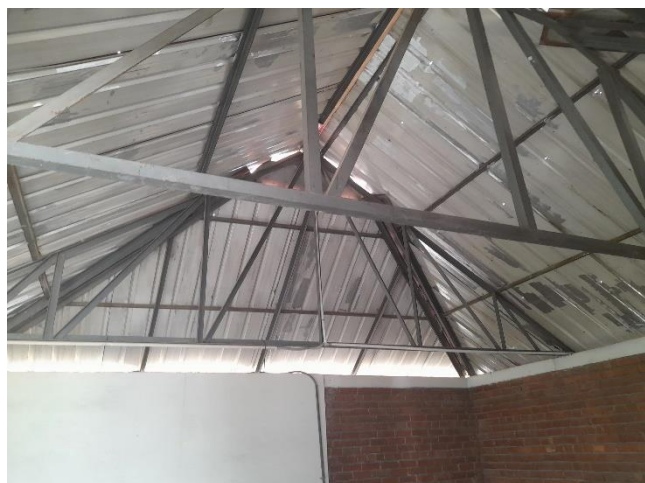
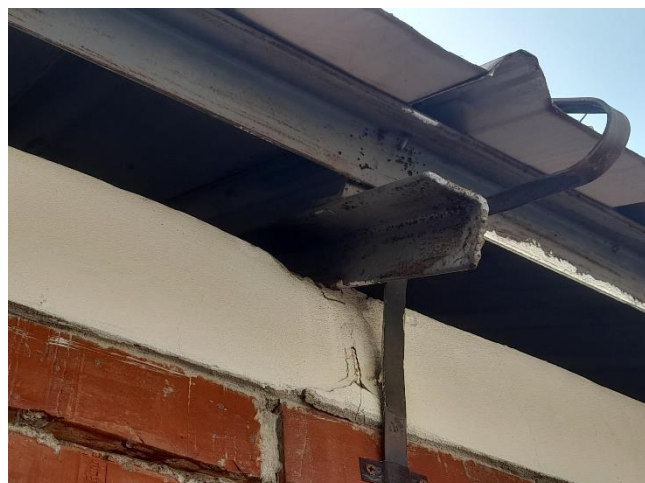
| Observation 2: Lack of structural connection (Building-03 (Office Building)). | |
|---|---|
| <p><u>Steel truss roofing system</u></p> | <p><u>Truss angle rested on masonry wall</u></p> |
| <p><b>Description:</b> During inspection no structural connection was observed between steel roof truss of staircase and supporting masonry wall. Factory engineers are required to check the connection adequacy for uplift forces as part of DEA.</p> | |

| Item No. | Observation | Action Plan | Timeline |
|---|---|---|---|
| 3. | Lack of structural connection (Building-03 (Office Building)). | Factory engineers are required to check the connection adequacy for uplift forces as part of DEA. | within 6 weeks |

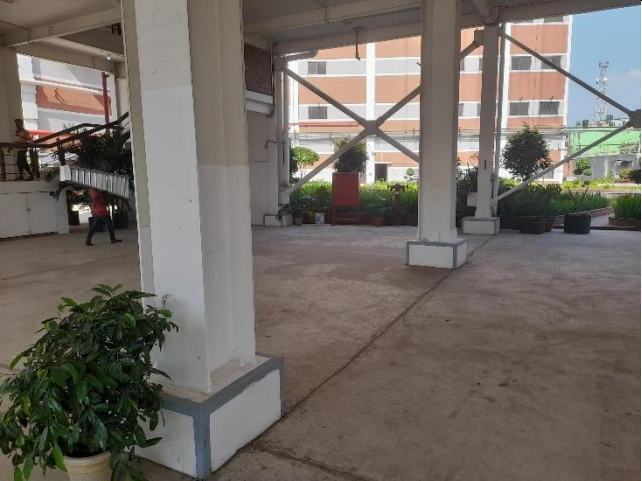
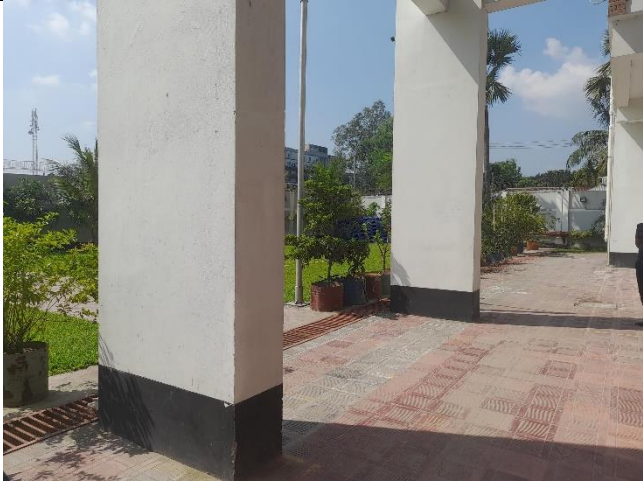
| <b>Observation 3:</b> Possibility of vehicle impact on columns of Building-03 (Office Building) & Building-05 (Link Bridge) | |

| <u>Exposed steel columns (Building-03)</u> | <u>Exposed RC columns (Building-05)</u> |
| <b>Description:</b> Steel columns at ground floor are prone to possible vehicle impact. Factory is required to provide barriers for all exposed column at ground floor to prevent from possible vehicle impact. | |

| Item No. | Observation | Action Plan | Timeline |
|---|---|---|---|
| 13. | Possibility of vehicle impact on columns in Building-05 (Link Bridge). | Factory is required to provide barriers for all exposed column at ground floor to avoid possible vehicle impact. | within 6 months |

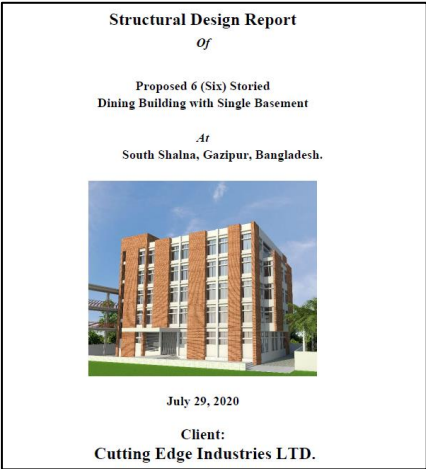
| <b>Observation 4:</b> Prepared design report needs to be reviewed against lateral loading (Building-04 (Dining Building)). | |

| <b>Description:</b> A Design report was available onsite where design material strength was considered. However, the design report needs to be reviewed against lateral loading. The building engineer is required to submit the design documents to RSC for review. | |

| Item No. | Observation | Action Plan | Timeline |
|---|---|---|---|
| 5. | The prepared design report needed to be reviewed against lateral loading (Building-04 (Dining Building)). | The building engineer is required to update the design report as per BNBC 2006. | within 6 weeks |

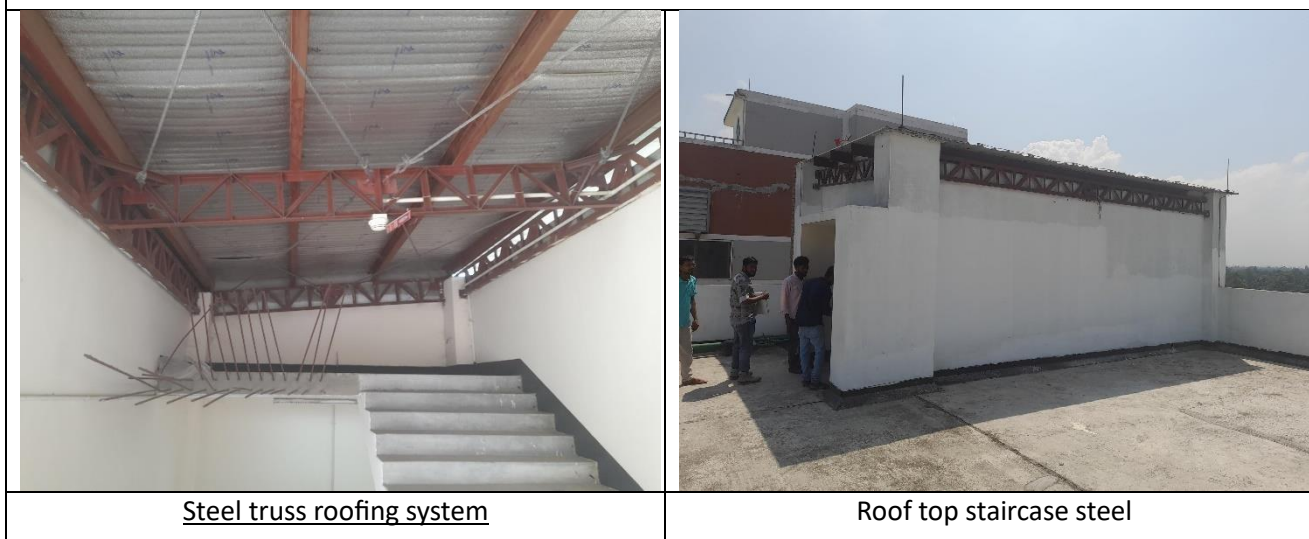
**Observation 5:** Missing information in a structural drawing of Building-04 (Dining Building).

**Description:** In the structural drawing, no structural details of rooftop staircase truss roofing were available. The building engineer is required to survey the structure and update the as-built drawing as per BNBC 2006.

| Item No. | Observation | Action Plan | Timeline |
|---|---|---|---|
| 7. | Missing information in as-built structural drawing (Building-04 (Dining Building)). | The building engineer is required to survey the structure and update the as-built drawing. | within 6 weeks |

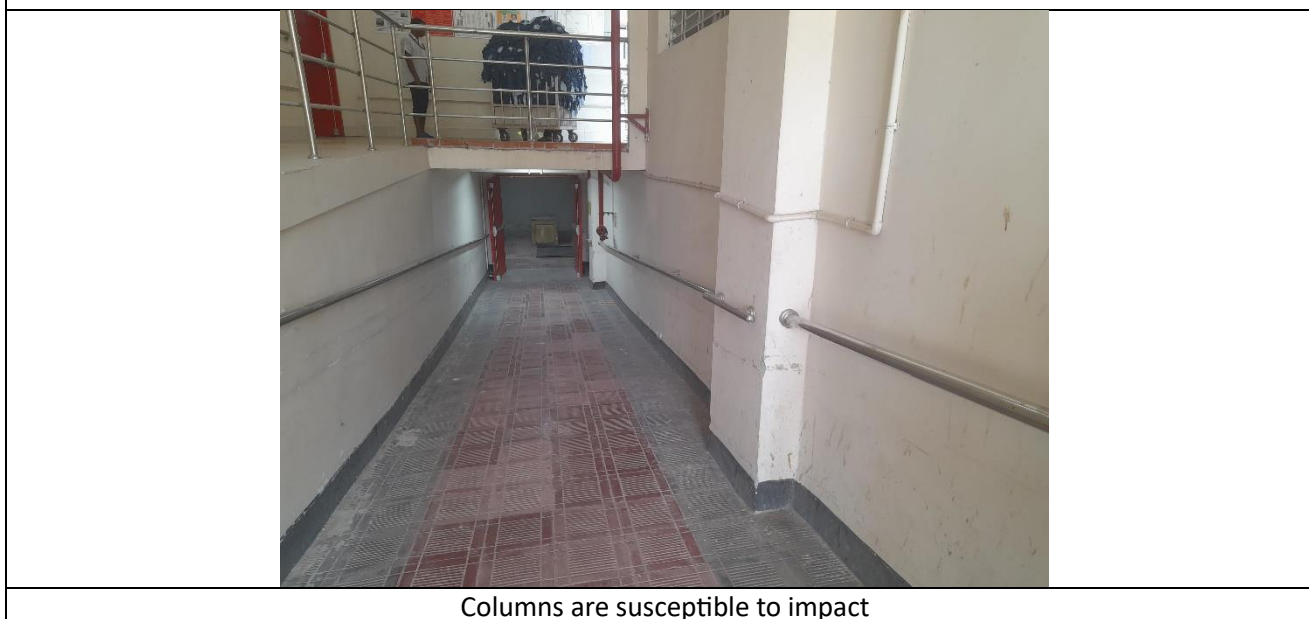
**Observation 6:** Column susceptible to trolley impact load on Building-04 (Dining Building).

**Description:** Columns are susceptible to impact loading from trolley. Signs of damage in columns were observed. Factory is required to provide guard for all exposed column and wall at ground floor to prevent from possible trolley impact.

| Item No. | Observation | Action Plan | Timeline |
|---|---|---|---|
| 9. | Column susceptible to trolley impact load (Building-04 (Dining Building)). | Factory is required to provide guard for all exposed columns and wall at ground floor to prevent from possible trolley impact. | within 6 months |
