Southeast Sweaters Ltd. NEW – (Extension)

Structural Inspection Report

Warehouse Building: 3-storied (G+2) prefabricated steel building.
ETP Building: Single-storied RC building.

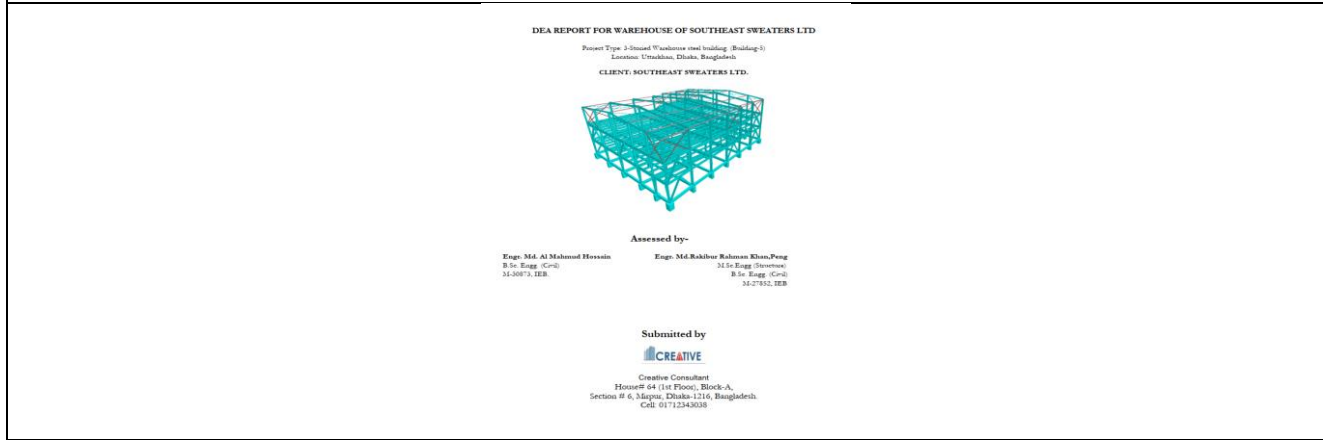
Observation 1: Lack of information in the design report (Warehouse Building).

Description: A design report was available onsite that doesn't include all the information. Pile capacity check is not provided separately for gravity and lateral load. The flexural capacity of the pile cap is not provided. Also, all serviceability and irregularity checks are not provided as per BNBC. The building engineer is required to update the design report as per 1.9.1 BNBC.

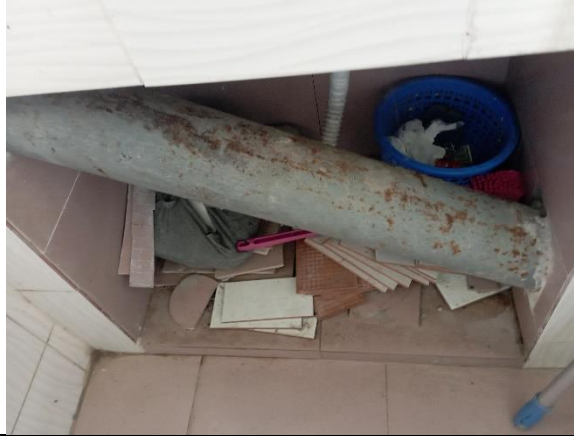
Observation 3: Corrosion on steel members (Warehouse Building).

Description: Corrosion was found on steel members in the toilet zone. Remove the corrosion and apply rust proof coating on steel members.
