# Lalmai Footwear Ltd. (Extension)

Dhanpur, Chapapur, PS: Adarsha Sadar, Cumilla-3500, Bangladesh.

25 September 2024

## 1. Building information

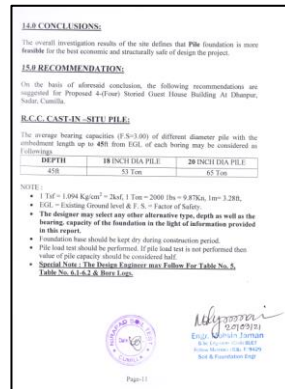
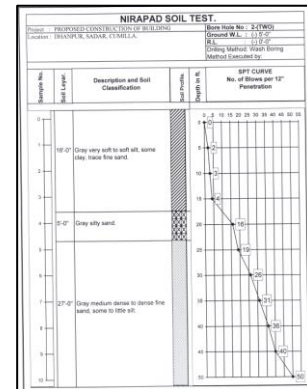
### Soil test report

### Observation 1: High stress in the foundation (Building 4- Workers' Dining & Resthouse).

**Description:** Cursory calculation indicates high stress in the foundation (footing) considering the recommended soil bearing capacity in the geotechnical report and footing sizes in the drawing. The building engineer is required to review the adequacy of footings and comply with BNBC based on the soil-bearing capacity.

The geotechnical investigation report consists of 4 borehole data up to a depth of 15m. As per BNBC-2020 table no 6.2.13 requirement a 30 m bore is required to determine the harmonic average SPT "N" value.

| Item No. | Observation | Action Plan | Timeline |
|---|---|---|---|
| 1. | High stress in the foundation. (Building 4- Workers' Dining & Resthouse) | Carry out a geotechnical investigation to close the vicinity of the building following BNBC-2020 requirements and determine the accurate soil bearing capacity at foundation depth. | within 6 weeks |
| 2. | | The building engineer is required to review the adequacy of footings as per the updated geotechnical investigation report. | within 6 weeks |

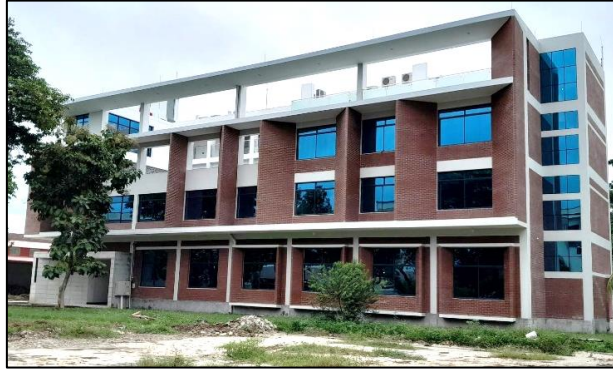
**Observation 2:** Lack of design report and material test report. (Building 4- Workers' Dining & Resthouse).

**Description:** Only the as-built drawings were available for the building, no design report and material test report were available. The building engineer is required to prepare Detail Engineering Assessment (DEA) & verify the in-situ concrete strength by taking concrete cores from columns.

| Item No. | Observation | Action Plan | Timeline |
|---|---|---|---|
| 3. | Lack of design report and material test report. (Building 4- Workers' Dining & Resthouse) | Verify in-situ concrete strength by taking concrete cores following BNBC guidelines from lower-tier columns. | within 6 weeks |
| 4. | | Conduct a Detail Engineering Assessment (DEA) for the building and submit the DEA to the RSC for review. | within 6 weeks |
| 5. | | Carry out suggested remedial works. | within 6 months |

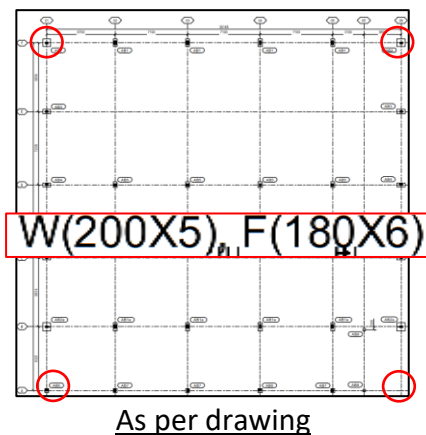
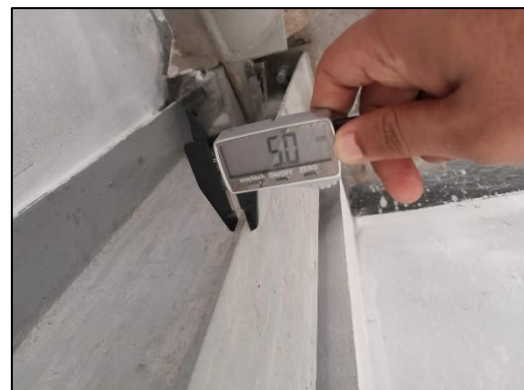
**Observation 4:** Mismatch in the as-built drawing. (Shed 7- Braiding Shed- Cycle Stand & Shop Shed).

**Description:** During the inspection, a mismatch was found in the as-built drawing. All corner columns were found W-200(5) X F 180 (5) instead of W-200(5) X F 180 (6). The building engineer is required to survey the full structure and update the as-built drawing as per on-site conditions.

| Item No. | Observation | Action Plan | Timeline |
|---|---|---|---|
| 8. | Mismatch in the as-built drawing. (Shed 7- Braiding Shed- Cycle Stand & Shop Shed). | The building engineer is required to survey the full structure and update the as-built drawing with connection details. | within 6 weeks |

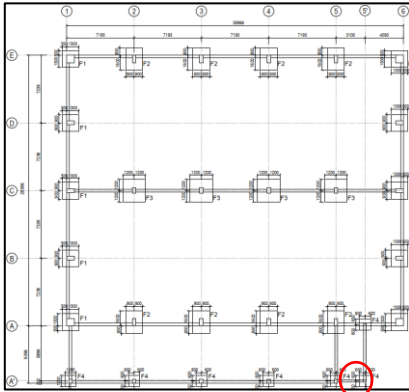
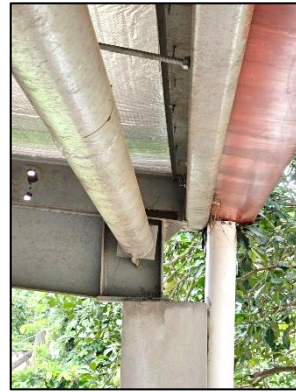
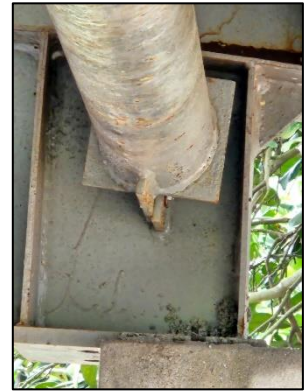
**Observation 5:** Improper connection between RC column and Steel Rafter. (Shed 7- Braiding Shed- Cycle Stand & Shop Shed).

**Description:** Improper connection was found between the RC column and the steel rafter. The building engineer is required to check the connection adequacy and proposed remedial works.

| Item No. | Observation | Action Plan | Timeline |
|---|---|---|---|
| 9. | Improper connection between RC column and steel rafter. (Shed 7- Braiding Shed- Cycle Stand & Shop Shed). | The building engineer is required to check the connection adequacy and proposed remedial works. | within 6 weeks |
| 10. | | Carry out suggested remedial works. | within 6 months |

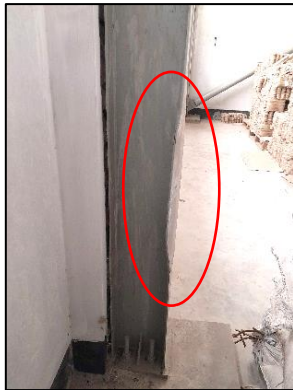
Onsite condition

**Observation 6:** Damage to steel column. (Shed 7- Braiding Shed- Cycle Stand & Shop Shed).

**Description:** During the inspection, a damaged steel column was identified. The building engineer is required to investigate the condition and repair with a suitable method.

| Item No. | Observation | Action Plan | Timeline |
|---|---|---|---|
| 11. | Damage to steel column. (Shed 7- Braiding Shed- Cycle Stand & Shop Shed). | The building engineer is required to investigate the condition and repair with a suitable method. | within 6 weeks |

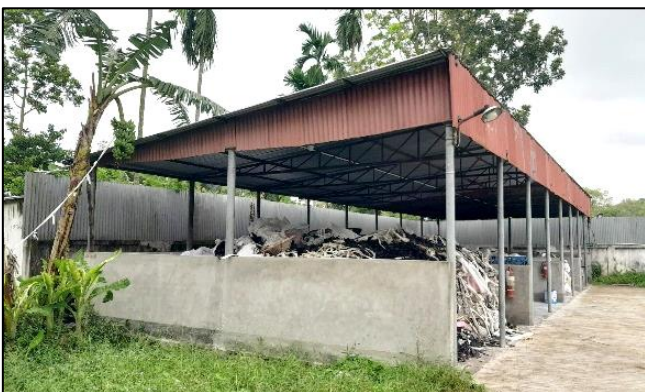
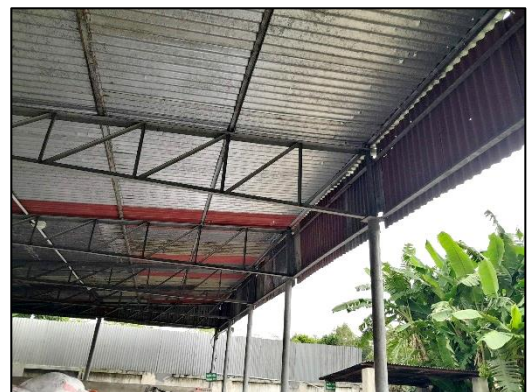
Wastage Goods Stack Area

**Observation 7:** Incomplete lateral load resisting system. (Shed 14- Wastage Goods Stack Area)

**Description:** Steel trusses are provided along the short direction. No lateral transfer media (struct) and horizontal/vertical cable bracing were provided along the long direction. Therefore, lateral stability in the long direction is incomplete. The building engineer is required to design the lateral load-resisting system, prepare a safety check report and submit it to the RSC for review.

| Item No. | Observation | Action Plan | Timeline |
|---|---|---|---|
| 12. | Incomplete lateral load resisting system. (Shed 14- Wastage Goods Stack Area) | The building engineer is required to design the lateral load-resisting system (strut, bracing & connections), prepare a safety check report and submit it to the RSC for review. | within 6 weeks |
| 13. | | Carry out remedial work where required. | within 6 months |

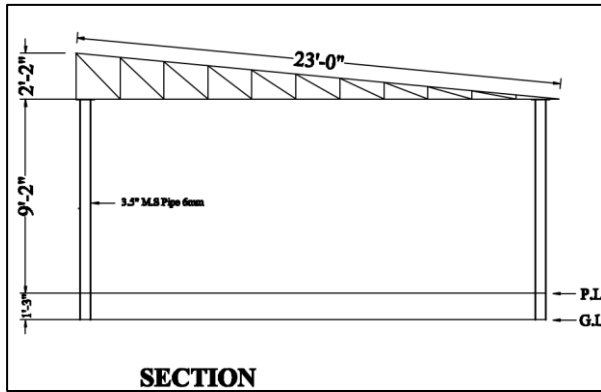
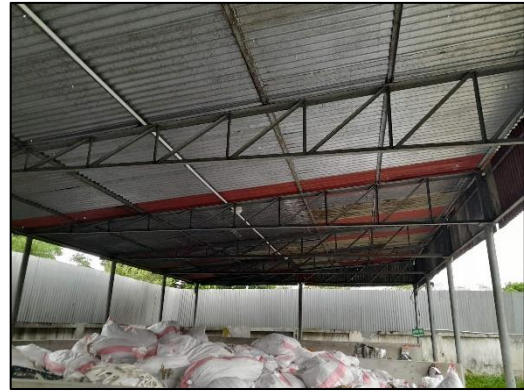
Wastage Goods Stack Area

**Observation 8:** Incomplete structural drawing. (Shed 14- Wastage Goods Stack Area)

**Description:** A set of drawings was found on site, but the column size of the truss details was missing in the structural drawing. The building engineer is required to survey the full structure and update the as-built drawings with foundation & connection details.

| 14. | Incomplete structural drawing. (Shed 14- Wastage Goods Stack Area) | The building engineer is required to prepare an accurate as-built drawing with connection details. | within 6 weeks |

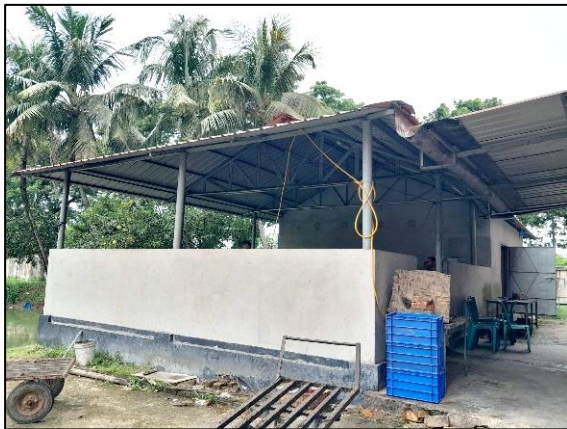
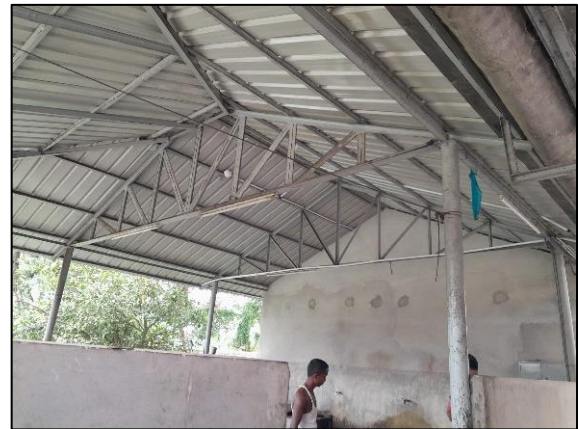
Kitchen & Store

**Observation 9:** Incomplete lateral load resisting system. (Shed 17- Kitchen & Store)

**Description:** Steel trusses are provided along the short direction. No lateral transfer media (struct) and horizontal/vertical cable bracing provided along the long direction. Therefore, lateral stability in the long direction is incomplete. The building engineer is required to design the lateral load-resisting system, prepare a safety check report and submit it to the RSC for review.

| 15. | Incomplete lateral load resisting system. (Shed 17- Kitchen & Store) | The building engineer is required to design the lateral load resisting system (strut, bracing & connections), prepare a safety check report and submit it to the RSC for review. | within 6 weeks |
| 16. | | Carry out remedial work where required. | within 6 months |

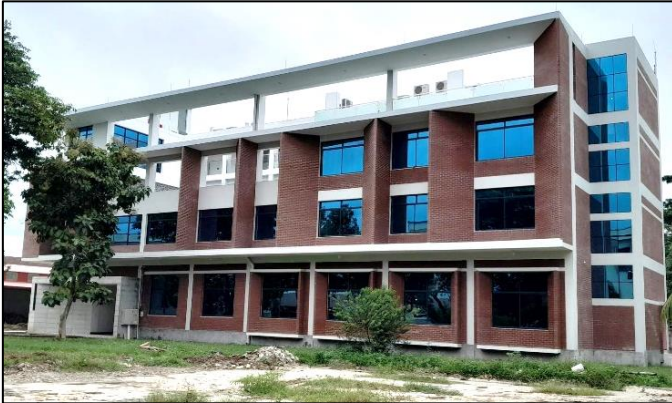
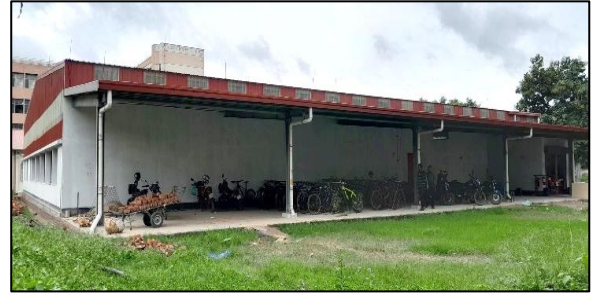
**Observation10.** Unavailable building permits/approval drawing. (Building 4- Workers' Dining & Resthouse, Shed 7- Braiding Shed- Cycle Stand & Shop Shed)

**Description:** The Building Permit/Approval drawing from the Local Authority was not available during the inspection. The building engineer is required to seek and collect the building Permit/Approval drawing.

| 17. | Unavailable building permits/approval drawing. (Building 4- Workers' Dining & Resthouse, Shed 7- Braiding Shed- Cycle Stand & Shop Shed) | The building engineer is required to seek and collect the building Permit/Approval drawing. | within 6 months |
