# Mazib Fashions

Mizmizi, Siddhirganj, Narayanganj

9 September 2024

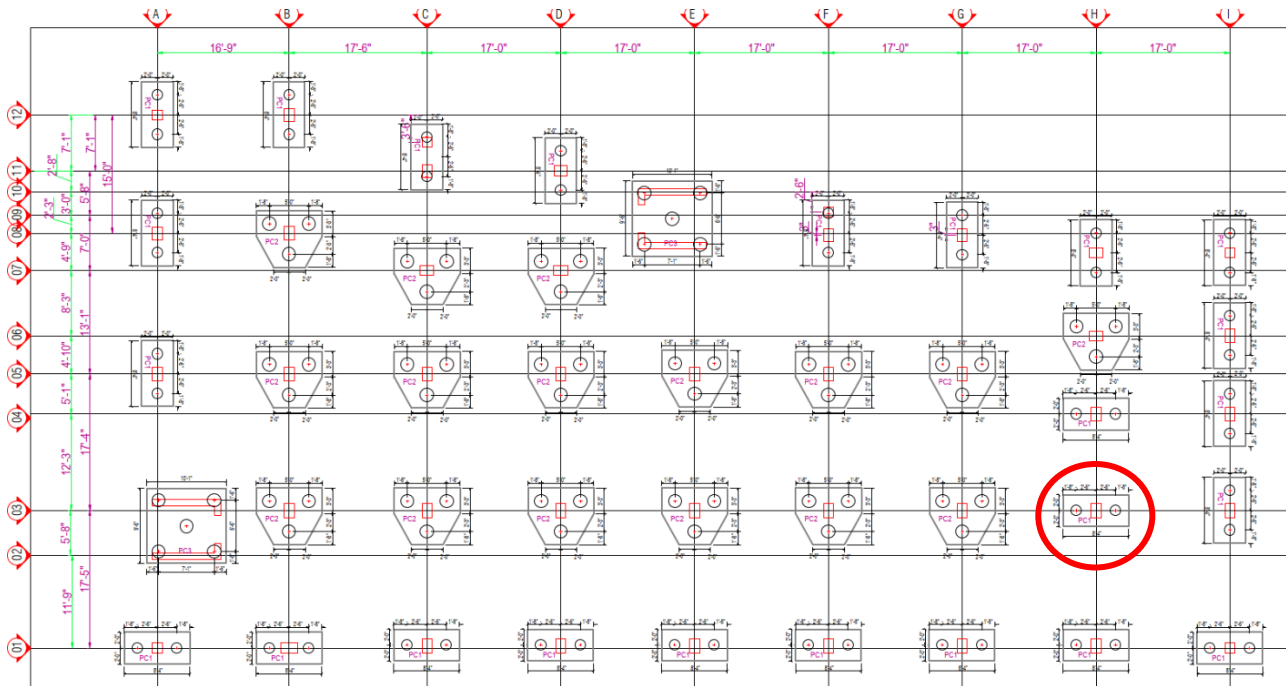
### Observation-1: Stress in foundation exceeds normal design limit (Main Building).

Foundation layout marking the stressed location

**Description:** cursory calculation indicates that the marked foundation appears to be stressed above normal design limits based on 3 kPa typical floor live load with calculated concrete core strength (29.3 MPa) and re-bar strength (415 MPa). The building engineer is required to carry out Detail Engineering Assessment (DEA) to review the design, loads and column & foundation stress based on in-situ material strength and soil-bearing capacity.

| Item No. | Observation | Action Plan | Timeline |
|---|---|---|---|
| 1. | Stress in the foundation exceeds the normal design limit (Main Building) | The building engineer is required to carry out Detail Engineering Assessment (DEA) to review the design, loads and column & foundation stress based on in-situ material strength and soil-bearing capacity. | within 6 weeks |
| 2. | | Implement remediation work if required. | within 6 months |

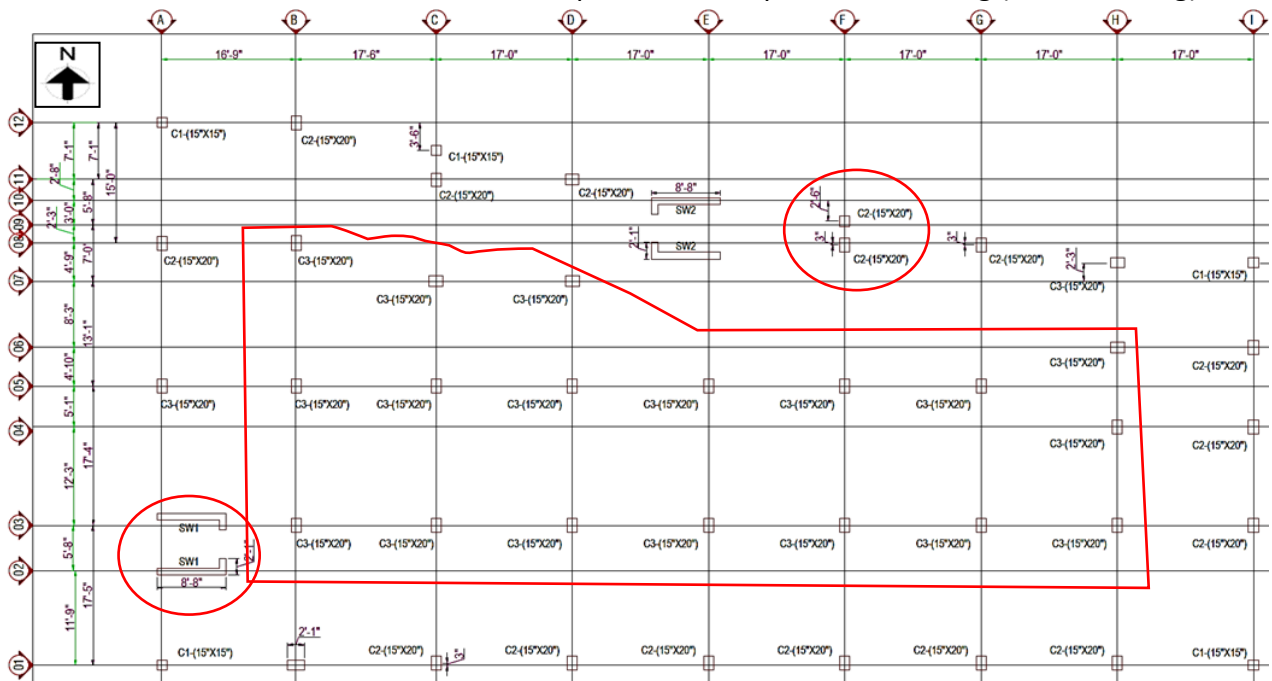
### Observation-2: Lack of information and discrepancies in the provided drawing (Main Building).

Column layout marking the discrepancies

**Description:** During the inspection, discrepancies were observed between the provided drawing and on-site conditions. RC column size & re-bar profile, beam alignment, and shear wall re-bar profile mismatches were observed. Also, no information was available for the roof shed. The building engineer is required to survey the whole structure and update the drawing reflecting actual on-site condition.

| Item No. | Observation | Action Plan | Timeline |
|---|---|---|---|
| 3. | Lack of information and discrepancies in the provided drawing (Main Building) | The building engineer is required to survey the whole structure and update the drawing reflecting actual on-site condition. | within 6 weeks |

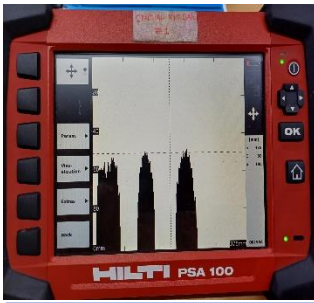
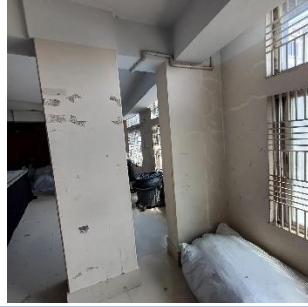
Column C2 size observed 250X375 instead of 375X500 and re-bar profile found by scanning 3/3 (8 no's) instead of 3/5 (12 no's)

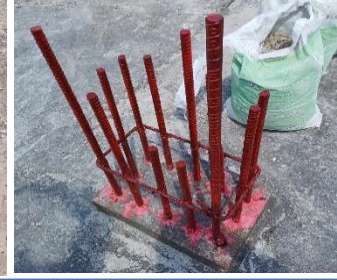
Column C3 (375X500) re-bar profile found by 12Ø20 instead of 8Ø25+4Ø20

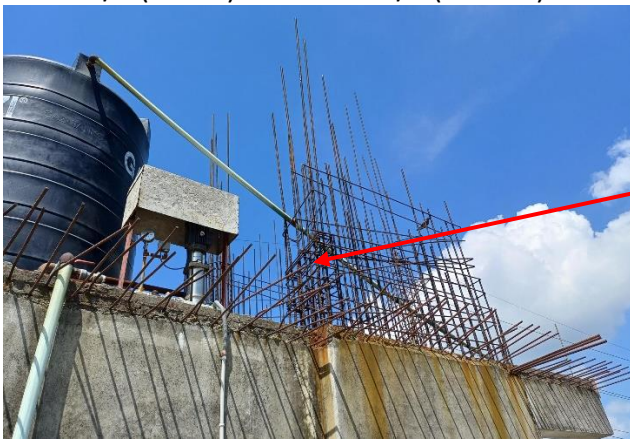
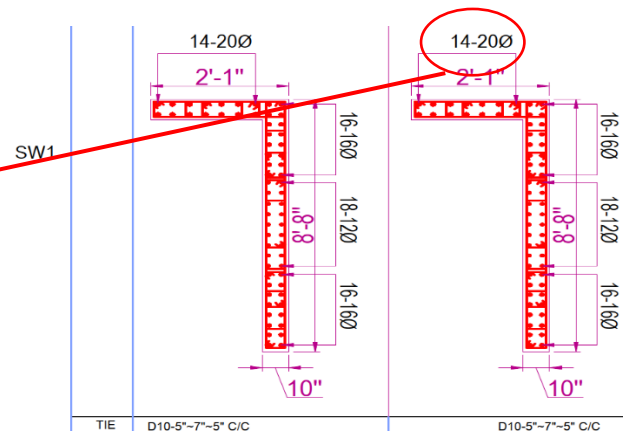
Shear wall re-bar profile found 8Ø20 instead of 14Ø20

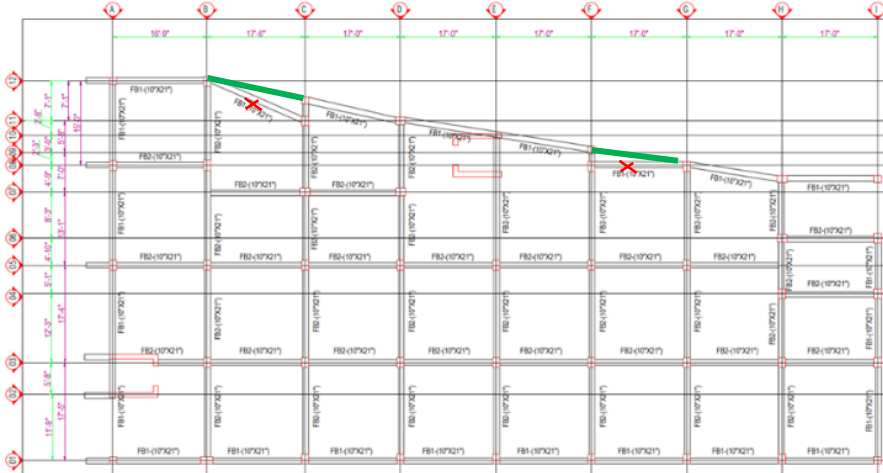
Beam alignment mismatching: The marked beams were found in place of green-marked

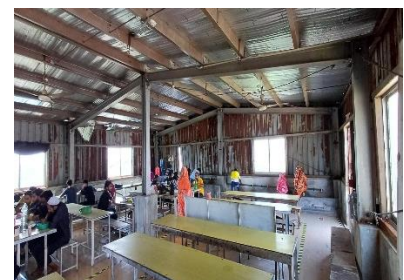
No drawing was provided for the roof shed

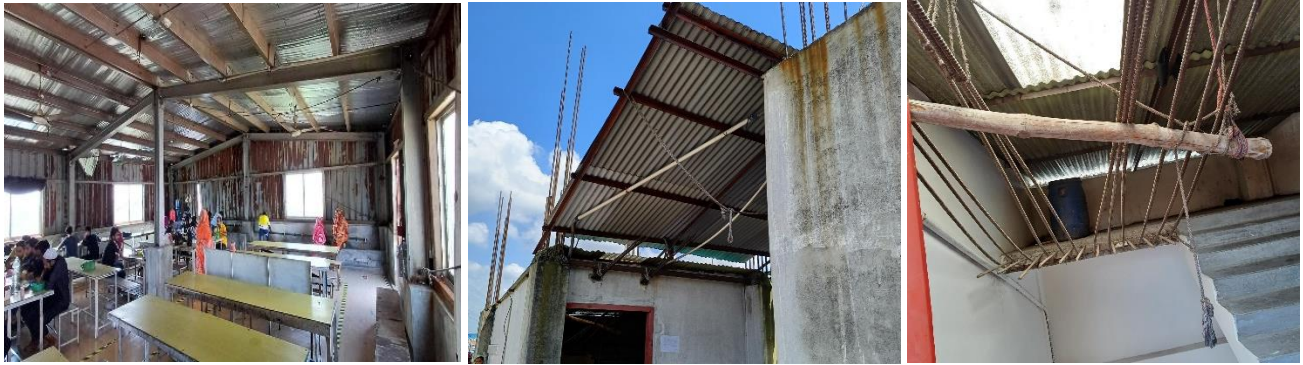
### Observation-3: Lack of lateral stability system in the roof shed and staircase (Main Building).

**Description:** During the inspection, the roof shed was observed with the portal framing system along the East-West direction but no lateral load transfer and resisting media (i.e. compression strut) was observed in the North-South direction. As well as inadequate member size was observed in the staircase. The building engineer is required to assess the stability of the roof shed and staircase and provide the remedial drawing.

| Item No. | Observation | Action Plan | Timeline |
|---|---|---|---|
| 4. | Lack of lateral stability system in the roof shed and staircase (Main Building) | The building engineer is required to assess the stability of the roof shed and staircase and provide the remedial drawing. | within 6 weeks |

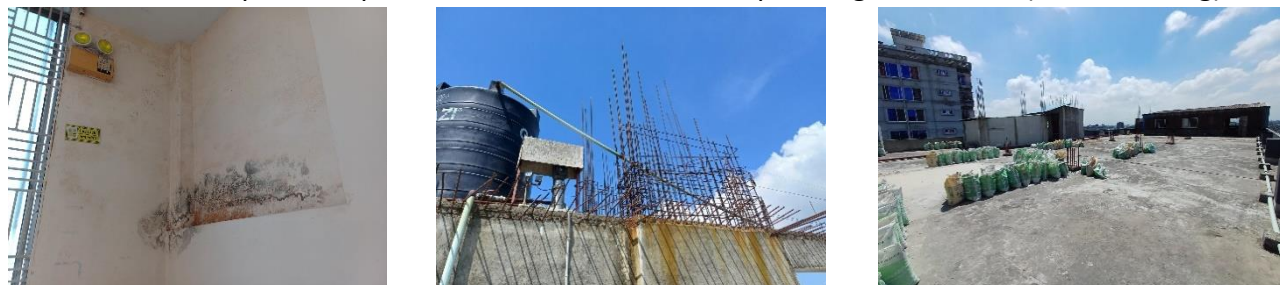
### Observation-5: Dampness, exposed re-bar and lack of waterproofing on the roof (Main Building).

Dampness

Exposed Re-bar

No waterproofing layer on the roof (MCAC on Roof)

**Description:** During the inspection, dampness was observed in several areas of the building. An exposed re-bar was found on the roof, making it vulnerable to corrosion. Additionally, no waterproofing layer was detected on the roof. The factory is required to address the dampness, apply the anticorrosive coating to the exposed re-bar, and construct a waterproofing layer on the roof.

| Item No. | Observation | Action Plan | Timeline |
|---|---|---|---|
| 6. | Dampness, exposed re-bar and lack of waterproofing on the roof (Main Building) | The factory is required to address the dampness, apply the anticorrosive coating to the exposed re-bar, and construct a waterproofing layer on the roof. | within 6 months |

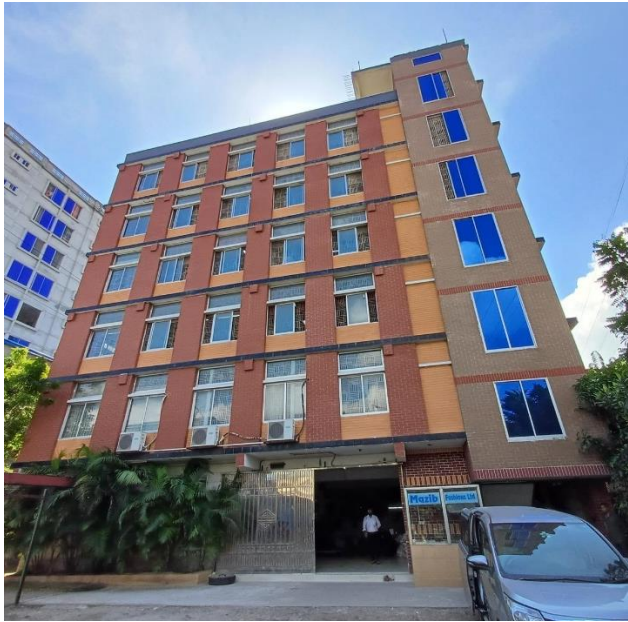
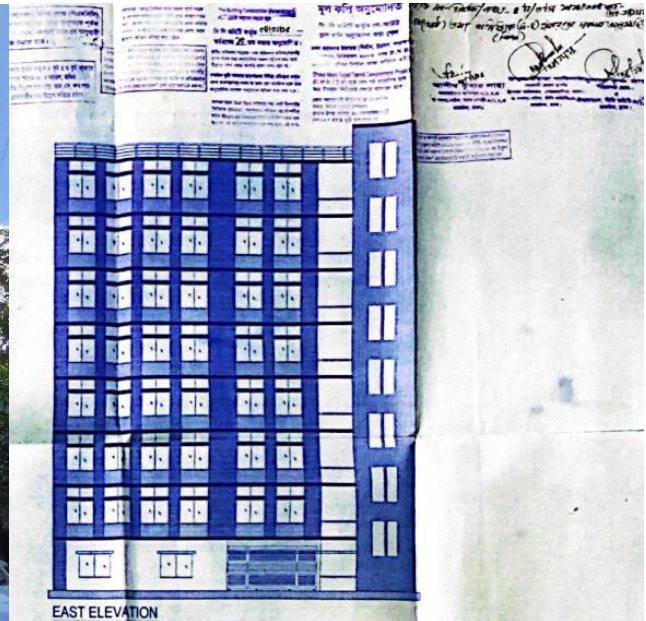
**Observation-6: Possible vertical extension (Main Building).**

**Description:** The factory has taken RAJUK (Local Authority) approval for the 8-storied (G+7) Main Building dated 4 December 2014. Also, projected reinforcement is left at the current roof which indicates possible future vertical extension. The building engineer is required to prepare a Detailed Engineering Assessment (DEA) report before conducting any vertical extension.

| Item No. | Observation | Action Plan | Timeline |
|---|---|---|---|
| 7. | Possible vertical extension (Main Building) | The building engineer is required to prepare a Detailed Engineering Assessment (DEA) report prior to conducting any vertical extension. | within 6 months |

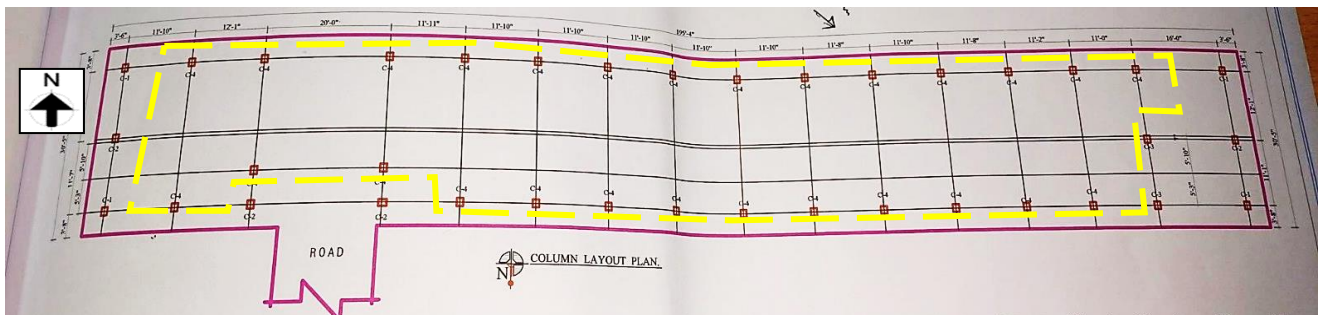
**Observation-7: Incomplete and inconsistent information in the provided drawing (Warehouse & Utility Building).**

Column layout- yellow marking of all C4 columns' size & re-bar mismatch

**Description:** During the inspection, discrepancies were observed between the provided drawing and on-site conditions. RC column size and re-bar profile mismatches were observed. Also, no information was available for the steel part and above marked areas of the structure. The building engineer is required to survey the whole structure and update the drawing reflecting actual on-site condition.

| Item No. | Observation | Action Plan | Timeline |
|---|---|---|---|
| 8. | Incomplete and inconsistent information in the provided drawing (Warehouse & Utility Building) | The building engineer is required to survey the whole structure and update the drawing reflecting actual on-site condition. | within 6 weeks |

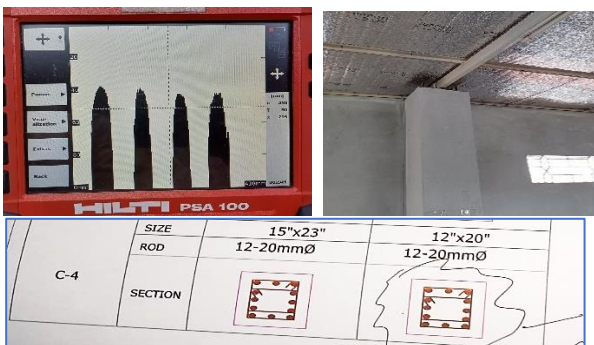
Column C4 size observed 300X375 instead of 300X500 and re-bar profile found by scanning 3/4 (10 no's) instead of 3/5 (12 no's)

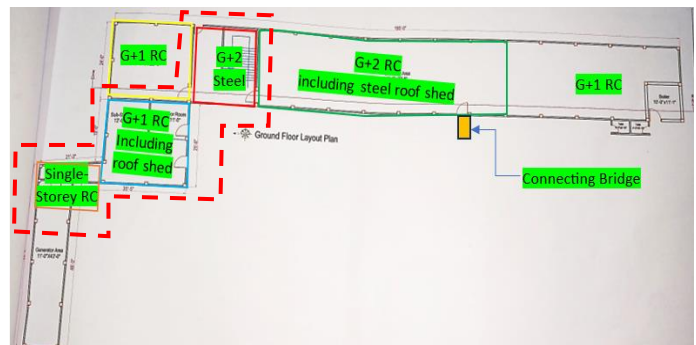
No drawing was provided for steel part and marked locations

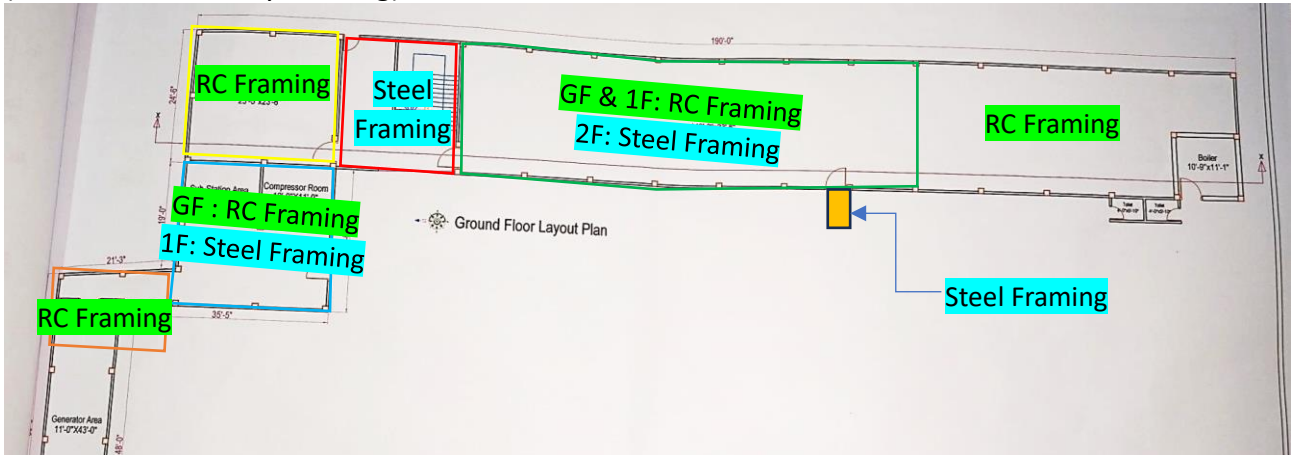
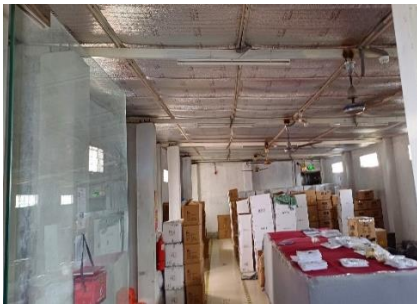
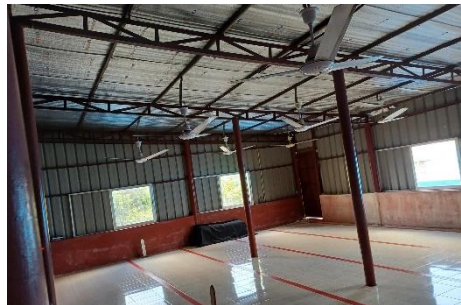
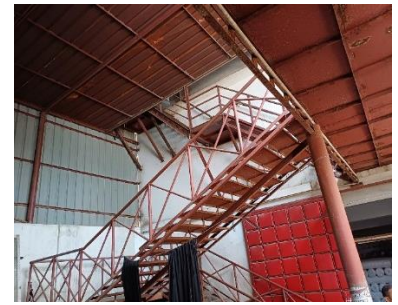
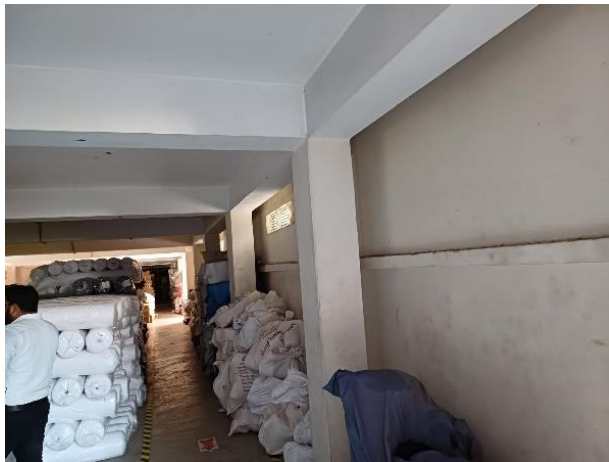
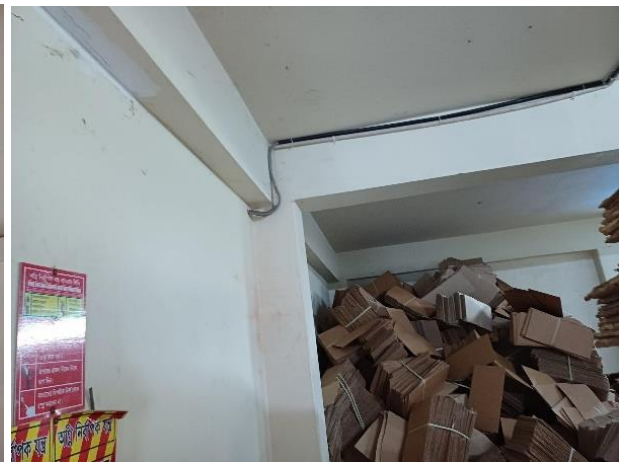
**Observation-8:** Different structural framing systems and lack of engineering assessment documents (Warehouse & Utility Building).

Steel Roof Shed (G+2 RC including steel roof shed)

RC Beam-Column framing

**Description:** The building consists of both RC & steel framing systems where the shape of both framing is horizontally irregular. The irregular shape induces torsion in the structure. Also, the structural integrity of the structure is questionable. The building engineer is required to check the framing system & structural integrity of the structure and prepare an EA report addressing the above-mentioned issues.

| Item No. | Observation | Action Plan | Timeline |
|---|---|---|---|
| 9. | Different structural framing systems and lack of engineering assessment documents (Warehouse & Utility Building) | The building engineer is required to check the framing system & structural integrity of the structure and prepare an EA report addressing the above-mentioned issues. | within 6 weeks |
| 10. | | Implement remediation work if required. | within 6 months |

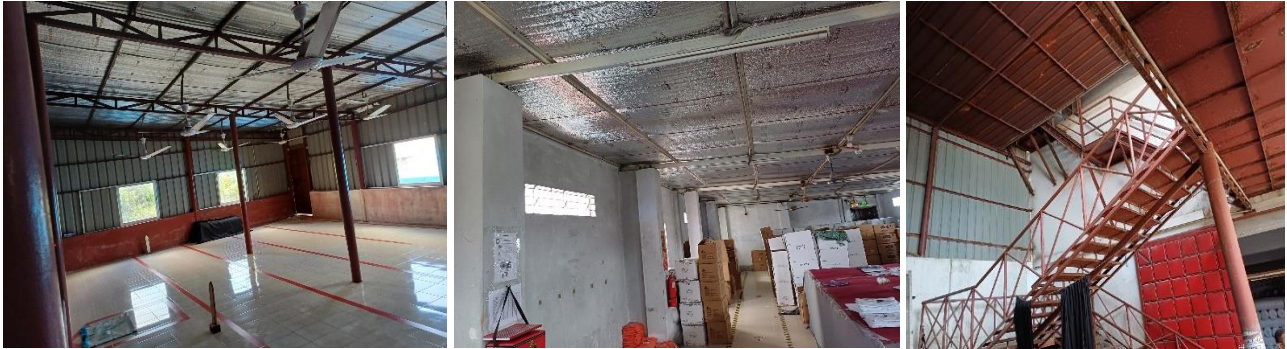
**Observation-9: Lack of lateral stability system in the roof sheds (Warehouse & Utility Building).**

**Description:** During the inspection, the roof sheds were observed with the truss system and c-channel supported on the RC column. However, no lateral load transfer and resisting media (i.e. compression strut) were observed in the perpendicular direction. As well as inadequate member size was observed in the staircase. The building engineer is required to assess the stability of the roof shed and staircase and provide the remedial drawing.

| Item No. | Observation | Action Plan | Timeline |
|---|---|---|---|
| 11. | Lack of lateral stability system in the roof sheds (Warehouse & Utility Building) | The building engineer is required to assess the stability of the roof shed and staircase and provide the remedial drawing. | within 6 weeks |

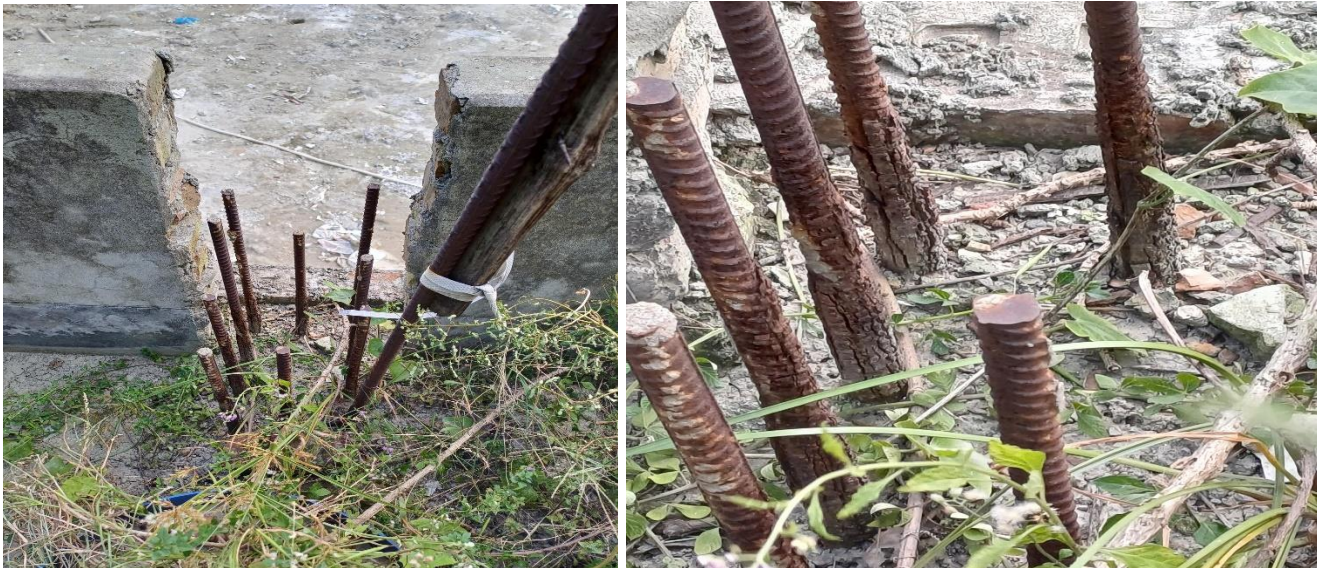
**Observation-10: Corrosion on the exposed re-bar (Warehouse & Utility Building).**

**Description:** During the inspection, corroded exposed rebar was found on the roof. The factory must remove the corrosion and apply an anti-corrosive coating to the exposed rebar.

| Item No. | Observation | Action Plan | Timeline |
|---|---|---|---|
| 12. | Corrosion on the exposed re-bar (Warehouse & Utility Building) | The factory must remove the corrosion and apply an anti-corrosive coating to the exposed rebar. | within 6 weeks |
