# Evitex Apparels limited Extension

Shirir Chala, Bagher Bazar, Gazipur

15 October 2024

### Observation 1: Missing information in the design report (Warehouse Extension Building).

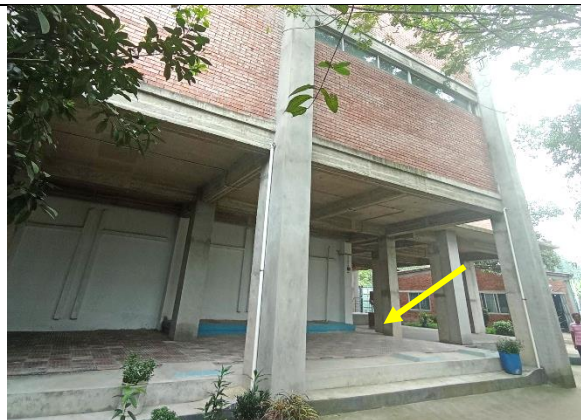
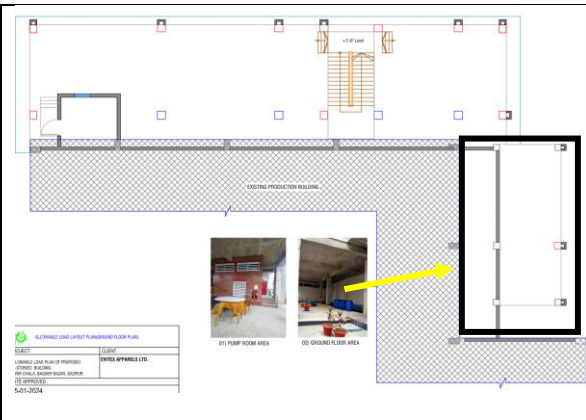
### Observation 2: Live load not mentioned for suspended slab of ground floor (Warehouse Extension Building).

**Description:** A septic tank is made below the ground floor of Part-2, but the live load is not shown in the load plan for that suspended ground floor slab. The building engineer is required to update the live load plan for all suspended slabs.

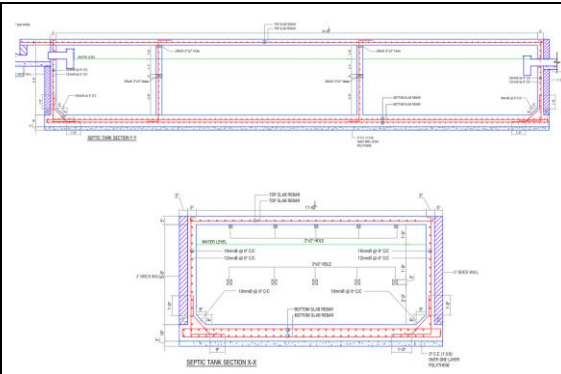
### Observation 3: Missing information in a built drawing (Warehouse Extension Building).

**Description:** Column details of the 2<sup>nd</sup> floor level are not provided in the column schedule. Also, the position of the septic tank to the existing footing is not clearly shown in the drawing. The building engineer is required to update the as-built drawing showing all missing information.
