# Jeans Plus Ltd. (Extension)

Plot No-398, Sreepur Bus Stand, Ganakbari, Savar, Dhaka.

14 October 2024

Factory Building (Extension): 6 storied (G+5) building with a partial basement.

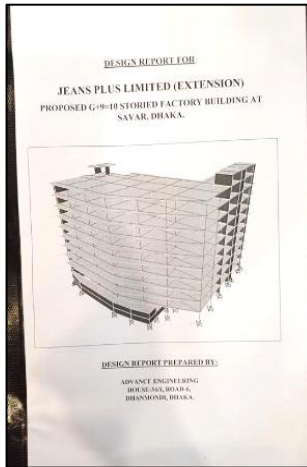
**Observation 01:** Inconsistency in the design report (for concrete design strength, combination of framing system, live loading on ground level suspended floors / prayer & dining room) (Factory Building- Extension) (Factory Building- Extension)

**Description:** Concrete design strength is considered in the report as 4760 psi (32.83 MPa) whereas 4500 psi in the structural documents. The structural framing is made of shear wall and moment frame but only moment frame considered in the design report. The floor live load plan was not prepared for suspended floors (UGWR top slab, rooftop slab, and basement mat). Also, the live load limit of dining & prayer area doesn't satisfy BNBC requirement. So, update the design documents based on design concrete strength and submit to RSC for review.

| SL | Observation | Action Plan | Timeline |
|---|---|---|---|
| 1. | Inconsistency in the design report (for concrete design strength, combination of framing system, live loading on ground level suspended floor slabs / prayer & dining room) (Factory Building-Extension) | The building engineer is required to update the design report based on in-situ material strength and submit the RSC for review. | within 6 weeks |
| 2. | | Produce and actively manage a loading plan for all suspended floor slabs considering floor, column and foundation capacity. | within 6 weeks |

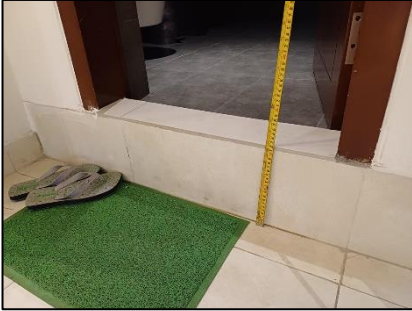
Built-ups

**Observation 02:** Mismatches/lacking in the as-built drawing (SW size, built-ups, basement layout) (Factory Building- Extension)

**Description:** Floor built-up was not shown in the load plan, basement & rooftop floor layout not prepared, column size at roof level found 900 mm instead of 600 mm. The building engineer is required to survey the structure and prepare as-built drawings.

| SL | Observation | Action Plan | Timeline |
|---|---|---|---|
| 4. | Mismatches/lacking in the as-built drawing (SW size, built-ups, basement layout) (Factory Building- Extension) | The building engineer is required to survey the structure and prepare as-built drawings. | within 6 weeks |

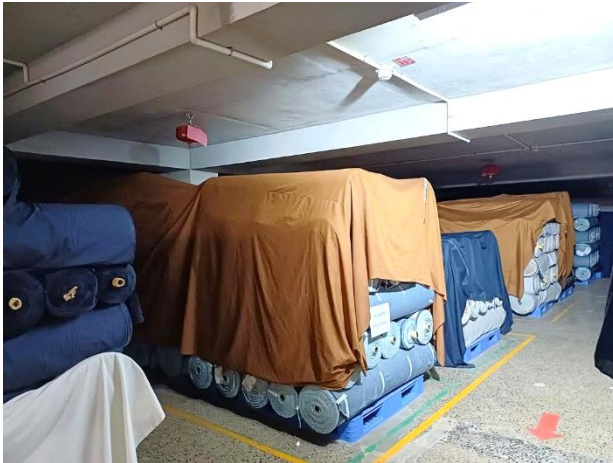
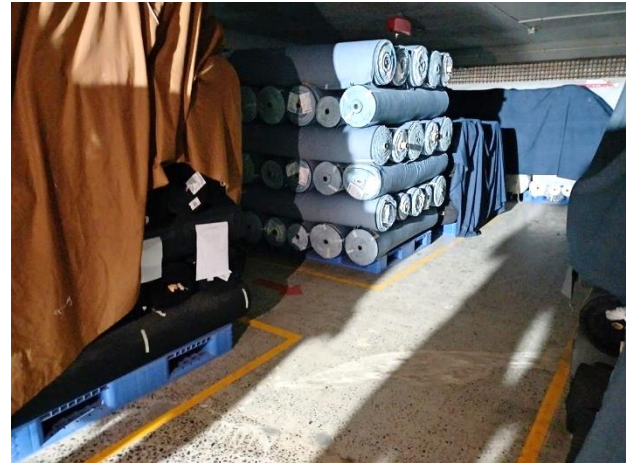
**Observation 03:** Heavy storage load on the ground floor suspended slabs. (Factory Building-Extension)

**Description:** During inspection, heavy storage (live load approximately 100 psf/5 kPa) was found on the top slab of UGWR at ground floor, load height marking was missing, and there was no live load plan available onsite. However, reduce storage loading immediately from ground floor suspended area to 3 kPa and maintain until finalization of load plan. Implement allowable load management plan (posting load plan, marking area & load height, maintaining floor load accordingly) after finalization.

| SL | Observation | Action Plan | Timeline |
|---|---|---|---|
| 5. | Heavy storage load on the ground floor suspended slabs. (Factory Building-Extension) | Reduce loading immediately from ground floor suspended area to 3 kPa and maintain until finalization of allowable floor live load plan. | Immediate |
| 6. | | Implement final floor load plan (posting load plan, marking area & load height, maintaining floor load accordingly). | within 6 months |

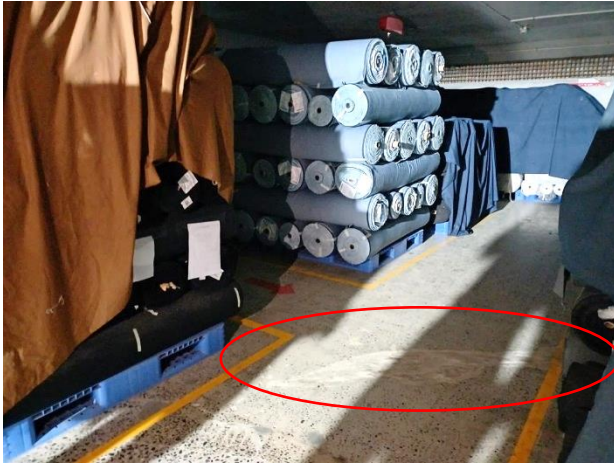
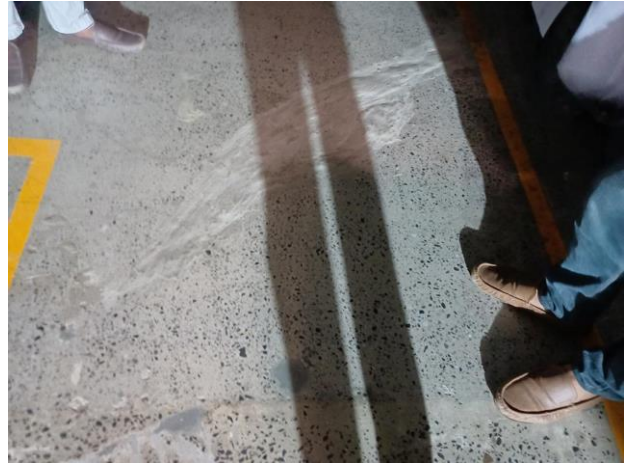
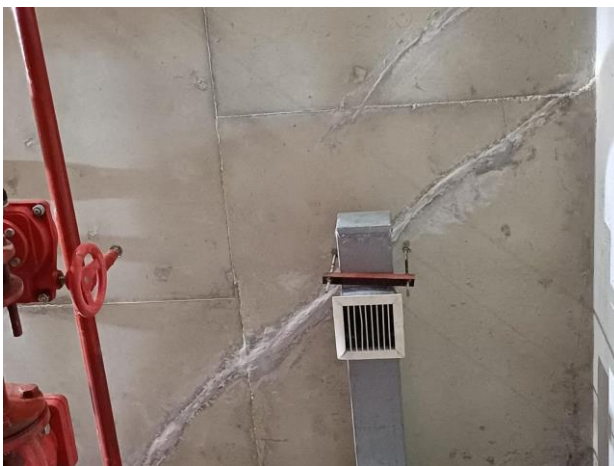
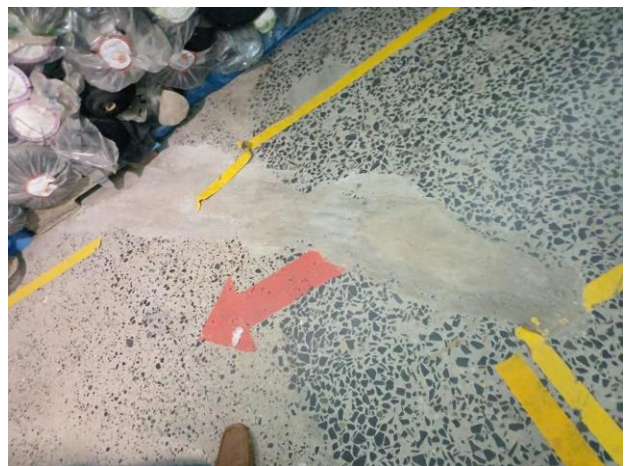
**Observation 04: Cracks in ground floor suspended slab. (Factory Building- Extension)**

**Description:** Cracks were found in the ground floor suspended slab (storage area & fire pump room). The building engineer is required to identify the reason for the crack, prepare an investigation report and submit it to RSC for review. Carryout remedial works as per crack investigation report after RSC approval/consent.

| SL | Observation | Action Plan | Timeline |
|---|---|---|---|
| 7. | Cracks in ground floor suspended slab. (Factory Building- Extension) | The building engineer is required to identify the reason for the crack, prepare an investigation report and submit it to RSC for review. Carryout remedial works as per crack investigation report after RSC approval/consent. | within 6 weeks |

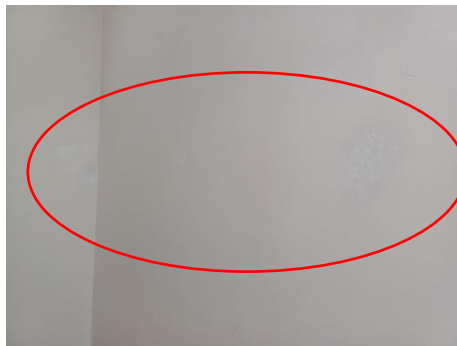
**Observation 05: Dampness on brick walls. (Factory Building- Extension)**

**Description:** Dampness observed on brick walls at north stair zone due to water intrusions. The factory is required to identify all the damp locations, seal the source of water, and repair the damp areas with suitable method.

| SL | Observation | Action Plan | Timeline |
|---|---|---|---|
| 8. | Dampness on brick walls. (Factory Building- Extension) | The factory is required to identify all the damp locations, seal the source of water, and repair the damp areas with suitable method. | within 6 weeks |

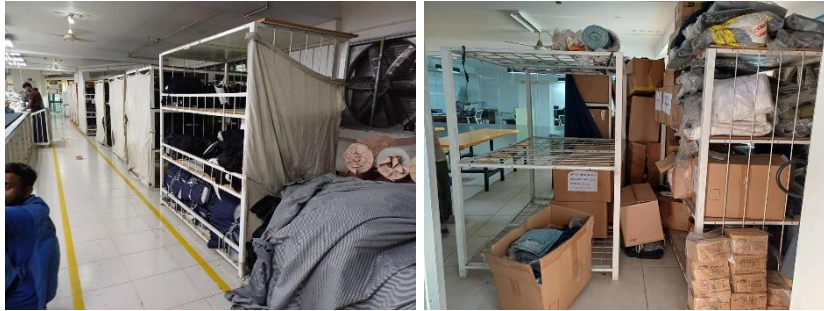
**Observation 06:** Lack of anchorage/bracing for non-structural elements including storage racks.  
(Factory Building- Extension)

**Description:** Lack of anchorage/bracing was observed for storage racks. Provide anchorage/bracing to the storage racks and water tanks.

| SL | Observation | Action Plan | Timeline |
|---|---|---|---|
| 9. | Lack of anchorage/bracing for non-structural elements including storage racks. (Factory Building- Extension) | Provide anchorage/bracing to the storage racks. | within 6 months |
