# Majumder Garments Ltd (relocation) (Extension)

Majumder Center, 113/1, Mudafa Paschim Para, Tongi, Gazipur  
(23.901078, 90.366939)

16 October 2024

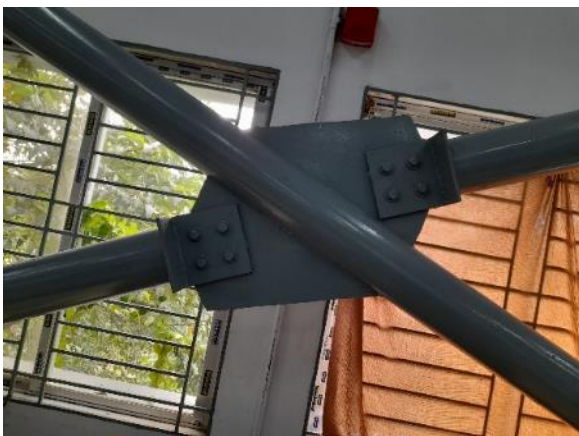
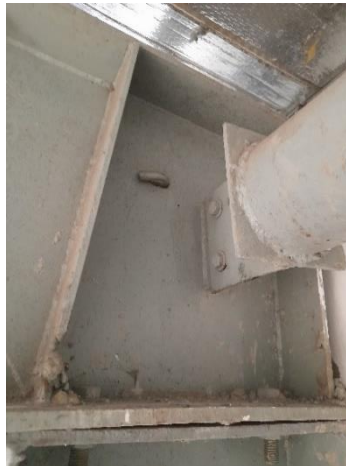
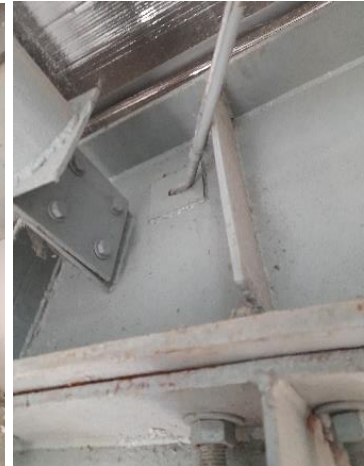
**Description:** Connection adequacy check for the bracing and other collector members has not been provided in the DEA report. The building engineer is required to revise the prepared design document and submit it to RSC for further review.

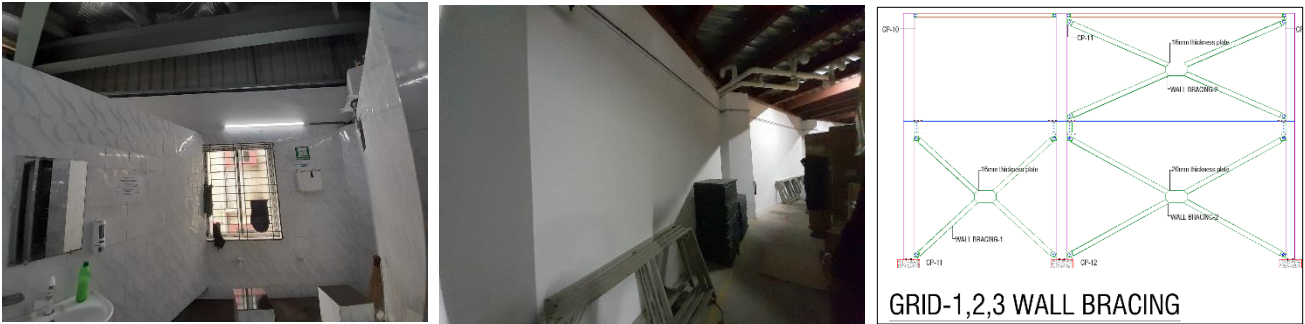
Wall bracing was found missing at 1st floor and ground floor at Grid-1,2&3.

| Serial No | Observation | Action Plan | Timeline |
|---|---|---|---|
| 3 | Inconsistencies in as-built drawings. (Two Storied Steel Shed Building). | The building engineer is required to update the as-built drawing reflecting the actual site condition. | within 6 weeks |

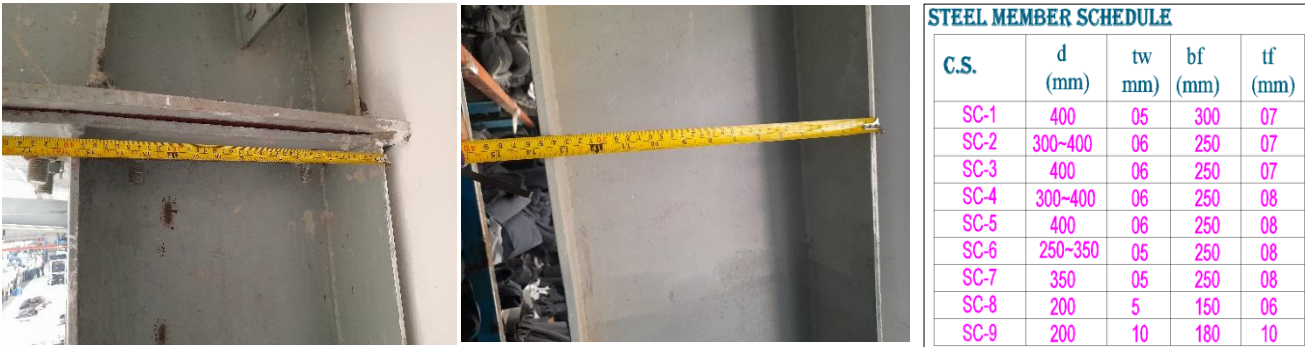
SC2 & SC6 columns were found regular shape on 1st floor, but the column has been mentioned as a tapered shape in the drawing.

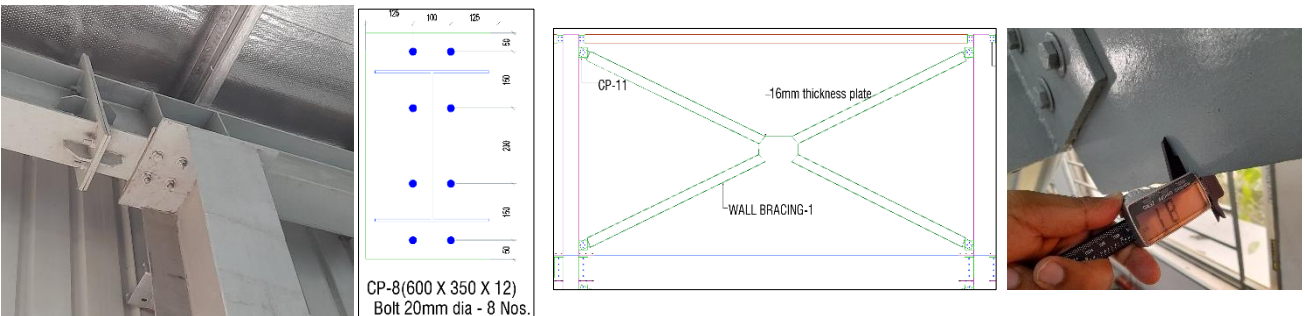
Connection details of CP-8

Connection details of bracing

**Description:** Connection details of CP-8 do not match with site conditions. The bolt arrangement does not Match. The orientation between the column and rafter was found mismatched. The connection details of the wall bracing do not match the site condition. The thickness of the gusset plate was found 8mm instead of 16mm. The building engineer is required to update the as-built drawing for the structure as per site condition

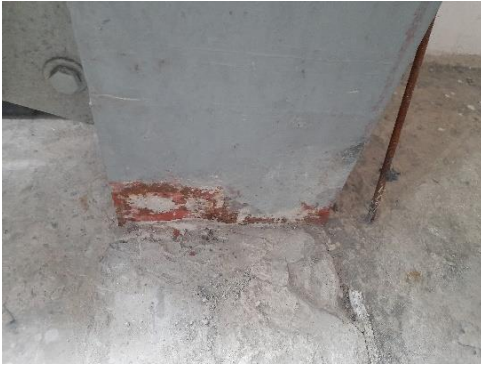
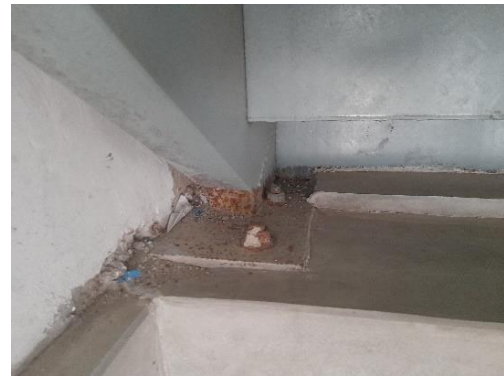
**Observation-03: Corrosion in steel member. (Two Storied Steel Shed Building)**

**Description:** Corrosion was in the steel member. The building engineer is required to repair the corrosion and provide rust-proof coating on steel member to protect from corrosion.

| Serial No | Observation | Action Plan | Timeline |
|---|---|---|---|
| 4 | Corrosion in steel member. (Two Storied Steel Shed Building). | The building engineer is required to repair the corrosion and provide rust-proof coating on steel member. | within 6 months |

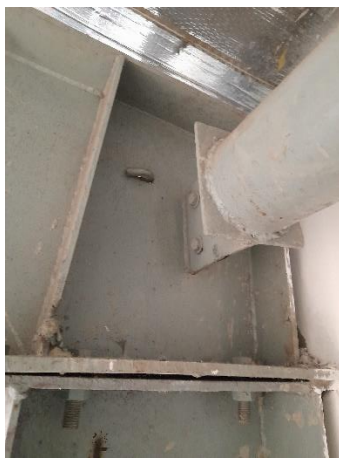
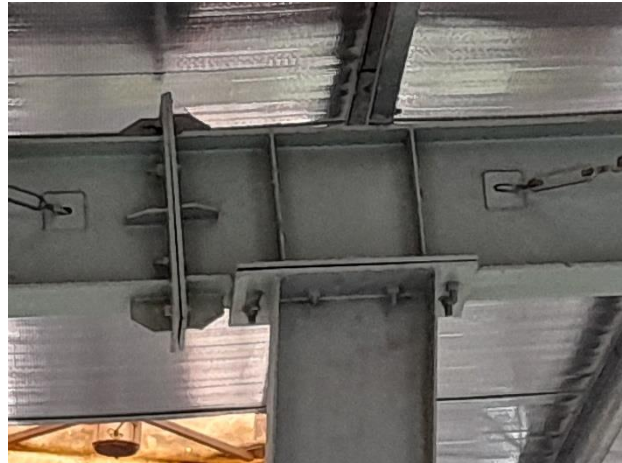
**Observation-04: Gap found in connection. (Two Storied Steel Shed Building)**

**Description:** Connection gaps and bolt missing were observed in the steel joint. The building engineer is required to carry out suitable remedial works.

| Serial No | Observation | Action Plan | Timeline |
|---|---|---|---|
| 5 | Gap found in connection. (Two Storied Steel Shed Building). | The building engineer is required to carry out suitable remedial works. | within 6 months |

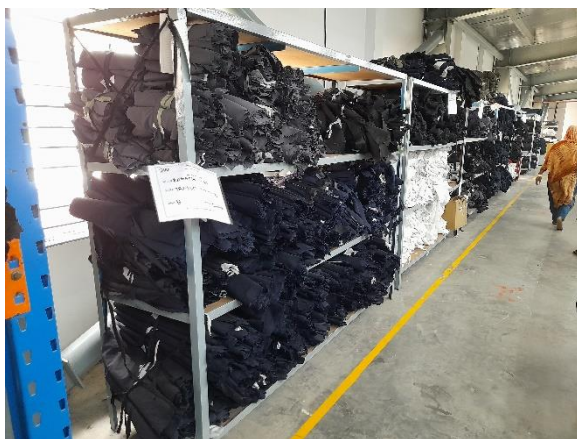
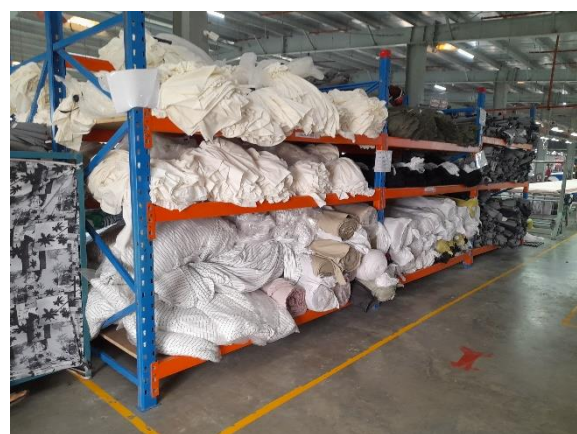
**Observation-05: Non-structural elements not anchored or braced. (Two Storied Steel Shed Building)**

**Description:** Some racks on floors are not anchored or braced to resist lateral (earthquake) forces. The factory is required to anchor/brace all non-structural elements adequately to resist earthquake forces.

| Serial No | Observation | Action Plan | Timeline |
|---|---|---|---|
| 6 | Non-structural elements not anchored or braced. (Two Storied Steel Shed Building). | The factory is required to anchor/brace all non-structural elements adequately to resist earthquake forces. | within 6 months |

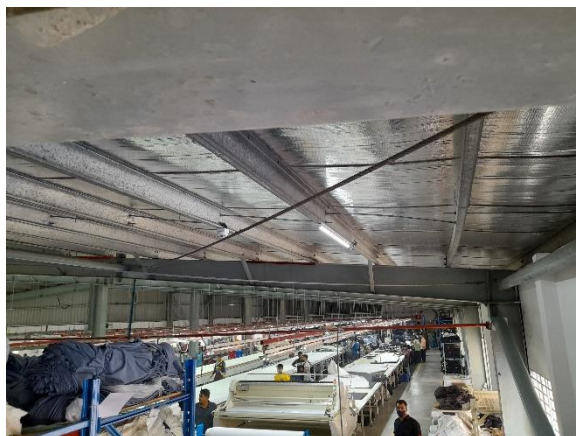
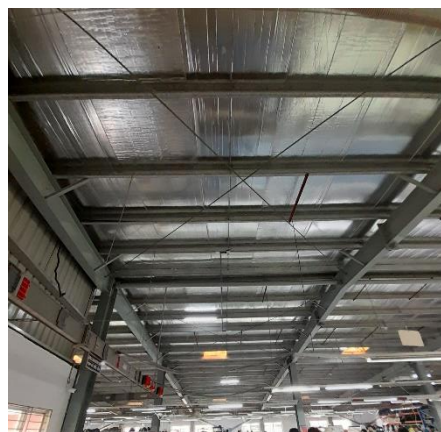
**Observation-06:** Loose cable bracing. (Two Storied Steel Shed Building)

**Description:** During inspection, roof Cable bracing was found loose. The building engineer is required to tighten the roof bracing.

| Serial No | Observation | Action Plan | Timeline |
|---|---|---|---|
| 7 | Loose cable bracing. (Two Storied Steel Shed Building). | Building engineer is required to tighten the loose bracing. | within 6 weeks |

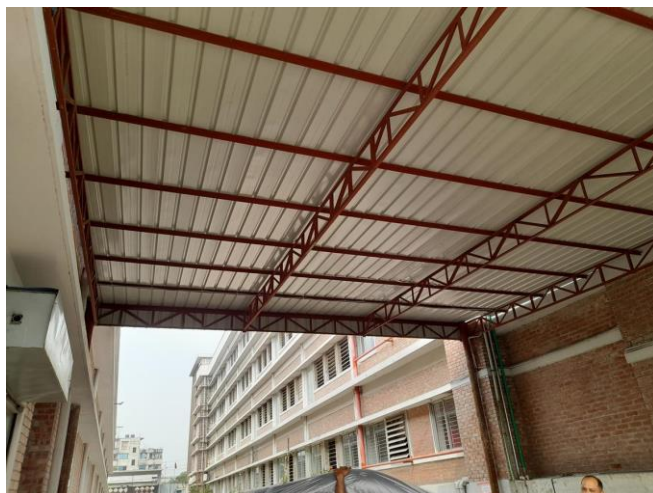
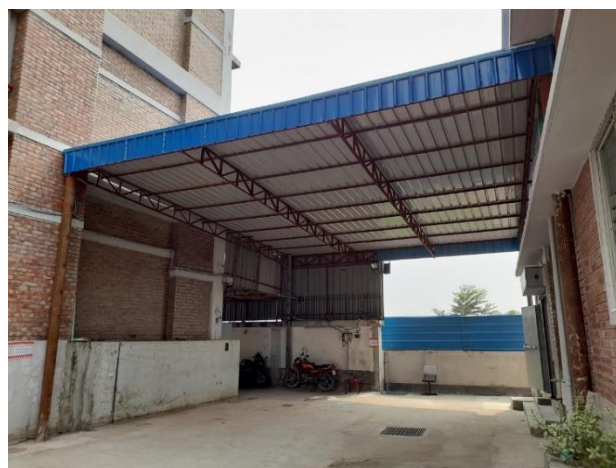
**Observation-07:** Lack of as-built drawing. (Loading-Unloading shed).

**Description:** As-built drawings (architectural and Structural) drawings were not available for the loading-unloading shed. Building engineer is required to prepare a full set of as-built drawing for the shed.

| Serial No | Observation | Action Plan | Timeline |
|---|---|---|---|
| 8 | Lack of as-built drawing. (Loading-Unloading shed). | The building engineer is required to survey the whole structure and prepare a full set of as-built drawings. | within 6 weeks |

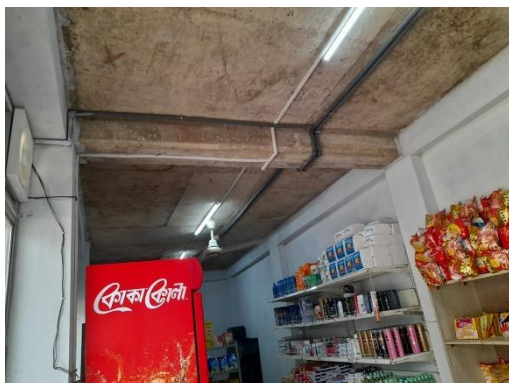
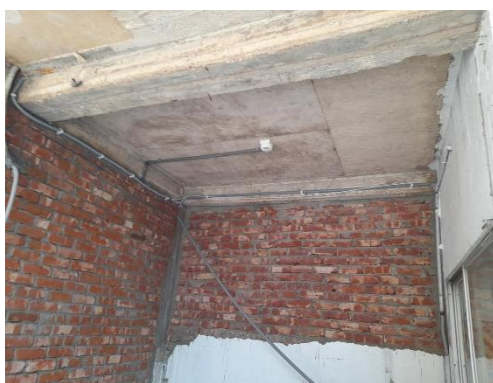
**Observation-08:** Lack of as-built drawing. (Security Building)

**Description:** As-built drawings (architectural and Structural) drawings were not available for the Security Building. Building engineer is required to prepare a full set of as-built drawing for the shed.

| Serial No | Observation | Action Plan | Timeline |
|---|---|---|---|
| 9 | Lack of as-built drawing. (Security Building). | The building engineer is required to survey the whole structure and prepare a full set of as-built drawings. | within 6 weeks |

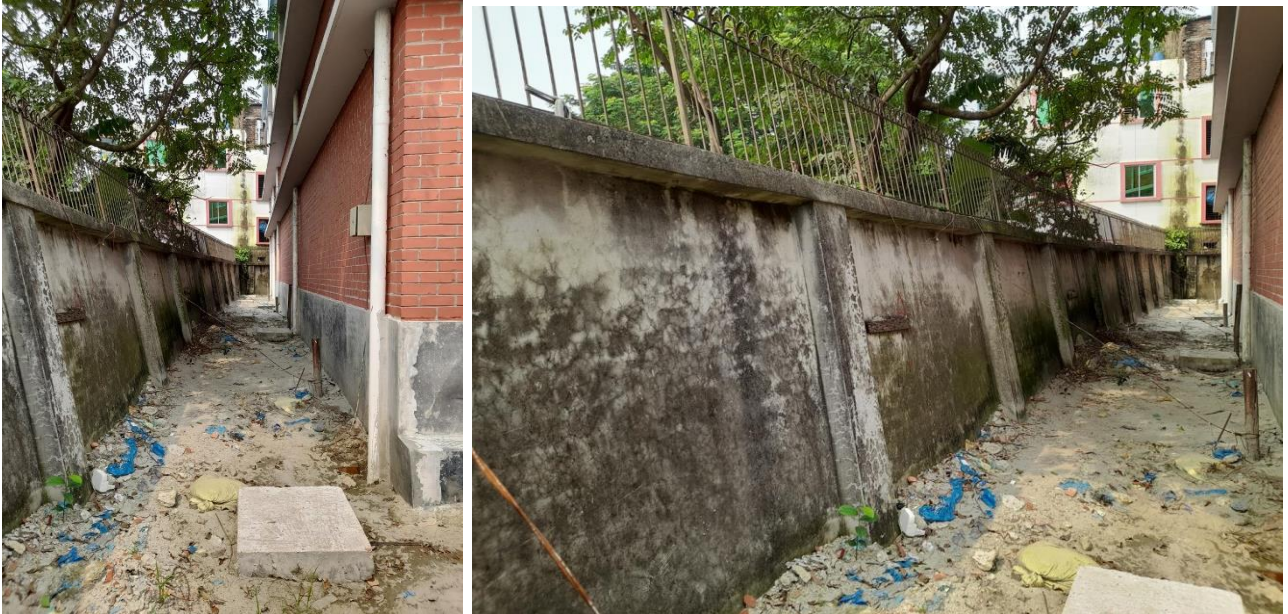
**Observation-09:** The boundary wall leaned to the west side of Two Storied Steel Shed Building.

**Description:** A boundary wall outward the factory premises. The outward side of the boundary wall is low land. The building engineer is required to investigate the reason for the tilting of the wall and suggest proper remedial action.

| Serial No | Observation | Action Plan | Timeline |
|---|---|---|---|
| 10 | The boundary wall leaned to the west side of Two Storied Steel Shed Building. | The factory is required to take necessary action to prevent the potential collapse of the boundary wall and provide the entry restriction to that location. | Immediate |
| 11 | The boundary wall leaned to the west side of Two Storied Steel Shed Building. | The Building is required to suggest remedial action for the boundary wall, otherwise reconstruct a properly designed wall. | within 6 months |
