# Hannan Knit & Textiles Ltd. (Extension)

505, Kalmeshor, Board Bazar, National University, Gazipur-1704.

21 October 2024

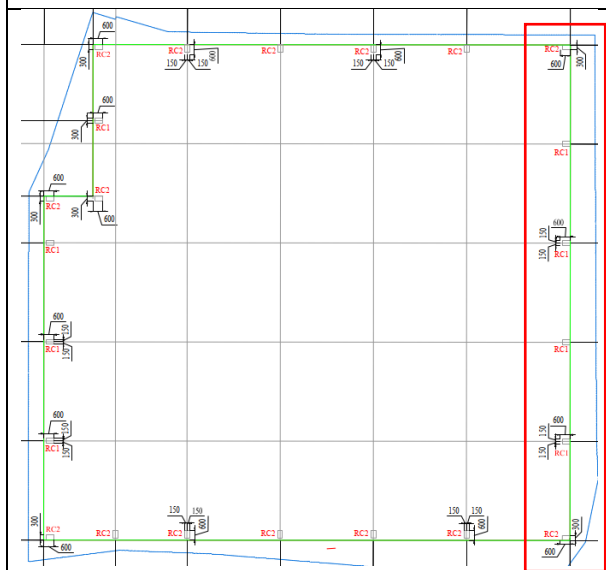
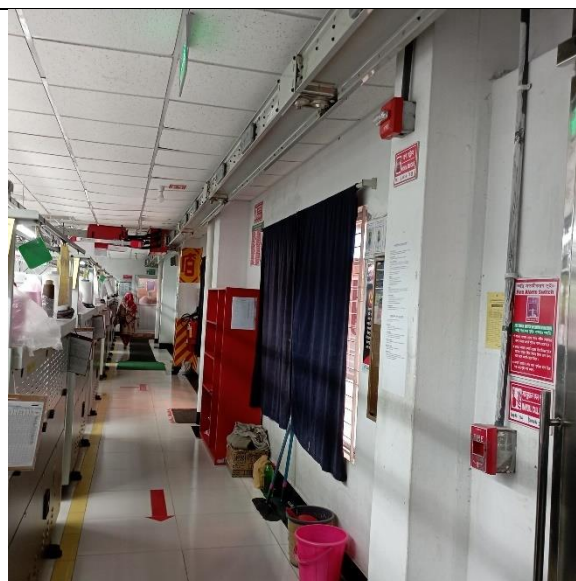
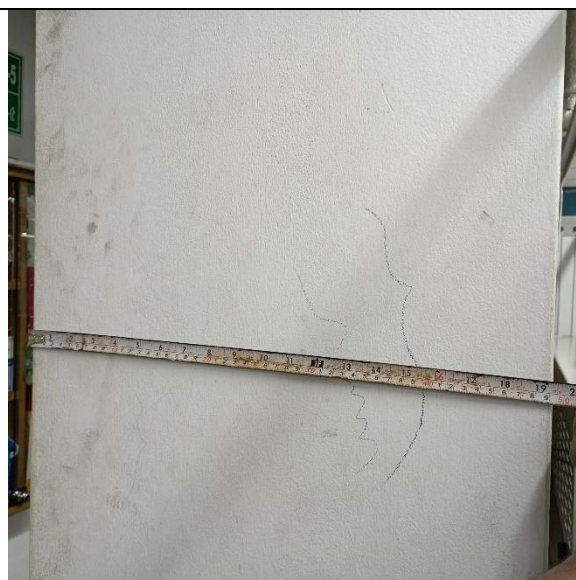
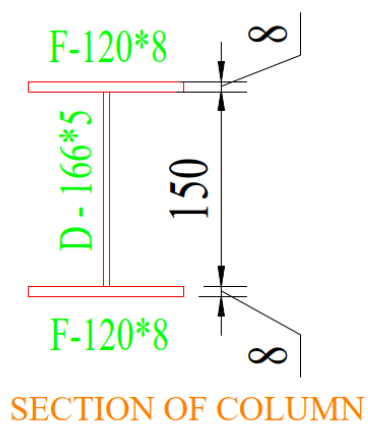
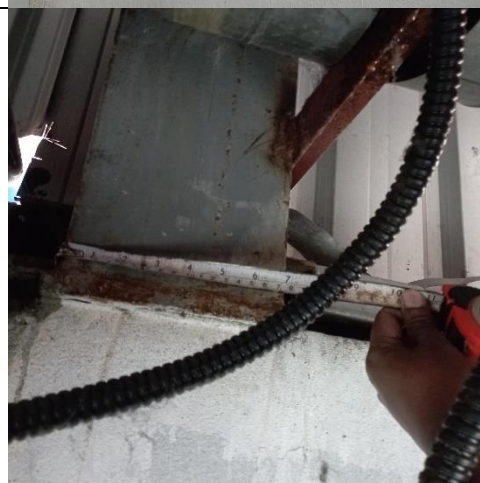
### Observation 1: Discrepancy in as-built drawing (Jacquard Shed).

**Description:** 7 Columns were found instead of 6 columns along grid-7. All RC columns were found 300x 450 instead of 300x600. All steel columns were found F170x W300 instead of F120x W150. The building engineer is required to produce accurate as-built drawings.

| Item No. | Observation | Action Plan | Timeline |
|---|---|---|---|
| 1. | Discrepancy in as-built drawing (Jacquard Shed). | The building engineer is required to produce accurate as-built drawings. | within 6 weeks |

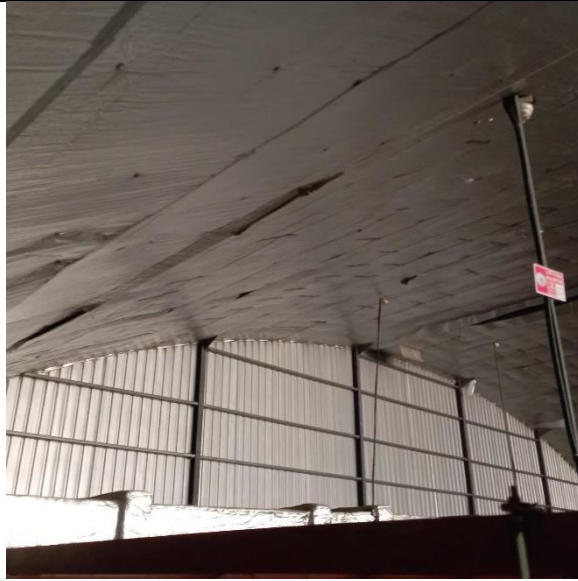
**Observation 2:** Lack of lateral stability (Jacquard Shed).

**Description:** Metal roof sheeting is only the member to transmit and resist lateral load in both directions. Also, a design report was not available for this structure. The building engineer is required to check the lateral stability of the structure and prepare a set of design reports in compliance with 1.9.1 BNBC.

| Item No. | Observation | Action Plan | Timeline |
|---|---|---|---|
| 2. | Lack of lateral stability (Jacquard Shed). | The building engineer is required to check the lateral stability of the structure and prepare a set of design reports in compliance with 1.9.1 BNBC. | within 6 weeks |
| 3. | Lack of lateral stability (Jacquard Shed). | Implement remediation work if required. | within 6 months |

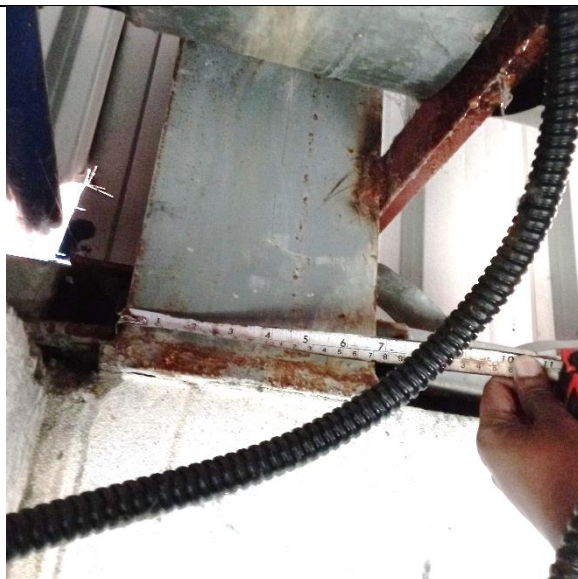
**Observation 3:** Corrosion on steel members (Jacquard Shed).

**Description:** Corrosion was found on steel members at several locations. The building engineer is required to apply rust-proof paint on steel members to prevent corrosion.

| Item No. | Observation | Action Plan | Timeline |
|---|---|---|---|
| 4. | Corrosion on steel members (Jacquard Shed). | The building engineer is required to apply rust-proof paint on steel members to prevent corrosion. | within 6 weeks |

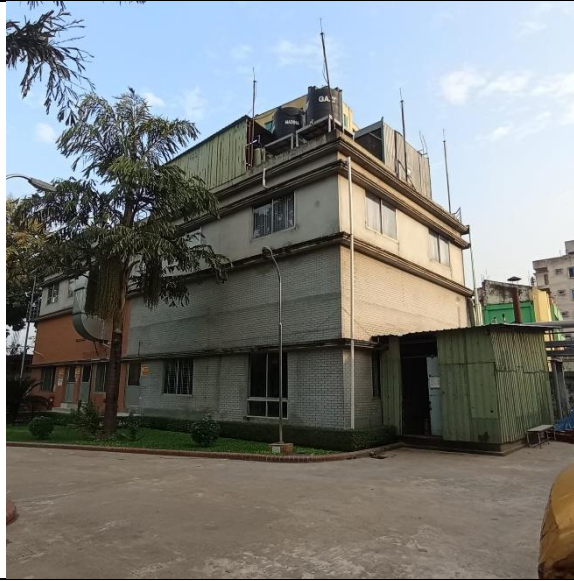
**Observation 4:** Lack of design report (Utility Building).

**Description:** As per BNBC, every building or structure designed shall have its design documents prepared in accordance with the provision of Section 1.9.1. The design document shall include a design report, and a set of structural drawings, which shall be prepared in compliance with section 1.9.1.1 and section 1.9.1.2 as per BNBC. At the time of inspection, the design report was not available, which must be prepared in compliance with section 1.9.1 (part-6, BNBC).

| Item No. | Observation | Action Plan | Timeline |
|---|---|---|---|
| 5. | Lack of design report (Utility Building). | The building engineer is required to prepare a set of design reports in compliance with 1.9.1 BNBC. | within 6 weeks |
| 6. | Lack of design report (Utility Building). | Implement remediation work if required. | within 6 months |

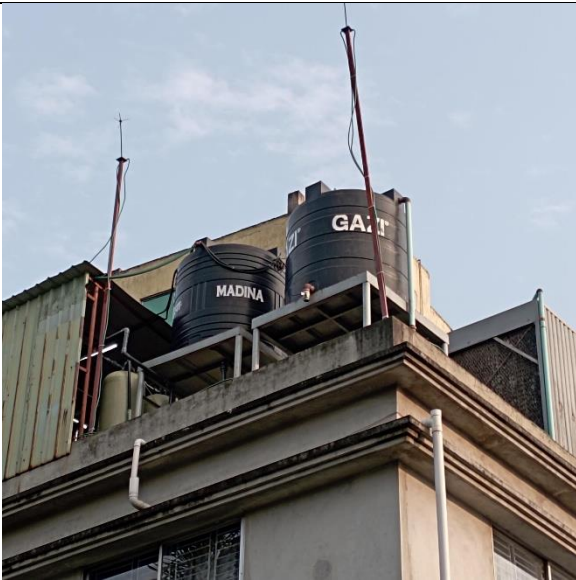
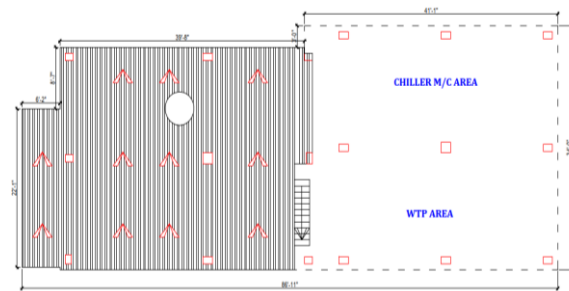
**Observation 5:** Missing information and lack of as-built drawing (Utility Building).

**Description:** Plastic water tanks (2-2000 liters each) were not shown in the drawings. No structural drawing was available for the shed (east part) and RO plant shed (west part). The building engineer is required to produce an accurate and full set of as-built drawings.

| Item No. | Observation | Action Plan | Timeline |
|---|---|---|---|
| 7. | Missing information and lack of as-built drawing (Utility Building). | The building engineer is required to update the as-built drawing. | within 6 weeks |

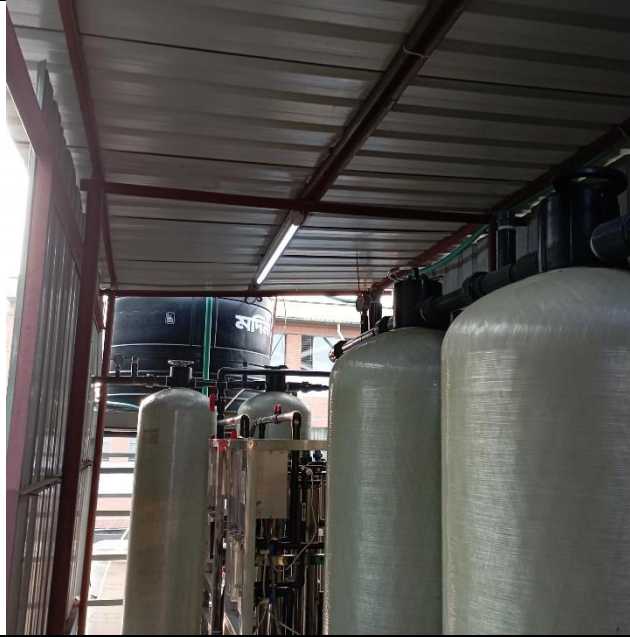
**Observation 6:** Missing bracing and strut members of RO shed (Utility Building).

**Description:** Horizontal bracing, vertical bracing, and strut members are absent to transmit and resist the lateral load. The building engineer is required to prepare a remediation plan for the bracing system and install it after getting acceptance from RSC.

| Item No. | Observation | Action Plan | Timeline |
|---|---|---|---|
| 8. | Missing bracing and strut members of RO shed (Utility Building). | The building engineer is required to prepare a remediation plan for the bracing system and install it after getting acceptance from RSC. | within 6 months |

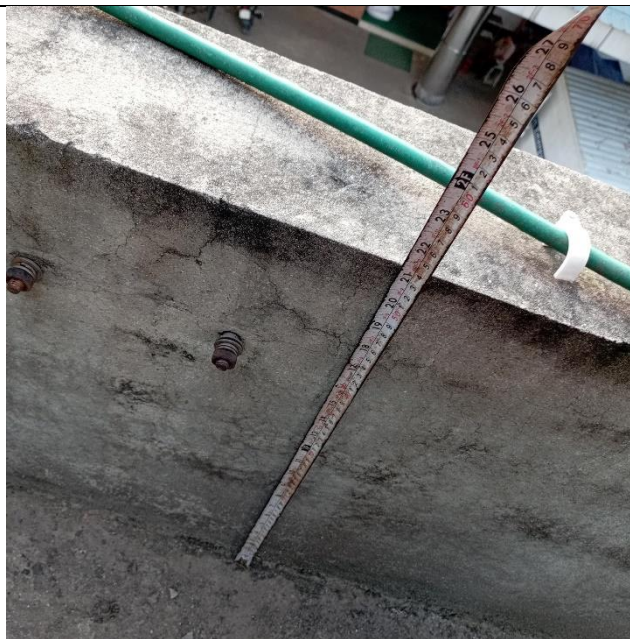
**Observation 7:** Low parapet height at roof (Utility Building).

**Description:** Parapet height was found only 540mm on the roof. The building engineer is required to increase the parapet height to avoid falling hazard.

| Item No. | Observation | Action Plan | Timeline |
|---|---|---|---|
| 9. | Low parapet height at roof (Utility Building). | The building engineer is required to increase the parapet height to avoid falling hazard. | within 6 weeks |

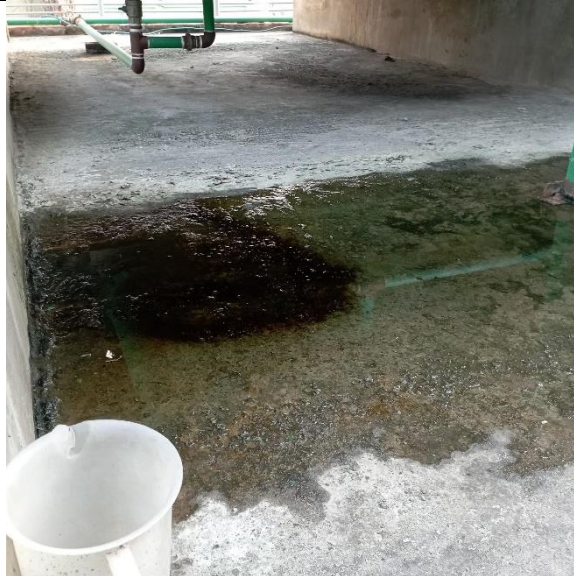
**Observation 8:** Dampness on roof slab (Utility Building).

**Description:** Dampness was found on roof slab. The building engineer is required to repair the dampness and improve the drainage system on roof slab.

| Item No. | Observation | Action Plan | Timeline |
|---|---|---|---|
| 10. | Dampness on roof slab (Utility Building). | The building engineer is required to repair the dampness and improve the drainage system on roof slab. | within 6 months |

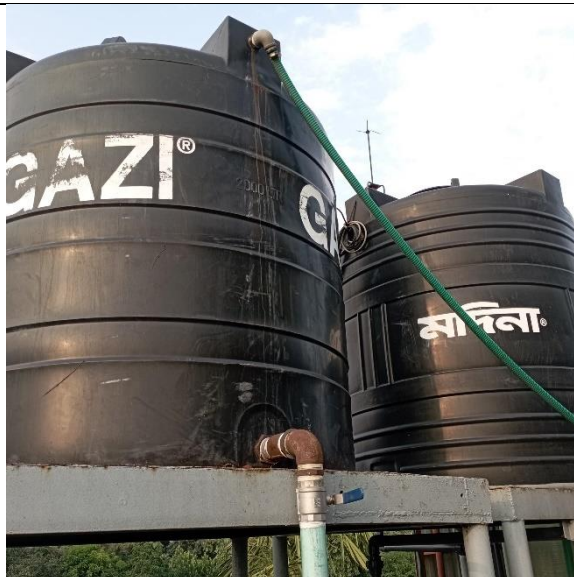
**Observation 9:** Nonstructural elements not anchored/braced (Utility Building).

**Description:** Nonstructural elements (plastic water tanks) at the roof level are not anchored/braced. The building engineer is required to anchor/brace all nonstructural elements.

| Item No. | Observation | Action Plan | Timeline |
|---|---|---|---|
| 11. | Nonstructural elements not anchored/braced (Utility Building). | The building engineer is required to anchor/brace all nonstructural elements. | within 6 months |

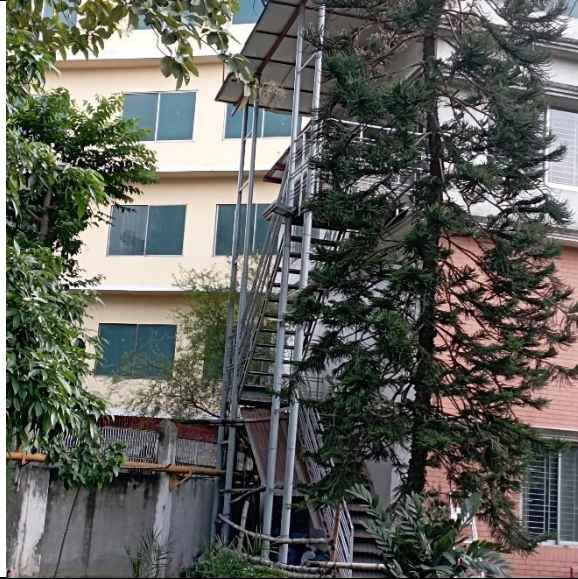
**Observation 10:** Lack of vertical and lateral Stability of the adjacent steel stair. (Utility Building).

**Description:** A steel stair was observed adjacent to the Utility Building. The column was found on only one side and the other side was found connected to the building. Also, no bracing system was found to resist the lateral load. The building engineer is required to check the lateral and vertical stability of the steel stairs.

| Item No. | Observation | Action Plan | Timeline |
|---|---|---|---|
| 12. | Lack of vertical and lateral Stability of the adjacent steel stairs. (Utility Building). | The building engineer is required to check the lateral and vertical stability of the steel stairs. | within 6 weeks |
| 13. | Lack of vertical and lateral Stability of the adjacent steel stairs. (Utility Building). | Implement remediation work if required. | within 6 months |

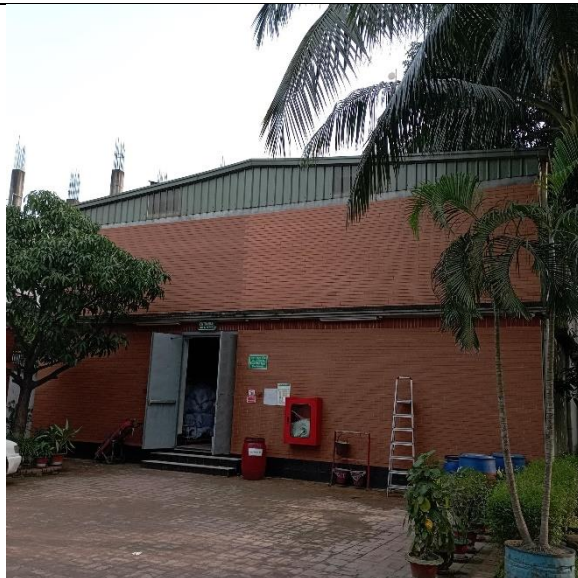
**Observation 11:** Lack of design report (Yarn Storage).

**Description:** As per BNBC, every building or structure designed shall have its design documents prepared in accordance with the provision of Section 1.9.1. The design document shall include a design report, and a set of structural drawings, which shall be prepared in compliance with section 1.9.1.1 and section 1.9.1.2 as per BNBC. At the time of inspection, the design report was not available, which must be prepared in compliance with section 1.9.1.1 (part-6, BNBC).

| 14. | Lack of design report (Yarn Storage). | The building engineer is required to prepare a set of design reports in compliance with 1.9.1 BNBC. | within 6 weeks |

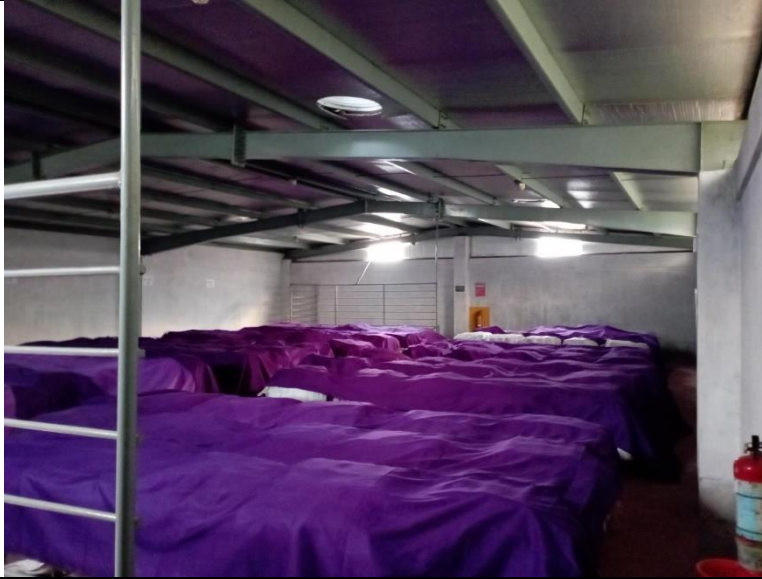
**Observation 12:** Lack of lateral Stability of the shed (1<sup>st</sup> floor) (Yarn Storage).

**Description:** No bracing system (strut, horizontal, and vertical bracing) was found to transmit and resist the lateral load. The building engineer is required to check the lateral stability of the shed and prepare a remediation plan.

| 15. | Lack of lateral Stability of the shed (1st floor) (Yarn Storage). | The building engineer is required to check the lateral stability of the structure. | within 6 weeks |
| 16. | Lack of lateral Stability of the shed (1st floor) (Yarn Storage). | Implement remediation work if required. | within 6 months |

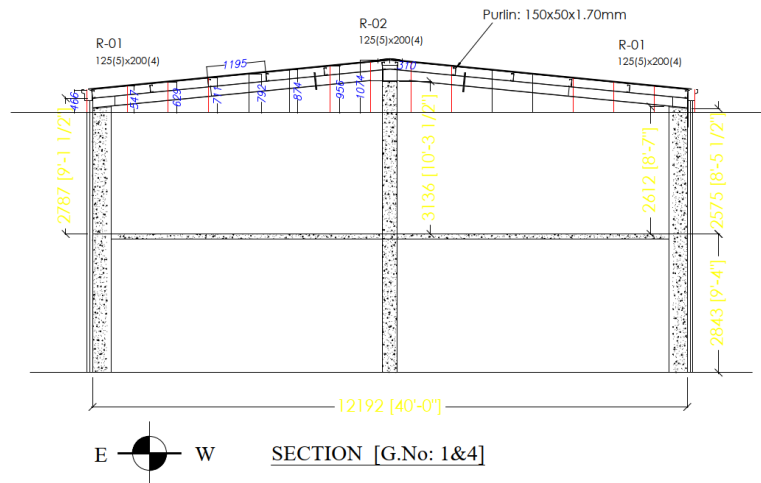
**Observation 13:** Missing information in as-built drawing (Yarn Storage).

**Description:** Connection details were not provided as-built drawing. The building engineer is required to produce a full set of as-built drawings.

| 17. | Missing information in as-built drawing (Yarn Storage). | The building engineer is required to update the as-built drawing. | within 6 weeks |

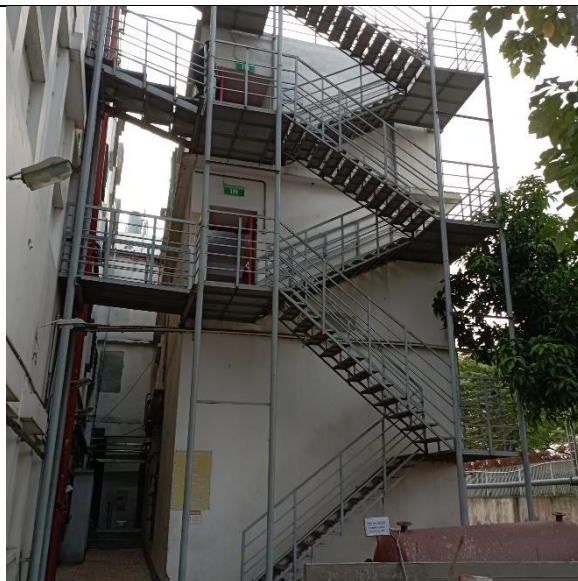
**Observation 14:** Lack of design report (ETP Building).

**Description:** As per BNBC, every building or structure designed shall have its design documents prepared in accordance with the provision of Section 1.9.1. The design document shall include a design report, and a set of structural drawings, which shall be prepared in compliance with section 1.9.1.1 and section 1.9.1.2 as per BNBC. At the time of inspection, the design report was not available, which must be prepared in compliance with section 1.9.1.1 (part-6, BNBC).

| 18. | Lack of design report (ETP Building). | The building engineer is required to prepare a set of design reports in compliance with 1.9.1 BNBC. | within 6 weeks |

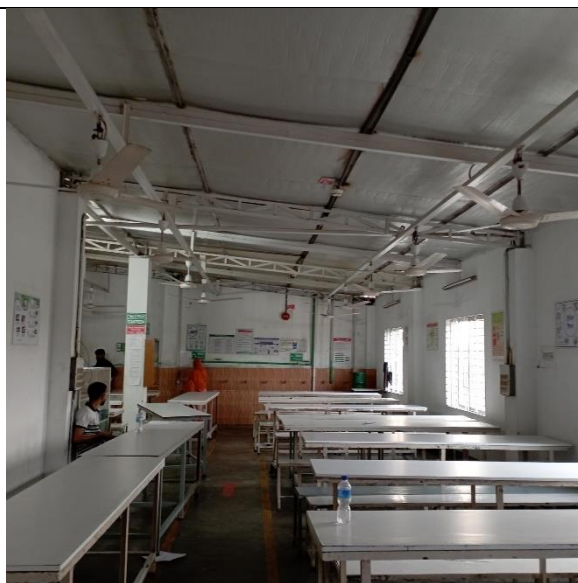
**Observation 15:** Lack of lateral Stability of the shed-roof shed (ETP Building).

**Description:** No bracing system (strut, horizontal, and vertical bracing) was found to transmit and resist the lateral load. The building engineer is required to check the lateral stability of the shed and prepare a remediation plan.

| 19. | Lack of lateral Stability of the shed-roof shed (ETP Building). | The building engineer is required to check the lateral stability of the structure. | within 6 weeks |
| 20. | Lack of lateral Stability of the shed-roof shed (ETP Building). | Implement remediation work if required. | within 6 months |

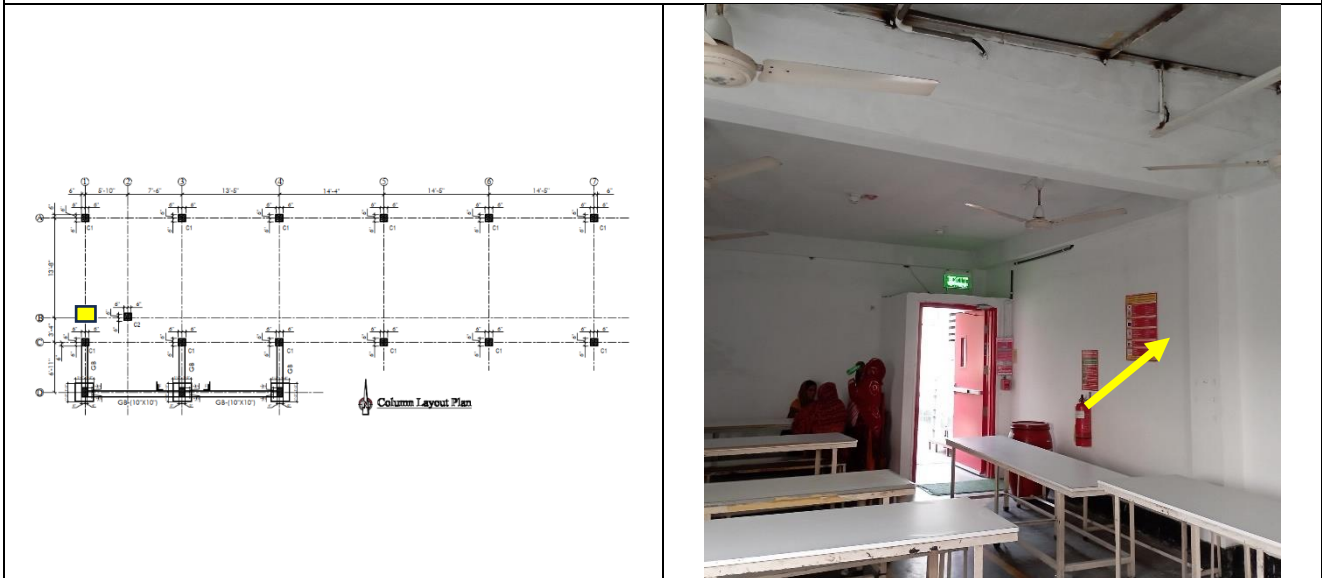
**Observation 16:** Discrepancy in as-built drawing (ETP Building).

**Description:** Marked (yellow) column was not shown in column layout. Also, structural drawing of shed was not available. The building engineer is required to produce a full set of accurate as-built drawings.

| 21. | Discrepancy in as-built drawing (ETP Building). | The building engineer is required to update the as-built drawing. | within 6 weeks |

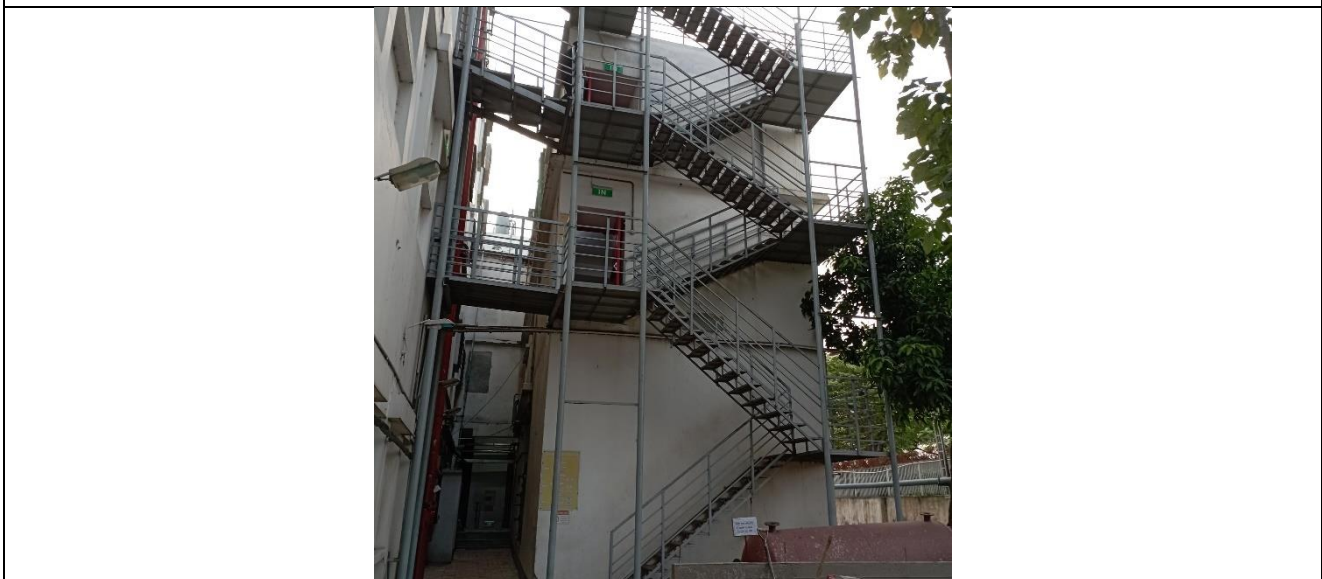
**Observation 17:** Lack of vertical and lateral Stability of the adjacent steel stair. (ETP Building).

**Description:** A steel stair was observed adjacent to the Utility Building. The column was found on only one side and the other side was found connected to the building. Also, no bracing system was found to resist the lateral load. The building engineer is required to check the lateral and vertical stability of the steel stairs.

| 22. | Lack of vertical and lateral Stability of the adjacent steel stairs. (ETP Building). | The building engineer is required to check the lateral and vertical stability of the steel stairs. | within 6 weeks |
| 23. | Lack of vertical and lateral Stability of the adjacent steel stairs. (ETP Building). | Implement remediation work if required. | within 6 months |

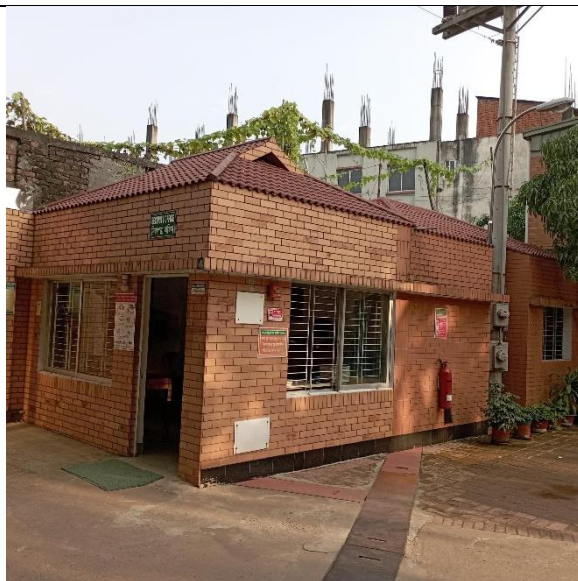
**Observation 18:** Lack of as-built drawings (Security & RMS Room).

**Description:** As built a drawing was not available for this structure. The building engineer is required to produce as-built drawings of the structure.

| 24. | Lack of as-built drawings (Security & RMS Room). | The building engineer is required to produce as-built drawings of the structure. | within 6 weeks |

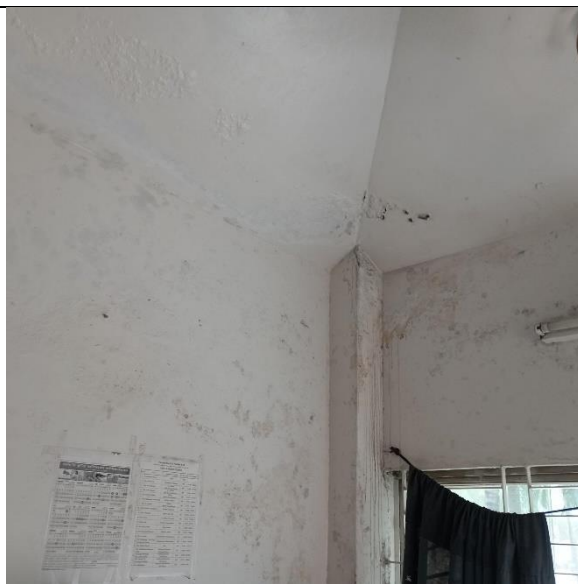
**Observation 19:** Dampness on the wall (Security & RMS Room).

**Description:** Dampness observed on the internal wall. The building engineer is required to identify the damp areas and repair the dampness with a suitable method.

| 25. | Dampness on the wall (Security & RMS Room). | The building engineer is required to identify the damp areas and repair the dampness with a suitable method. | within 6 weeks |
