# That's It Fashion Ltd - Extension (previously Peak Apparels)

65/1 Vogra, National University, Joydevpur, Gazipur, Dhaka.

8 October 2024

## 2. Observations:

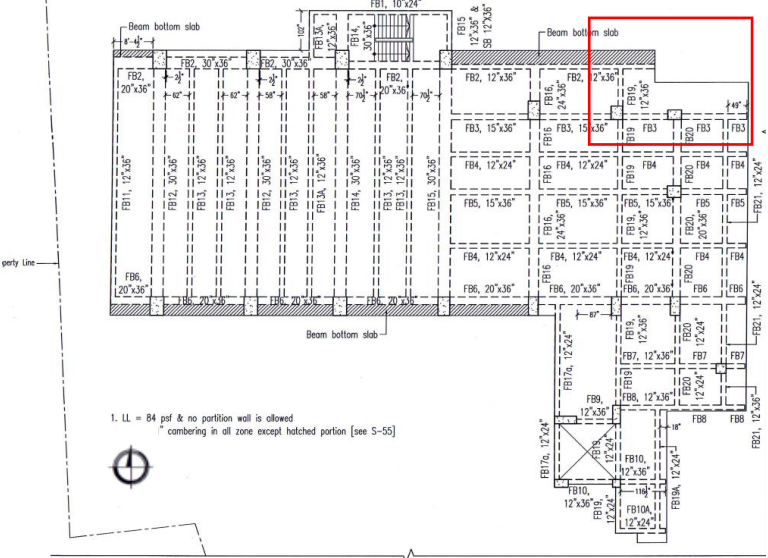
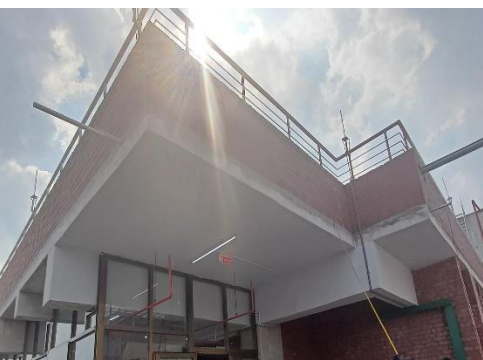
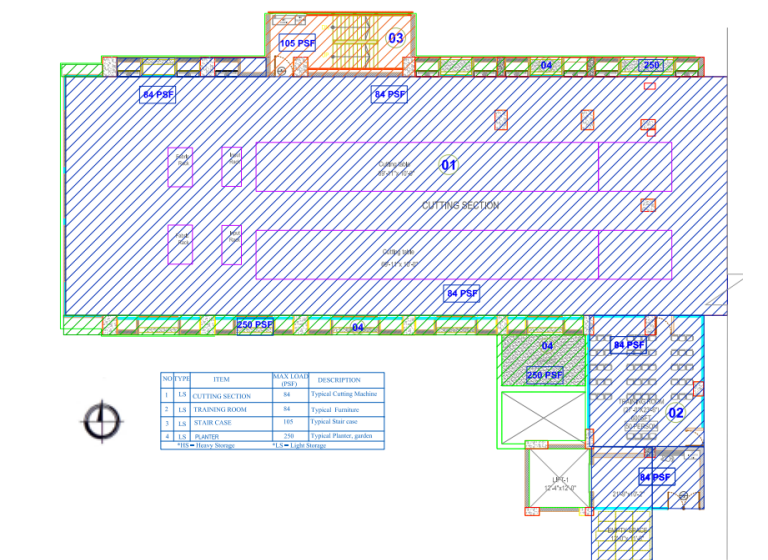
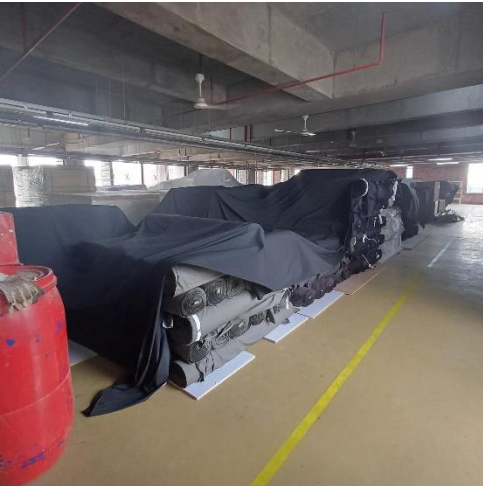
### Observation-1: Inconsistencies in as-built drawing. (Production Building (Extension))

<p>1. LL = 84 psf &amp; no portion wall is allowed<br/>cantilevering in all zone except hatched portion [see S-55]</p>                                                                                                                                                                                                                                                                                                                                                                                                              |

| | | | | | | | | | | | | | | | | | | | | | | | |
|---|---|---|---|---|---|---|---|---|---|---|---|---|---|---|---|---|---|---|---|---|---|---|---|---|---|
| <u>Roof floor beam layout</u> | <u>Roof floor beams at the east side</u> | | | | | | | | | | | | | | | | | | | | | | | | |
|

| Item No. | Observation | Action Plan | Timeline |
|---|---|---|---|
| 1 | Inconsistencies in as-built drawing. (Production Building (Extension)) | The building engineer is required to update the as-built drawing according to the as-built condition. | within 6 weeks |
| 2 | | The building engineer is required to revise the load plan as per BNBC requirements and check the design accordingly. | within 6 weeks |
| 3 | | Produce and actively manage live load plan. | within 6 weeks |

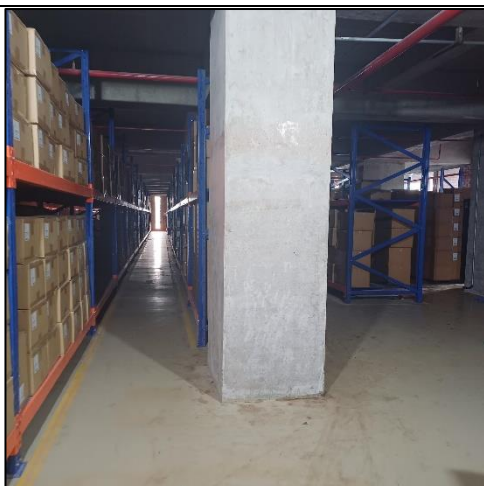
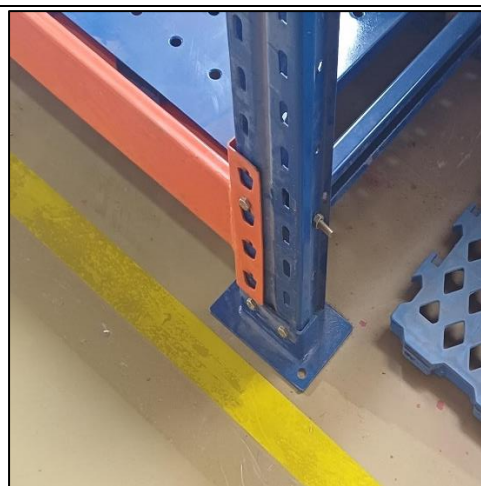
## Observation-3: Lack of anchorage of non-structural elements. (Production Building (Extension))

**Description:** On the 1<sup>st</sup> floor, the storage rack was not found anchored/braced. The building engineer is required to anchor/brace all the non-structural elements.

| Item No. | Observation | Action Plan | Timeline |
|---|---|---|---|
| 6 | Lack of anchorage of non-structural elements. (Production Building (Extension)) | The building engineer is required to anchor/brace all the non-structural elements. | within 6 weeks |

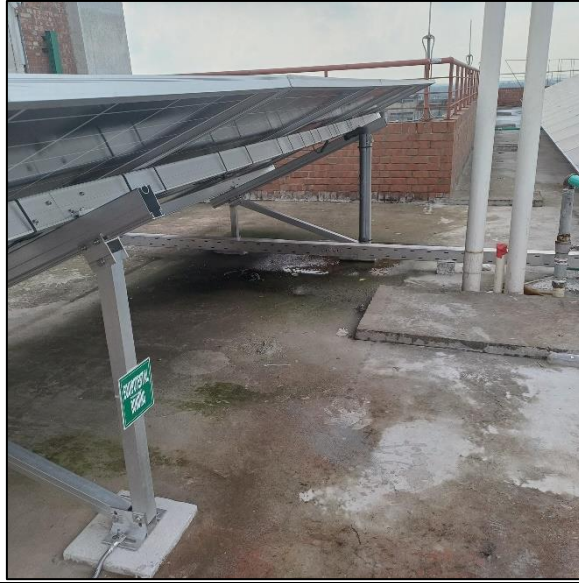
**Observation-4:** Signage of water ponding on the roof. (Production Building (Extension))

**Description:** During the inspection, signage of water ponding was found on the roof. The building engineer is required to improve the roof drainage system.

| Item No. | Observation | Action Plan | Timeline |
|---|---|---|---|
| 7 | Signage of water ponding on the roof. (Production Building (Extension)) | The building engineer is required to improve the roof drainage system. | within 6 weeks |

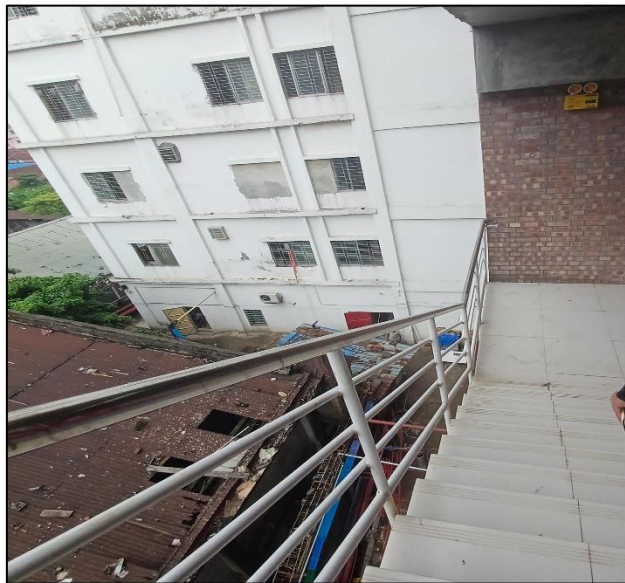
**Observation-5:** Falling hazard beside the stairs on the north side. (Production Building (Extension))

**Description:** During the inspection, inadequate railing height was observed at the stairs on the north side which may cause a falling hazard. The building engineer is required to increase the railing height to avoid falling hazards.

| Item No. | Observation | Action Plan | Timeline |
|---|---|---|---|
| 8 | Falling hazard beside the stairs on the north side. (Production Building (Extension)) | The building engineer is required to increase the railing height to avoid falling hazards. | within 6 weeks |

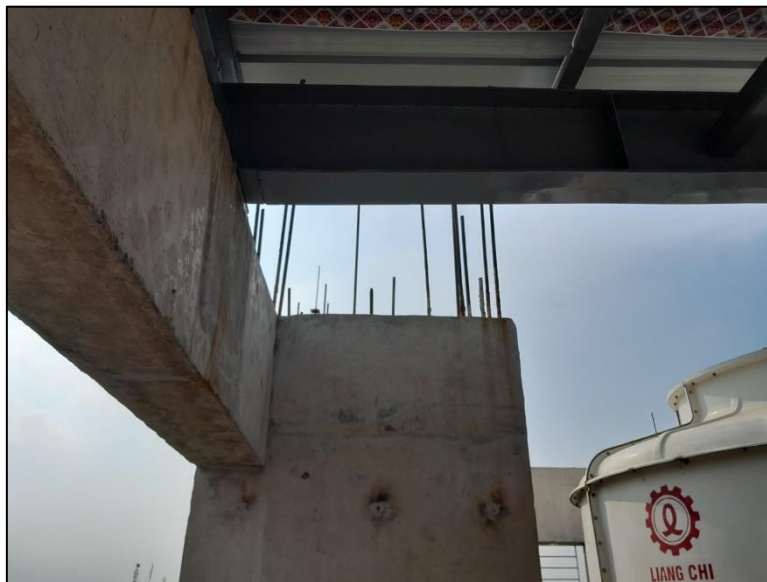
#### Observation-7: Exposed rebar on the roof. (Utility Building)

**Description:** Exposed reinforcement is left on the roof, which was prone to corrosion. The building engineer is required to provide rust-proof paint on exposed reinforcement to protect from corrosion.

| Item No. | Observation | Action Plan | Timeline |
|---|---|---|---|
| 11 | Exposed rebar on the roof. (Utility Building) | The building engineer is required to provide rust-proof paint on exposed reinforcement to protect from corrosion. | within 6 weeks |
