SP Garments Ltd (Extension 2)

7 October 2024

1. Building Information

1. This is a two-storied (G+1) building. The ground floor has an RC frame, and the first floor is a prefabricated steel structure.

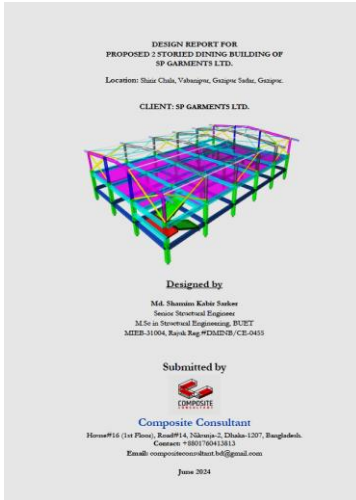
Observation-1: Design report required to be reviewed by RSC for lateral loading. (Dining Building)

Description: A set of design reports for the dining building was available. The design report needs to be reviewed for lateral loading.

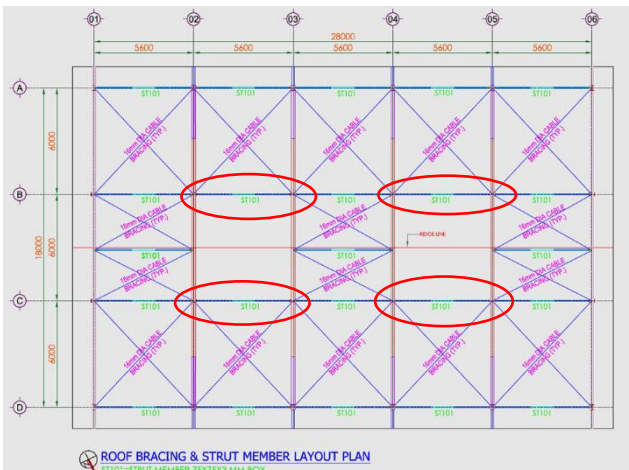
Strut member layout

Moreover, the marked strut members were not found on-site. The building engineer is required to survey the full structure and prepare complete as-built structural drawings. Also, the stability system should be checked, considering the strut member's position at the site.

Item No	Observation	Action Plan	Timeline
01	Design report required to be reviewed by RSC for lateral loading. (Dining Building)	The building engineer is required to survey the full structure and prepare complete as-built structural drawings.	within 6 weeks
02		The building engineer is required to check the stability of the structure considering the strut member's position at the site.	within 6 weeks
03		Prepared design report to be checked against lateral loads following BNBC 2020 by RSC.	within 6 weeks
04		Carry out the suggested remedial works.	within 6 months
05	Present floor usage does not comply with the prepared load plan. (Dining Building)	The building engineer is required to maintain the prepared load plan otherwise revise the load plan and related design documents based on alternative BNBC requirements.	within 6 weeks
06	Connection gap. (Dining Building)	The building engineer is required to carry out suitable remedial work.	within 6 weeks

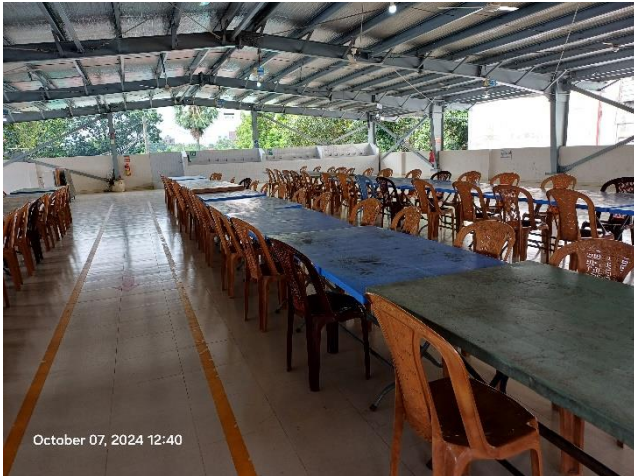
Observation-2: Present floor usage does not comply with the prepared load plan. (Dining Building)

Description: As per the prepared load plan (2.9 kN/m²) the seats are to be fastened to the floor. However, the seats are not fastened to the floor. The building engineer is required to maintain the prepared load plan otherwise revise the load plan and related design documents based on alternative (4.8 kN/m²) BNBC requirements.

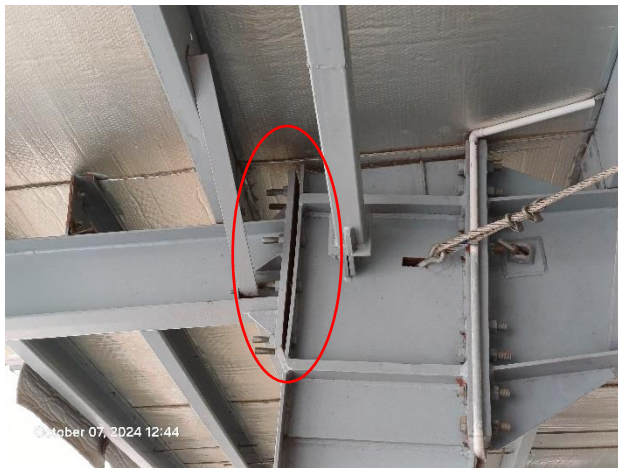
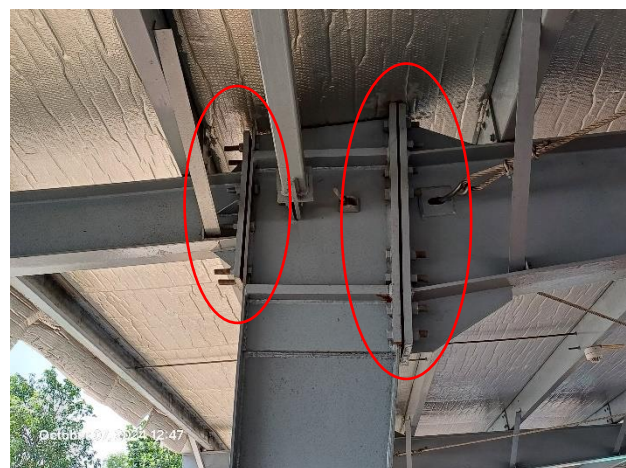
Observation-3: Connection gap. (Dining Building)

Description: Connection gaps were observed at the joint. The building engineer is required to carry out suitable remedial work.
