# Sams Attire Ltd (Extension 2)

Bhuiyan Tower, Plot No. 10, Ashulia Jamgora, Savar, Dhaka.

3 November 2024

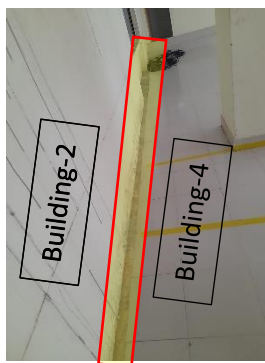
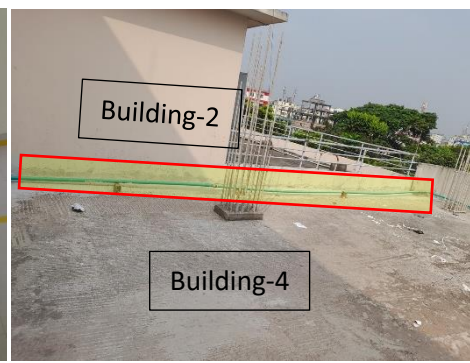
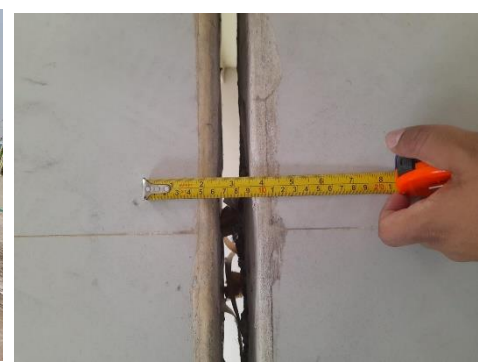
#### Separation of North Part and South Part

The separation between Building-2 and Building-4 is not clear. Also, the expansion gap has been provided 2 inch between the north part and south part. In the provided design report, the required width of the expansion gap has not been mentioned. The building engineer is required to check the required width of the expansion gap in the design report and suggest accordingly.

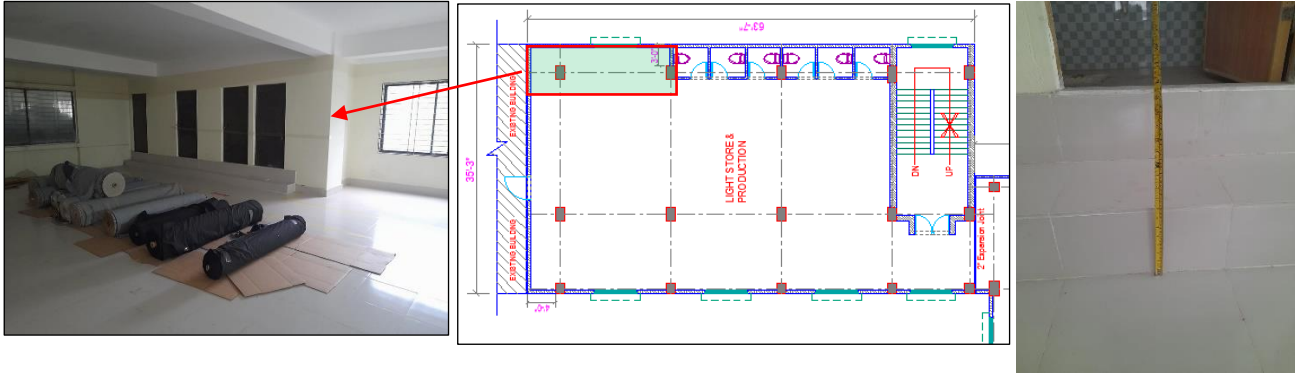
**Description:** During the inspection, the mismatch was found between the provided drawing and the site condition. The toilet zone position was not found as per the drawing. The toilet zone was found as marked location in the layout. Also, approximately 350mm build-up was found in the toilet zone.

| Serial No | Observation | Action Plan | Timeline |
|---|---|---|---|
| 4 | Mismatch in the provided drawing. (Building-4) | The building engineer is required to survey the whole structure and prepare accurate as-built drawings. | within 6 weeks |

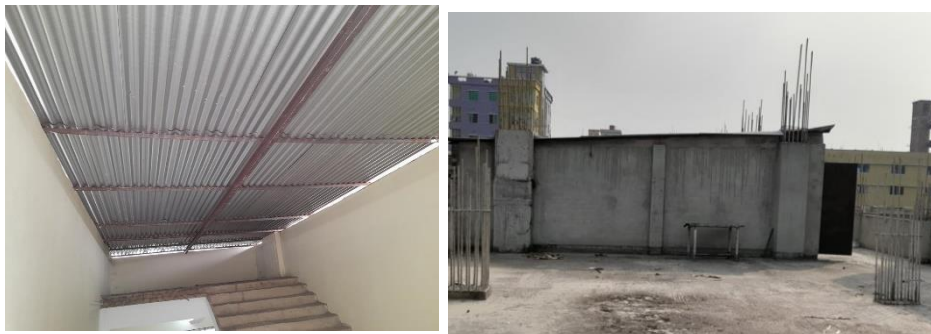
The is a lightweight steel tin shed over the stair top. The drawing was not available for the shed in the provided drawing,  
The building engineer is required to survey the whole structure and prepare accurate as-built drawings.

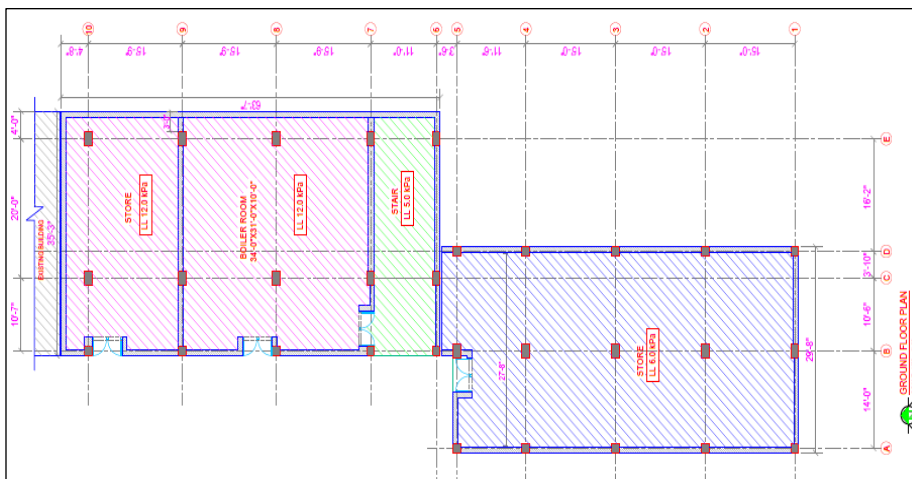
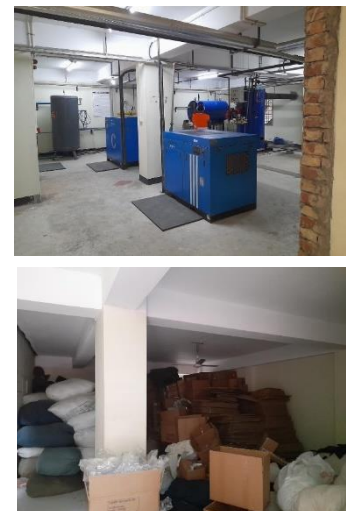
Load plan of suspended ground floor column and loading at ground floor

**Description:** During the inspection, utility facilities (boiler room) were found on ground floor slab. But the weight of the machine has not been mentioned in the load plan. Also uncontrolled storage loading was found at ground floor slab. Load limit marking has not been provided in the storage area. The building engineer is required to update the load plan mentioning the machine weight and provide load limit marking at storage area.

| Serial No | Observation | Action Plan | Timeline |
|---|---|---|---|
| 5 | Lack of load management program. (Building-4) | The building engineer is required to update the load plan mentioning the machine weight and provide load limit marking at the storage area. | within 6 weeks |
| 6 | Lack of load management program. (Building-4) | Implement the floor load management plan. | within 6 months |

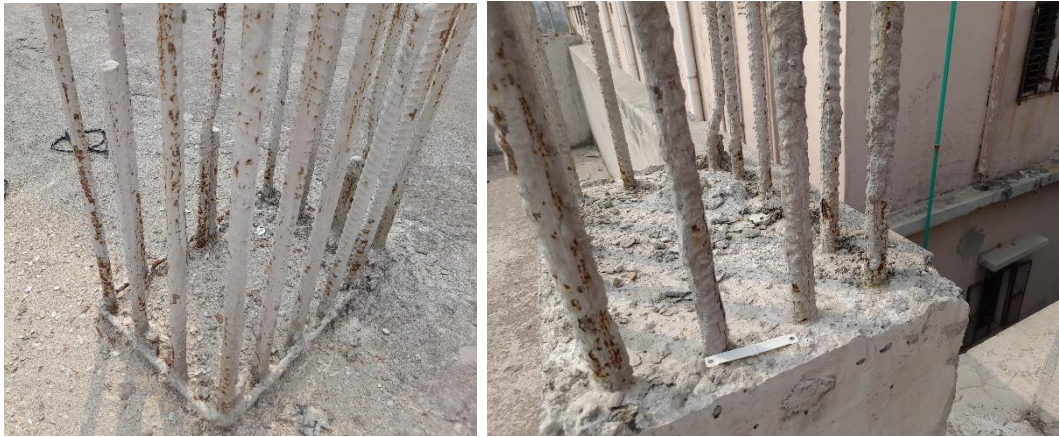
**Observation-4:** Appearance of corrosion in re-bar at roof. (Building-4)

**Description:** Corrosion was found in reinforcement of roof columns. The building engineer is required to provide anti-corrosive coating in re-bar to prevent the corrosion.

| Serial No | Observation | Action Plan | Timeline |
|---|---|---|---|
| 7 | Appearance of corrosion in re-bar at roof. (Building-4) | The building engineer is required to provide anti-corrosive coating in re-bar to prevent the corrosion. | within 6 months |

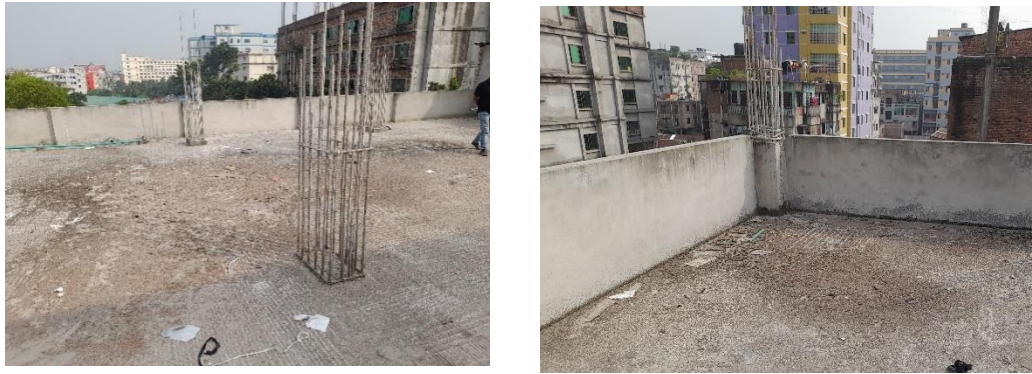
**Observation-5:** Signage of water ponding at roof (Building-4)

**Description:** During inspection, signage of water ponding was found on existing roof (4<sup>th</sup> floor slab). The building engineer is required to develop a drainage system with adequate slope to avoid water ponding.

| Serial No | Observation | Action Plan | Timeline |
|---|---|---|---|
| 8 | Signage of water ponding at roof (Building-4) | Building engineer is required to develop the drainage system to avoid water ponding. | within 6 months |

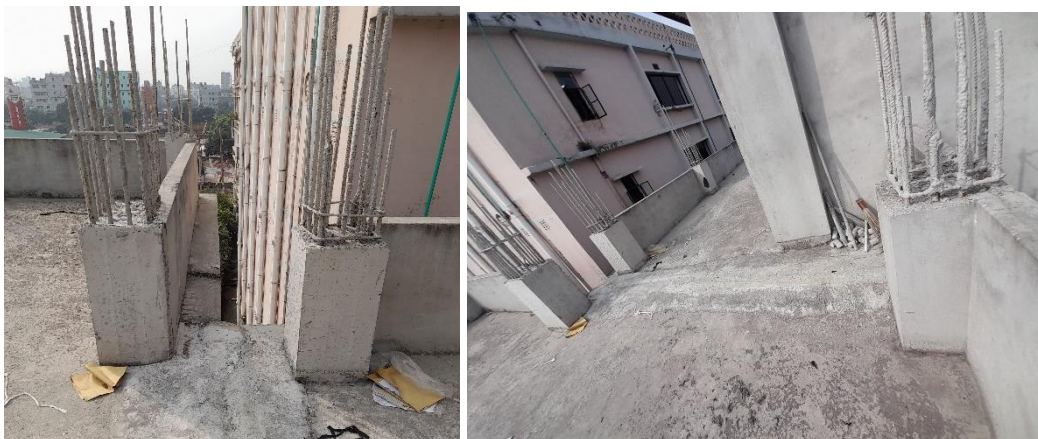
**Observation-6:** Falling hazard risk at roof. (Building-4)

**Description:** During inspection, a portion of the parapet wall found missing on roof which is susceptible to falling hazard. The building engineer is required to provide barrier or construct parapet wall at that location to mitigate the falling hazard.

| Serial No | Observation | Action Plan | Timeline |
|---|---|---|---|
| 9 | Falling hazard risk at roof. (Building-4) | The Building engineer is required to provide barrier or parapet wall to avoid falling hazard. | within 6 months |

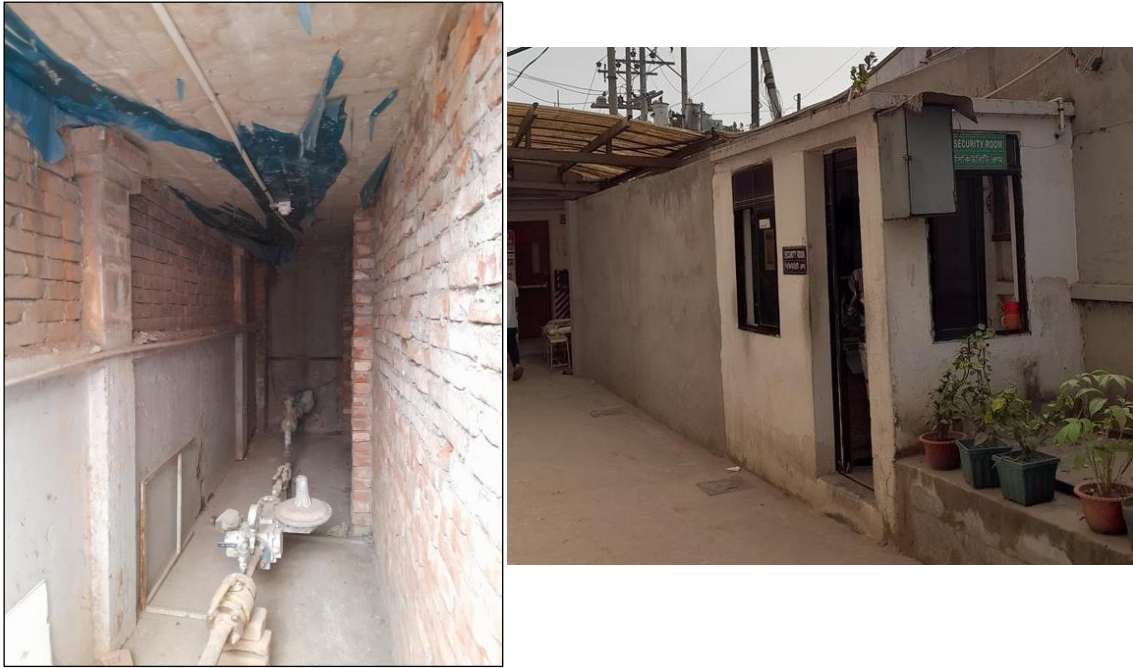
**Observation-7:** Lack of as-built drawing. (Building-5)

**Description:** During inspection, the as-built drawing was not available for Building-5. The building is being used for the RMS room and security room. The building engineer is required to survey the structure and prepare accurate as-built drawings.

| Serial No | Observation | Action Plan | Timeline |
|---|---|---|---|
| 10 | Lack of as-built drawing. (Building-5) | The building engineer is required to survey the whole structure and prepare accurate as-built drawing | within 6 weeks |
