Jin Hong Garments Ltd

Building -1, Tangail Road, Nawjor, Chandona Chowrasta, Gazipur

23 October 2024

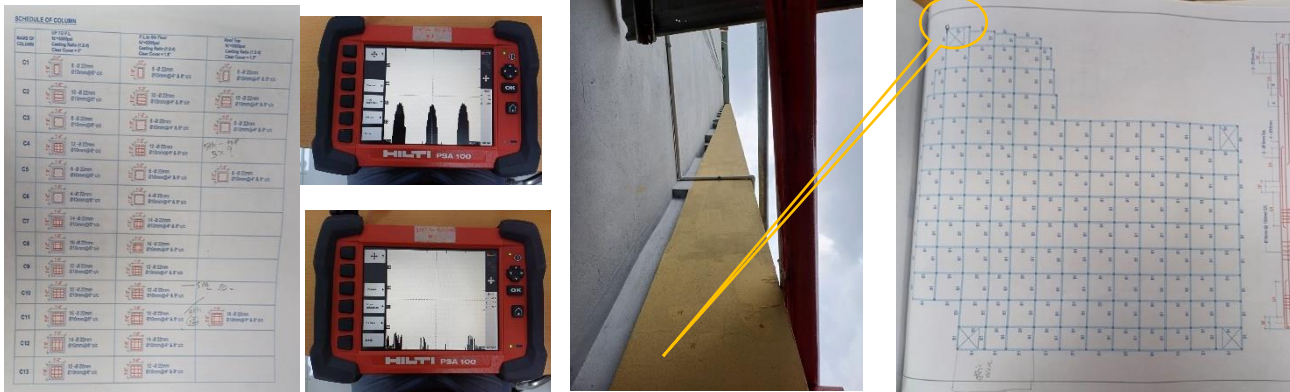
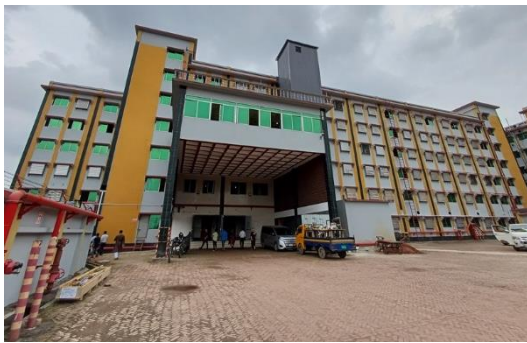
Additional bay at front

Observation-1: Inconsistencies in as-built drawings and DEA report. (Main Production Building)

Description: The number of rebars in the internal columns were found to be less than the column schedule on 5th floor. Also, the beam-column layout was found mismatched on the south-east corner. Corner column was found offset from main grid 13-N. On the other hand, the front side extra bay is neither shown in as built drawings nor considered in the DEA report. Which is monolithically connected with the main structure.

The building engineer is required to address the inconsistencies in the as-built drawings and incorporate in the existing DEA documents.

Item No.	Observation	Action Plan	Timeline
1.	Inconsistencies in as-built drawings and DEA report. (Main Production Building)	The building engineer is required to survey the whole structure and prepare a full set of as-built drawings as per on site condition.	within 6 weeks

2.	Inconsistencies in as-built drawings and DEA report. (Main Production Building)	The building engineer is required to address the inconsistencies in the existing DEA documents and submit to RSC for further review.	within 6 weeks

3.	Inconsistencies in as-built drawings and DEA report. (Main Production Building)	Carry out remedial work if required.	within 6 months
4.	Inconsistencies in as-built drawings and DEA report. (Main Production Building)	Implement floor load plan	within 6 months

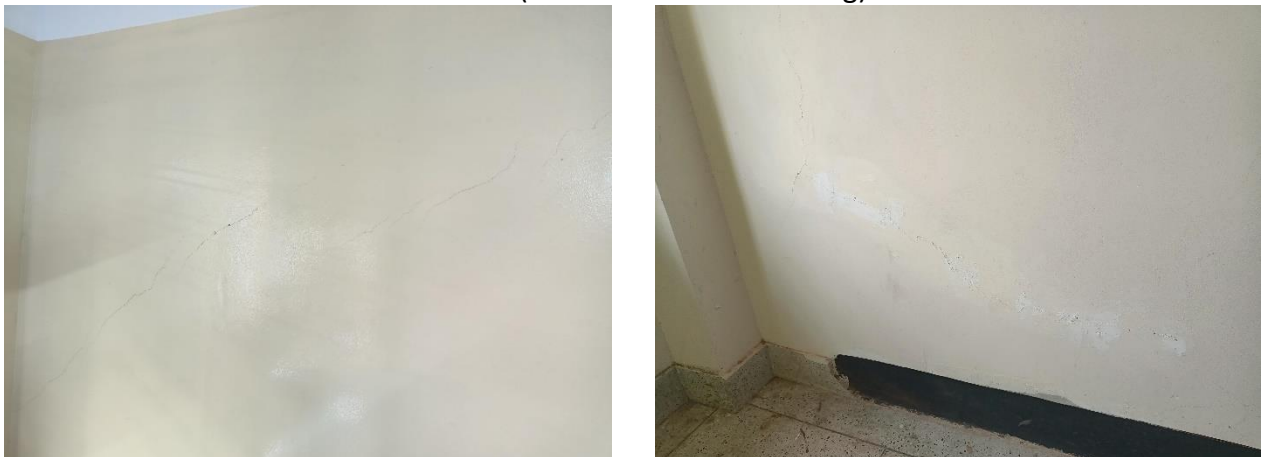
Observation-2: Crack on the brick wall. (Main Production Building)

Description: Crack was observed on the stair wall. The building engineer is required to investigate the reason for the crack and suggest proper remedial action accordingly.

5.	Crack on the brick wall. (Main Production Building)	The building engineer is required to investigate the reason for the crack and suggest proper remedial action accordingly.	within 6 weeks

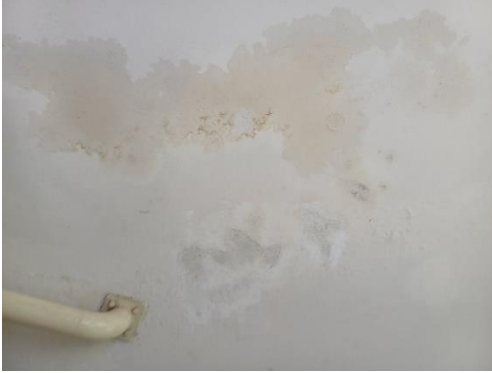
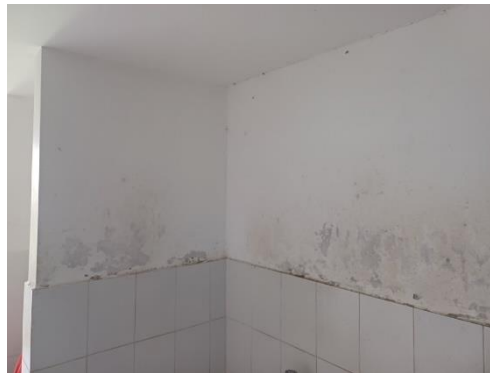
Observation-3: Dampness was found on the walls. (Main Production Building)

Description: Dampness was found on the stair and toilet partitions walls. The building engineer is required to investigate the cause of the dampness and repair it using a suitable method.

6.	Dampness was found on the walls. (Main Production Building)	The building engineer is required to investigate the cause of the dampness and repair it using a suitable method.	within 6 weeks

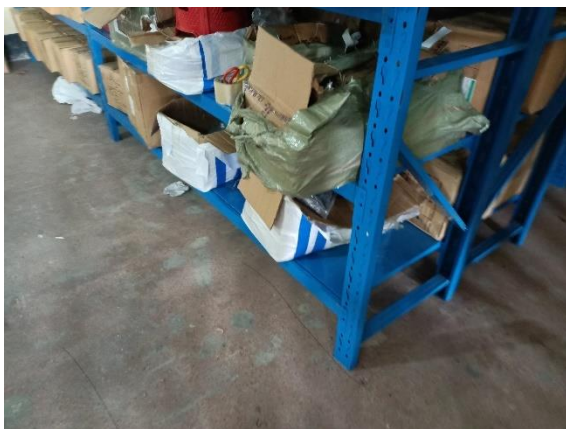
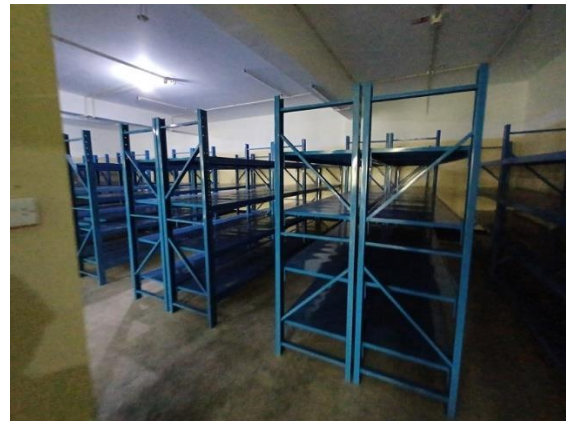
Observation-4: Non-structural elements are not anchored. (Main Production Building)

Description: Non-structural elements (Storage racks) were found on different floors of the buildings. The building engineer is required to adequately anchor and brace all the nonstructural elements to avoid falling hazards during earthquakes.

7.	Non-structural elements are not anchored. (Main Production Building)	The building engineer is required to adequately anchor and brace all the nonstructural elements to avoid falling hazards during EQ.	within 6 weeks

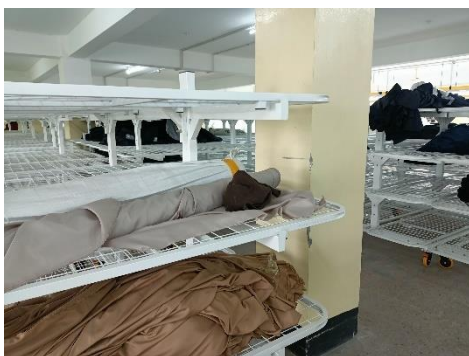
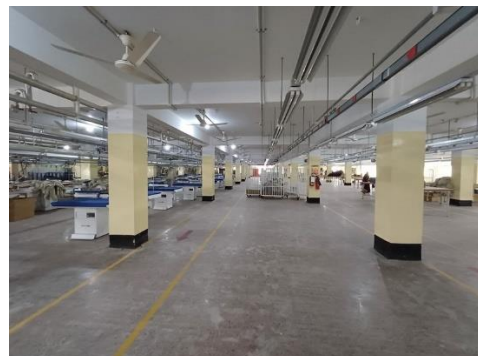
Observation-5: Column susceptible to trolley impact. (Main Production Building)

Description: During the inspection, RC columns on different floors were found damaged due to trolley impact. The building engineer is required to provide a barrier around the column to avoid trolley impact.

8.	Column susceptible to trolley impact. (Main Production Building)	The building engineer is required to provide a barrier around the column to avoid trolley impact.	within 6 weeks

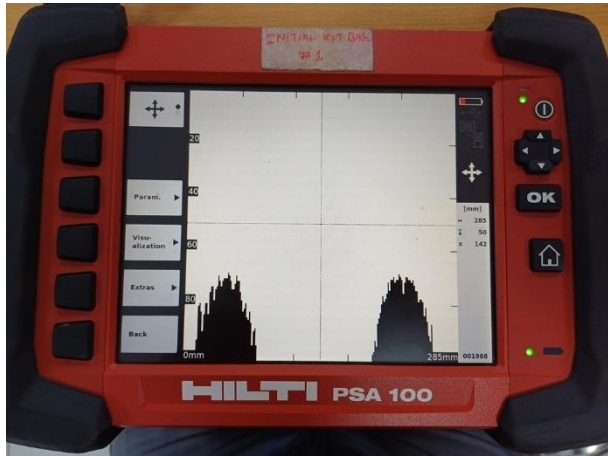
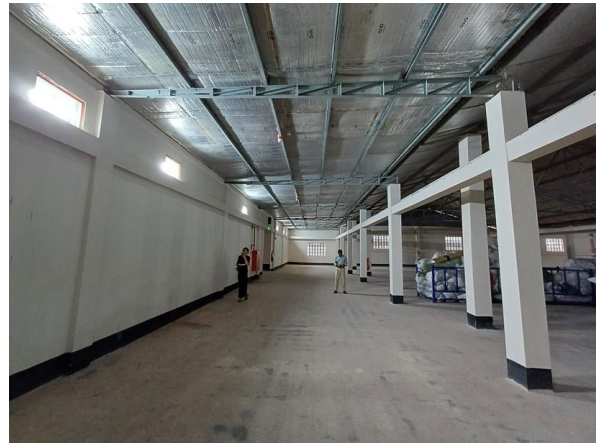
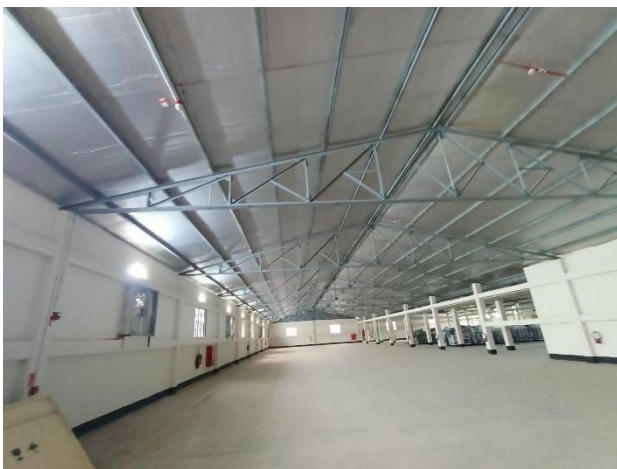
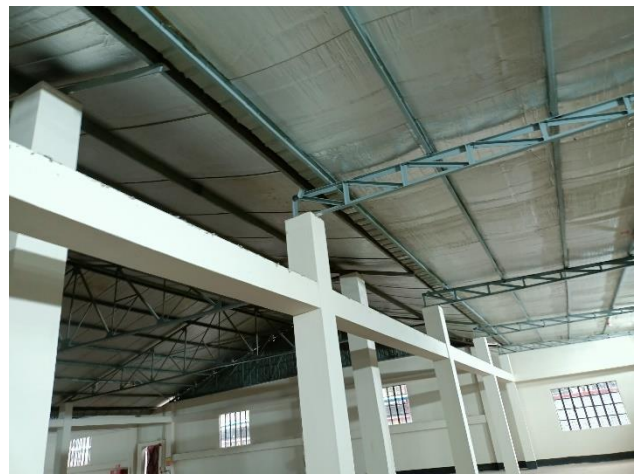
Observation-6: Mismatches in as-built drawing. (Warehouse Shed)

Description: At north part, amount of rebar in RC column were found 4 instead of 6. Grade Beam, lintel and column layout were not updated as per actual conditions. Moreover, connection details were not mentioned in the provided drawings.

Building engineer is required to address the inconsistencies in the as-built drawings and incorporate in the existing EA documents. Also, check whether the lateral stability is compromised or not due to the changes.

9.	Mismatches in as-built drawing. (Warehouse Shed)	The building engineer is required to prepare accurate as-built drawings.	within 6 weeks
10.	Mismatches in as-built drawing. (Warehouse Shed)	Building engineer is required to update EA documents addressing the mismatches and submit to RSC for further review. Also, check whether the lateral stability is compromised or not due to the changes.	within 6 weeks

11.	Mismatches in as-built drawing. (Warehouse Shed)	Carry out remedial work if required.	within 6 months
12.	Lack of information and mismatches in as-built drawing. (Boiler & Compressor Building, Sub Station & Generator Building, Medical Building & Childcare, MDB Building)	The building engineering is required to prepare a full set of architectural and structural drawings.	within 6 weeks

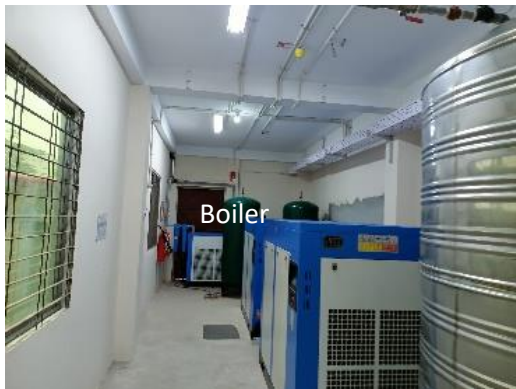
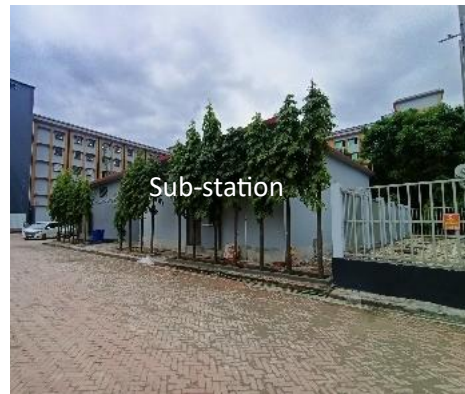
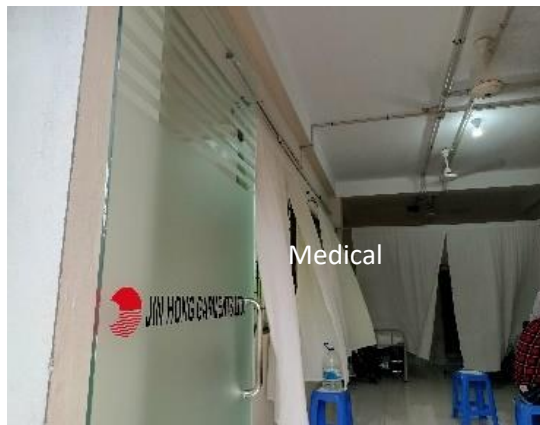
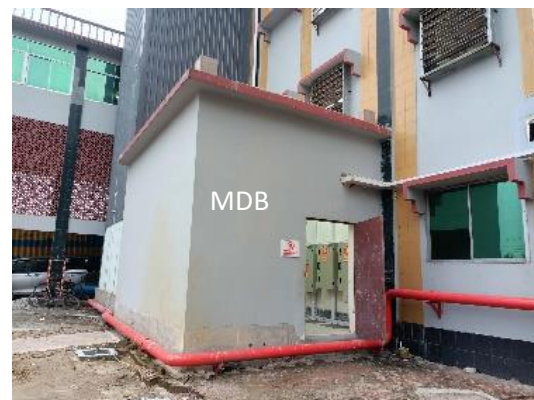
Observation-7: Lack of information and mismatches in as-built drawing. (Boiler & Compressor Building, Sub Station & Generator Building, Medical Building & Childcare, MDB Building)

Description: Architectural drawings were not available for Boiler & Compressor Building, Sub Station & Generator Building, Medical Building & Childcare, MDB Building. Also, grid dimensions were not matched with drawings for medical buildings. The building engineering is required to prepare a full set of architectural and structural drawings.

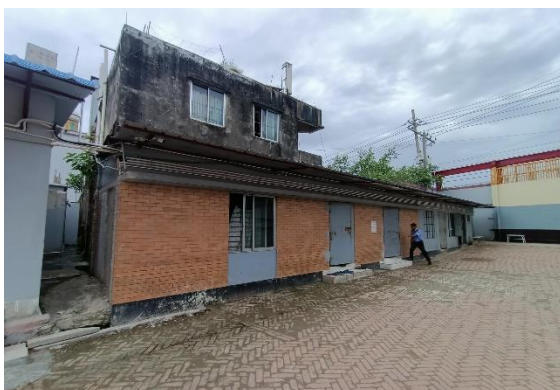
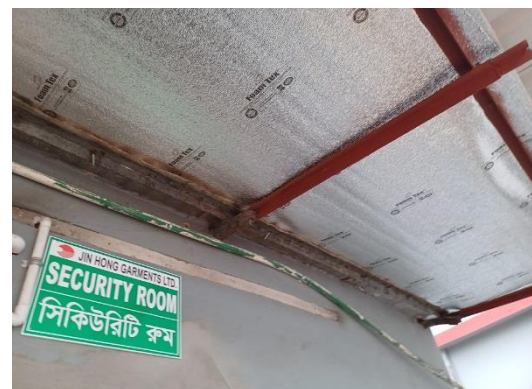
Observation-8: Lack of as-built drawings. (Security Shed)

Description: As-built drawings were not available for the shed. The building engineer is required to prepare a full set of as-built drawings with complete structural details.

13.	Lack of as-built drawings. (Security Shed)	The building engineer is required to prepare a full set of as-built drawings with complete structural details.	within 6 weeks

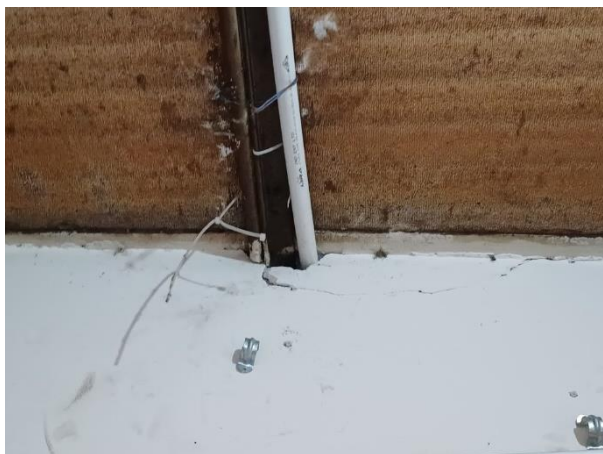
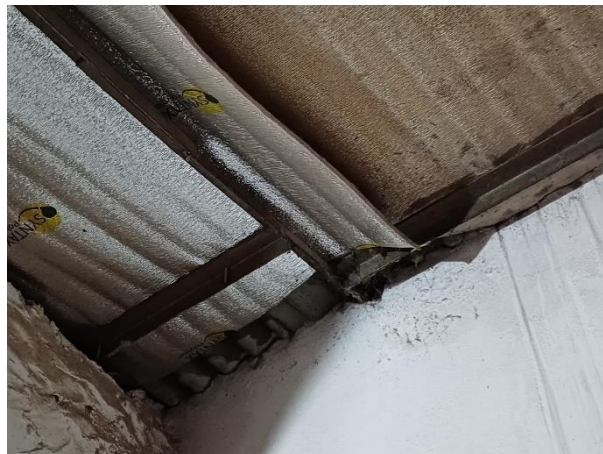
Observation-9: Inadequate connection. (Security Shed)

Description: Inadequate connections were found in the Security Shed. The building engineer is required to prepare a safety check report of the structure for uplift pressure against wind.

Item No.	Observation	Action Plan	Timeline
14.	Inadequate connection. (Security Shed)	Building engineer is required to prepare a safety check report of the structure for uplift pressure of wind according to Accord Building Standards.	within 6 weeks
