# Tosrifa Industries Ltd (Extension)

4/2 A, 135 Gopalpur, Post Office - Munnunagar, Tongi, Gazipur-1710

20 October 2024

## **1. Building Information**

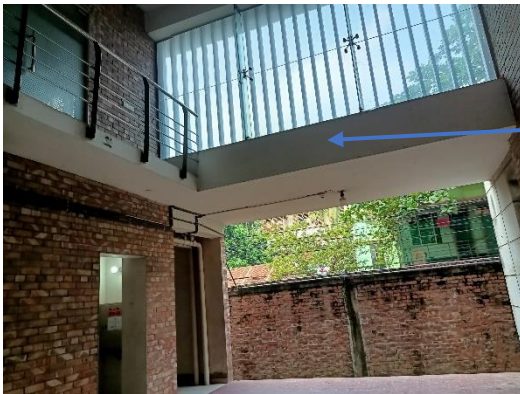
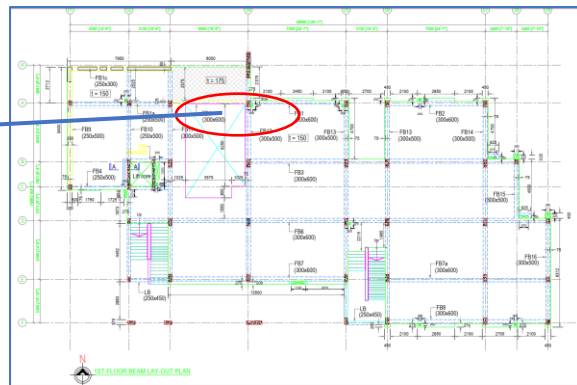
### Observation-1: Mismatches in as-built drawings (Admin Building).

**Description:** Marked beam was found missing in as-built conditions. Also, architectural drawings were found incomplete. Building engineer is required to survey the whole structure and prepare accurate as-built drawings for the structure.

| Item No | Observation | Action Plan | Timeline |
|---|---|---|---|
| 01 | Mismatches in as-built drawings (Admin Building). | Building engineer is required to survey the whole structure and prepare accurate as-built drawings for the structure. | within 6 weeks |

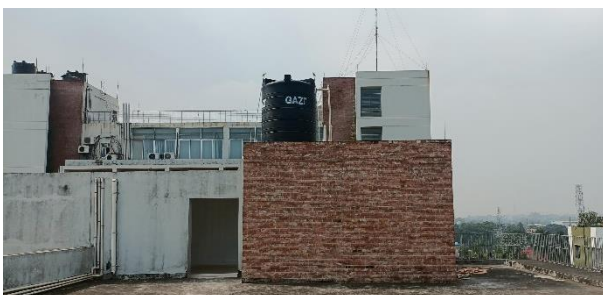
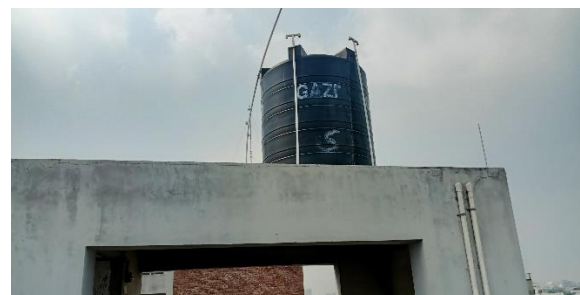
### Observation-3: Unbraced PVC water tank on the stair roof (Admin Building).

**Description:** Unbraced plastic water tanks were found on the staircase roof. The factory is required to anchor and brace all types of non-structural elements to avoid falling hazards during EQ.

| Item No | Observation | Action Plan | Timeline |
|---|---|---|---|
| 05 | Unbraced PVC water tank on the stair roof (Admin Building). | The factory is required to anchor and brace all types of non-structural elements to avoid falling hazards during EQ. | within 6 months |

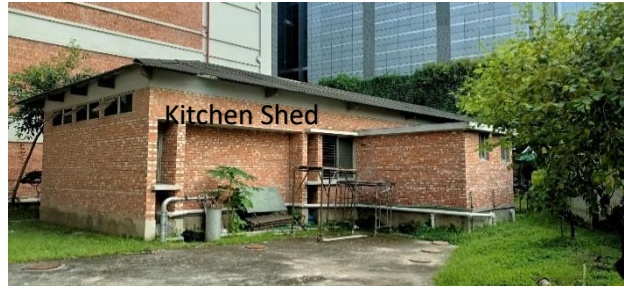
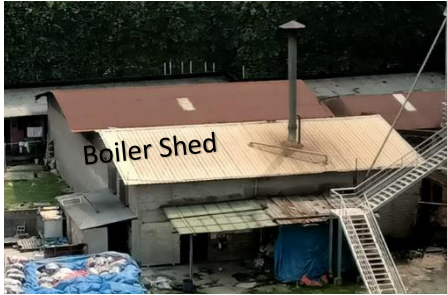
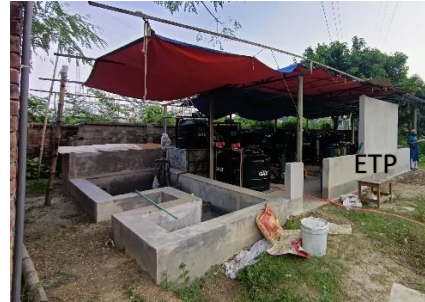
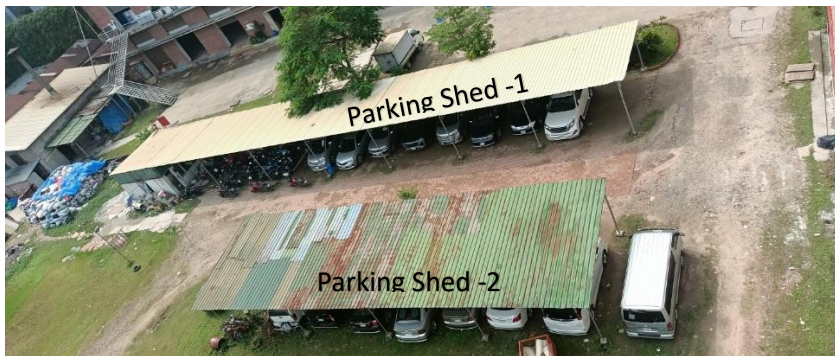
**Observation-4:** Lack of Structural drawings (Kitchen Shed, Boiler Shed, Parking Shed-1&2, ETP).

**Description:** As-built structural drawings were not available for these sheds. Building engineer is required to survey the whole structure and prepares full set of as-built structural drawings.

| Item No | Observation | Action Plan | Timeline |
|---|---|---|---|
| 06 | Lack of Structural drawings (Kitchen Shed, Boiler Shed, Parking Shed-1&2, ETP). | Building engineer is required to survey the whole structure and prepare complete structural and architectural drawings for the building. | within 6 weeks |

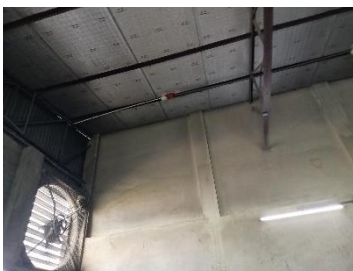
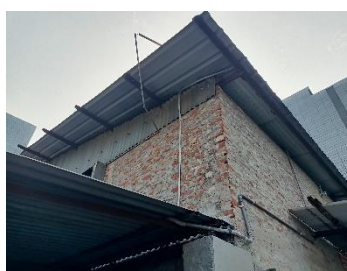
Truss conection

**Observation-5:** Improper connection and missing lateral load transfer media. (Boiler Shed)

**Description:** Truss frames are connected with brick walls. Also, lateral load transfer media (bracing & strut) were found missing. On the other hand, South part of the shed is being occupied by another factory which is separated by boundary walls.

There is no access from this factory premises. The building engineer is required to check the connection & stability system (safety check) for the whole structure and suggest proper alternatives accordingly following Accord Building Standard.

| Item No | Observation | Action Plan | Timeline |
|---|---|---|---|
| 07 | Improper connection and missing lateral load transfer media. (Boiler Shed) | The building engineer is required to check the connection & stability system (safety check) for the whole structure and suggest proper alternatives accordingly following Accord Building Standard. | within 6 weeks |
| 08 | Improper connection and missing lateral load transfer media. (Boiler Shed) | Implement remediation work if required. | within 6 months |

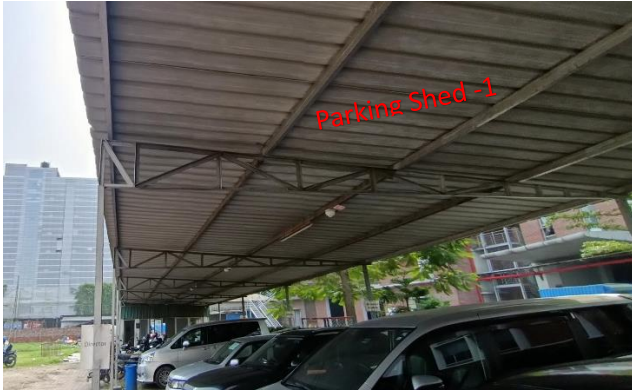
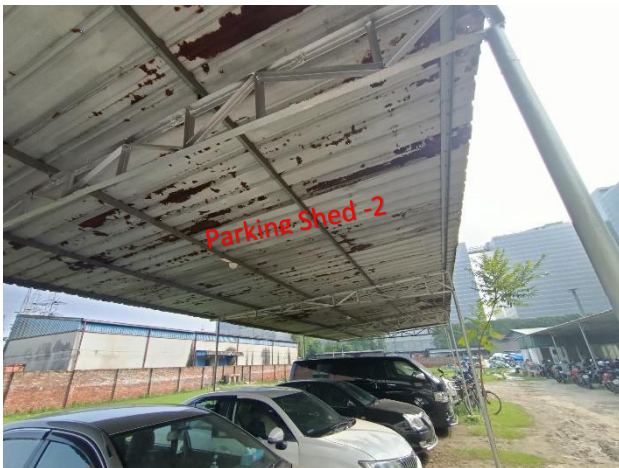
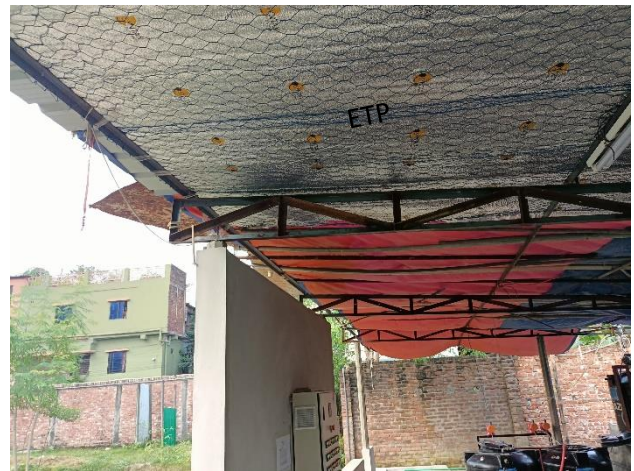
**Observation 6:** Improper connection and inadequate vertical member. Also, lateral load transfer media missing. (Parking Shed-1&2, ETP).

**Description:** Lack of lateral & vertical stability system (strut and bracing), and inadequate connection, member size was observed.

The building engineer is required to check the connection & stability system (safety check) of the structure and suggest proper alternatives accordingly following Accord Building Standard.

| Item No | Observation | Action Plan | Timeline |
|---|---|---|---|
| 09 | Improper connection and inadequate vertical member. Also, lateral load transfer media missing. (Parking Shed-1&2, ETP). | The building engineer is required to check the connection & stability system (safety check) of the structure and suggest proper alternatives accordingly following Accord Building Standard. | within 6 weeks |
| 10 | Improper connection and inadequate vertical member. Also, lateral load transfer media missing. (Parking Shed-1&2, ETP). | Implement remediation work if required. | within 6 months |
