APPARELS JB21 LTD

FS SFB #4, Road #2, Bay Area, CEPZ, Chattogram

31 October 2024

1. Building Information:

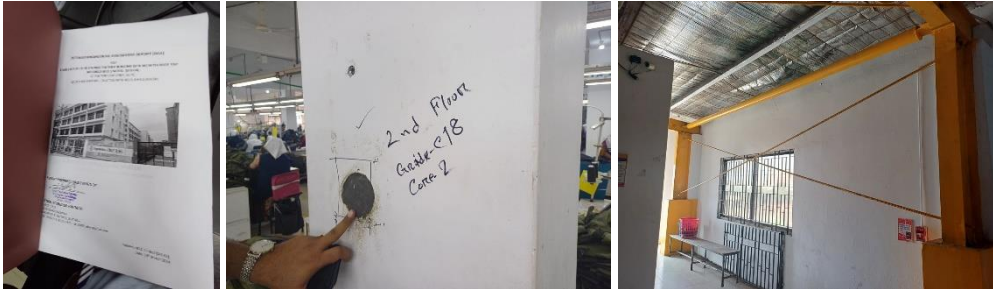
Observation-1: Prepared design report needs to be reviewed against lateral loadings. Building 1 (MAIN PRODUCTION BUILDING)

Design report, new core cutting, and extra braced bays

Description: During the inspection, a Detail Engineering Assessment (DEA) report was found onsite. New cores were taken to confirm the design strength. Additional braces are installed in the rooftop shed. Also, some discrepancies were observed in the structural member sizes. For portal frame steel framing response modification factor is considered as 8 without proper justification. However, the building engineer is required to revise the prepared DEA report based on as-built framing & member sizes. Submit the revised DEA documents to the RSC for detailed review against lateral forces.

Item No.	Observation	Action Plan	Timeline
1.	Prepared design report needs to be reviewed against lateral loadings. Building 1 (MAIN PRODUCTION BUILDING)	The building engineer is required to revise the prepared DEA report based on as-built framing system & member sizes. Submit the revised DEA documents to the RSC for detailed review against lateral forces.	within 6 weeks

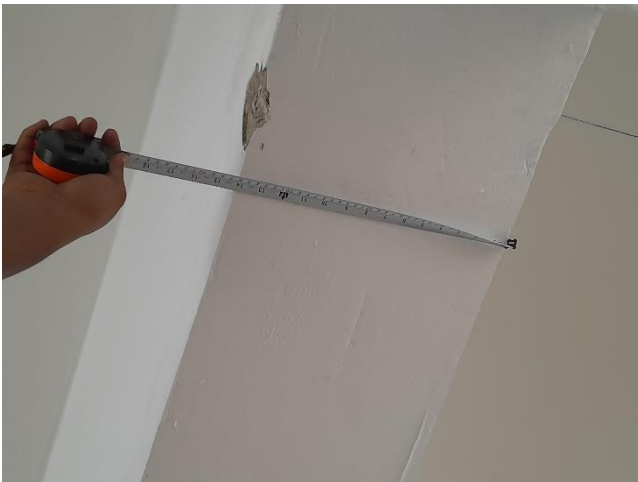
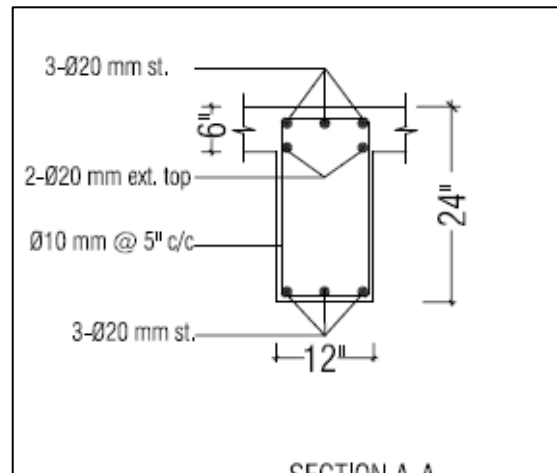
RB1 was measured as 350x475 mm which was shown as 300x475 mm in the drawing

Description: During the inspection, discrepancies and lack of information were observed between the provided drawing and on-site conditions. Floor beam RB1 was measured 350x475 mm which was shown 300x475 mm in drawing. Flange thickness of Steel column SC1 was measured 6 mm onsite which was shown as 7 mm in as-built drawing. Also, some drawings were incomplete. The building engineer is required to survey the whole structure and update the drawing reflecting on-site conditions.

2.		Carry out suggested remedial works if required.	within 6 months
3.		Continue to implement a proper load management plan.	within 6 months
4.	Discrepancy in as-built drawing. Building 1 (MAIN PRODUCTION BUILDING)	The building engineer is required to survey the whole structure and update the drawing reflecting on-site condition.	within 6 weeks

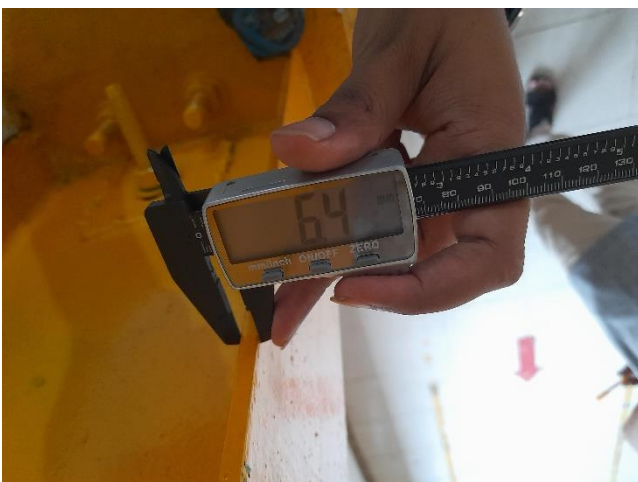
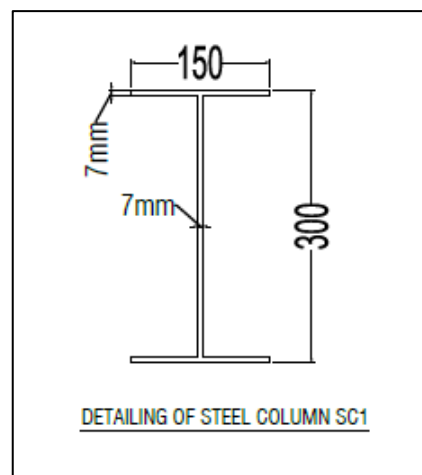
Flange thickness of SC1 was measured 6 mm onsite where 7 mm shown in the drawing

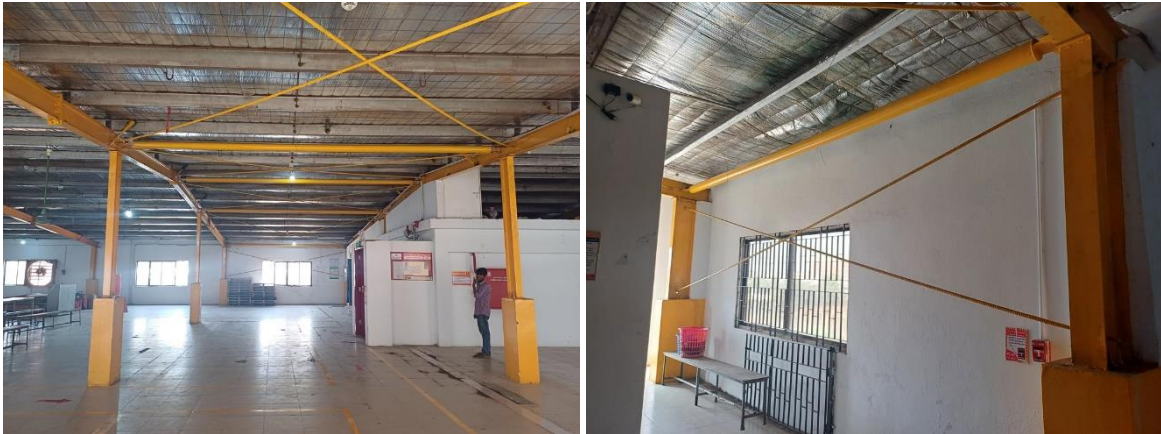
Extra bracing was observed in two bays

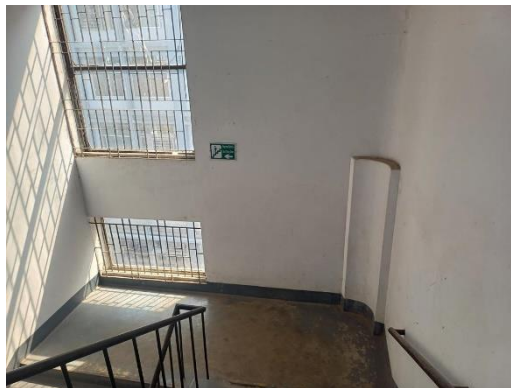
Retrofitting column didn't reach the proposed floor level

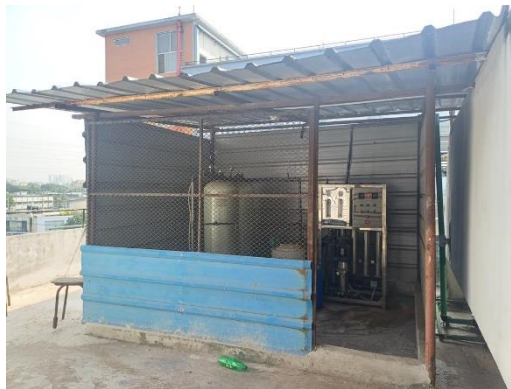
Structural details of the rooftop RO shed were not available

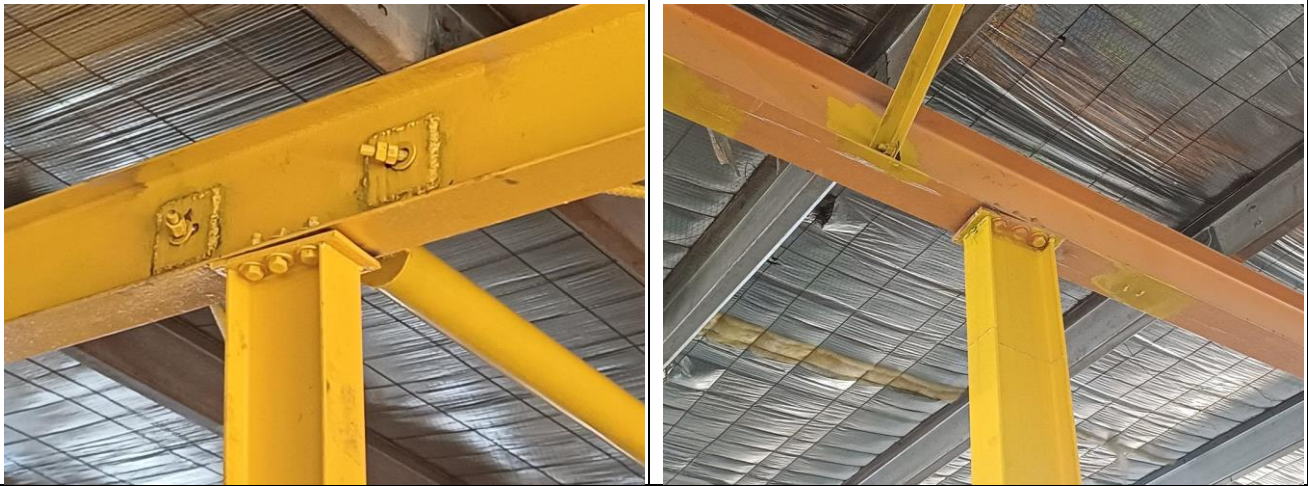
Observation 3: Gap between steel connection plates. Building 1 (MAIN PRODUCTION BUILDING)

Description: Gap was found between steel connection plates in the rooftop shed. The building engineer is required to fill the gap with suitable methods.

5.	Gap between steel connection plates. Building 1 (MAIN PRODUCTION BUILDING)	The building engineer is required to fill the gap with suitable methods.	within 6 weeks

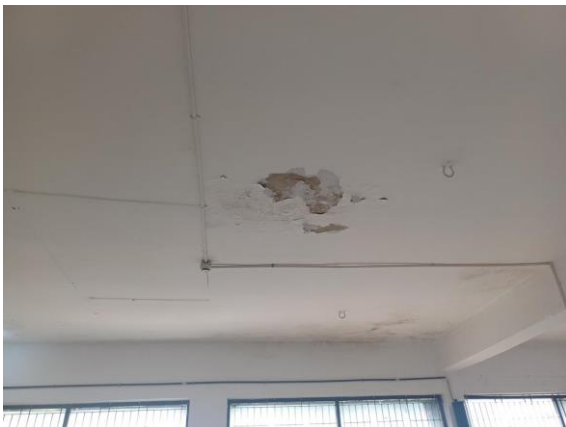
Slab soffit

Observation 4: Dampness due to water ingress into the roof slab & brick wall. Building 1 (MAIN PRODUCTION BUILDING)

Description: Dampness was found on slab soffit and wall surface. The building engineer is required to seal the source of water and repair the damp area with a suitable method.

6.	Dampness due to water ingress into the roof slab & brick wall. Building 1 (MAIN PRODUCTION BUILDING)	The factory is required to seal the source of water and repair the damp area with suitable method	within 6 weeks

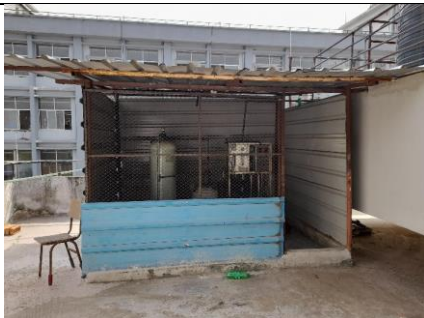
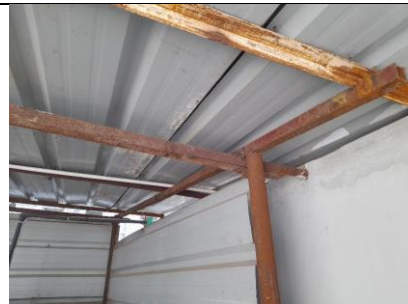
Observation 5: Corrosion of steel members. Building 1 (MAIN PRODUCTION BUILDING)

Description: Corrosion was found on steel members of the rooftop RO shed. Building engineer is required to remove the corrosion and apply rust-proof coating on steel members.

7.	Corrosion of steel members. Building 1 (MAIN PRODUCTION BUILDING)	The building engineer is required to remove the corrosion and apply rust proof coating on steel members.	within 6 weeks

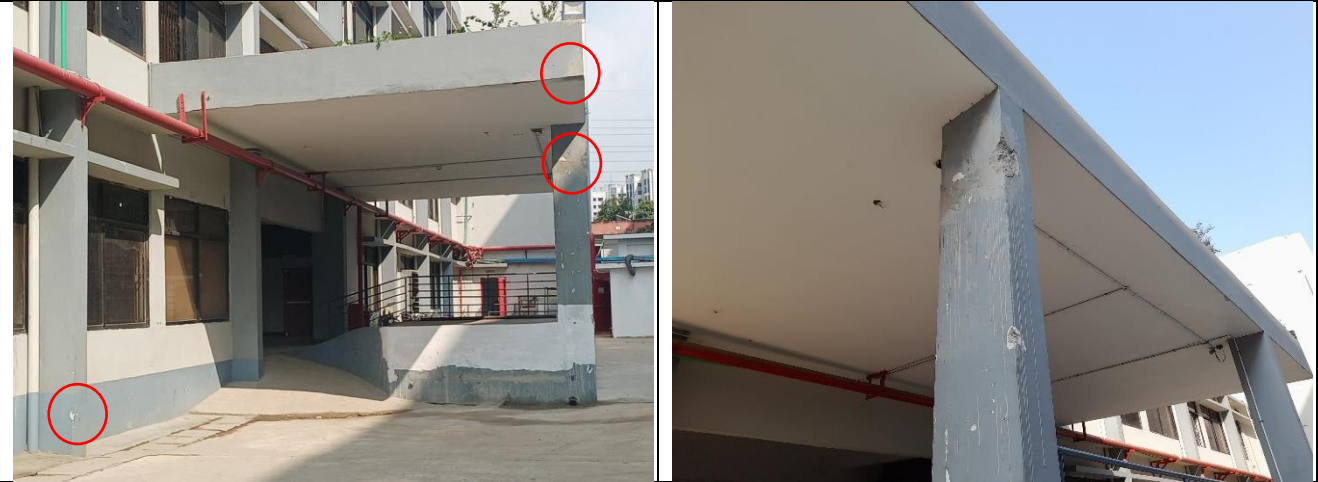
RC columns at the loading-unloading zone susceptible to vehicle impact

Description: RC columns on the ground floor are prone to possible vehicle impact. Signs of damage in columns were observed. Factory is required to provide separate barriers for all exposed column/slabs at the loading-unloading zone floor to prevent possible vehicle impact.

8.	Possibility of vehicle impact on columns. Building 1 (MAIN PRODUCTION BUILDING)	Factory is required to provide separate barriers for all exposed column/slabs at the loading-unloading zone floor to prevent from possible vehicle impact.	within 6 weeks

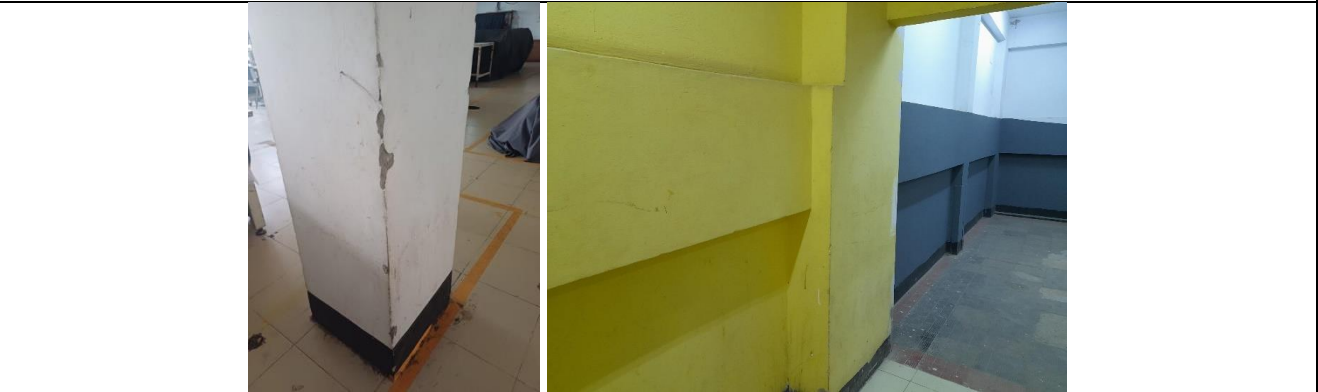
Columns are susceptible to impact

Description: Columns are susceptible to impact loading from trolley. Signs of damage in columns were observed. Factory is required to provide guard for all exposed columns and walls to prevent from possible trolley impact.

9.	Column susceptible to trolley impact. Building 1 (MAIN PRODUCTION BUILDING)	Factory is required to provide a guard for all exposed columns and wall to prevent from possible trolley impact.	within 6 weeks

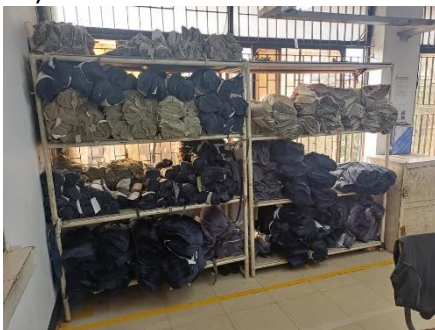
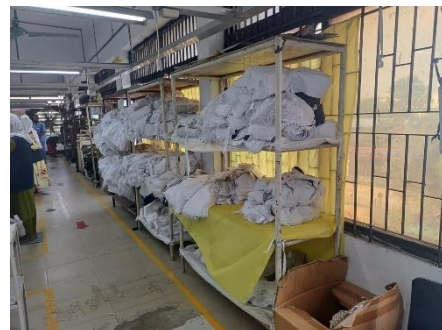
Observation-8: Unbraced storage racks on different floors. Building 1 (MAIN PRODUCTION BUILDING)

Description: Unbraced storage racks were observed on different floors. The building engineer is required to provide anchorage/bracing to the storage racks to protect them from falling hazards.

10.	Unbraced storage racks on different floors. Building 1 (MAIN PRODUCTION BUILDING)	The building engineer is required to provide anchorage/bracing to the storage racks to protect them from falling hazards.	within 6 months
