# Southern Services Ltd (Extension 2)

DOCTOR BARI, ZIRABO, ASHULIA, SAVAR, DHAKA

11 November 2024

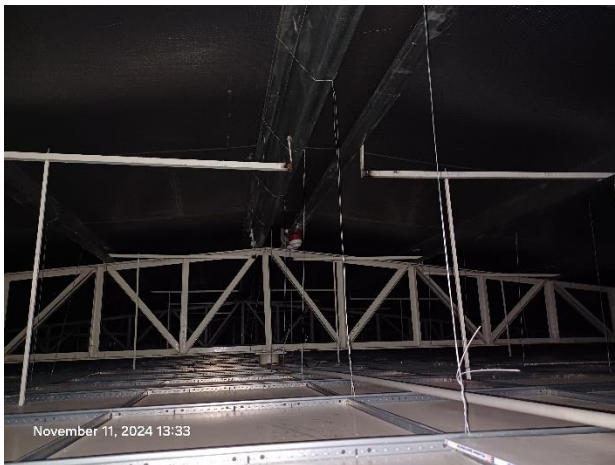
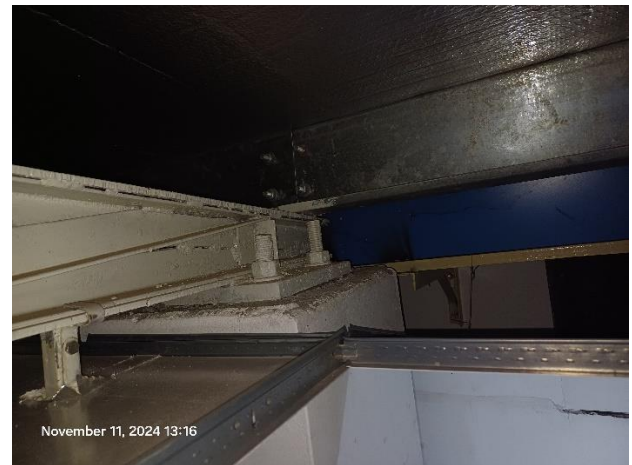
**Observation-1:** Lack of lateral stability system (bracing & strut along the ridge). (Building 2)

**Description:** Lateral load transfer media compression struts were missing along the ridge. So, the lateral stability of the structure is questionable. A design report was available for the building. The design report did not incorporate the adequacy of steel members' connections. However, the building engineer is required to incorporate an adequacy check of steel member's connections in the design report including the review against lateral loading, and submit it to RSC for detailed review. Once the review of design documents is finalized, implement the proposed remedial works (if any).

| Item No. | Observation | Action Plan | Timeline |
|---|---|---|---|
| 01 | Lack of lateral stability system (bracing & strut along the ridge) (Building 2) | The design report needs to be reviewed against lateral loading, incorporate the connection adequacy check in the design report, and submit it to the RSC for detailed review. | within 6 weeks |
| 02 | | Carry out the suggested remedial works. | within 6 months |

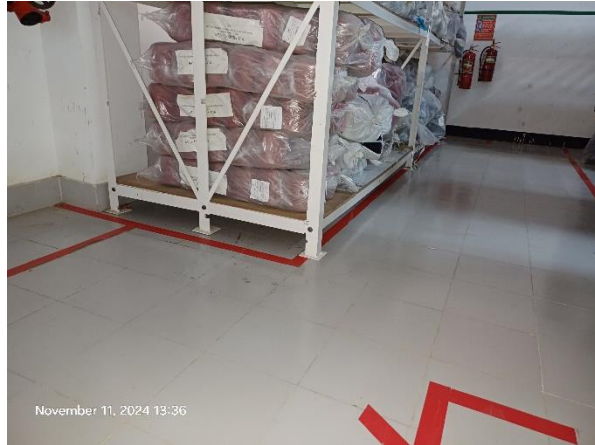
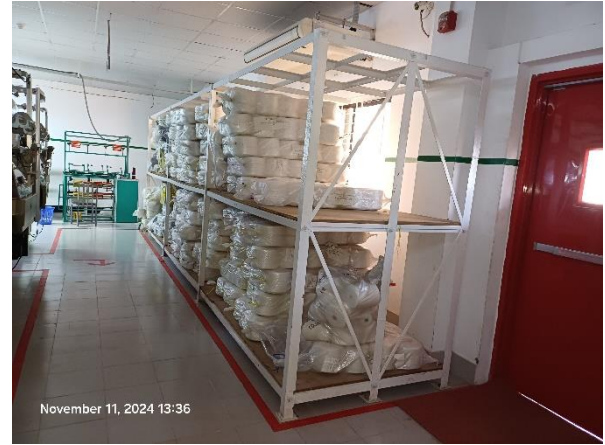
**Observation-2:** Nonstructural elements found not anchored/braced (Building 2)

**Description:** Non-structural elements suspended from, attached to, or resting atop the structure shall be adequately anchored and braced to resist earthquake forces. Factory is required to brace/anchor all non-structural elements (storage racks).

| Item No. | Observation | Action Plan | Timeline |
|---|---|---|---|
| 03 | Nonstructural elements found not anchored/braced (Building 2) | Factory is required to brace/anchor all non-structural elements. | within 6 months |
