# INITIAL FIRE SAFETY INSPECTION REPORT

## Southern Services Ltd (Extension 2)

**RSC ID: 25895**

**Date: 11-Nov-2024**

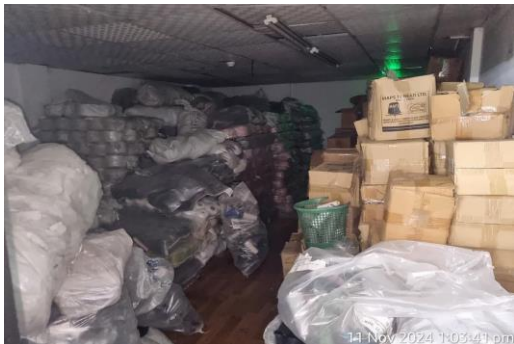
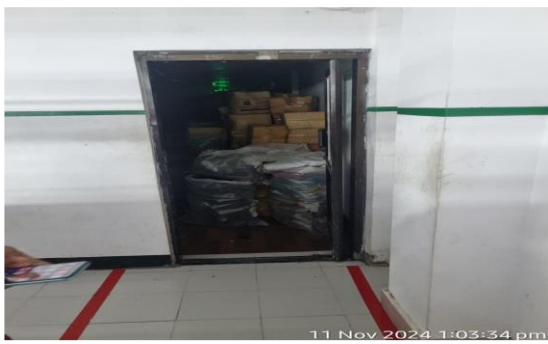
| Sl No. | Category | Findings | Required Action | Remediation Time Frame |
|---|---|---|---|---|
| 1 | Fire Rated Construction | Room used for combustible storage are not separated by fire rated construction.<br>Location: South side inside the floor. | Separate the storage room by a minimum 1- hr fire-rated construction. Seal and/or protected all unprotected openings to maintain the required fire separations. | Within 3 months |

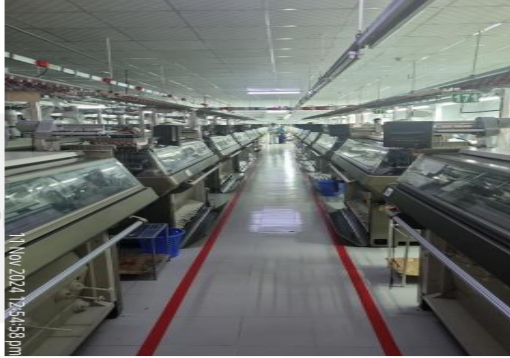
| 2 | Egress Lighting | Based on the number and location of emergency lights observed, adequate illumination levels are not anticipated along egress routes. | Test the emergency lighting system on each floor and provide additional emergency fixtures to provide adequate illumination along the means of egress. Provide a minimum illumination of 10 lux at the floor level within exit stairs and exit discharge paths and minimum 2.5 lux along exit access aisles. | Within 2 months |

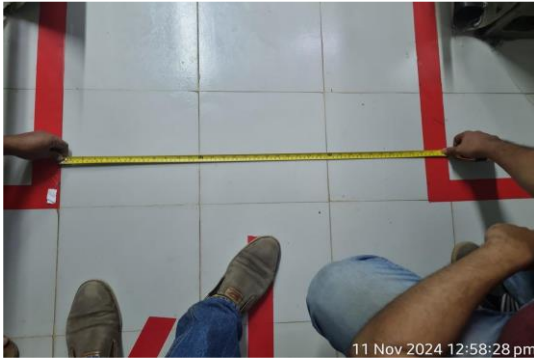
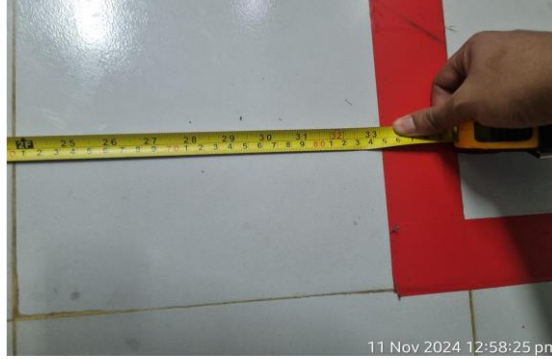
| 3 | Means of Egress | The clear-width of egress aisles were found to be less than 0.9 m (36 in.). | Provide egress aisles with a minimum unobstructed clear-width of 0.9 m (36 in.). | Within 2 months |

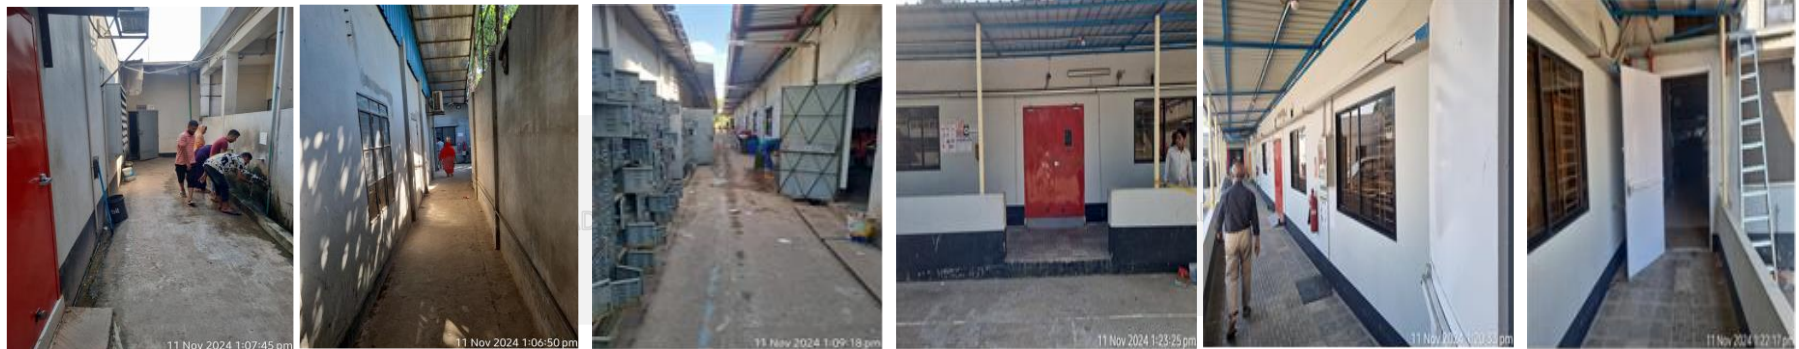
| 5 | Means of Egress | <p>The egress court serving as a portion of the exit discharge path is less than 10 ft wide and is not separated from the building interior. Also some portion of the egress court is neither open to sky and nor provided with a fire resistance rated enclosure.</p> <p>Location: Both east and west egress court of Building-2. The east egress court also serves the two-storied main building.</p> | <p>An egress court serving as a portion of the exit discharge shall be open to the sky or provided with a fire resistance rated enclosure the same as the exit enclosure.</p> <p>Egress courts less than 3050 mm (10 ft) in width (as measured from the building and the adjacent property line) shall be provided with walls having a 1-hr fire resistance rated construction for a distance of 3050 mm (10 ft) above the floor of the court.</p> <p>Alternatively, provide a second remote discharge path to the public way</p> | Within 3 months |

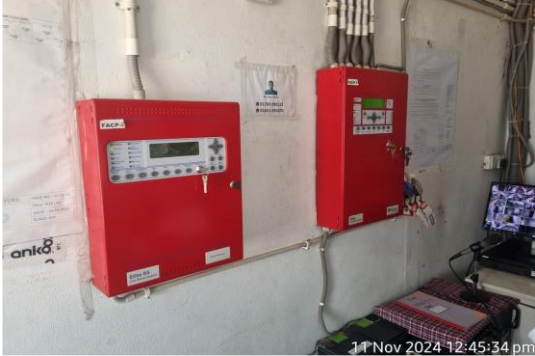
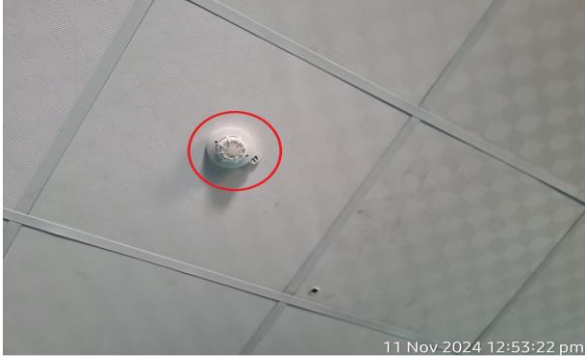
| 6 | Fire Alarm & Detection System (FADS) | The shed was previously under the old ID (11459), where the system was approved by the RSC through the T&C process. Since the shed has been reconstructed and the system reinstalled, a verification process is required before approval under the new ID. | Update the design documents and ensure the system is fully functional. The system will be verified by the RSC during the next regular follow-up inspection. | Within 1 month |

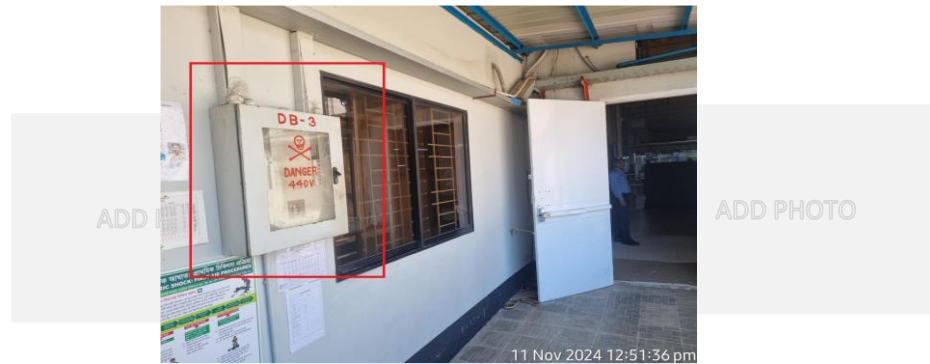
| 8 | Means of egress | Electrical panel (DB board) was observed inside exit enclosure. | Remove/relocate the electrical panel from the exit enclosure. | Within 2 months |
