# Unimas Sportswear (Extension 2)

BAGBARI, KASHIMPUR, GAZIPUR SADAR

14 November 2024

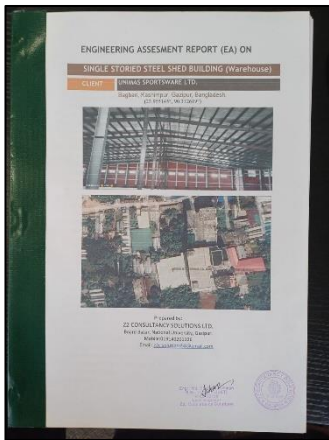
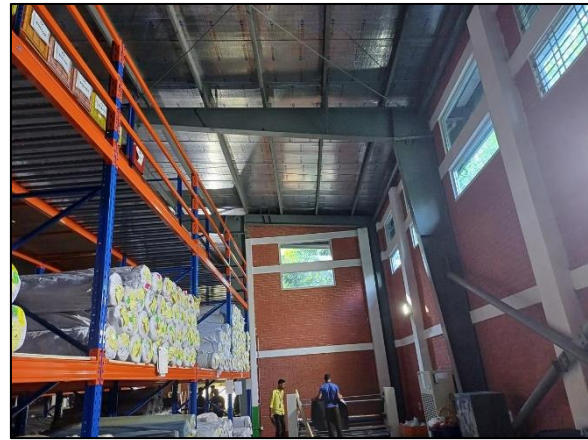
### Design report

**Observation-01:** Prepared design report needs to be reviewed against lateral loadings (Warehouse Shed-1).

**Description:** During the inspection, an Engineering Assessment (EA) report was found onsite. No connection adequacy was included in the EA report. However, the building engineer is required to revise the prepared EA report based on as-built member sizes. Submit the revised EA documents to the RSC for detailed review against lateral forces.

| Item No | Observation | Action Plan | Timeline |
|---|---|---|---|
| 1. | Prepared design report needs to be reviewed against lateral loadings (Warehouse Shed-1). | The building engineer is required to revise the prepared EA report based on as-built member sizes. Submit the revised EA documents to the RSC for detailed review against lateral forces. | within 6 weeks |
| 2. | | Carry out suggested remedial works if required. | within 6 months |

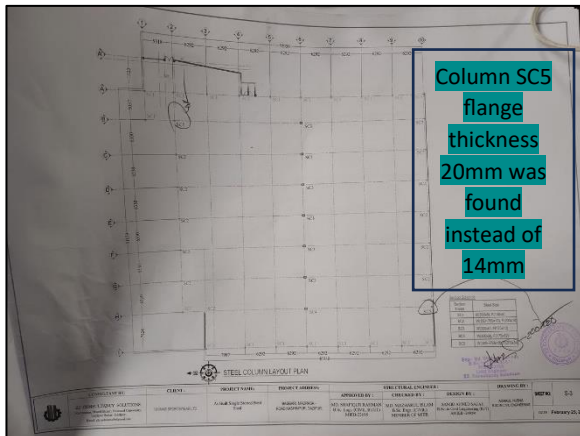
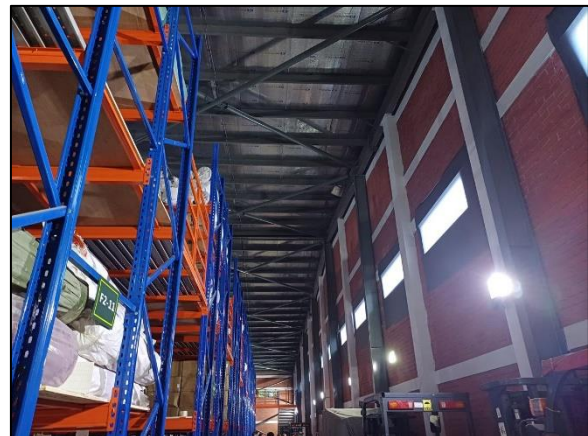
### As built drawings

**Observation-02:** Discrepancy in as-built drawing (Warehouse Shed-1).

**Description:** During the inspection, mismatch was observed in the provided drawing with the as-built condition for the mentioned structures. Column SC5 mismatch was found with as-built drawings. The building engineer is required to survey the whole structure and update the drawing reflecting on-site condition.

| Item No | Observation | Action Plan | Timeline |
|---|---|---|---|
| 3. | Discrepancy in as-built drawing (Warehouse Shed-1). | The building engineer is required to survey the whole structure and update the drawing reflecting on-site condition. | within 6 weeks |

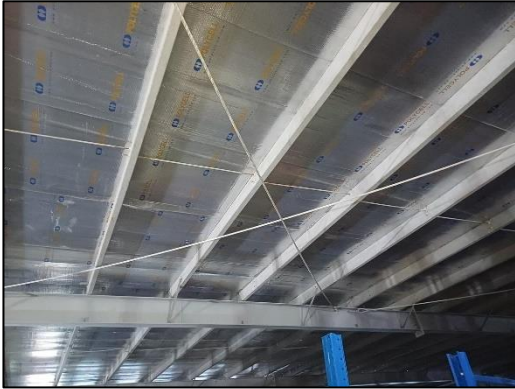
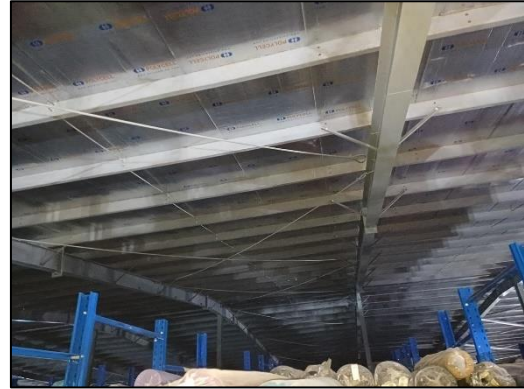
**Observation-03:** Loose cable bracing (Warehouse Shed-1).

Loose cable bracing

**Description:** During the inspection, Loose cable bracing was found at the roof bracing. The factory is required to tighten the loose bracings for transferring the lateral loads properly.

| Item No | Observation | Action Plan | Timeline |
|---|---|---|---|
| 4. | Loose cable bracing (Warehouse Shed-1). | The factory is required to tighten the loose bracings for transferring the lateral loads properly. | within 6 weeks |

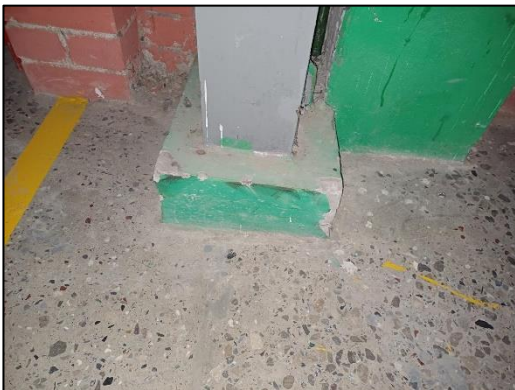
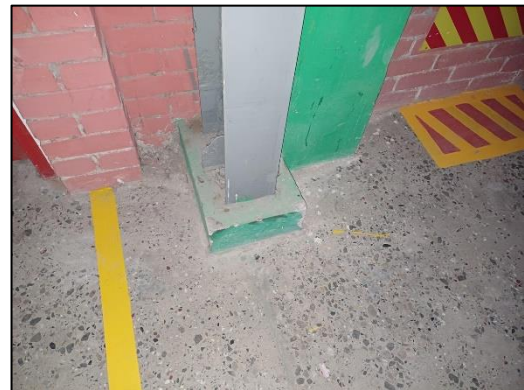
**Observation 4:** RC short column susceptible to trolley impact (Warehouse Shed-1).

Columns are susceptible to trolley impact

**Description:** Columns are susceptible to impact loading from trolley. Signs of damage in columns were observed. Factory is required to provide guard for all exposed column to prevent from possible trolley impact.

| Item No | Observation | Action Plan | Timeline |
|---|---|---|---|
| 5. | RC short column susceptible to trolley impact (Warehouse Shed-1). | Factory is required to provide guard for all exposed column to prevent from possible trolley impact. | within 6 weeks |

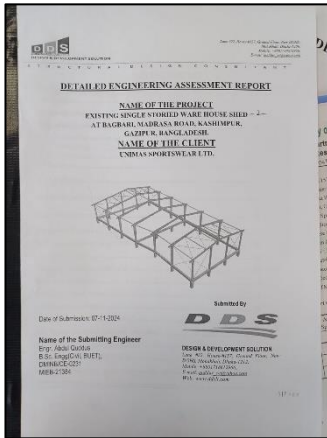
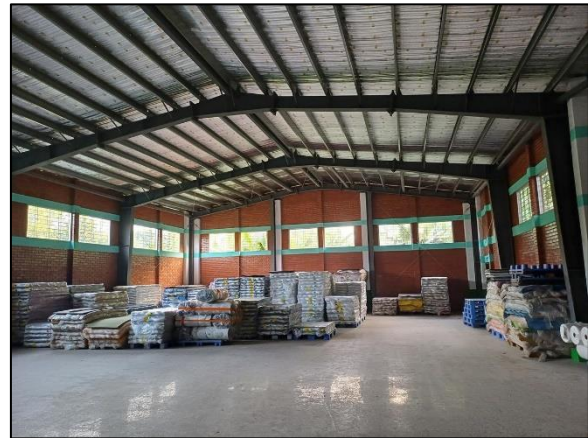
Design report

**Observation-05:** Prepared design report needs to be reviewed against lateral loadings (Warehouse Shed-2).

**Description:** During the inspection, an Engineering Assessment (EA) report was found onsite. However, the building engineer is required to revise the prepared EA report based on as-built member sizes. Submit the revised EA documents to the RSC for detailed review against lateral forces.

| Item No | Observation | Action Plan | Timeline |
|---|---|---|---|
| 6. | Prepared design report needs to be reviewed against lateral loadings (Warehouse Shed-2). | The building engineer is required to revise the prepared DEA report based on as-built member sizes. Submit the revised DEA documents to the RSC for detailed review against lateral forces. | within 6 weeks |
| 7. | | Carry out suggested remedial works if required. | within 6 months |

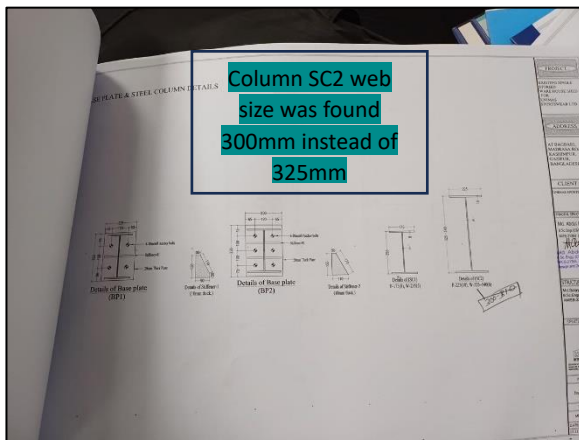
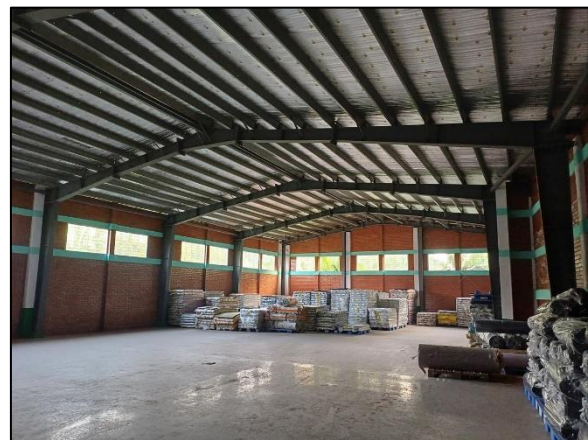
As built drawings

**Observation-06:** Discrepancy in as-built drawing (Warehouse Shed-2).

**Description:** During the inspection, mismatch was observed in the provided drawing with the as-built condition for the mentioned structures. Column SC2 mismatch was found with as-built drawings. The building engineer is required to survey the whole structure and update the drawing reflecting on-site condition.

| Item No | Observation | Action Plan | Timeline |
|---|---|---|---|
| 8. | Discrepancy in as-built drawing (Warehouse Shed-2). | The building engineer is required to survey the whole structure and update the drawing reflecting on-site condition. | within 6 weeks |

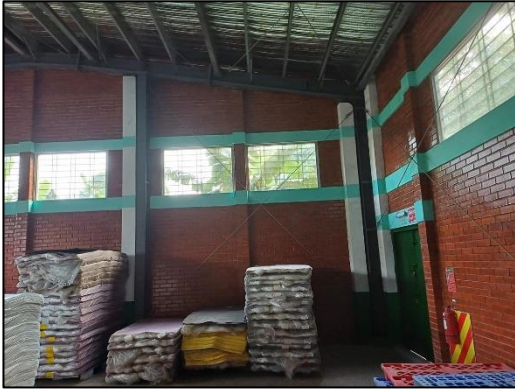
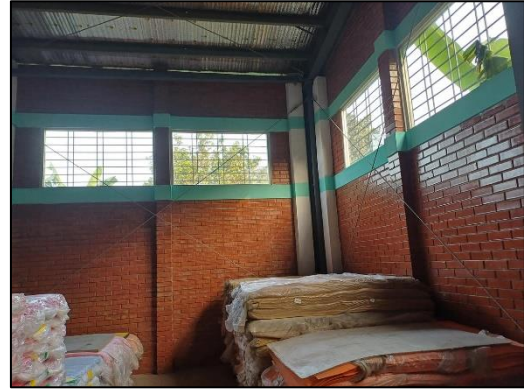
**Observation-07:** Loose cable bracing (Warehouse Shed-2).

Loose cable bracing

**Description:** During the inspection, Loose cable bracing was found on the wall and roof bracing. The factory is required to tighten the loose cable bracings for transferring the lateral loads properly.

| Item No | Observation | Action Plan | Timeline |
|---|---|---|---|
| 9. | Loose cable bracing (Warehouse Shed-2). | The factory is required to tighten the loose bracings for transferring the lateral loads properly. | within 6 months |

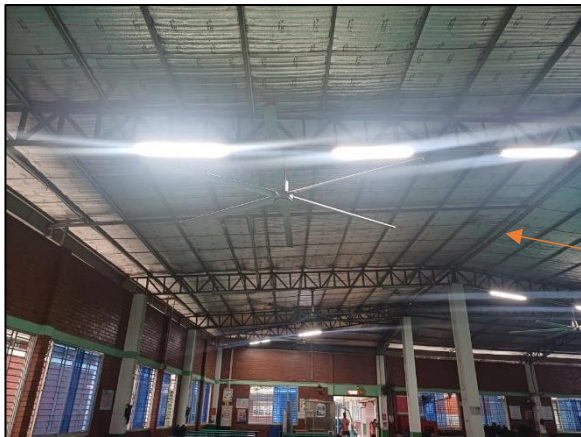
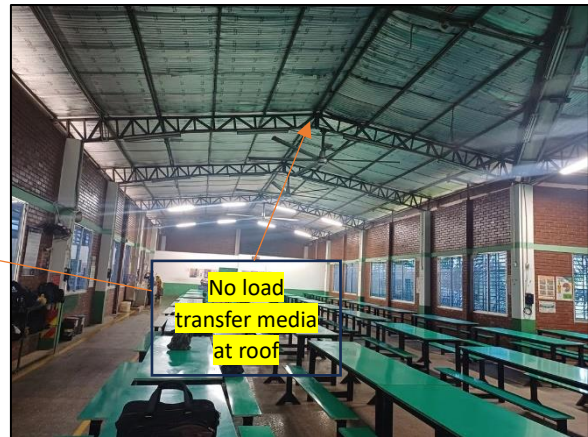
Lateral stability

**Observation-08:** Incomplete lateral stability and absence of design report (Dining & Store Shed).

**Description:** Load transfer media is not provided along long direction for this shed. Therefore, the lateral stability system of the shed is incomplete. During inspection, no design report was available for this structure. The building engineer is required to check the lateral stability of the structure, prepare a design report and submit to RSC for detailed review against lateral forces.

| Item No | Observation | Action Plan | Timeline |
|---|---|---|---|
| 10. | Incomplete lateral stability and absence of design report (Dining & Store Shed). | The building engineer is required to check the lateral stability of the structure, prepare a design report and submit to RSC for review. | within 6 weeks |
| 11. | | Carry out suggested remedial works if required. | within 6 months |

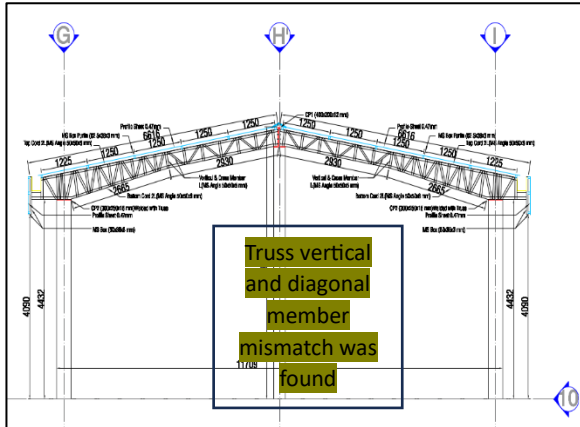
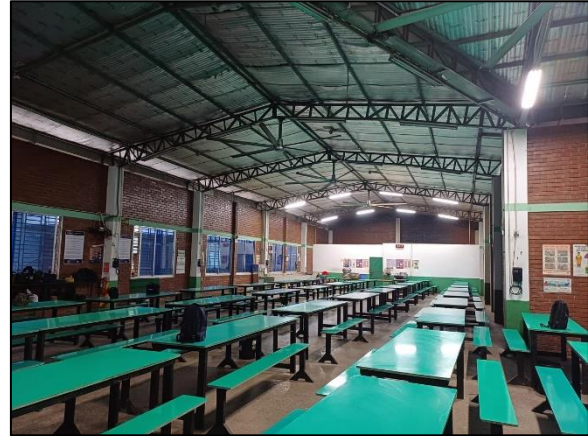
As built drawings

**Observation-09:** Discrepancy in as-built drawing (Dining & Store Shed).

**Description:** During the inspection, mismatch was observed in the provided drawing with the as-built condition for the mentioned structures. Truss vertical and diagonal members were found single and double angle at different locations. As per provided drawings double angle were shown instead of single angle. The building engineer is required to survey the whole structure and update the drawing reflecting on-site condition..

| Item No | Observation | Action Plan | Timeline |
|---|---|---|---|
| 12. | Discrepancy in as-built drawing (Dining & Store Shed). | The building engineer is required to survey the whole structure and update the drawing reflecting on-site condition. | within 6 weeks |

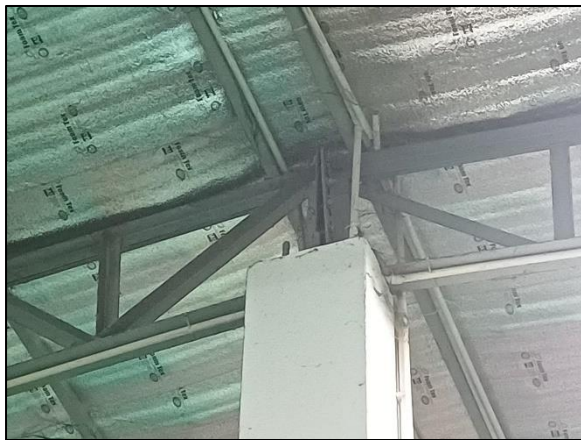
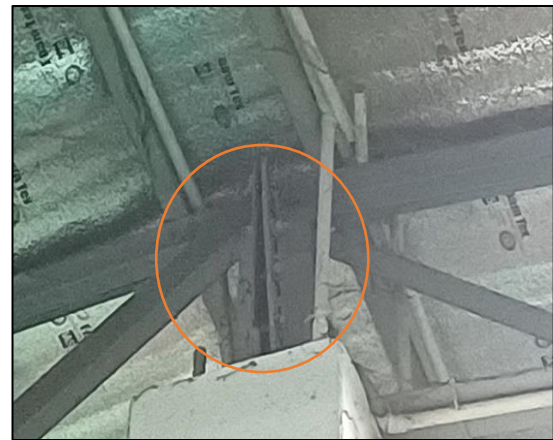
Connection gap

**Observation 10:** Gap between steel connection plates (Dining & Store Shed).

**Description:** Gap was found between steel connection plates at truss joint. The building engineer is required to fill the gap with suitable methods.

| Item No | Observation | Action Plan | Timeline |
|---|---|---|---|
| 13. | Gap between steel connection plates (Dining & Store Shed). | The building engineer is required to fill the gap with suitable methods. | within 6 months |

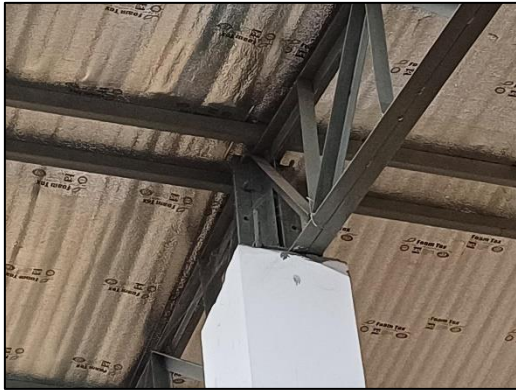
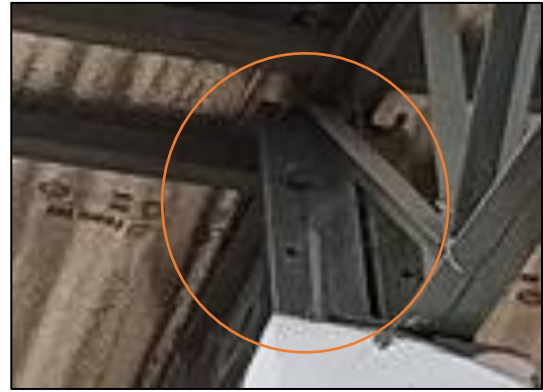
**Observation 11:** Missing nut-bolts at truss joint plate (Dining & Store Shed).

Bolt missing

**Description:** Missing bolt was found at truss joint. The factory is required to install the missing bolts.

| 14. | Missing nut-bolts at truss joint plate (Dining & Store Shed). | The factory is required to install the missing bolts. | within 6 weeks |

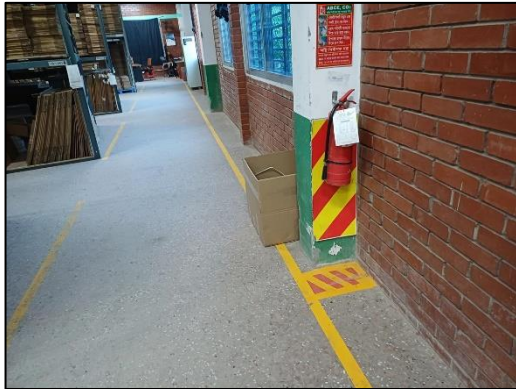
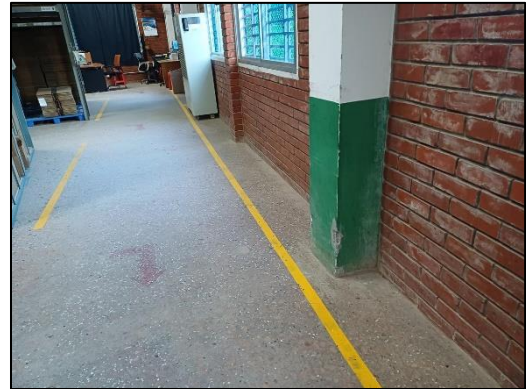
**Observation 12:** Column susceptible to trolley impact (Dining & Store Shed).

Columns are susceptible to trolley impact

**Description:** Columns are susceptible to impact loading from trolly. Signs of damage in columns were observed. Factory is required to provide guard for all exposed column to prevent from possible trolly impact.

| 15. | Column susceptible to trolley impact (Dining & Store Shed). | Factory is required to provide guard for all exposed column to prevent from possible trolley impact. | within 6 weeks |

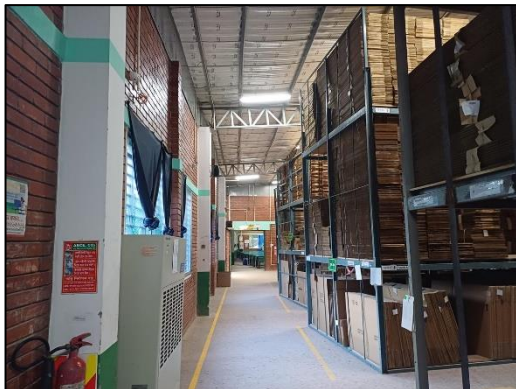
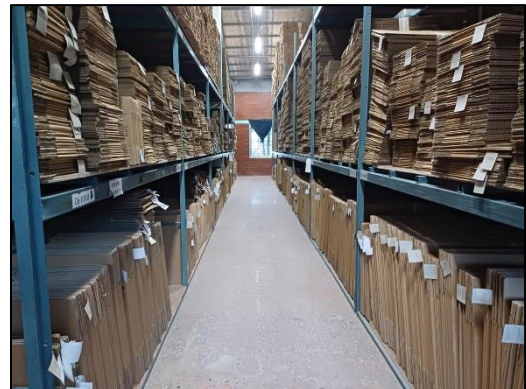
**Observation 13:** Unbraced storage racks on different floors (Dining & Store Shed).

Unbraced storage racks

**Description:** Unbraced storage racks were observed on the ground floor. The factory is required to provide anchorage/bracing to the storage racks to protect from falling hazard.

| 16. | Unbraced storage racks on different floors (Dining & Store Shed). | The factory is required to provide anchorage/bracing to the storage racks to protect from falling hazard. | within 6 weeks |
