# Nippon Garment Industries Ltd. (Extension)

Auchpara, Tongi, Gazipur- 1711

27 October 2024

## **1. Building Information**

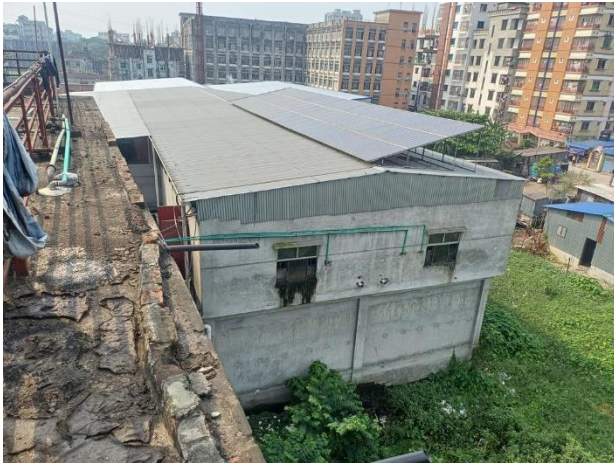
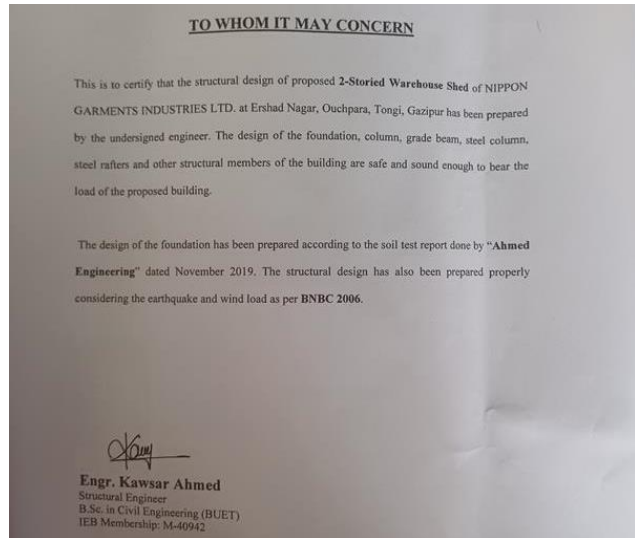
**Observation 01:** Lack of design documents for Warehouse-1.

**Description:** During the inspection, some drawings, a soil test report, and a declaration letter were available onsite. In the declaration letter, the consultant declared that the building is safe and sound enough to bear the proposed load without any reference calculation/design report. The building engineer is required to carry out an Engineering Assessment (EA) to confirm that the building has adequate capacity to bear the gravity & lateral loads as per BNBC-2006. And submit the EA documents to the RSC for detailed review.

| SL | Observation | Action Plan | Timeline |
|---|---|---|---|
| 1. | Lack of design documents for Warehouse-1. | The building engineer is required to carry out an Engineering Assessment (EA) to confirm that the building has adequate capacity to bear the gravity & lateral loads as per BNBC-2006. And submit the EA documents to the RSC for detailed review. | within 6 weeks |
| 2. | | Carry out suggested remedial works if required. | within 6 months |
| 3. | | Implement floor load management program (posting load plan, marking storage area and height, and maintaining floor loading). | within 6 months |

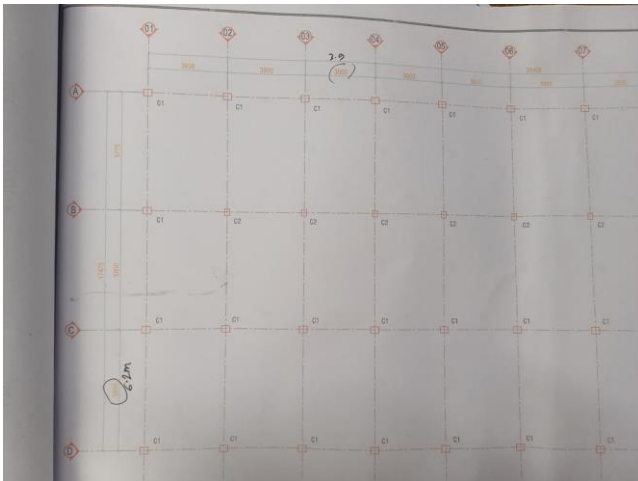
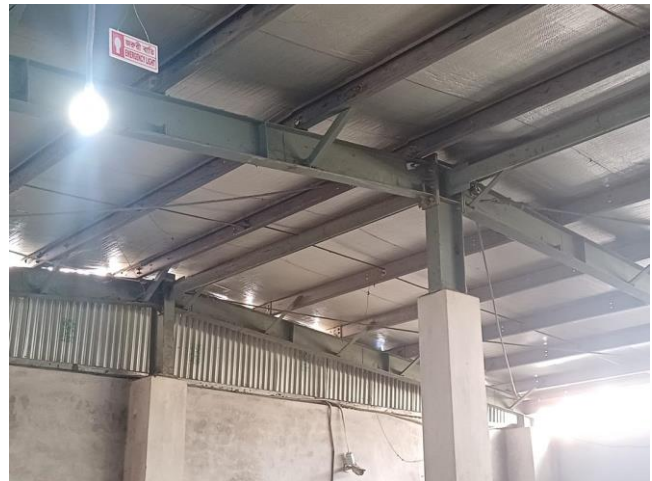
**Observation 02:** Mismatch between drawing and as-built condition of Warehouse-1

**Description:** Mismatches in column grid spacing (6.2 m instead of 5.8 m at C-D & 3.9 m instead of 3.6 m at 3-4) were observed. Also, Steel short columns were not shown in the drawings. Furthermore, the steel rafter flange was found slightly more than the drawings (6 mm). The building engineer is required to survey the structures and prepare accurate as-built drawings.

| SL | Observation | Action Plan | Timeline |
|---|---|---|---|
| 4. | Mismatch between drawing and as-built condition of Warehouse-1 | The building engineer is required to survey the structures and prepare accurate as-built drawings. | within 6 weeks |

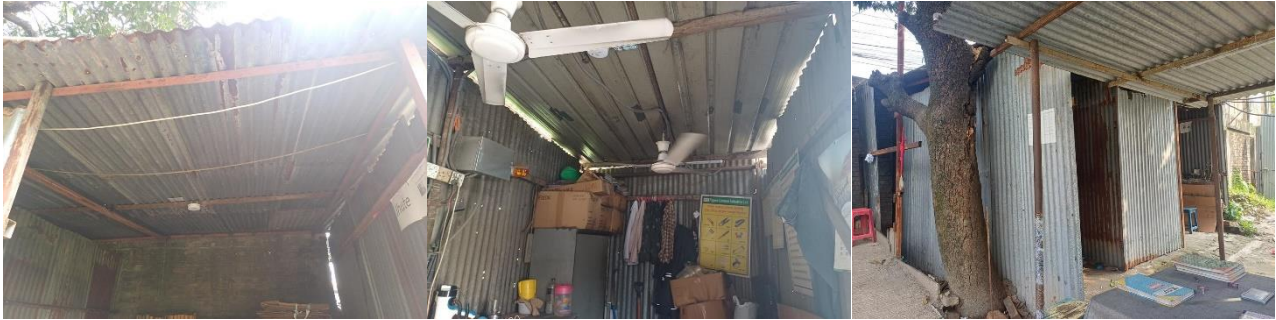
**Observation 05:** Poor structural configuration (framing, connection, members) and lack of documents for the Security & Wastage Shed

**Description:** The columns and rafters of the shed were made of steel angles, and some rafters (of wastage portion) were rested on the adjacent boundary wall. The framing arrangement, member sizes, and their joints were apparently inadequate. Also, the foundation of the shed was unknown. The building engineer is required to survey the structures, prepare accurate as-built drawings with foundation & joint details, prepare a safety check report, and suggest necessary alternatives for the Shed. Submit the safety check report to the RSC for review. The factory is required to follow the recommendation of the safety check report.

| SL | Observation | Action Plan | Timeline |
|---|---|---|---|
| 7. | Poor structural configuration (framing, connection, members) and lack of documents for the Security & Wastage Shed | The building engineer is required to survey the structures, prepare accurate as-built drawings with foundation & joint details, prepare a safety check report, and suggest necessary alternatives for the Shed. Submit the safety check report to the RSC for review. | within 6 weeks |
| 8. | | The factory is required to follow the recommendation of the safety check report. | within 6 months |

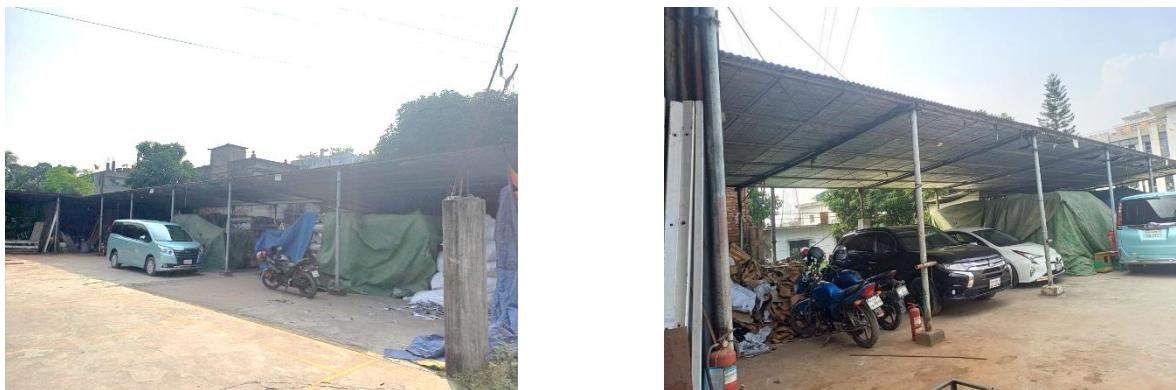
**Observation 06:** Lack of as-built drawings. (Parking Shed)

**Description:** There were no documents for the shed. The building engineer is required to survey the structure and prepare accurate as-built drawings with foundation and joint details.

| SL | Observation | Action Plan | Timeline |
|---|---|---|---|
| 9. | Lack of as-built drawings. (Parking Shed) | The building engineer is required to survey the structure and prepare accurate as-built drawings with foundation and joint details. | within 6 weeks |

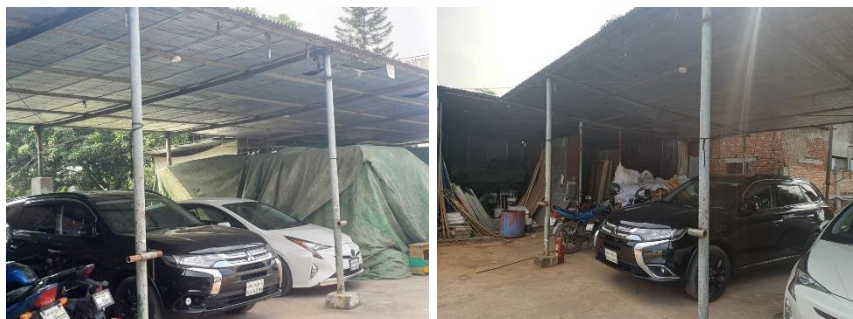
**Observation 07:** Lack of bracing at the roof for Parking Shed

**Description:** There was no roof bracing and no efficient lateral load-resisting system in the shed. The building engineer is required to check the basic safety level of the structure and propose a suitable lateral load-resisting system accordingly. Submit the safety check report to the RSC for review. The factory is required to follow the recommendation of the safety check report.

| 10. | Lack of bracing at roof for Parking Shed | The building engineer is required to check the basic safety level of the structure and propose suitable lateral load resisting system accordingly. Submit the safety check report to the RSC for review. | within 6 weeks |
| 11. | | The factory is required to follow the recommendation of the safety check report. | within 6 months |

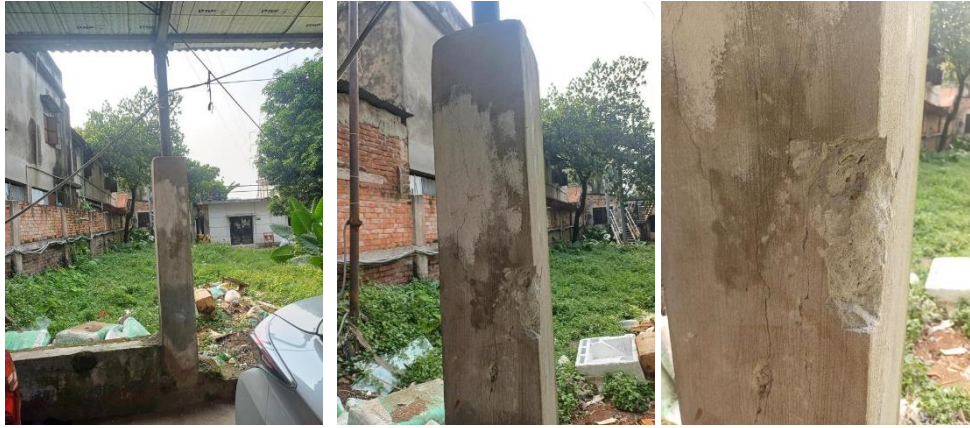
**Observation 08:** Crack in column surface of Parking Shed. (Parking Shed)

Crack in RC column of parking shed

**Description:** A crack was observed in the RC column of the shed. During the onsite investigation, the column's sound was found as solid and the crack was found within the cover. The building engineer is required to check the reason for the crack, prepare an investigation report, and submit it to RSC for review. Repair the crack columns after RSC approval/engineer's consent.

| 12. | Crack in column surface of Parking Shed. (Parking Shed) | The building engineer is required to check the reason for the crack, prepare an investigation report, and submit it to RSC for review. Repair the crack columns after RSC approval/engineer's consent. | within 6 weeks |
