# TS Casual Wear Limited

24 November 2024

## 1. Building Information

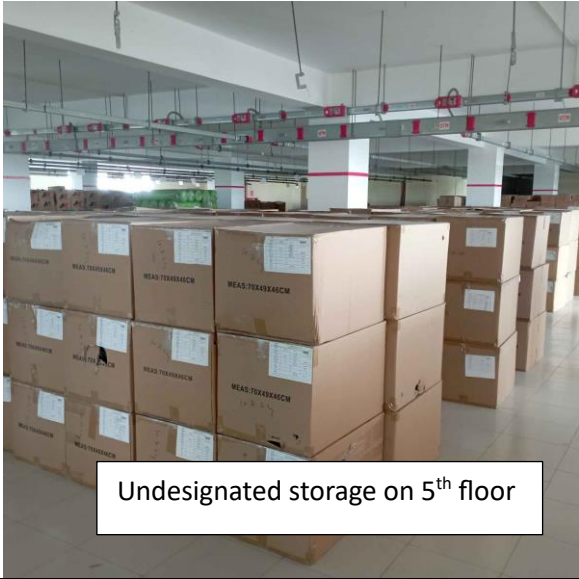
**Observation 2:** The load plan doesn't comply with BNBC (Main Production Building).

Undesignated storage on 5<sup>th</sup> floor

**Description:** Live load for storage is considered as 5 kPa. Also, undocumented storage was found on 4<sup>th</sup> and 5<sup>th</sup> floor. The building engineer is required to update the load plan for the storage area in compliance with BNBC.

2.		Implement remediation work if required.	within 6 months
3.	The load plan doesn't comply with BNBC (Main Production Building).	The building engineer is required to update the load plan for the storage area in compliance with BNBC.	within 6 weeks

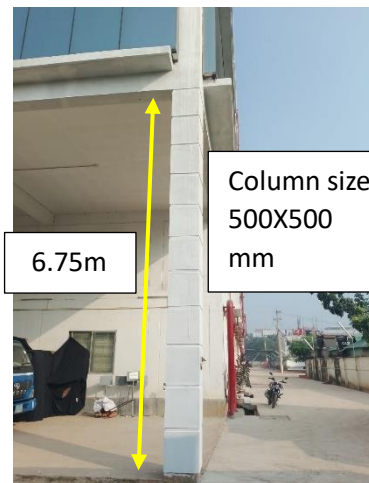
**Observation 3:** The column appears to be slender (Main Production Building).

**Description:** The column appears to be slender due to heigh unsupported length. The building engineer is required to check the column for slenderness ratio and incorporate it in the design report.

4.	The column appears to be slender (Main Production Building).	The building engineer is required to check the column for slenderness ratio and incorporate it in the design report.	within 6 weeks

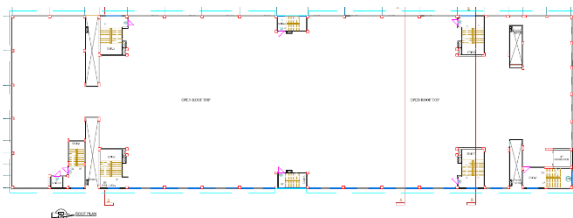
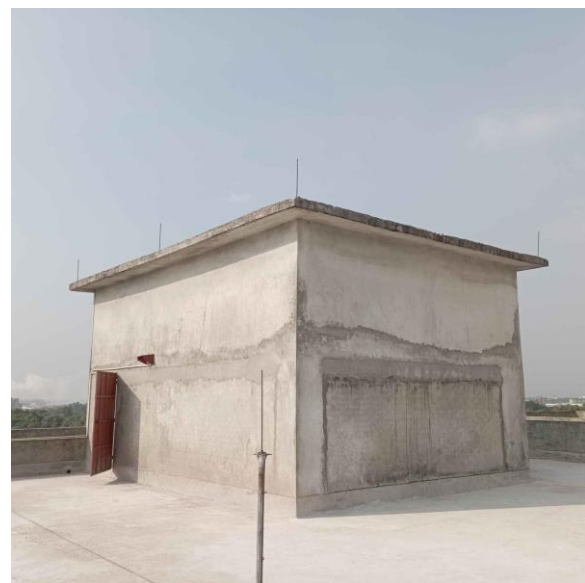
**Observation 4:** Missing information in as-built drawing (Main Production Building).

**Description:** The location of overhead tanks is not shown in the as-built drawing. The building engineer is required to update the as-built drawing.

5.	Missing information in the as-built drawing (Main Building).	The building engineer is required to update the as-built drawing.	within 6 weeks
6.	Possibility of vehicle/trolley impact (Main Production Building).	The building engineer is required to provide a barrier to the exposed column to avoid vehicle impact.	within 6 weeks

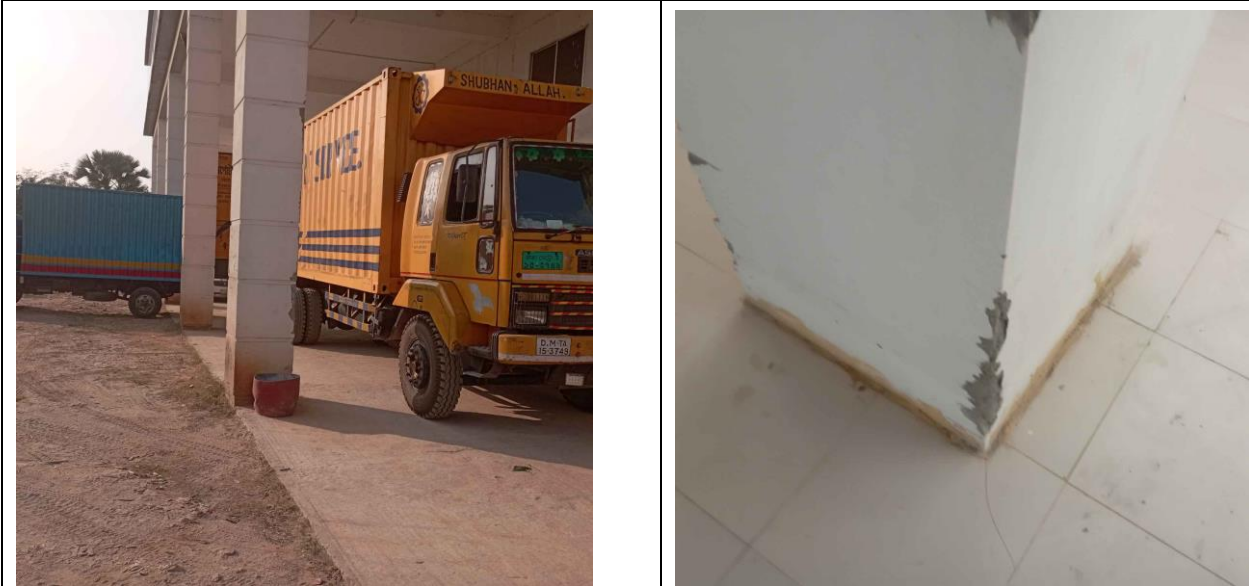
**Observation 5:** Possibility of vehicle/trolley impact (Main Production Building).

**Description:** Exposed columns were found prone to vehicle impact. Also, column plaster was found damaged due to trolley impact in floors. The building engineer is required to provide a barrier to the exposed column to avoid vehicle impact. Also, repair the damaged plaster and provide a column guard to prevent trolley impact.

7.		Also, repair the damaged plaster and provide a column guard to prevent trolley impact.	within 6 weeks
8.	Plaster cracks on brick walls and beams. (Main Production Building).	The building engineer is required to identify all the locations and repair the crack using a suitable method.	within 6 weeks

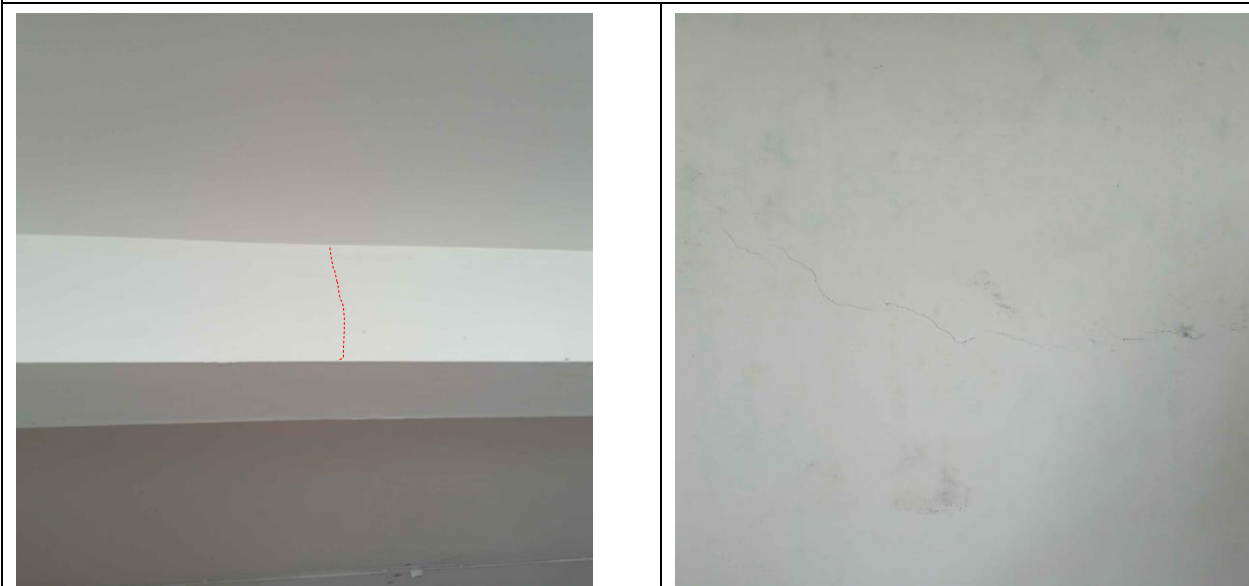
**Observation 6:** Plaster cracks on brick wall and beam. (Main Production Building).

**Description:** A crack was observed on the brick wall (3rd-floor north end) and beam (roof). The building engineer is required to repair the crack with a suitable method.

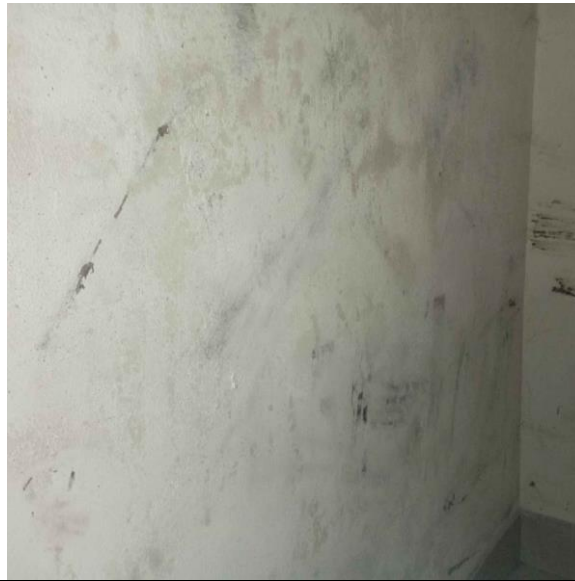
**Observation 7:** Dampness on a brick wall (Main Production Building).

**Description:** Dampness was observed on the brick wall (3rd-floor north end). The building engineer is required to repair the dampness with a suitable method.

9.	Dampness on a brick wall (Main Production Building).	The building engineer is required to identify all the locations and repair the dampness using a suitable method.	within 6 weeks

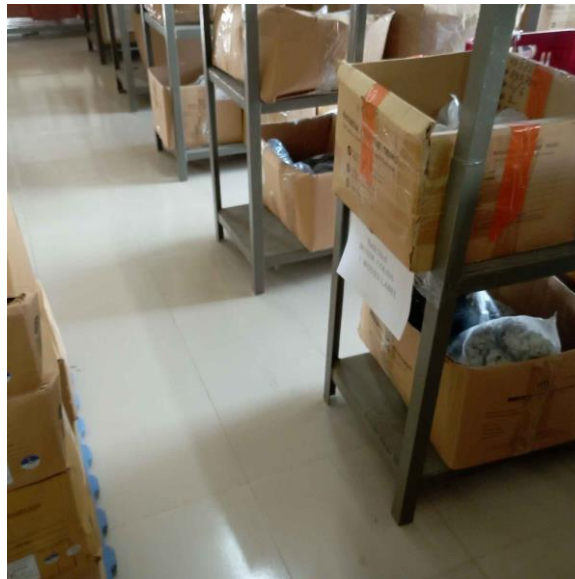
**Observation-8:** Nonstructural elements found not anchored/braced (Main Production Building).

**Description:** Nonstructural elements (storage racks) were found not anchored/braced. The building engineer is required to anchor/brace all nonstructural elements within the factory.

10.	Nonstructural elements (storage racks) were found not anchored/braced (Main Production Building).	The building engineer is required to anchor/brace all nonstructural elements within the factory.	within 6 weeks

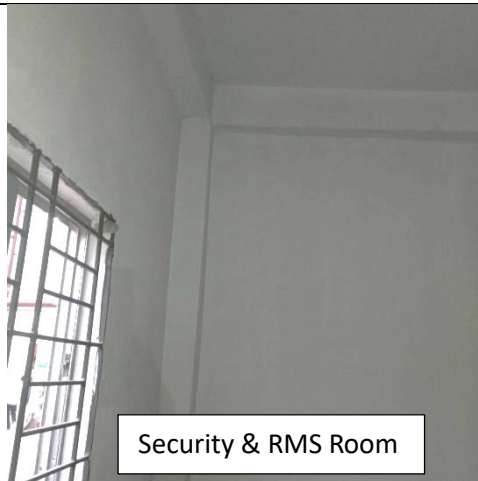
Security & RMS Room

**Observation-10:** Discrepancy in as-built drawing (Security room & RMS room, Utility Building-1, Utility Building-2).

**Description:** Column C-1 was found as 250mmX300mm instead of 450mmX450mm in the Security room & RMS room. The dimension of the beam was found 250 (w)X375(d) instead of 300(w)X450(d) in (Utility Building-1, Utility Building-2).

11.	Discrepancy in as-built drawing (Security room & RMS room).	The building engineer is required to update the as-built drawing.	within 6 weeks
12.	Discrepancy in as-built drawing (Utility Building-1).	The building engineer is required to update the as-built drawing.	within 6 weeks

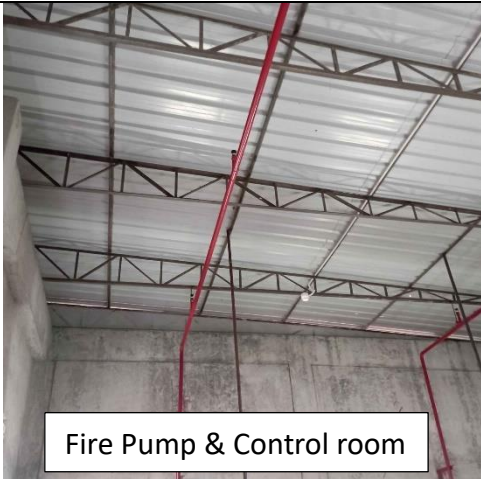
Fire Pump & Control room

**Observation-11:** Retrofitting work not carried out (Utility Building-1, Fire Pump & Control room, Maintenance Room).

**Description:** The retrofitting drawing was available for these structures but retrofitting work was not carried out. The building engineer is required to submit the retrofitting scheme to RSC for review. Implement it after getting acceptance from RSC.

17.	Retrofitting work not carried out (Pump & Control room).	The building engineer is required to submit the retrofitting scheme to RSC for review.	within 6 weeks

18.		Implement retrofitting work after getting acceptance from RSC.	within 6 months
19.	Corrosion on roof sheet (Security Restroom).	The building engineer is required to provide rust-proof paint on steel members and roof sheets to prevent corrosion.	within 6 weeks

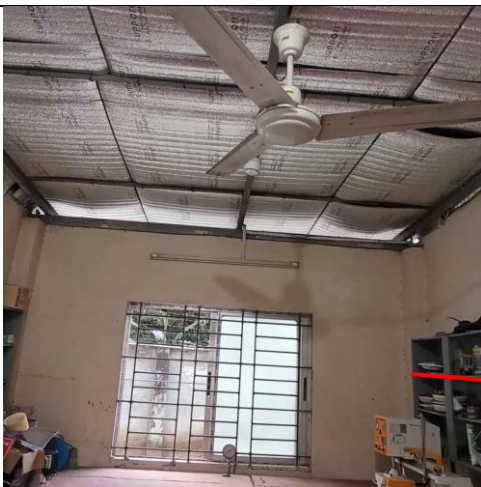
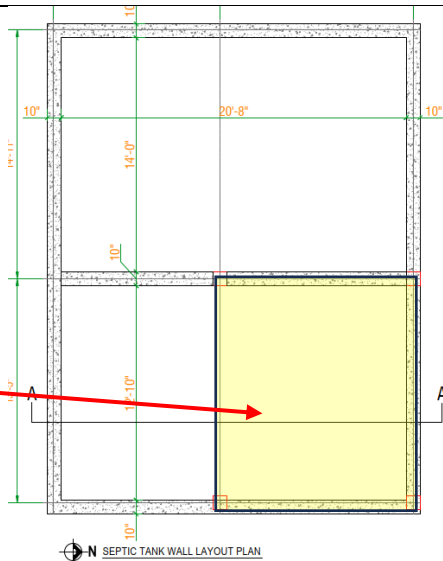
**Observation-12:** Lack of load plan (Maintenance Room).

**Description:** The maintenance room is over a septic tank, but no load plan was available for that structure. The building engineer is required to prepare a load plan for this structure.

21.		Implement retrofitting work after getting acceptance from RSC.	within 6 months
22.	Lack of load plan (Maintenance Room).	The building engineer is required to prepare a load plan for this structure.	within 6 weeks

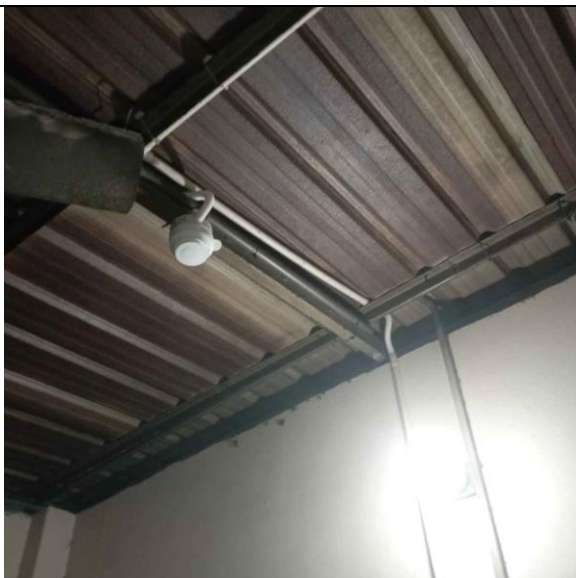
**Observation-13:** Corrosion on roof sheet (Security Restroom).

**Description:** Corrosion was found on the roof sheet. The building engineer is required to provide rust-proof paint on steel members and roof sheets to prevent corrosion.
