# Sadma Fashion Wear Ltd. (Extension 2)

Mouchak, Kaliakoir, Gazipur

1 October 2024

## 2. Observations

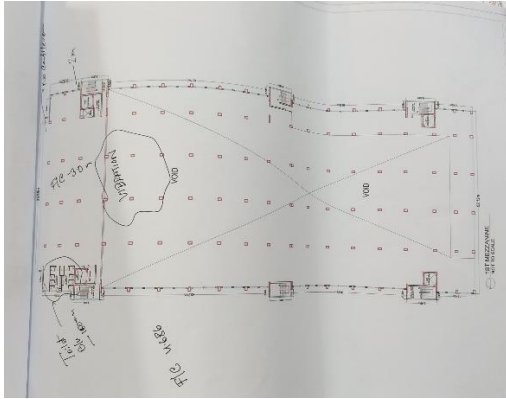
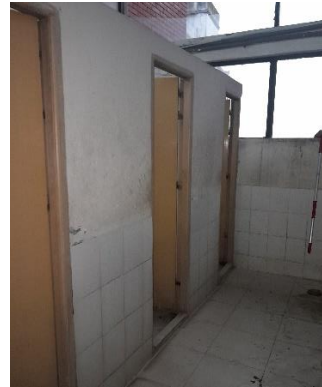
### Observation 01: Mismatches in as-built drawings. (New Dyeing Building)

**Description:** The beam layout above the ground floor was found missing in the drawings. Also, architectural drawings were not fully matched on the 1st floor. Moreover, the toilet built-up is not shown in the drawings. The building engineer is required to prepare as-built drawings reflecting the on-site condition.

| Item No | Observation | Action Plan | Timeline |
|---|---|---|---|
| 1. | Mismatches in as-built drawings. (New Dyeing Building) | The building engineer is required to prepare as-built drawings reflecting the on-site condition. | within 6 weeks |

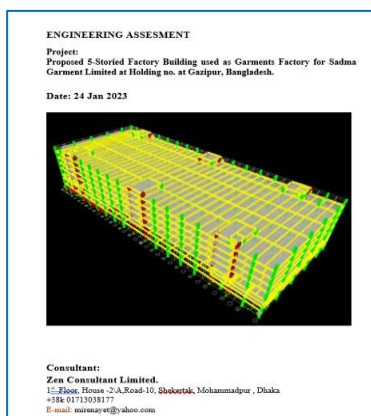
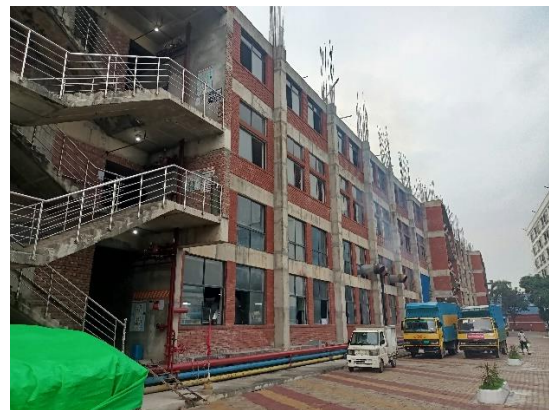
### Observation 02: Lack of information in the design report. (New Dyeing Building)

**Description:** A design report was available for the building in which wind load calculation, and concrete strength calculation according to BNBC 5.12 were not found. The structural design report needs to be revised as per 1.9.1 BNBC and submitted to RSC for further review.

| Item No | Observation | Action Plan | Timeline |
|---|---|---|---|
| 2. | Lack of information in the design report. (New Dyeing Building) | The structural design report needs to be revised as per BNBC and submitted to RSC for further review. | within 6 weeks |
| 3. | Lack of information in the design report. (New Dyeing Building) | Verify in situ concrete strength by taking concrete cores or existing cylinder test data that meets BNBC 5.12. | within 6 weeks |
| 4. | Lack of information in the design report. (New Dyeing Building) | Implement the recommendations of the design report. | within 6 months |
| 5. | Lack of information in the design report. (New Dyeing Building) | Implement floor load plan. | within 6 months |

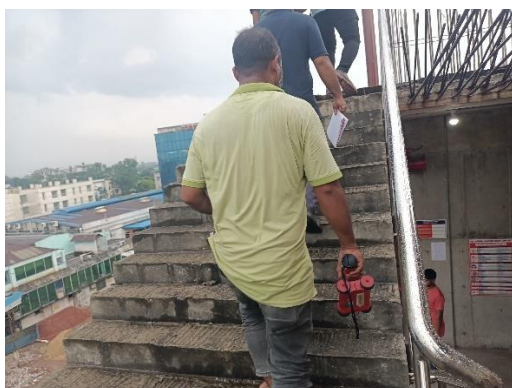
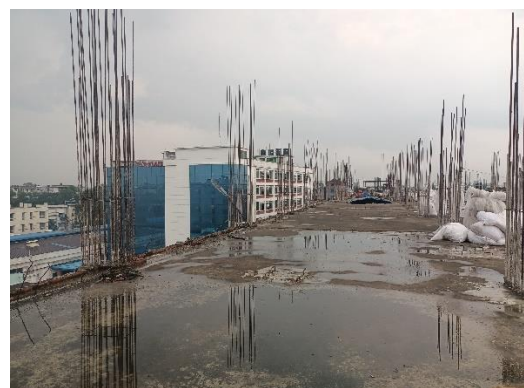
### Observation 03: Falling hazard risk on stairs and current roof. (New Dyeing Building)

**Description:** Falling hazard risk was found on the stairs and existing roof. The building engineer is required to provide adequate edge protection to prevent falling hazards.

| Item No | Observation | Action Plan | Timeline |
|---|---|---|---|
| 6. | Falling hazard risk on stairs and current roof. (New Dyeing Building) | The building engineer is required to provide adequate edge protection to prevent falling hazards. | Immediate |

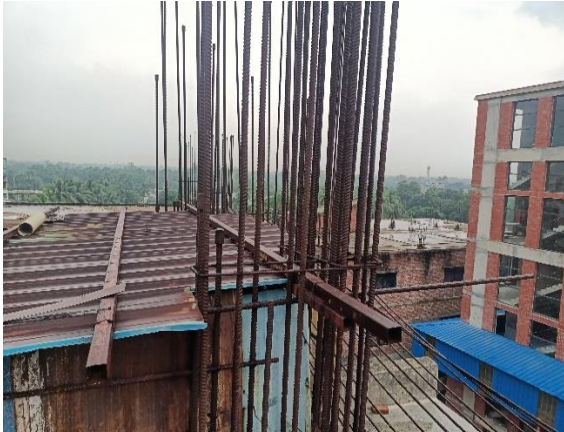
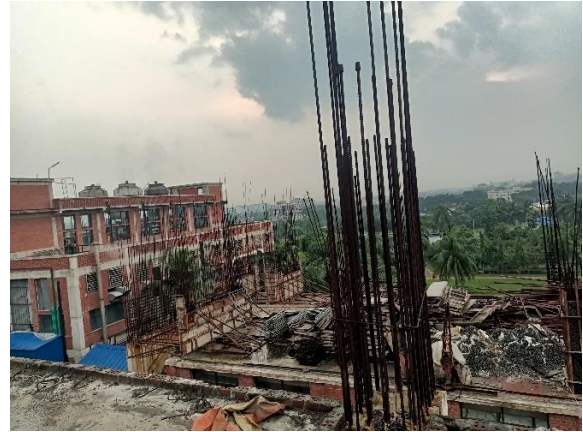
**Observation 04: Corrosion on Exposed rebar. (New Dyeing Building)**

**Description:** Corrosion was observed on exposed rebars. The building engineer is required to provide rust-proof paint on exposed rebars to protect them from corrosion.

| Item No | Observation | Action Plan | Timeline |
|---|---|---|---|
| 7. | Corrosion on the exposed rebar. (New Dyeing Building) | The building engineer is required to provide rust-proof paint on exposed rebars to protect them from corrosion. | within 6 weeks |

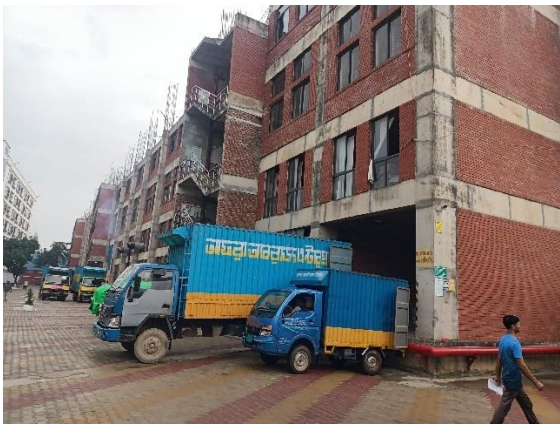
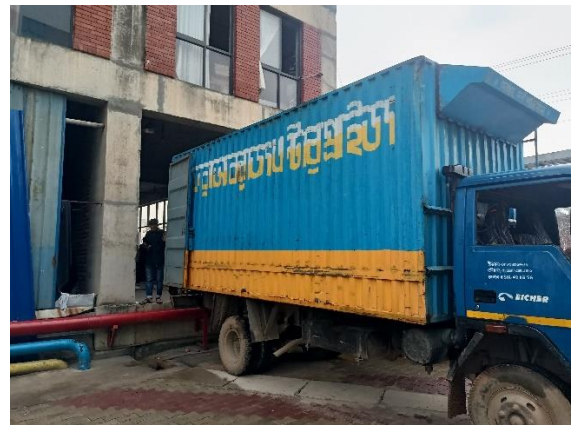
**Observation 05: Column susceptible to vehicle impact. (New Dyeing Building)**

**Description:** Columns in the loading and unloading area are susceptible to vehicle impact. The building engineer is required to provide barriers around the column to protect against possible vehicle impact.

| Item No | Observation | Action Plan | Timeline |
|---|---|---|---|
| 8. | Column susceptible to vehicle impact. (New Dyeing Building) | The building engineer is required to provide barriers around the column to protect against possible vehicle impact. | within 6 weeks |

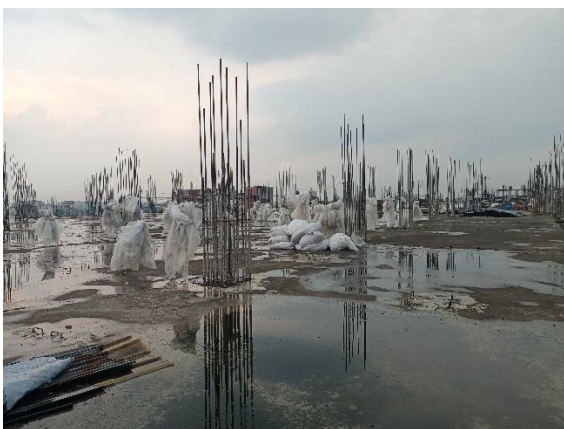
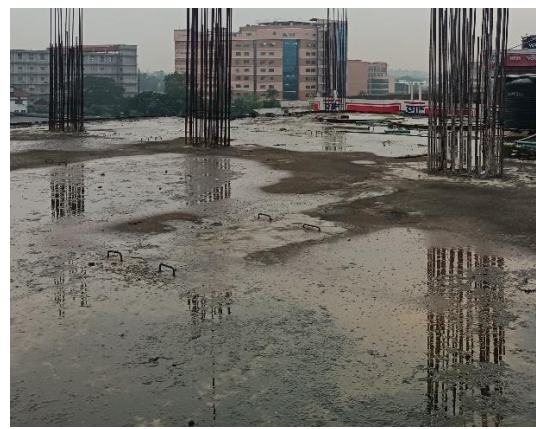
**Observation 06: Water ponding and vegetation growth on the roof. (New Dyeing Building)**

**Description:** Water ponding and vegetation growth were observed on the existing roof. The building engineer is required to provide adequate slopes to discharge the rainwater. Also, clean up the vegetation.

| Item No | Observation | Action Plan | Timeline |
|---|---|---|---|
| 9. | Water ponding and vegetation growth on the roof. (New Dyeing Building) | The building engineer is required to provide an adequate slope to discharge the rainwater. Also, clean up the vegetation. | within 6 weeks |

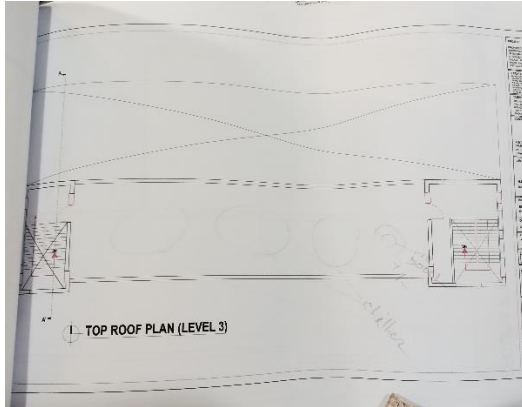
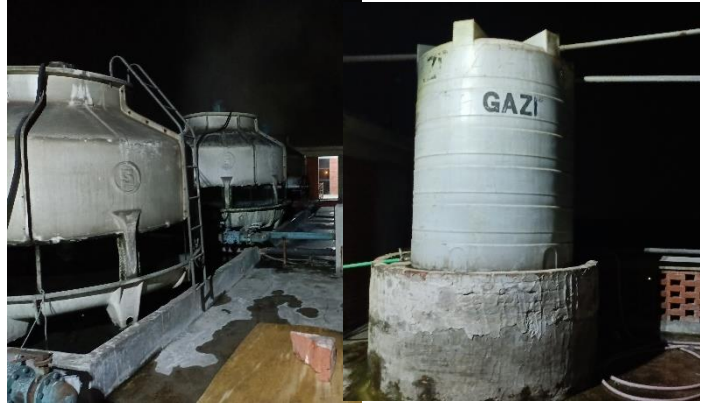
**Observation 07:** Lack of information in drawings. (New Utility building)

**Description:** The roof chiller and plastic water tank were not shown in the roof layout. The building engineer is required to prepare as-built drawings reflecting the on-site condition.

| Item No | Observation | Action Plan | Timeline |
|---|---|---|---|
| 10. | Lack of information in drawings. (New Utility building) | The building engineer is required to prepare as-built drawings reflecting the on-site condition. | within 6 weeks |

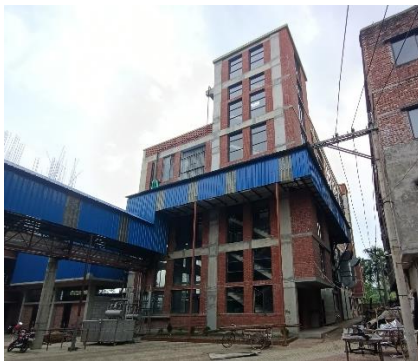
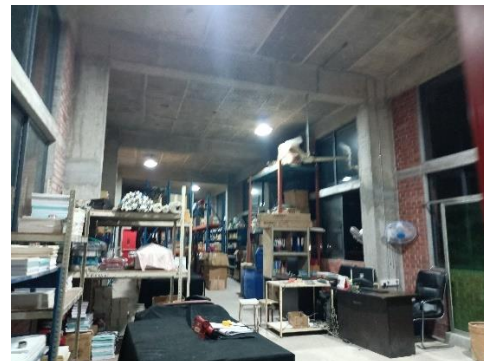
**Observation 08:** Absence of design documents and load plan (New Utility building).

**Description:** As per BNBC, every building or structure designed shall have its design documents prepared following the provision of Section 1.9.1. The design document shall include a design report and a structural drawing. At the time of inspection, no design reports were available which are required to be prepared in compliance with section 1.9.1.1 and section 1.9.1.2 (part 6, BNBC).

| Item No | Observation | Action Plan | Timeline |
|---|---|---|---|
| 11. | Absence of design documents and load plan (New Utility building). | Prepare design report for the structure as per 1.9.1 BNBC. | within 6 weeks |
| 12. | Absence of design documents and load plan (New Utility building). | Implement the recommendations of the design report. | within 6 months |
| 13. | Absence of design documents and load plan (New Utility building). | Implement floor load plan. | within 6 months |

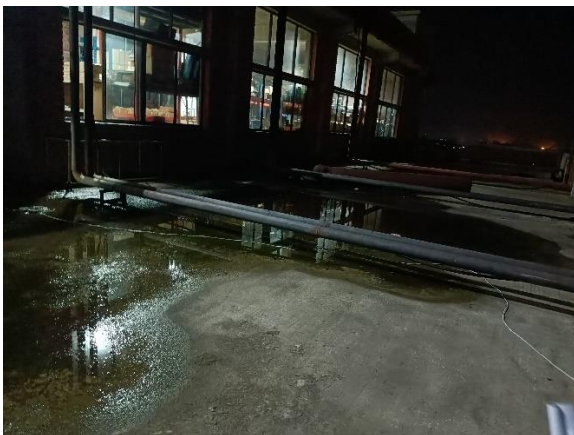
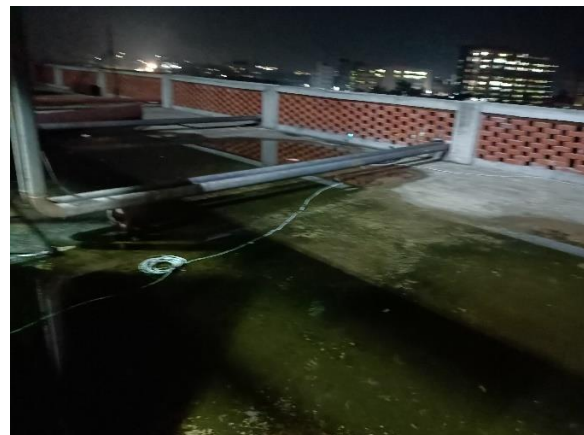
**Observation 09:** Water ponding on the roof (New Utility building)

**Description:** Stagnant water due to undulation of the screed. The building engineer is required to provide an adequate slope to discharge the stagnant water.

| 14. | Water ponding on the roof (New Utility building) | The building engineer is required to provide an adequate slope to discharge the stagnant water. | within 6 weeks |

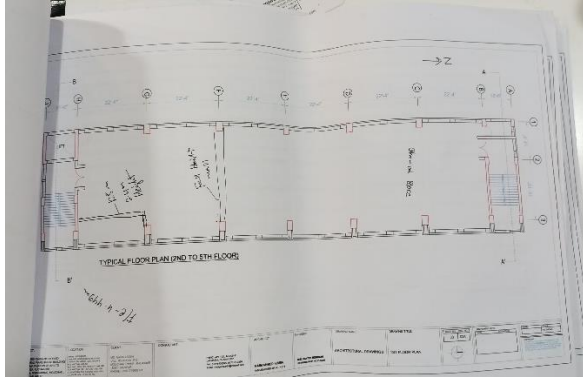
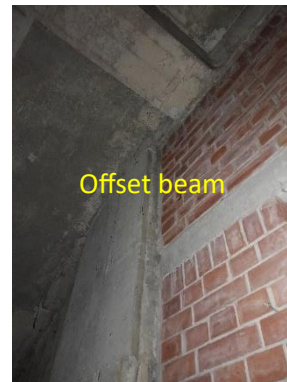
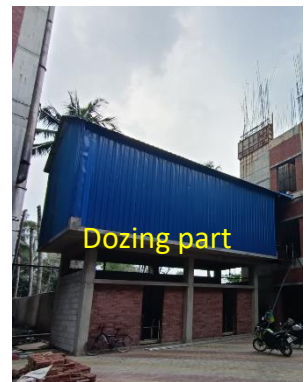
**Observation 10: Paucity in drawings. (Warehouse Building)**

**Description:** Floor layouts were not fully matched with drawings. Also, the landing beam was found offset to the column which is not mentioned in the drawings. On the other hand, no drawings were available for the adjacent 2-storied Dozing part. The building engineer is required to prepare as-built drawings reflecting the on-site condition.

| 15. | Paucity of drawings. (Warehouse Building) | The building engineer is required to prepare as-built drawings reflecting the on-site condition. | within 6 weeks |

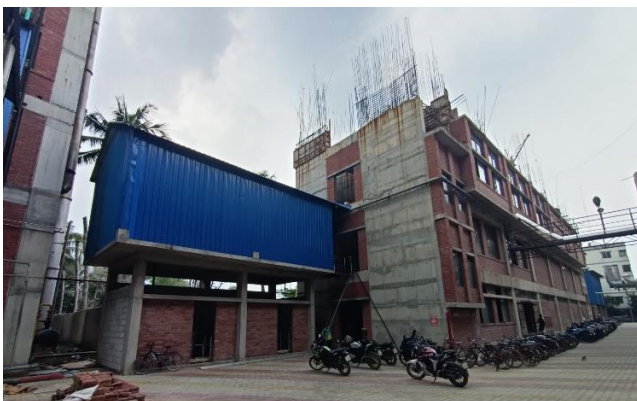
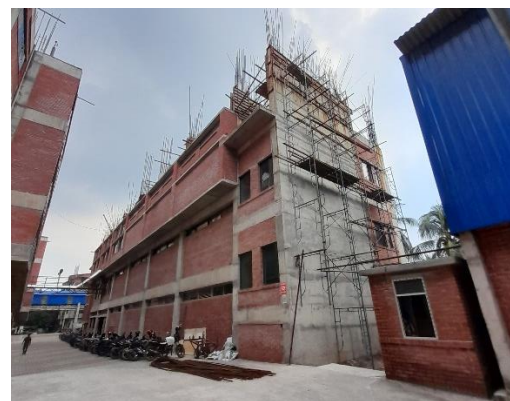
**Observation 11: Absence of design documents. (Warehouse Building)**

**Description:** As per BNBC, every building or structure designed shall have its design documents prepared following the provision of Section 1.9.1. The design document shall include a design report, and a set of structural drawings, which shall be prepared in compliance with section 1.9.1.1 and section 1.9.1.2 as per BNBC. At the time of inspection, no design reports were available which are required to be prepared in compliance with section 1.9.1.1 and section 1.9.1.2 (part 6, BNBC).

| 16. | Absence of design documents. (Warehouse Building) | Prepare design report for the structure as per 1.9.1 BNBC. | within 6 weeks |
| 17. | Absence of design documents. (Warehouse Building) | Implement the recommendations of the design report. | within 6 months |
| 18. | Absence of design documents. (Warehouse Building) | Implement floor load plan. | within 6 months |

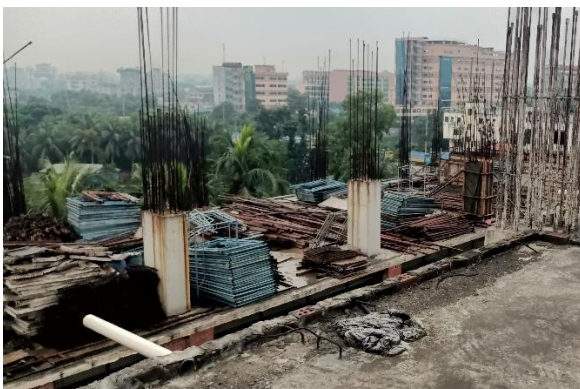
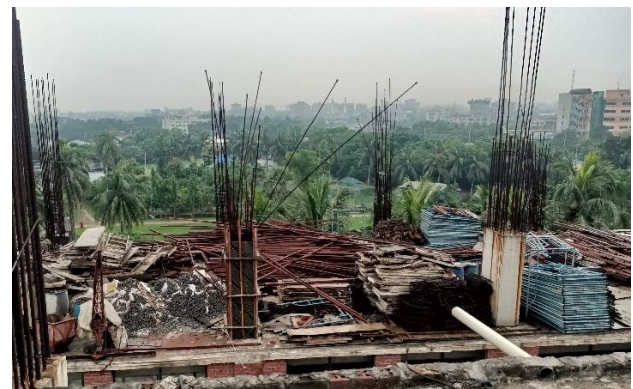
**Observation 12: Construction materials on existing roof. (Warehouse building)**

**Description:** Massive construction materials were found almost everywhere on the existing roof. The building engineer is required to remove all kinds of construction materials from the roof.

| 19. | Construction materials on the existing roof. (Warehouse building) | The building engineer is required to remove all kinds of construction materials from the roof. | within 6 weeks |

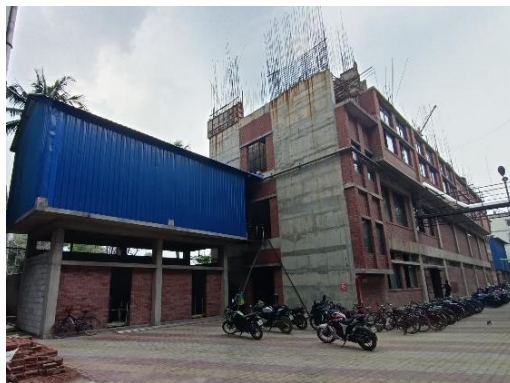
**Observation 13:** Lack of building approval from the local authority. (Warehouse Building)

**Description:** At the time of inspection, no approval drawing from the local authority was available for the above-mentioned structure. The building engineer is required to seek approval from the local authority.

| 20. | Lack of building approval from local authorities. (Warehouse Building) | The building engineer is required to seek approval from the local authority. | within 6 months |

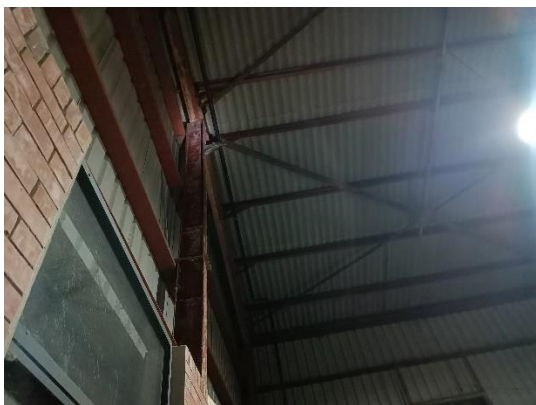
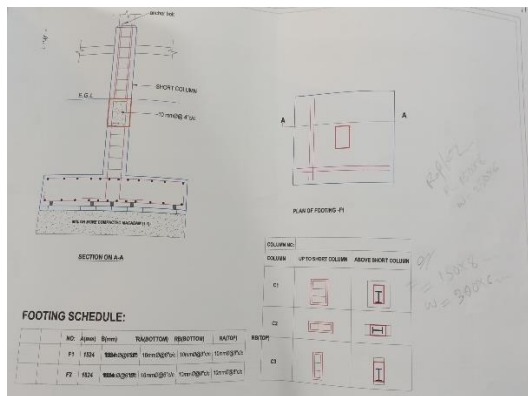
**Observation 14:** Lack of information in drawings. (Thermo Oil Heater Shed)

**Description:** Steel member size and connection details were not available on the provided drawings. The building engineer is required to prepare a full set of as-built drawings reflecting the on-site condition.

| 21. | Lack of information in drawings. (Thermo Oil Heater Shed) | The building engineer is required to prepare a full set of as-built drawings reflecting the on-site condition. | within 6 weeks |

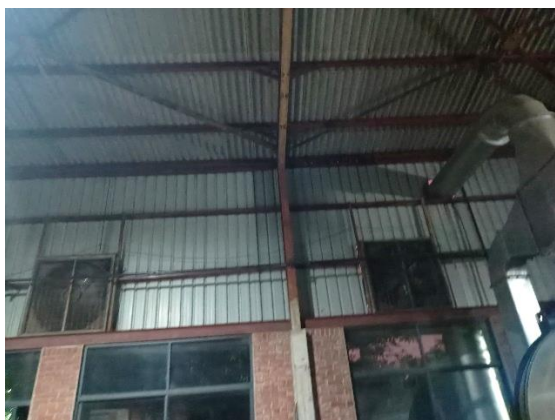
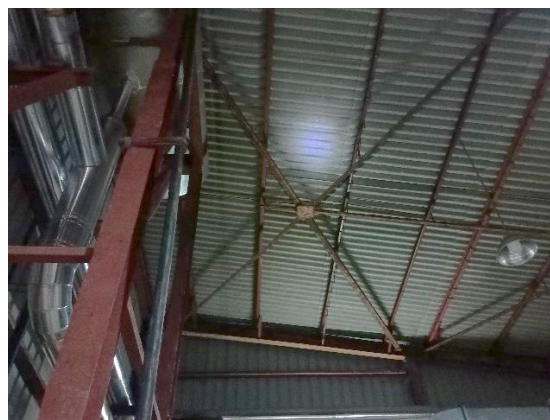
**Observation 15:** Absence of complete lateral load transfer media. (Thermo Oil Heater Shed).

**Description:** Only roof bracing was available on the shed. Vertical bracing or compression strut was not found. The building engineer is required to check the connection & stability system (safety check) for the whole structure and suggest proper remediation accordingly following the Accord Building Standard.

| 22. | Absence of complete lateral load transfer media. (Thermo Oil Heater Shed) | The building engineer is required to check the connection & stability system (safety check) for the whole structure and suggest proper remediation accordingly following Accord Building Standards. | within 6 weeks |
| 23. | Absence of complete lateral load transfer media. (Thermo Oil Heater Shed) | Implement the recommendations of the safety check report. | within 6 months |

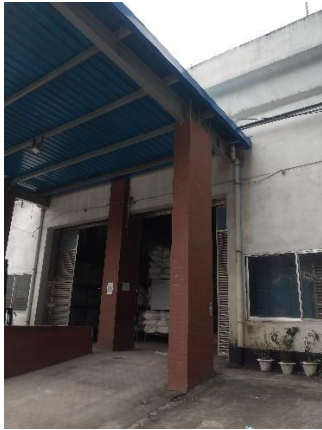
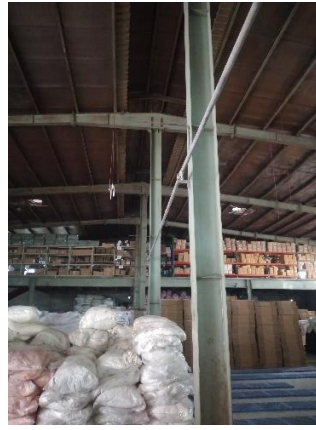
**Observation 16:** Lack of as-built drawings (Finished Storage - Old Dyeing Finishing).

**Description:** As built drawings were not available for the shed. The building engineer is required to prepare a full set of as-built drawings reflecting the on-site condition.

| 24. | Lack of as-built drawings (Finished Storage - Old Dyeing Finishing) | The building engineer is required to prepare a full set of as-built drawings reflecting the on-site condition. | within 6 weeks |

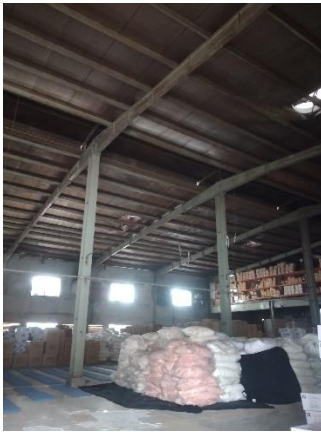
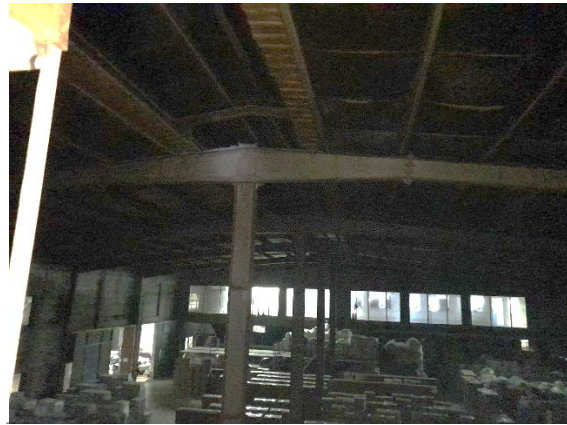
**Observation 17:** Lack of lateral stability. (Finished Storage - Old Dyeing Finishing)

**Description:** Load transfer media is not provided along the long direction for this shed. Therefore, the lateral stability system of the shed is incomplete. The building engineer is required to check the lateral stability of the structure.

| 25. | Lack of lateral stability. (Finished Storage - Old Dyeing Finishing) | The building engineer is required to check the lateral stability of the structure. | within 6 weeks |
| 26. | Lack of lateral stability. (Finished Storage - Old Dyeing Finishing) | Implement the remedial work if required. | within 6 months |

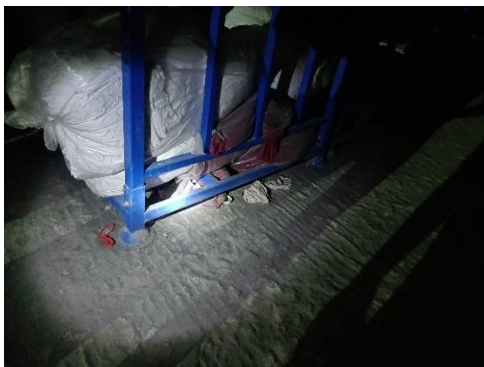
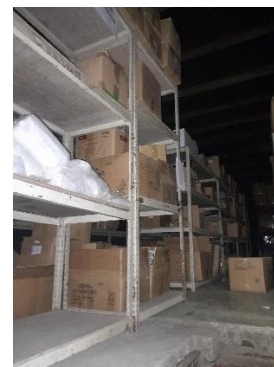
**Observation 18:** Unbrace storage racks/plastic tanks. (All structures)

**Description:** Non-anchored racking system and unbraced plastic tanks were found. The building engineer is required to provide adequate anchoring or bracing to all the non-structural elements including the racking system.

| 27. | Unbrace storage racks/plastic tanks. (All structures) | The building engineer is required to provide adequate anchoring or bracing to all the non-structural elements including the racking system. | within 6 weeks |
