# Pacific Cotton Ltd. (Extension)

Village: Amtoli, Union: Habirbari, P.O: Seed Store Bazar, P.S: Valuka, District: Mymensingh

24 October 2024

## **1. Executive Summary**

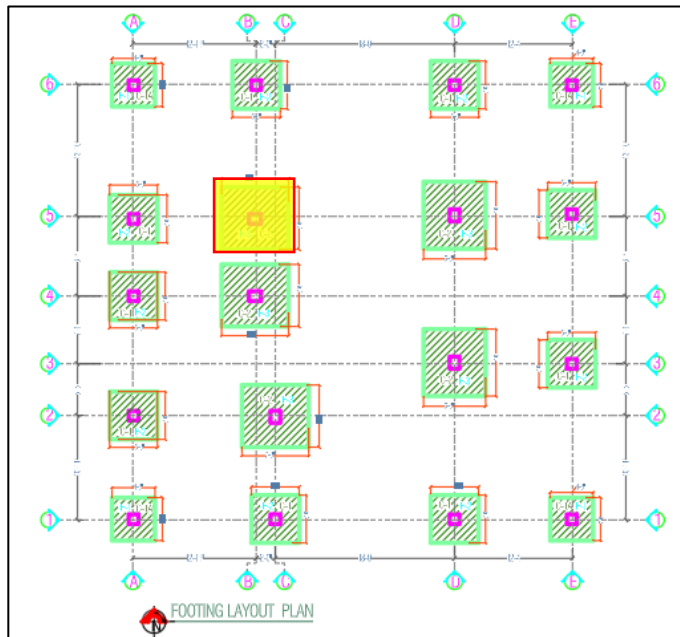
### Observation-01: Foundation found to be stressed. (Dormitory Building)

**Description:** Cursory calculation indicates the marked footing is stressed for bearing. The loading is considered 3 kPa for a typical floor and the bearing capacity of the soil was considered 0.72 ksf as per soil test report. The building engineer is required to review the design load and foundation stresses.

| Item No | Observation | Action Plan | Timeline |
|---|---|---|---|
| 1 | Foundation found to be stressed.<br>(Dormitory Building) | The building engineer is required to review the design load and foundation stresses. | within 6 weeks |
| 2 | | Produce and actively manage a loading plan for all floor plates within the factory, considering floor, column, and foundation capacity. | within 6 weeks |
| 3 | | verify in-situ concrete strength by taking concrete cores or existing cylinder test data that meets BNBC 5.12. | within 6 weeks |
| 4 | | Carry out the suggested remedial work if required. | within 6 months |

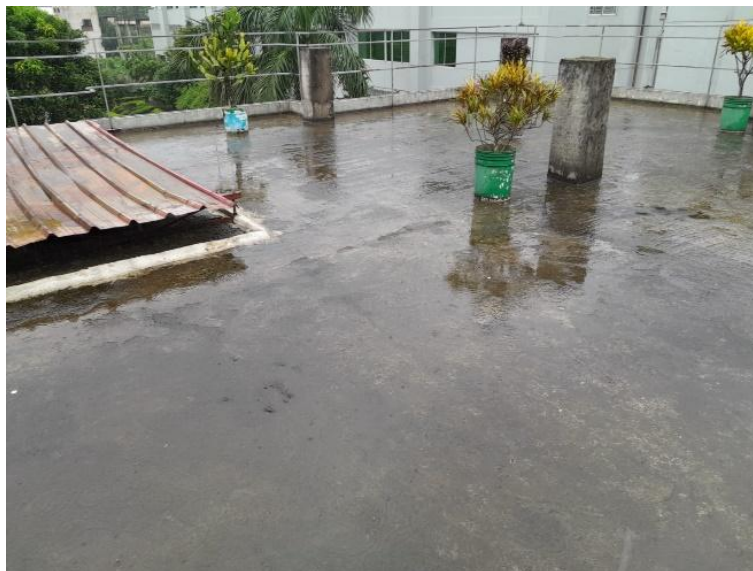
### Observation-02: Poor roof drainage system. (Dormitory Building)

**Description:** During inspection, water ponding was observed on the roof. The building engineer is required to improve the roof drainage system.

| Item No | Observation | Action Plan | Timeline |
|---|---|---|---|
| 5 | Poor roof drainage system.<br>(Dormitory Building) | The building engineer is required to improve the roof drainage system. | within 6 months |

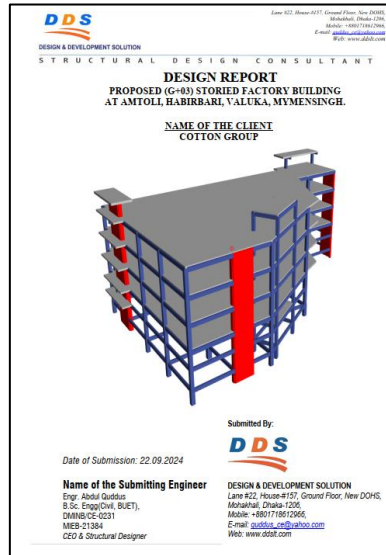
### Observation-03: Inconsistencies and lack of information in the design report. (Building-3)

**Description:** Inconsistencies and lack of information observed in the design report. Absence of detail calculation of the seismic design parameters, and seismic detailing calculation of the framing system. Concrete cylinder test data calculation and confirmation are not mentioned in the design report. Slab adequacies check and eccentric footing adequacy check are not mentioned in the design report.

The building engineer is required to prepare the design report as per BNBC 1.9.

| Item No | Observation | Action Plan | Timeline |
|---|---|---|---|
| 6 | Inconsistencies and lack of information in the design report. (Building-3) | The building engineer is required to prepare the design report as per BNBC 1.9. | within 6 weeks |
| 7 | | Verify in-situ concrete strength by taking the core test from lower tier columns (100 mm diameter min 4 nos) | within 6 weeks |
| 8 | | Carry out the suggested remedial work if required. | within 6 months |

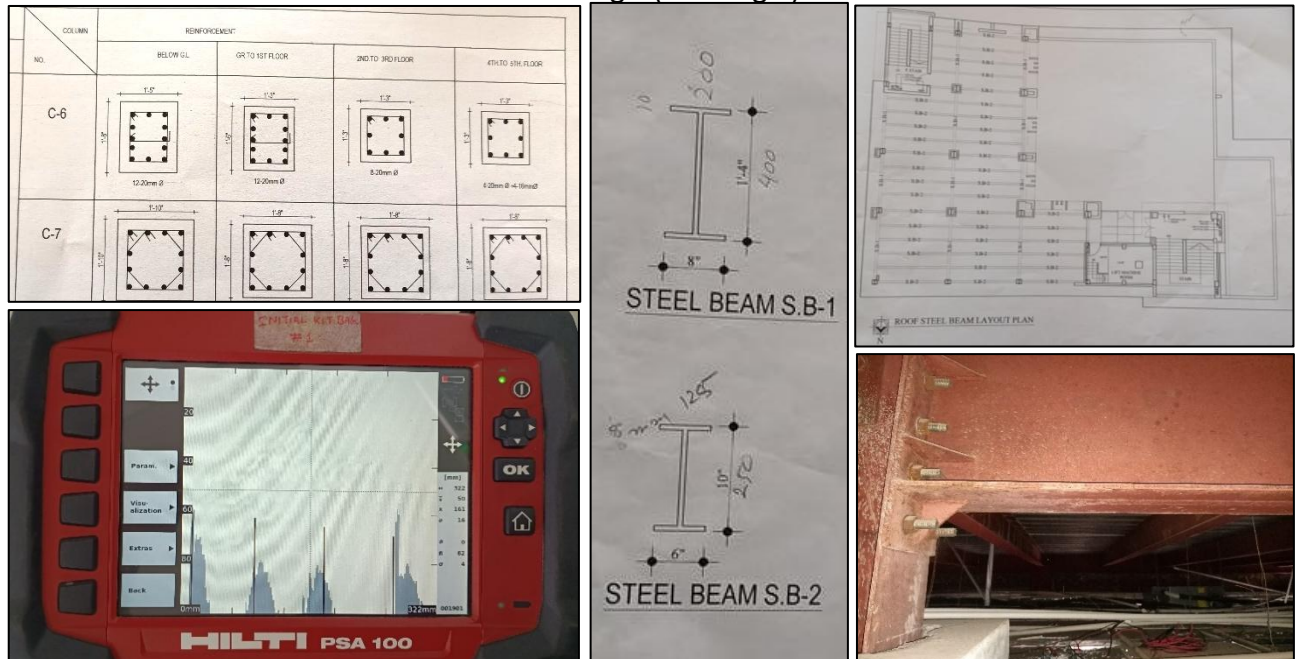
### Observation-04: Mismatches in as-built drawings. (Building 3)

**Description:** The number of rebars in the periphery column (C-6 type) was found to be 4 nos on the long face instead of 5 nos. On the other hand, steel member thickness and connection details were not found in the provided drawings for the roof shed.

The building engineer is required to survey the whole structure and prepare a full set of as-built drawings.

| Item No | Observation | Action Plan | Timeline |
|---|---|---|---|
| 9 | Mismatches in as-built drawings. (Building 3) | The building engineer is required to survey the whole structure and prepare a full set of as-built drawings. | within 6 weeks |

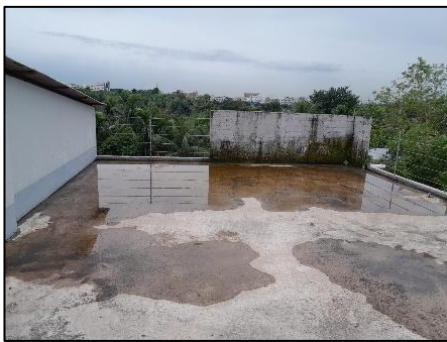
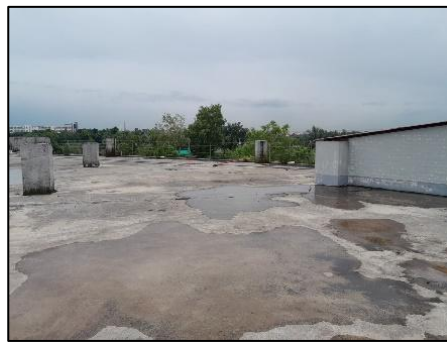
**Observation-05:** Poor roof drainage system. (Building 3)

**Description:** During inspection, water ponding was observed on the roof. The building engineer is required to improve the roof drainage system.

| Item No | Observation | Action Plan | Timeline |
|---|---|---|---|
| 10 | Poor roof drainage system.<br>(Building 3) | The building engineer is required to improve the roof drainage system. | within 6 months |

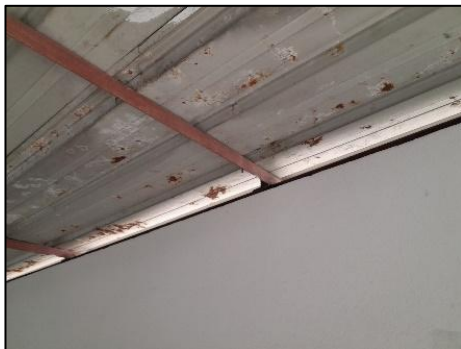
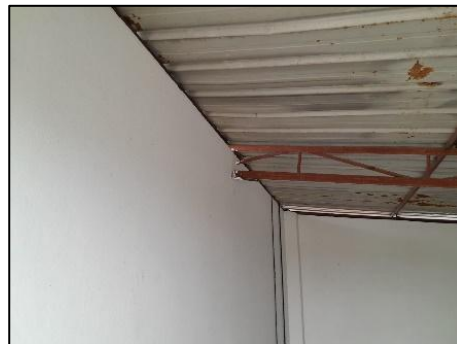
**Observation-06:** Inadequate connection against uplift forces for the staircase roof structure. (Building 3)

**Description:** Poor connection details were observed on the staircase roof structure. The building engineer is required to check the connection adequacy against uplift forces and propose improvement plan for the connection.

| Item No | Observation | Action Plan | Timeline |
|---|---|---|---|
| 11 | Connection improvement of the staircase roof structure.<br>(Building 3) | The building engineer is required to check the connection adequacy against uplift forces and propose improvement plans for the existing connections. | within 6 weeks |
| 12 | | Carry out remedial work where required | within 6 months |

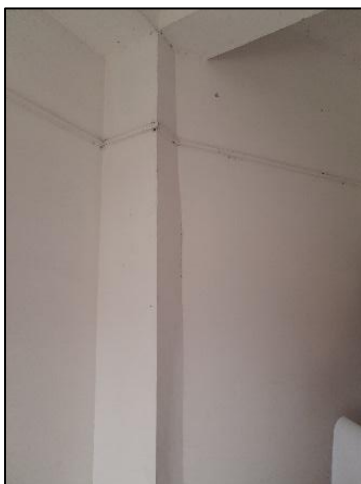
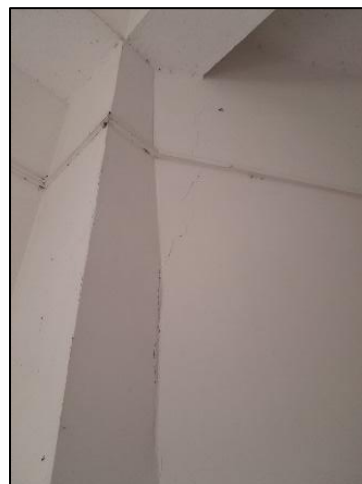
**Observation-07:** Crack in the brick wall. (Building 3)

**Description:** Crack was observed on the brick wall and RC column joint. The building engineer is required to investigate the reason and repair the crack as per recommendation.

| Item No | Observation | Action Plan | Timeline |
|---|---|---|---|
| 13 | Crack in the brick wall. (Building 3) | The building engineer is required to investigate the reason and repair the crack as per recommendation. | within 6 weeks |

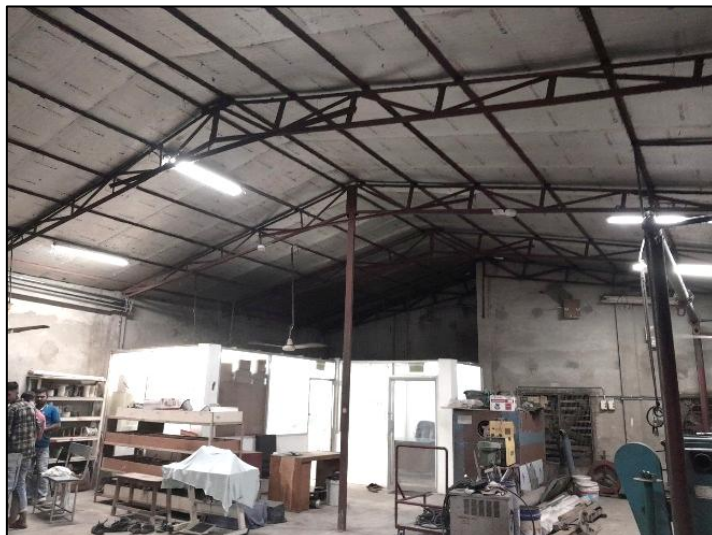
**Observation-08:** Lack of As-built drawing. (Maintenance Office with Workshop)

**Description:** The as-built drawing wasn't observed in the shed. The building engineer is required to prepare the as-built drawing.

| 14 | Lack of as-built drawing.<br>(Maintenance Office with Workshop) | The building engineer is required to prepare the as-built drawing. | within 6 weeks |

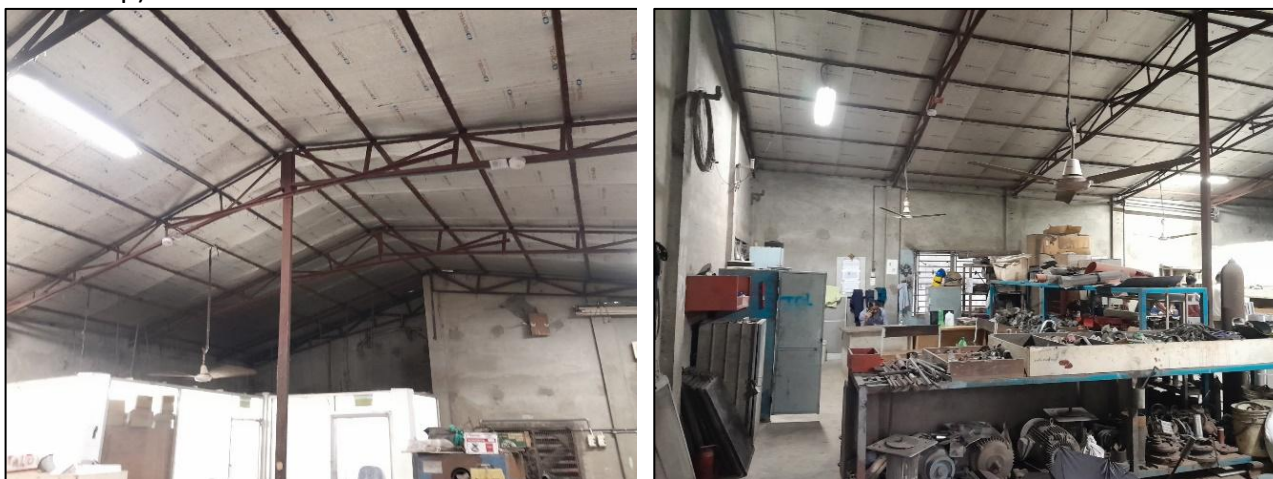
**Observation-09:** Lack of lateral stability and inadequate member size. (Maintenance Office with Workshop)

**Description:** Lack of lateral stability system (bracing & strut) observed in the shed. The building engineer is required to prepare a safety check report according to the Accord Building Standard to address this issue.

| 15 | Lack of lateral stability.<br>(Maintenance Office with Workshop) | The building engineer is required to prepare a safety check report according to the Accord Building Standard to address this issue. | within 6 weeks |
| 16 | | Carry out remedial work where required | within 6 months |

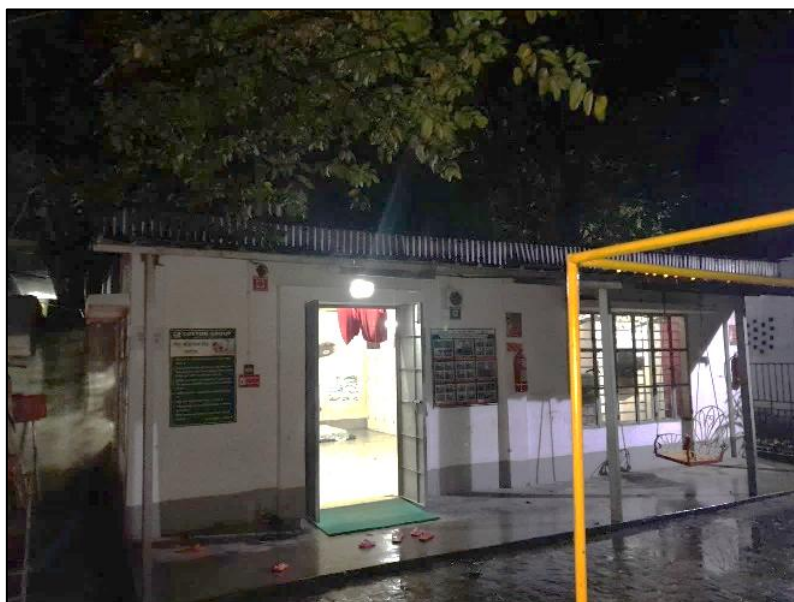
**Observation-10:** Lack of As-built drawing. (Childcare)

**Description:** The as-built drawing wasn't observed in the shed. The building engineer is required to prepare the as-built drawing.

| 17 | Lack of As-built drawing.<br>(Childcare) | The building engineer is required to prepare the as-built drawing. | within 6 weeks |

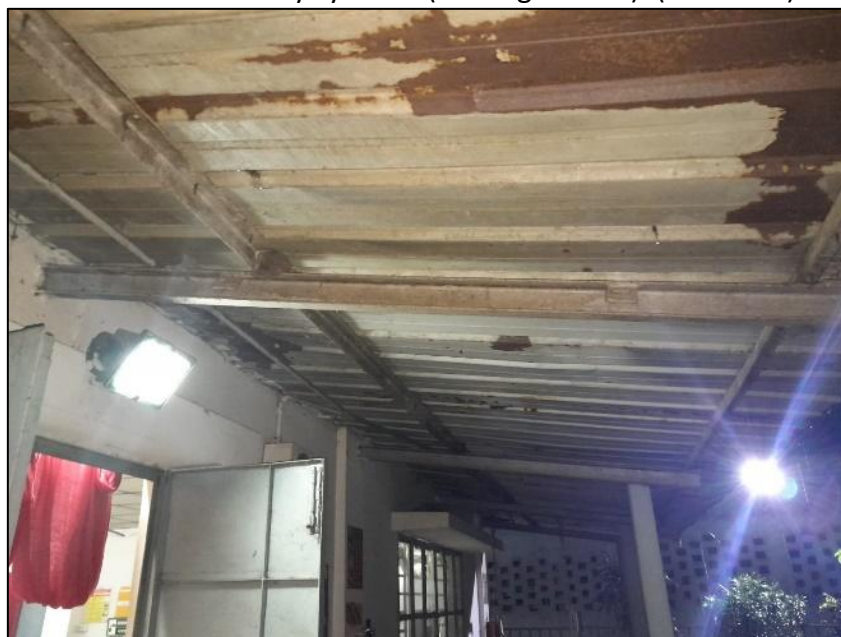
**Observation-11:** Lack of lateral stability systems (bracing & strut). (Childcare)

**Description:** Lack of lateral stability systems (bracing & strut) observed in the shed. The building engineer is required to prepare a safety check report according to the Accord Building Standard to address this issue.

| 18 | Lack of lateral stability.<br>(Childcare) | The building engineer is required to prepare a safety check report according to the Accord Building Standard to address this issue. | within 6 weeks |
| 19 | | Carry out remedial work where required | within 6 months |

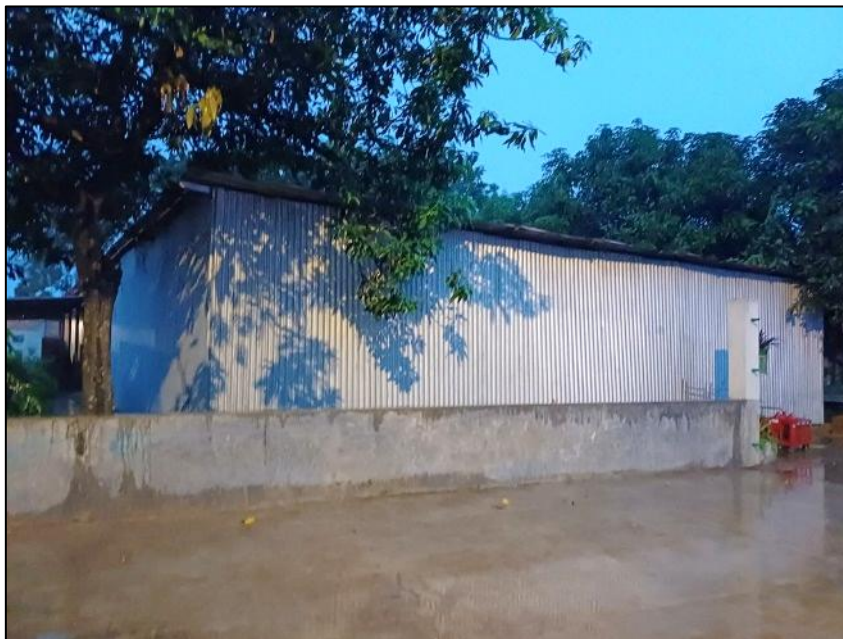
**Observation-12:** Lack of As-built drawing. (Wastage Store)

**Description:** The as-built drawing wasn't observed in the shed. The building engineer is required to prepare the as-built drawing.

| 20 | Lack of As-built drawing.<br>(Wastage Store) | The building engineer is required to prepare the as-built drawing. | within 6 weeks |

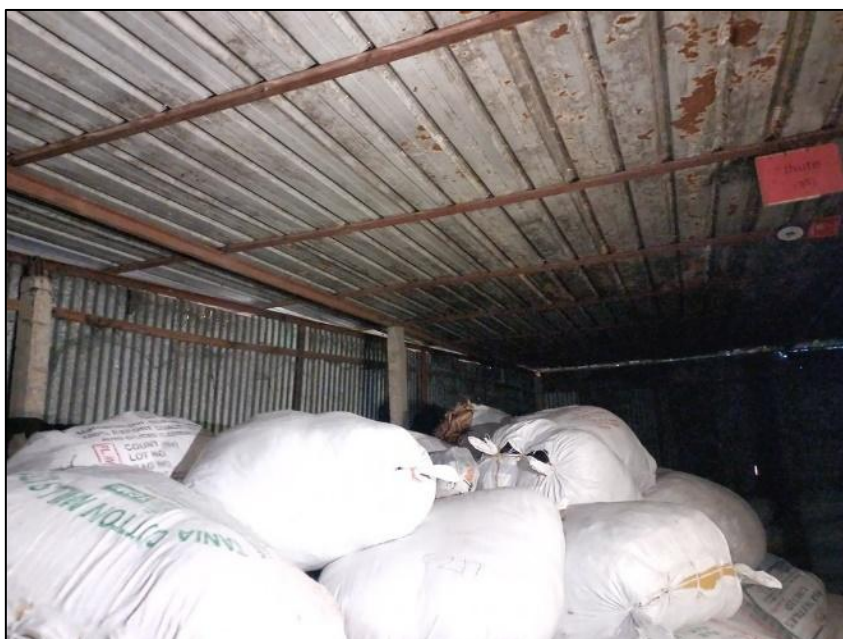
**Observation-13:** Lack of lateral stability systems (bracing & strut) and inadequate member size. (Wastage Store)

**Description:** Lack of lateral stability systems (bracing & strut) observed in the shed. The building engineer is required to prepare a safety check report according to the Accord Building Standard to address this issue.

| 21 | Lack of lateral stability. (Wastage Store) | The building engineer is required to prepare a safety check report according to the Accord Building Standard to address this issue. | within 6 weeks |
| 22 | | Carry out remedial work where required | within 6 months |

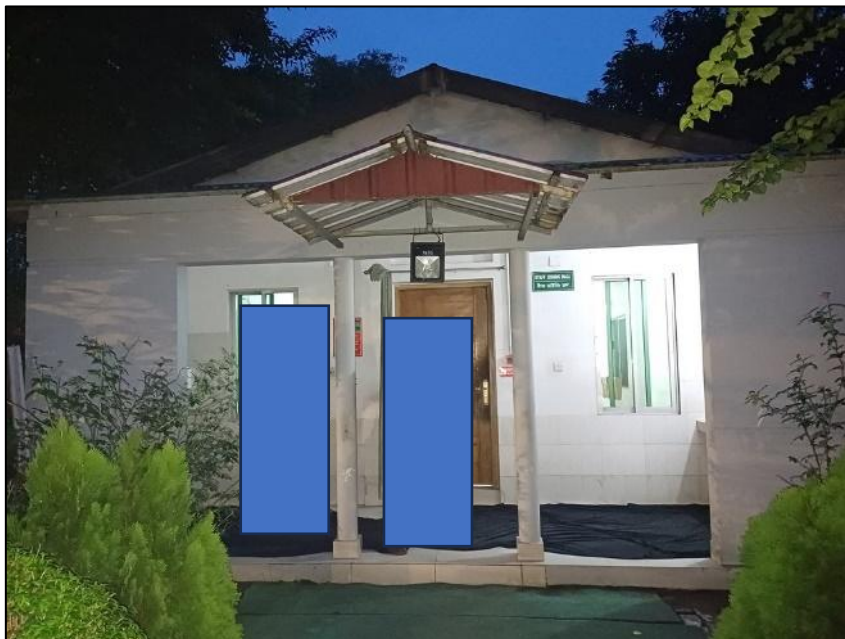
**Observation-14:** Lack of As-built drawing. (Staff Dining)

**Description:** The as-built drawing wasn't observed in the shed. The building engineer is required to prepare the as-built drawing.

| 23 | Lack of As-built drawing. (Staff Dining) | The building engineer is required to prepare the as-built drawing. | within 6 weeks |

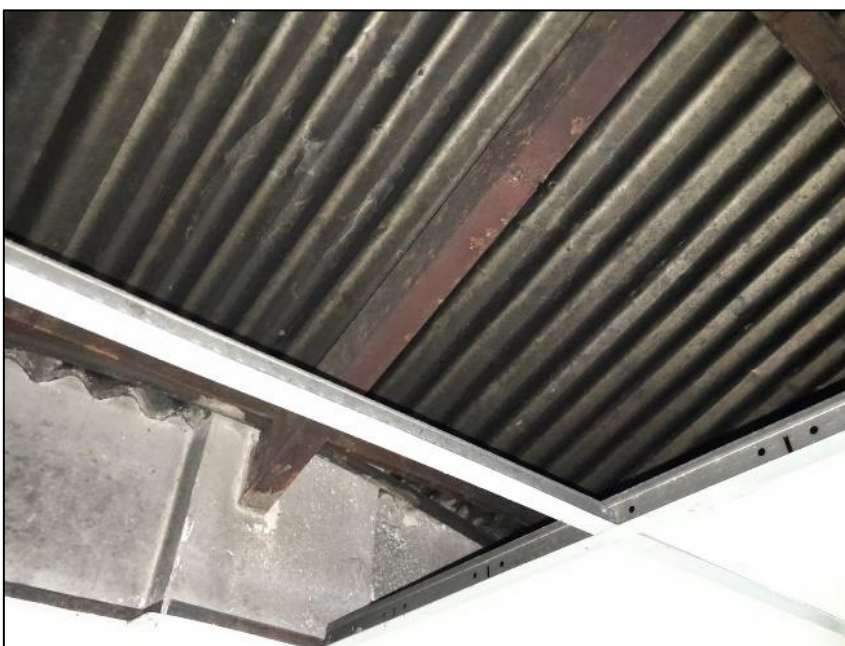
**Observation-15:** Lack of lateral stability systems (bracing & strut). (Staff Dining)

**Description:** Lack of lateral stability systems (bracing & strut) observed in the shed. The building engineer is required to prepare a safety check report according to the Accord Building Standard to address this issue.

| 24 | Lack of lateral stability. (Staff Dining) | The building engineer is required to prepare a safety check report according to the Accord Building Standard to address this issue. | within 6 weeks |
| 25 | | Carry out remedial work where required | within 6 months |

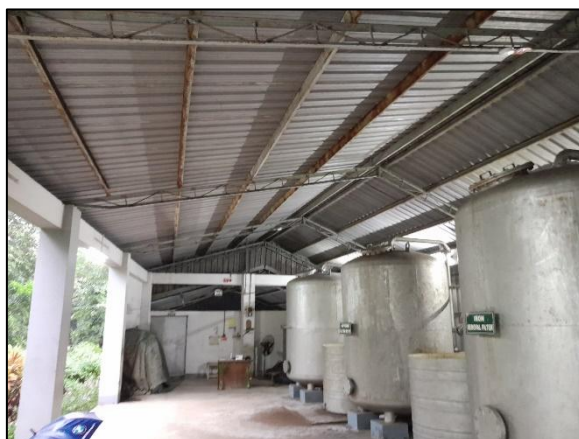
**Observation-16:** Lack of As-built drawing. (WTP Shed)

**Description:** The as-built drawing wasn't observed in the shed. The building engineer is required to prepare the as-built drawing.

| 26 | Lack of As-built drawing. (WTP Shed) | The building engineer is required to prepare the as-built drawing. | within 6 weeks |

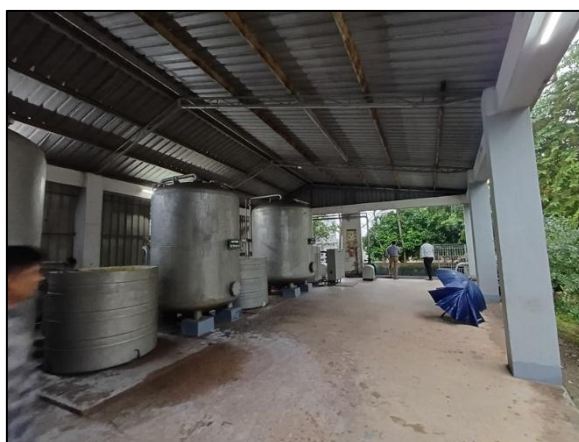
**Observation-17:** Lack of lateral stability. (WTP Shed)

**Description:** Lack of lateral stability observed in the shed. The building engineer is required to prepare a safety check report according to the Accord Building Standard to address this issue.

| 27 | Lack of lateral stability. (WTP Shed) | The building engineer is required to prepare a safety check report according to the Accord Building Standard to address this issue. | within 6 weeks |
| 28 | | Carry out remedial work where required | within 6 months |

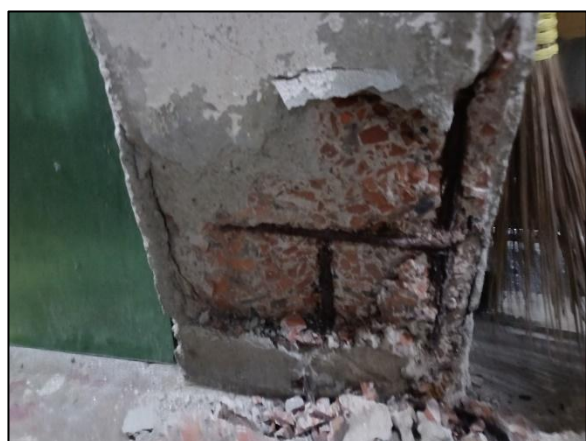
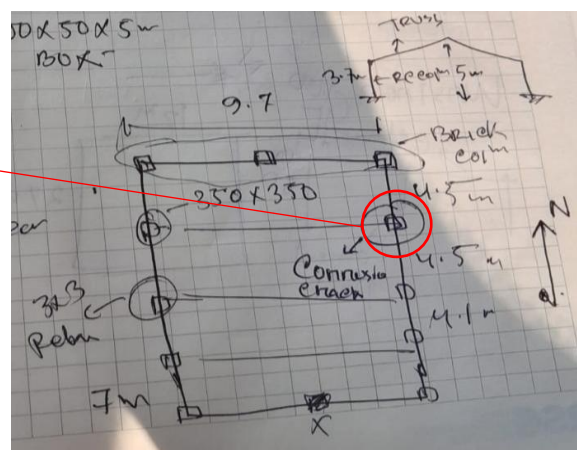
**Observation-18:** Crack in RC column. (WTP Shed)

**Description:** Corrosion-related crack was found on the periphery column. The building engineer is required to investigate the reason for the crack and suggest proper remedial actions. The factory is required to implement remedial actions.

| 29 | Crack in RC column. (WTP Shed) | The building engineer is required to investigate the cracked column and suggest proper remedial works. | Immediate |
| 30 | | Carry out remedial work where required | within 6 weeks |

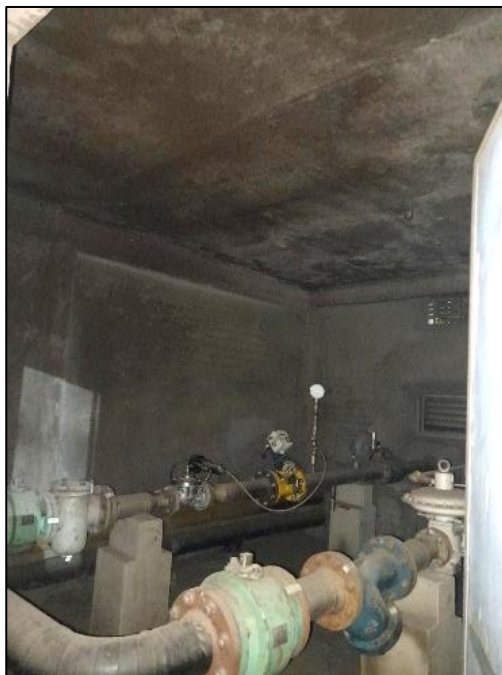
**Observation-19:** Lack of As-built drawing. (RMS Room)

**Description:** The as-built drawing wasn't observed in the building. The building engineer is required to prepare the as-built drawing.

| 31 | Lack of As-built drawing. (RMS Room) | The building engineer is required to prepare the as-built drawing. | within 6 weeks |

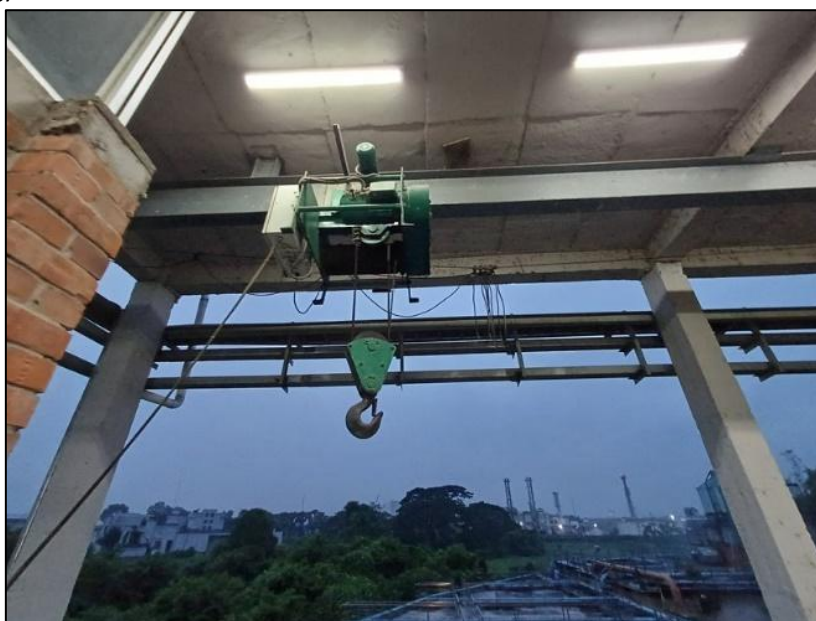
**Observation-20:** Stress in slender columns and crane supported on beam/slab and columns. (3-MLD ETP Building)

**Description:** During inspection, some slender columns were found on ETP. Also, a heavy-loaded crane was supported on beam/slab and columns. However, no assessment report was available on site to confirm the capacity of columns. The building engineer is required to prepare the design report considering slender column & crane loading.

| 32 | Stress in slender columns and crane supported on beam/slab and columns. (3-MLD ETP Building) | The building engineer is required to prepare the design report considering slender column & crane loading. | within 6 weeks |
| 33 | | Carry out remedial work where required. | within 6 months |
