AR-TEX COMPOSITE LTD. (EXTENSION)

Bholail, Kashipur, Fatullah, Narayangonj.

18 November 2024

2. Observation

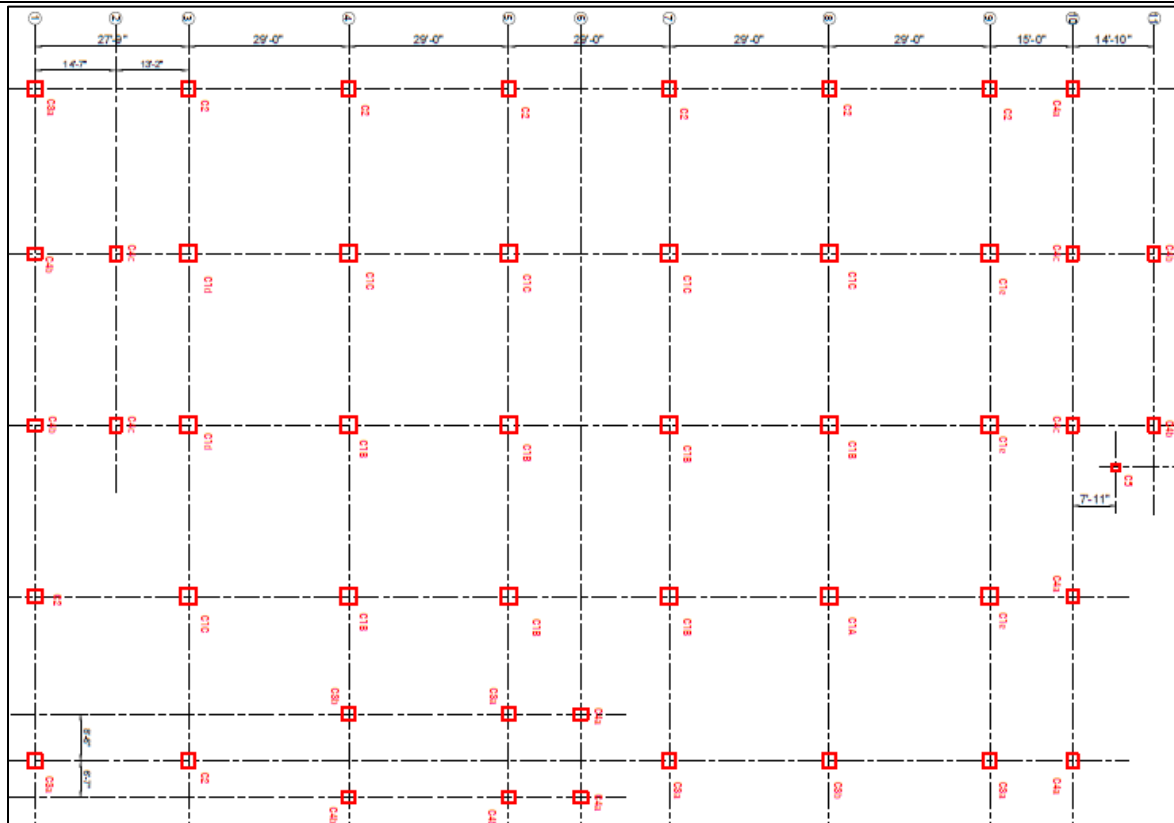
Column layout plan

Observation-1: Stress in column marginally above the design limit and pile load test report.

Description: The cursory calculation indicated that the columns are marginally stressed above the normal design limit considering the prepared live load plan and concrete strength from the core test report. Building engineer is required to review the design load and column stress. Building engineer is required to collect the pile load test report and check the pile adequacy.

Item No.	Observation	Action Plan	Timeline
1.	Stress in column marginally above the design limit and pile load test report. (Building-04).	Building engineer is required to review the design load and column stress as per BNBC 2020.	within 6 weeks

2.		Building engineer is required to collect the pile load test report and check the pile adequacy.	within 6 weeks
3.		Implement the floor loading plan	within 6 weeks

4.		Implement remediation work if required.	within 6 months
5.	Lack of approval drawing from local authority (Building 4 & 5).	The factory is required to collect building permits from the concerned local authority.	within 6 months

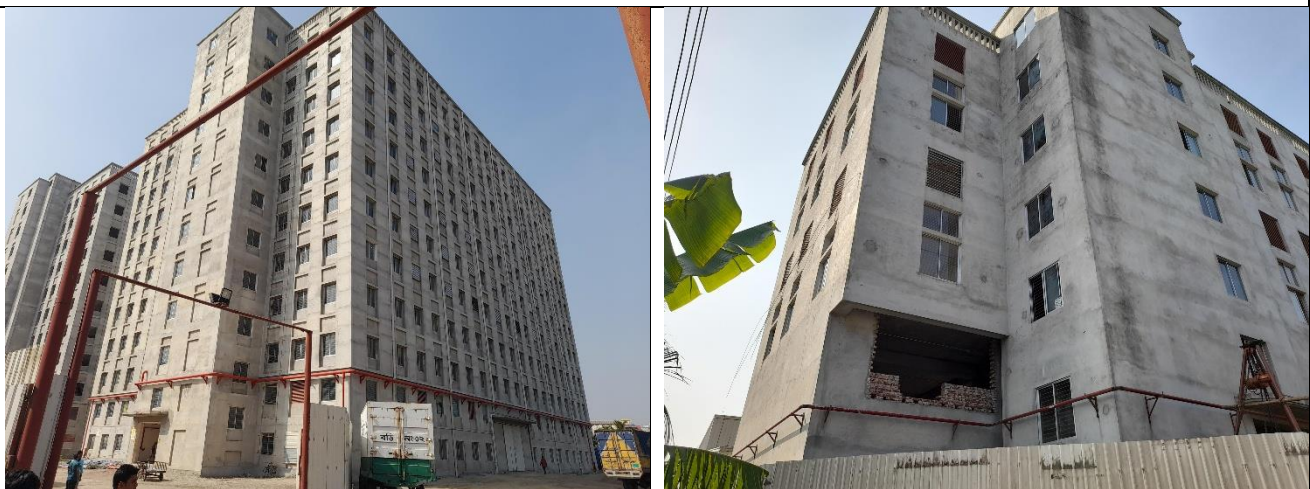
Observation 2: Lack of approval drawing from the local authority. (Building 4 & Building 5)

Description: No approval from local authorities for both Building 4 & Building 5 was available. The building engineer is required to get approval from concerned authorities for each building.

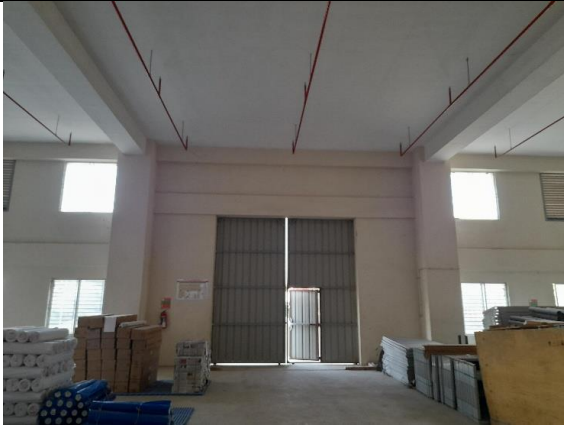
Tie beams with different levels

Description: During inspection, tie beams with different levels were observed on the ground floor. However, structural information for tie beams with different levels was not incorporated in the structural drawing. The building engineer is required to survey the structure and update the as-built drawing as per BNBC.

6.	Lack of information in as-built structural drawing (Building-04).	The building engineer is required to survey the structure and update the as-built drawing.	within 6 weeks

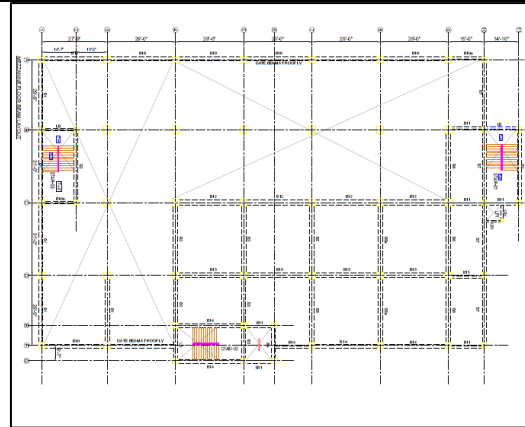
Ground floor beam layout plan

Observation 3: Lack of information in as-built structural drawing (Building-04).

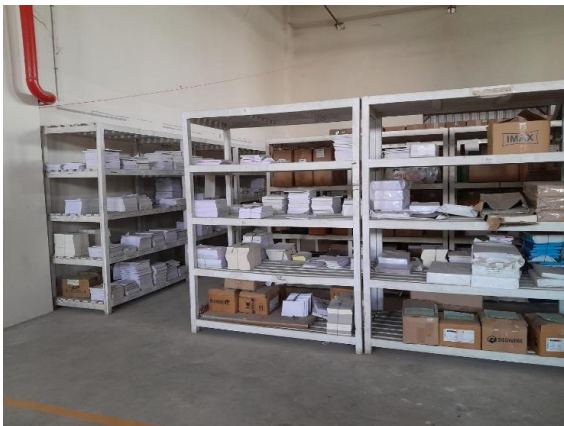
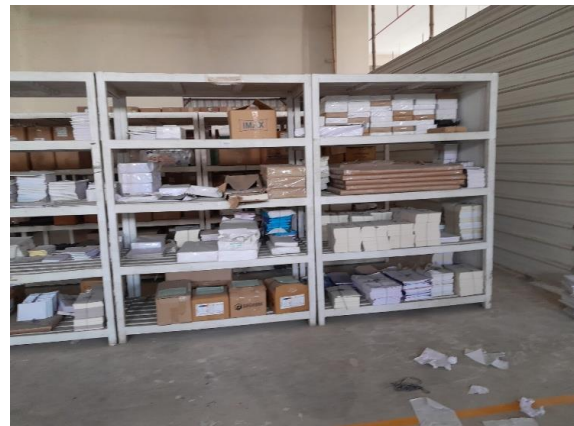
Observation-4: Unbraced storage racks on different floors (Building-04).

Description: Unbraced storage racks were observed on different floors. The building engineer is required to provide anchorage/bracing to the storage racks to protect them from falling hazards.

7.	Unbraced storage racks on different floors (Building-04).	The building engineer is required to provide anchorage/bracing to the storage racks to protect them from falling hazards.	within 6 months

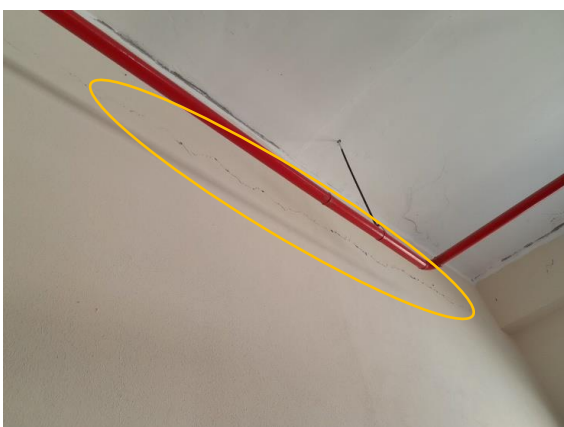
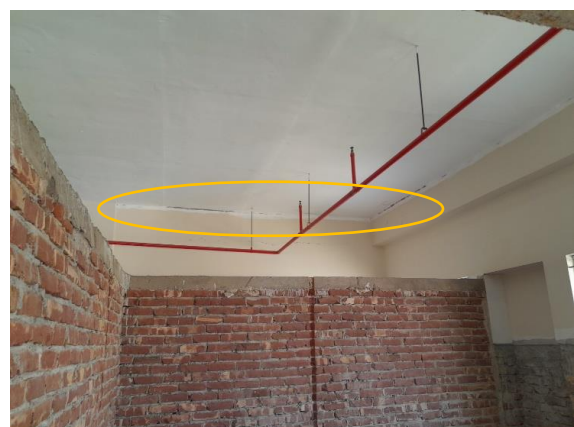
Observation-5: Masonry cracks on walls on different floors (Building-04).

Description: Masonry cracks were observed on walls on different floors. The building engineer is required to investigate the source of cracks and repair them accordingly.

8.	Masonry cracks on walls on different floors (Building-04).	The building engineer is required to investigate the source of cracks and repair them accordingly.	within 6 months

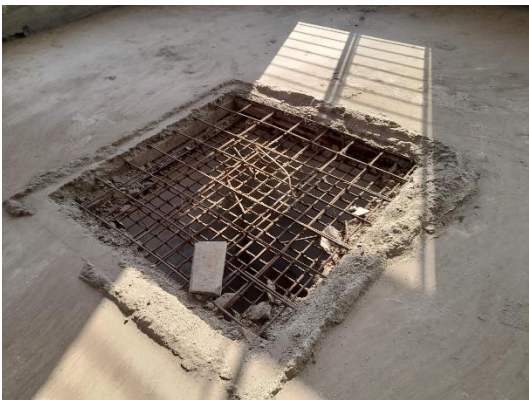
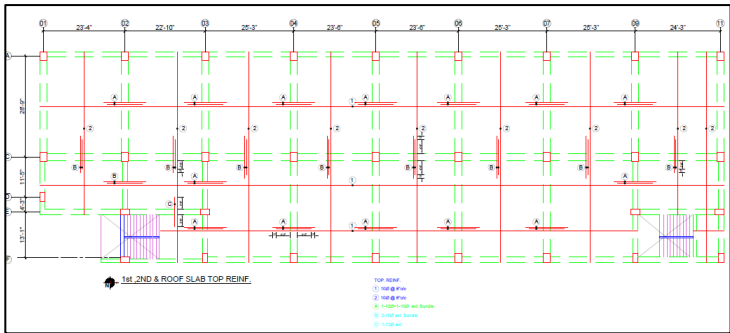
<u>Slab opening on 1st floor</u>	<u>1st floor slab layout plan</u>

Observation 7: Lack of information in as-built structural drawing (Building-05).

Description: During inspection, some slab openings were observed in the 1st floor slab which is not shown in the as-built structural drawing. The building engineer is required to survey the structure and update the as-built drawing as per BNBC.

10.		Implement remediation work if required.	within 6 months
11.	Lack of information in as-built structural drawing (Building-05).	The building engineer is required to survey the structure and update the as-built drawing.	within 6 weeks
