FIRE SAFETY INSPECTION REPORT

**CONTINENTAL GARMENTS IND (PVT) LTD
PLOT 8, WARD 2, BLOCK B, DEWAN IDRIS ROAD,
BORA RANGAMATIA.**

ACCORD
on Fire and Building Safety in Bangladesh

June 3, 2014

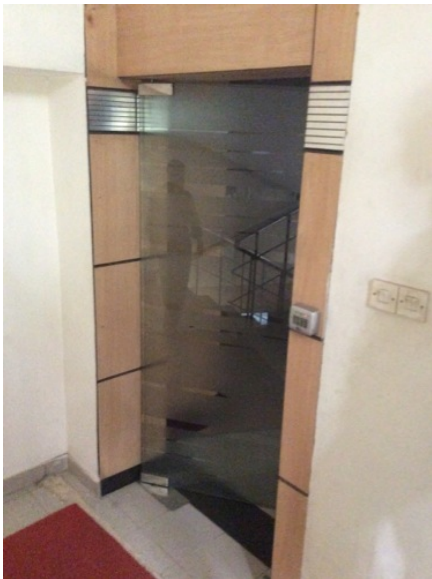
F-1	Fire Rated Construction	The northwest exit stair is not separated from office area at the first floor.	Provide a minimum 1.5-hr fire rated door and seal all unprotected openings to separate the exit stair from the office area in the 1st floor. Ensure that the fire doors are self-closing and positive latching and that they are provided with fire exit (panic) hardware where serving production floors.	Within 3 months
-----	----------------------------	--	--	-----------------

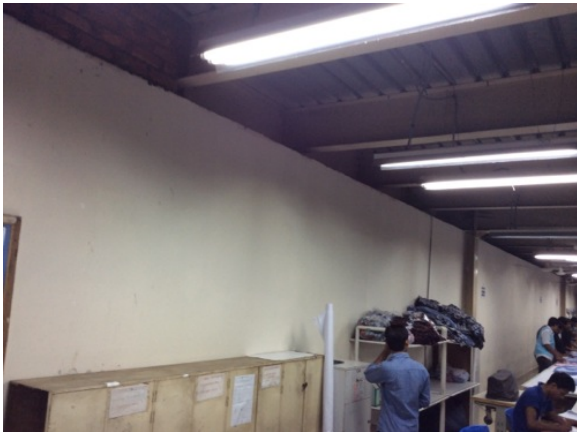
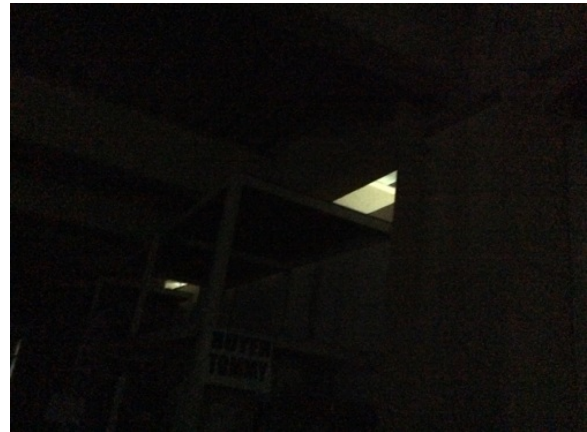
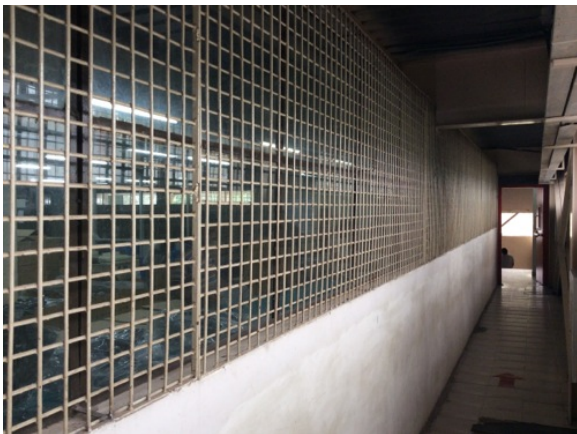
F-2	Fire Rated Construction	Areas used for combustible storage at the ground and first floors are not separated by fire-rated construction.	Provide dedicated storage rooms separated by minimum 1-hr fire-rated construction.	Within 3 months
-----	----------------------------	---	--	-----------------

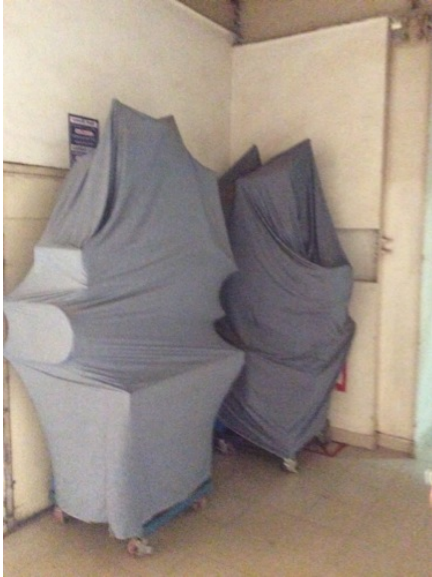
F-3	Egress	Storage was located in the exit stair. Combustible material were located at the bottom of northeast exit stair.	Remove all storage from exit stairs and egress paths.	Immediate
-----	--------	---	---	-----------

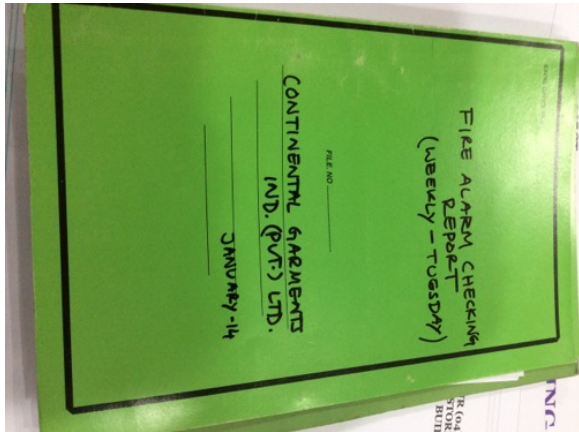
F-4	Egress	<p>Exit capacity is not adequate for the occupant load.</p> <p>2nd and 3rd floors exceed the maximum exit capacity of 796 occupants with an occupant load of 850.</p>	<p>Reduce occupant load to not more than available exit capacity of 796 occupants. In the future provide additional exit to increase occupant capacity.</p>	Immediate
F-5	Fire Protection	<p>Inspection, testing, and maintenance for the fire alarm system was not in accordance with NFPA 72.</p>	<p>Inspect, test and maintain the fire alarm system, and keep written records on-site, in accordance with NFPA 72.</p>	Within 3 months

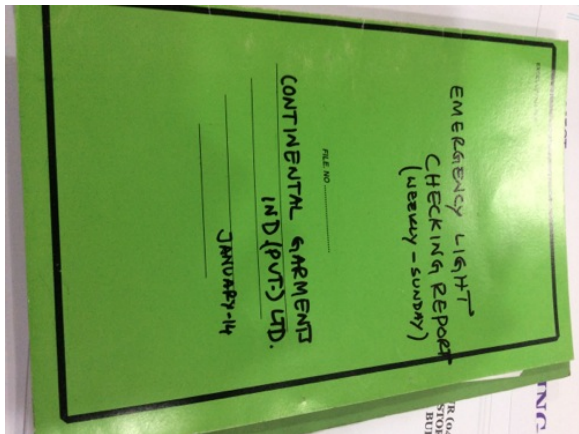
F-6 Egress Lighting

Inspection, testing, and maintenance records for the emergency lighting system were not in accordance of the ACCORD standards.

Inspect, test and maintain the emergency lighting system in accordance with The ACCORD standard. Keep written records on-site.
