# **FIRE SAFETY INSPECTION REPORT**

**EPYLLION STYLE LTD.  
BAHADURPUR, BHAWAL, MIRZAPUR**

**ACCORD**  
on Fire and Building Safety in Bangladesh

May 12, 2014

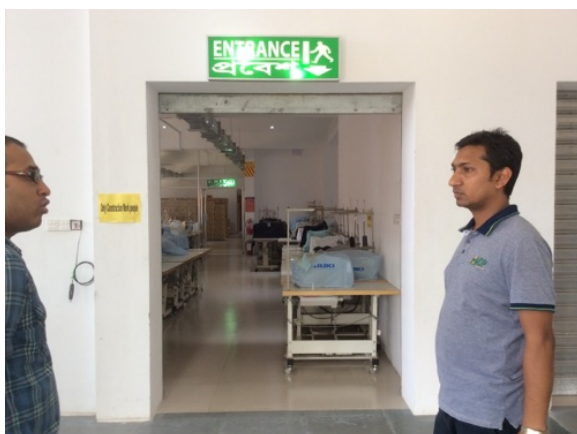
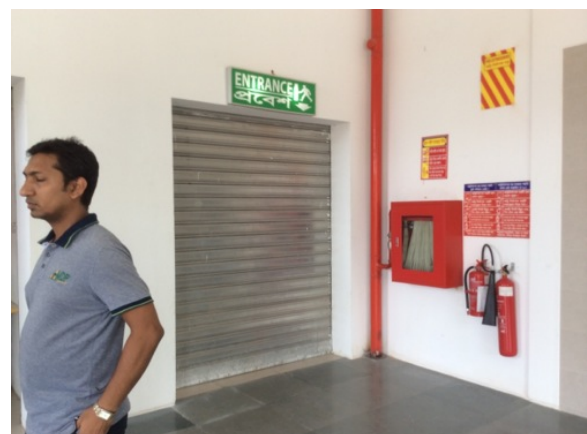
| No. | Category | Finding | Recommendation | Remediation Timeframe |
|---|---|---|---|---|
| F-1 | Fire Rated Construction | The exit stairs are not separated from work areas and other spaces on each floor by fire-rated construction. | <p>Provide minimum 1.5-hr fire rated doors and seal all unprotected openings to separate the exit stairs from work areas and other building spaces on all floor levels. Ensure that the fire doors are self-closing and positive latching and that they are provided with fire exit (panic) hardware where serving production floors.</p> <p>If fire doors are required to be held open for functional reasons, provide automatic-closing devices tied to the fire alarm system.</p> | Within 3 months |

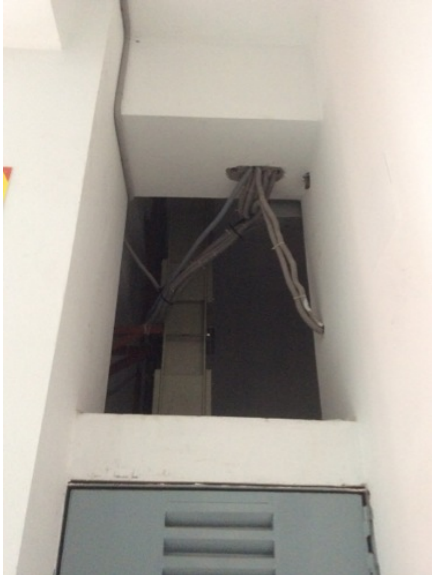
| F-2 | Fire Rated Construction | Unsealed penetrations and openings are located in the fire-rated floor. | Provide a minimum 2-hr fire-rated shaft to separate the utility risers from each floor level. | Within 3 months |

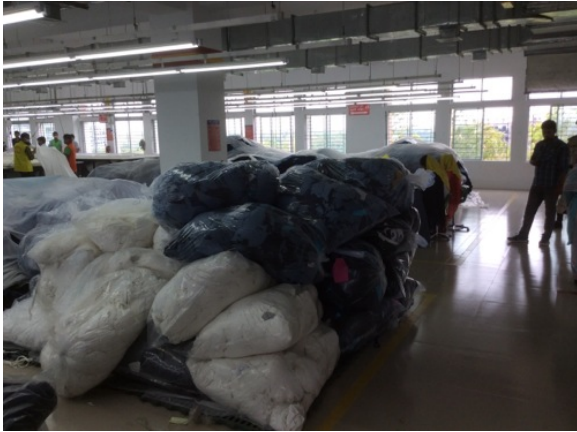
| F-3 | Fire Rated Construction | Areas used for combustible storage on several floors are not separated by fire-rated construction. | <p>Where separate storage rooms are not feasible, provide defined storage areas and limit the storage arrangement as follows:</p> <ul style="list-style-type: none"> <li>- Maximum height of 2.4m and maximum area of 23m<sup>2</sup></li> <li>- If sprinkler protected: maximum height of 3.66m and maximum area of 93m<sup>2</sup></li> </ul> <p>Separate areas of unenclosed combustible storage by a minimum clear distance of 3m.</p> | Within 3 months |

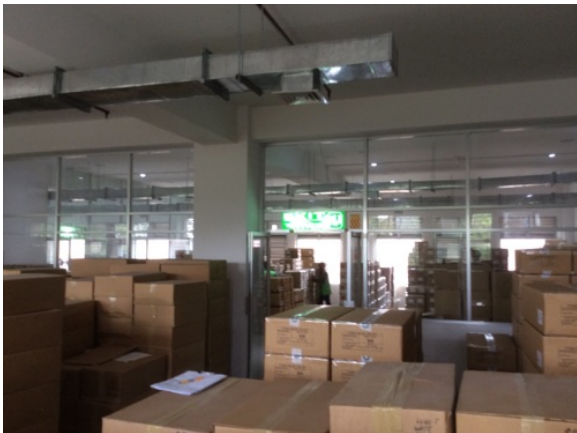
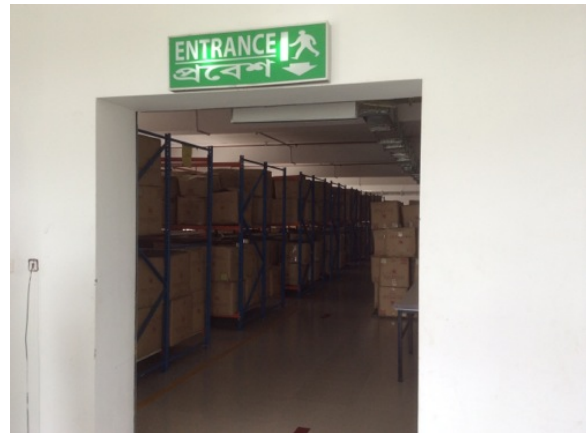
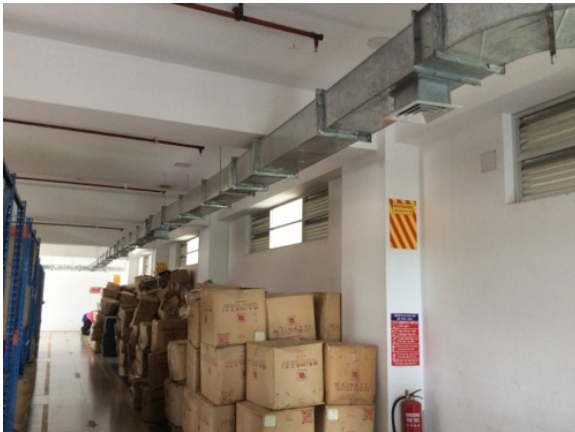
| F-4 | Fire Rated Construction | The storage room on several floors was unsealed penetrations and openings to the interior of the building are located in fire- rated (wall, floor, ceiling) assemblies. | Seal all penetrations and openings to the interior of the building in wall assemblies to maintain the fire separation. | Within 3 months |

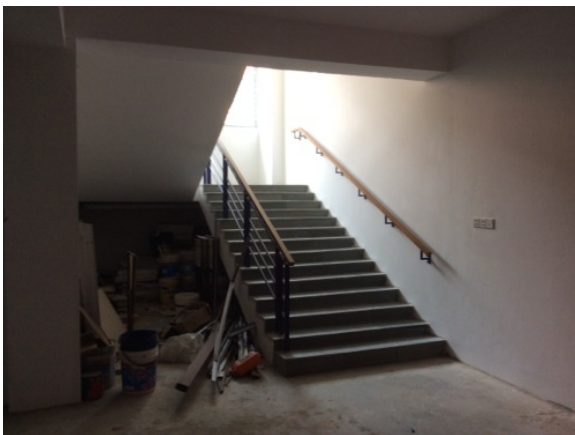
| F-5 | Egress | Storage was located in the exit stair. | Remove all storage from exit stairs and egress paths. | Immediate |

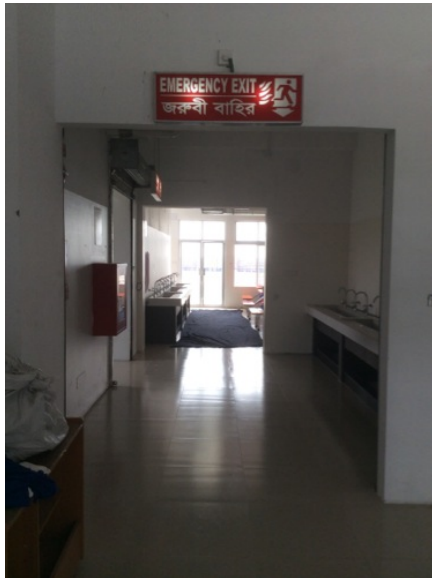
| F-6 | Egress | Egress gates with locking features are provided at north side along egress routes. | <p>Remove locking features from all egress doors and gates.</p> <p>If locks are required for security reasons, utilize special door locking features complying with NFPA 101.</p> | Immediate |

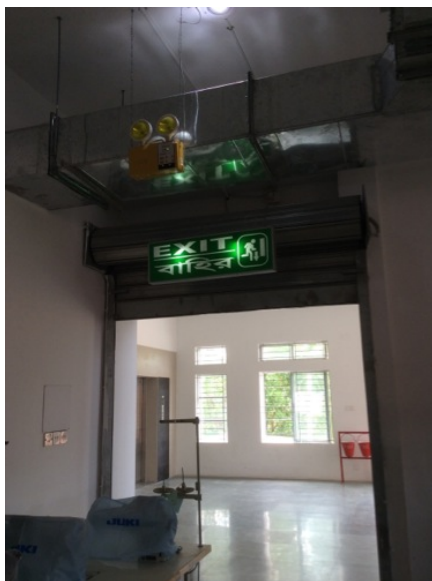
| F-7 | Egress | Sliding doors are provided at exit stairs, along egress routes. | Replace all gates and sliding doors along the means of egress with side-hinged, swinging egress doors. | Within 1 month |

| | | | If locks are required for security reasons, utilize special door locking features complying with NFPA 101. | |

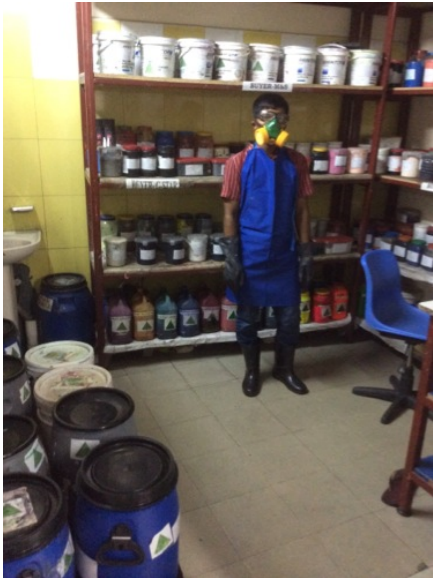
| No. | Category | Finding | Recommendation | Remediation Timeframe |
|---|---|---|---|---|
| F-1 | Fire Rated Construction | Hazardous materials storage area is not separated by fire-rated construction. | Separate the hazardous materials and flammable liquid storage room by a minimum 2-hr fire-rated construction. Seal and protected all openings to maintain the required fire separations. | Within 3 months |

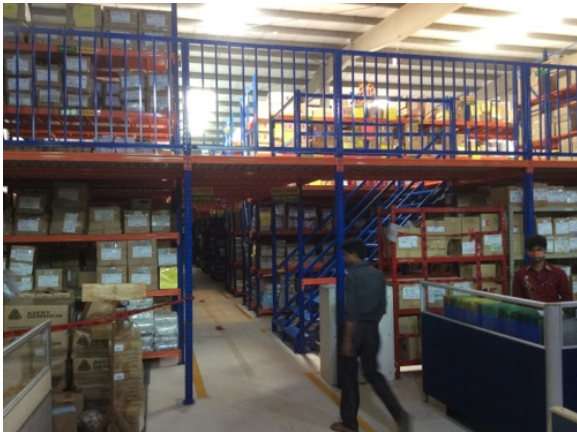
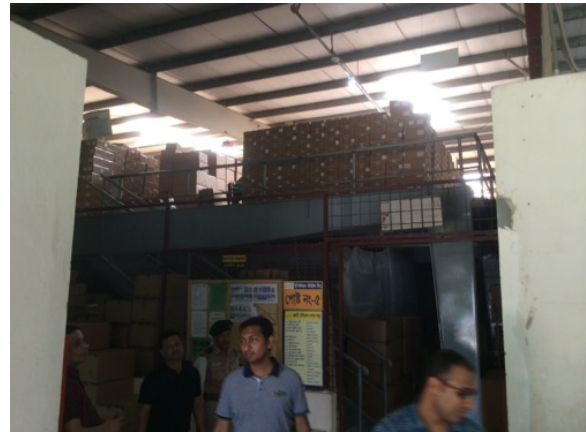
| No. | Category | Finding | Recommendation | Remediation Timeframe |
|---|---|---|---|---|
| F-2 | Fire Rated Construction | Areas used for storage ground floor is not separated by fire-rated construction. | Provide dedicated storage rooms separated by minimum 1-hr fire-rated construction. | Within 3 months |

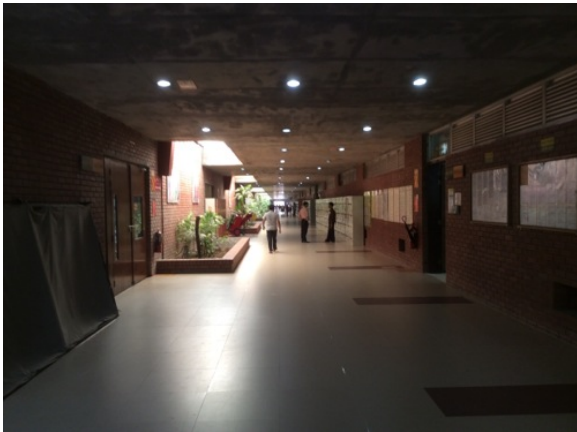
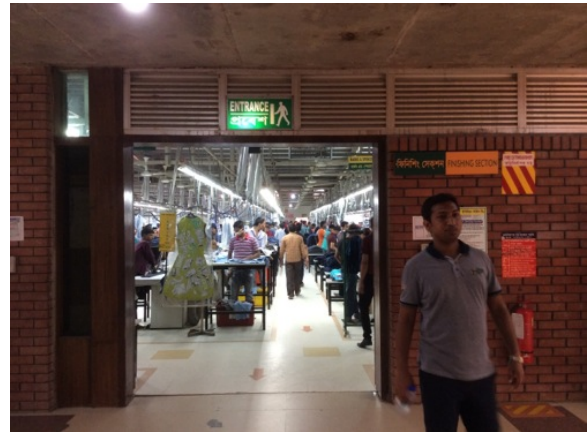
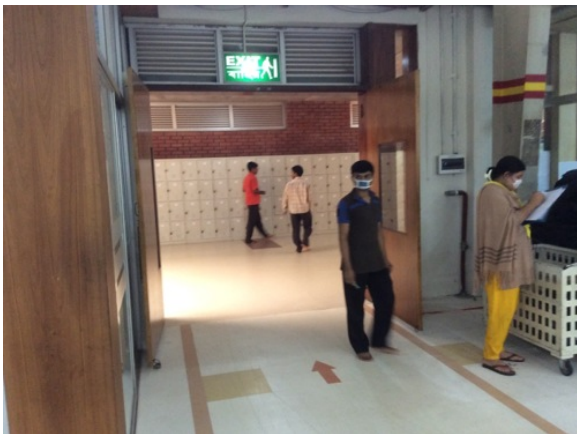
| F-3 | Fire Rated Construction | The corridor is not separated from work areas and other spaces by fire-rated construction. | <p>Provide minimum 1.5-hr fire rated doors and seal all unprotected openings to separate the corridor from work areas and other building spaces. Ensure that the fire doors are self-closing and positive latching and that they are provided with fire exit (panic) hardware where serving production floors.</p> <p>If fire doors are required to be held open for functional reasons, provide automatic-closing devices tied to the fire alarm system.</p> | Within 3 months |

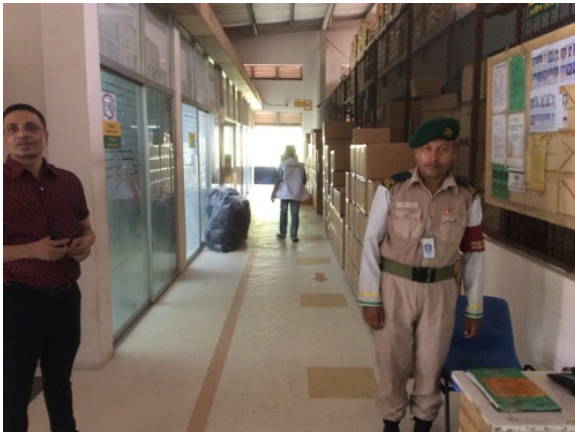
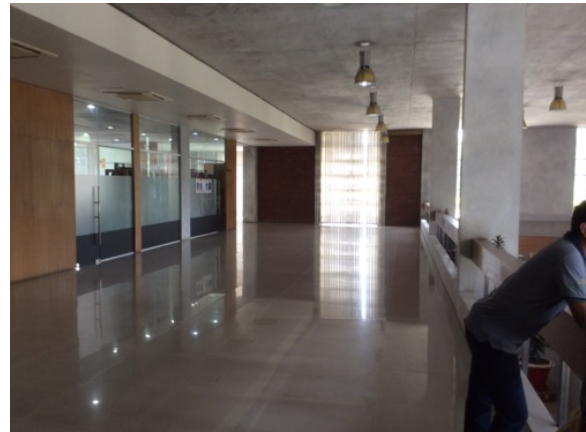
| F-4 | Egress | Common path of egress travel exceeds 30 m.<br><br>Specify locations : SE corner and mezzanine 1.(office area) | Reconfigure the egress arrangement to reduce the maximum common path of travel to not more than 30 m. | Within 3 months |

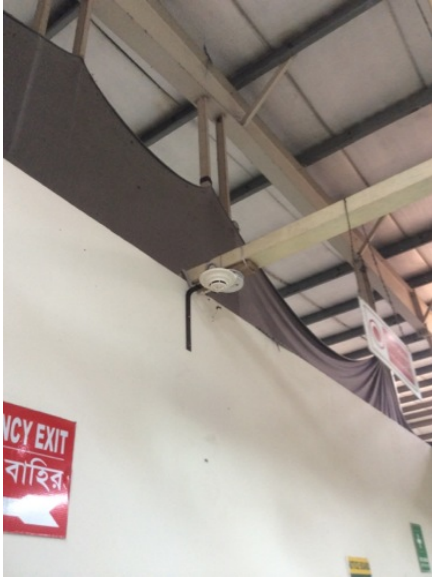
| F-7 | Fire Protection | Based off observations, the existing smoke detectors tied to the fire alarm, heat detectors were not adequately placed. | Based on ceiling configuration, provide additional detectors where needed, and space them in accordance with NFPA 72.<br>Alternatively, when complete sprinkler protection is provided throughout a floor with waterflow devices designed to initiate the alarm notification, smoke and fire detection devices can be eliminated throughout the floor. | Within 3 months |
