# Caesar Apparels Ltd New (Extension)

Yakub Synthetic Building, PBA Road, Moijjartek, Shikalbaha, Upzilla: Patiya, Chattogram  
(22.316036, 91.855888)

9 December 2024

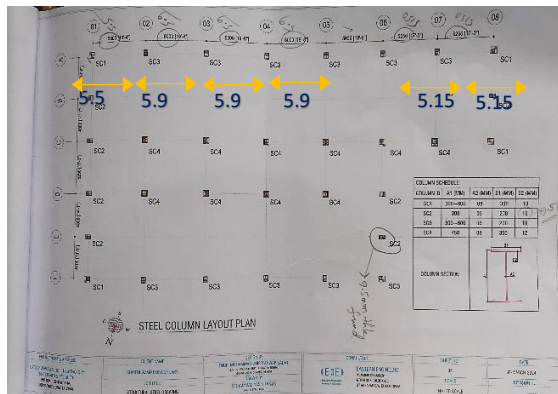
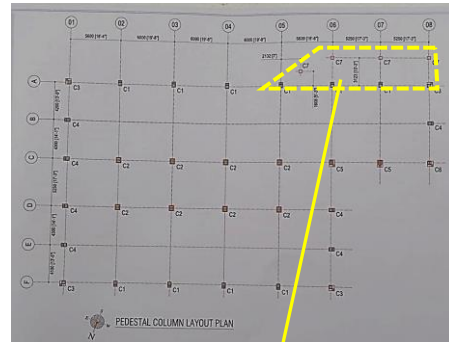
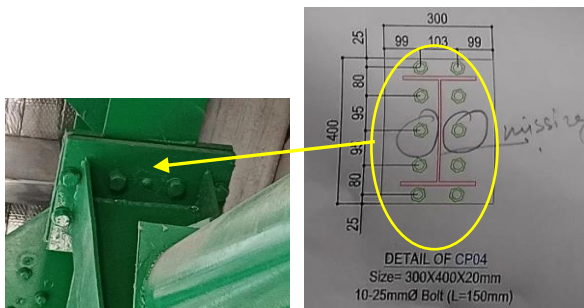
## Observation 02: Discrepancies in the as-built drawings (Production Shed).

**Description:** Discrepancies were found in the CP-04 connection at 1B, 1C, 1D, 1E, 6C, 6D and 6E (no. of bolts found 8 instead of 10 bolts). Also, grid distances were found 100 mm less in all grids except the 05-06 grid along the East-West direction. Furthermore, no structural details (roof members, connection details etc. ) were provided in the structural drawing for the adjacent toilet block. The building engineer is required to survey the whole structure and prepare accurate as-built drawings as per actual site condition.

| SL | Observation | Action Plan | Timeline |
|---|---|---|---|
| 3. | Discrepancies in the as-built drawings (Production Shed). | The building engineer is required to survey the whole structure and prepare accurate as-built drawings as per actual site conditions. | within 6 weeks |

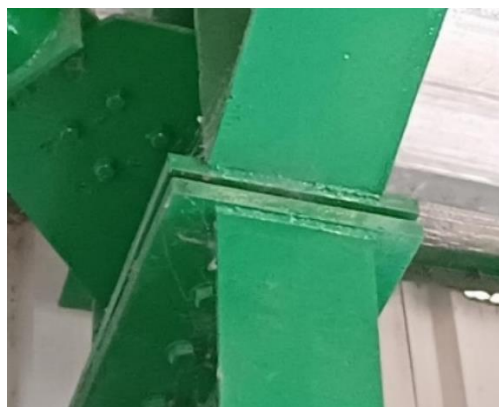
## Observation 03: Connection gap (Production Shed)

**Description:** During inspection, connection gaps were found in beam-column connections. The building engineer is required to repair the connection gap with a suitable method.

| SL | Observation | Action Plan | Timeline |
|---|---|---|---|
| 4. | Connection gap (Production Shed) | The building engineer is required to repair the connection gap with a suitable method. | within 6 weeks |

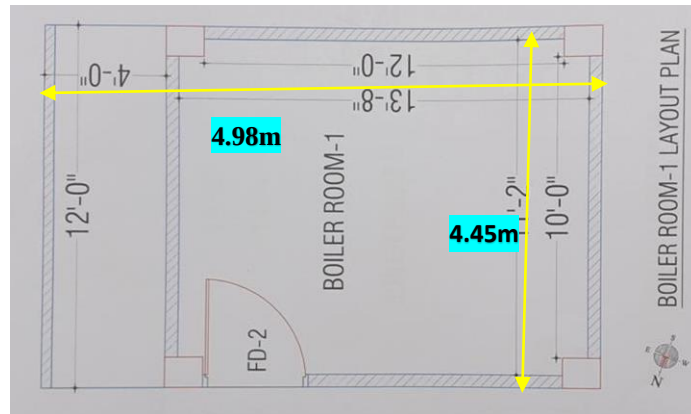
**Observation 04:** Discrepancies in as-built drawings (Boiler Room-02)

**Description:** During the inspection, discrepancies were found in the dimensions of Boiler Room-02 (4.98m found along the East-West direction and 4.45m found along the North-South direction). Also, all side elevations as well as sectional elevations were not provided in the as-built drawing. The building engineer is required to survey the whole structure and prepare accurate as-built drawings as per actual site conditions.

| SL | Observation | Action Plan | Timeline |
|---|---|---|---|
| 5. | Discrepancies in as-built drawings (Boiler Room-02) | The building engineer is required to survey the whole structure and prepare accurate as-built drawings as per actual site conditions. | within 6 weeks |

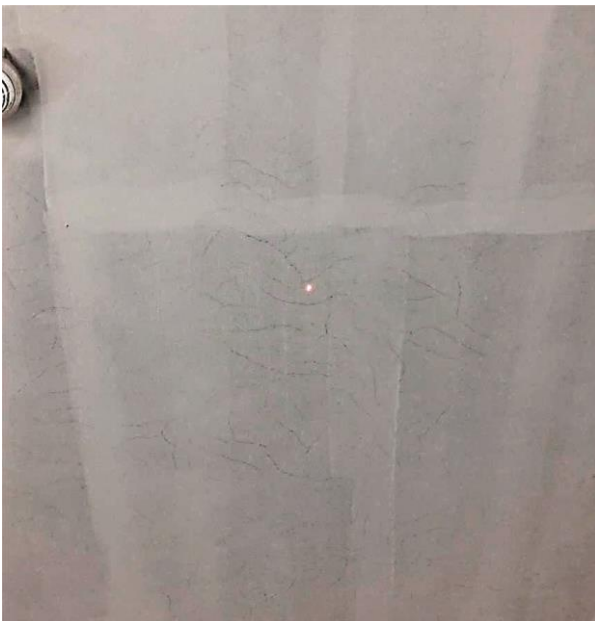
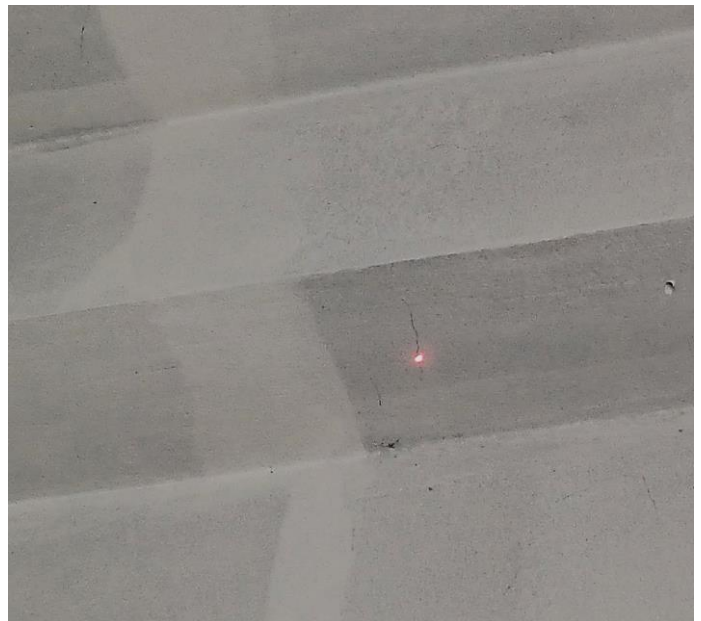
**Observation 05:** Hairline cracks on roof slab and beams (Boiler Room-02)

**Description:** During the inspection, hairline cracks were found on the roof slab and beams. The building engineer is required to investigate the reason and repair the cracks accordingly.

| SL | Observation | Action Plan | Timeline |
|---|---|---|---|
| 6. | Hairline cracks on roof slab and beams (Boiler Room-02) | The building engineer is required to investigate the reason and repair the cracks accordingly. | within 6 weeks |
